Metallurgy of the *RMS Titanic*

Tim Foecke
Metallurgy Division
National Institute of Standards and Technology

Abstract

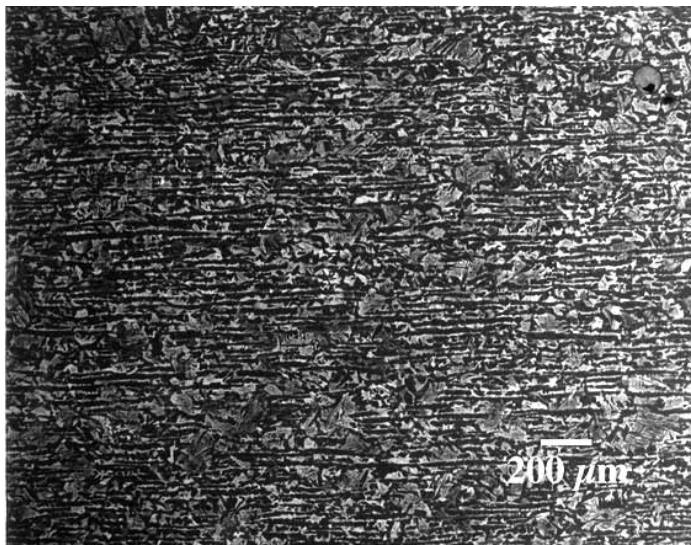
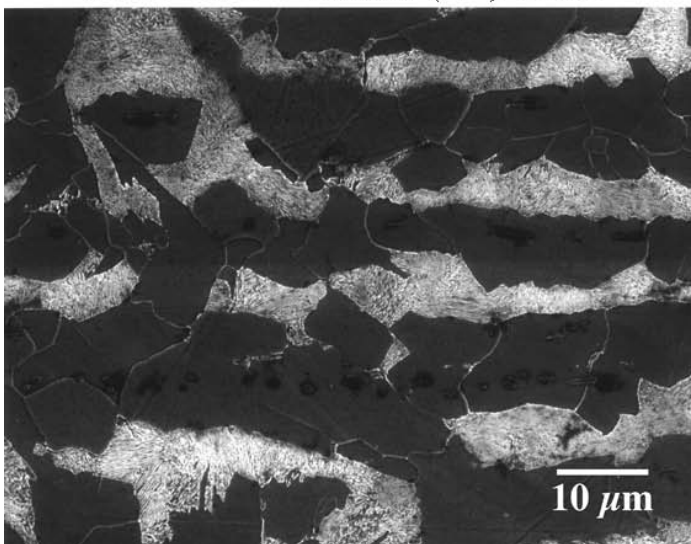
AISI 1018 25mm (1") Plate

A comparable modern steel grade is AISI 1018, which has a similar chemistry and does not possess a specialized microstructure. Micrographs of a modern 1018 steel show a finer grain size, much finer pearlite, and smaller and less numerous rare-earth doped MnS particles. This microstructure is typical of that produced in a modern high-speed mill, followed by a quench and normalization treatment.

Figure 1: Scanning electron microscope image of the polished and etched longitudinal sections of steel from the hull of the *Titanic*, and for comparison a modern hot-rolled 25 mm (1") AISI 1018 plate. Note the differences in grain size, pearlite lamella spacing, and MnS particle sizes.

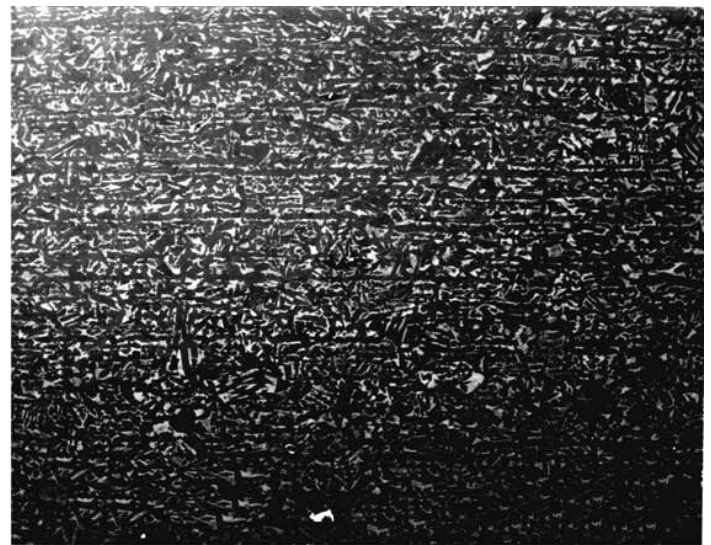
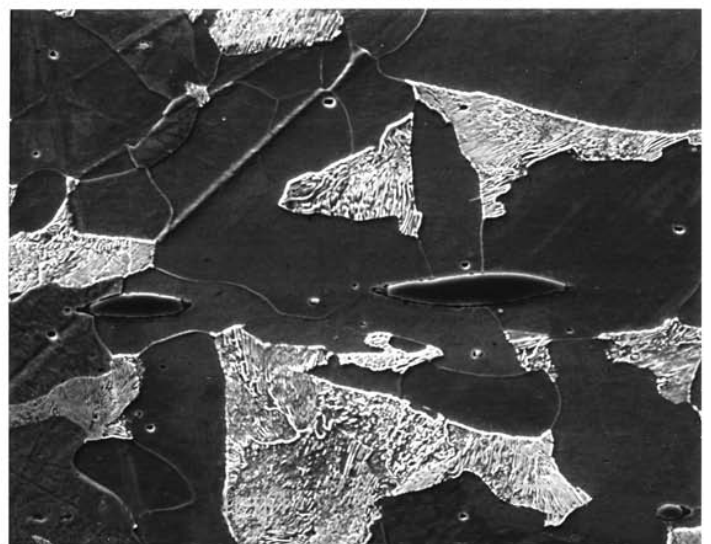
Titanic Hull Plate

Steel samples of all three orientations orthogonal with respect to the rolling plane were polished and etched to reveal the microstructure. A ferrite-pearlite microstructure was seen, with large ferrite grains (ASTM number = 4-5, 100 μm to 130 μm equivalent diameter) and large, coarse pearlite colonies (roughly 0.2 μm lamella thickness, but quite variable). The microstructure shows a large amount of banding in the rolling direction. MnS and oxide particles are evident throughout the material, and were quite large, occasionally exceeding 100 μm in length. The MnS particles were deformed into lenticular shapes instead of being melted into stringers. Given the lack of rare-earth additions to increase the sulfide melting point (see table 2), this indicates a low rolling temperature. The large grain size and coarse pearlite are consistent with air-cooling of the rolled

plate, with no evidence of quenching or normalization treatments evident. All of this evidence is consistent with the production of this plate in a low speed rolling mill, as was the norm in turn-of-the-century Ireland.

A finer microstructure, both in terms of grain size and in pearlite lamella spacing, would have exhibited a significantly higher transition temperature at this composition. This could have been obtained by rolling the steel at a higher speed and temperature, then subjecting the plate to a quench and normalization anneal. However, the concept of notch sensitivity of iron-based alloys was little understood, and the first quantitative ways to begin to evaluate the fracture toughness of a material, among them the Charpy V-notch test [21], was only devised in the five or so years before the

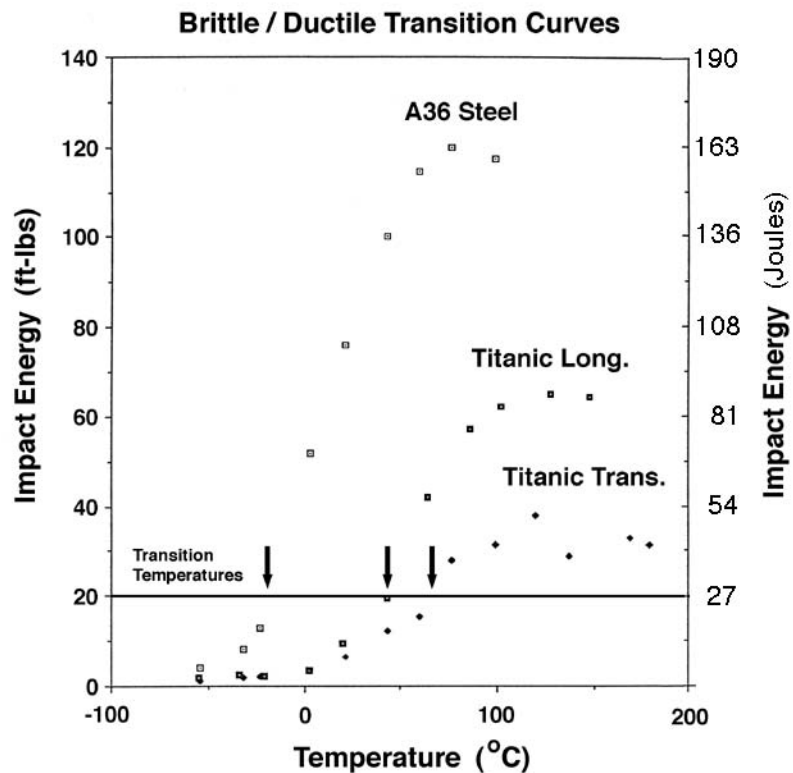
The data produced from tensile tests performed on steel recovered in 1996 [5] and 1991 [2] is shown in Table 1. The uncertainty in this data is unknown. These values are consistent with the design requirements of “15-20 tonnes per inch squared” as specified by Harland and Wolff (the shipbuilder who constructed *Titanic* in Belfast in 1911 [4]). Two groups of Charpy specimens were prepared such that in one group the long direction of the specimens were parallel to the longitudinal direction of the hull plate (LS) and in the second group the long axis of the specimen was parallel to the transverse direction (TL). The adjoining figure compares the experimental results from the Charpy impact test of the *Titanic* hull steel for the longitudinal and transverse rolling directions with a modern ASTM A36 mild steel [7]. Unfortunately for the purposes of a direct correlation of properties and microstructure, the comparison of mechanical behavior was made versus A36 steel, which is chemically nearly identical to AISI 1018 used in the microstructural comparison, but has a more specialized microstructure. Using 20 ft-pounds (27 J.) for the determination of the ductile-brittle transition temperature, the author [5] obtains a transition temperature of -15°C for the modern A36 steel, while the *Titanic* specimens yielded transition temperatures of $+40^{\circ}\text{C}$ for specimens in the longitudinal direction and $+70^{\circ}\text{C}$ for the transverse direction. The transition temperatures for the *Titanic* steel are much above the water temperature of -2°C at the time of the ship-iceberg collision [1].

Figure 2: A plot of the impact energy measured by the Charpy test versus temperature for two different orientations for the *Titanic* hull steel, as well as modern A36 (which is chemically and microstructurally very similar to AISI 1018). The transition temperature is marked for each series of samples, and is defined as that temperature where the sample exhibited 20 ft-lbs (27 J.) of energy. Data from reference [5]. The uncertainty in the data is unknown.

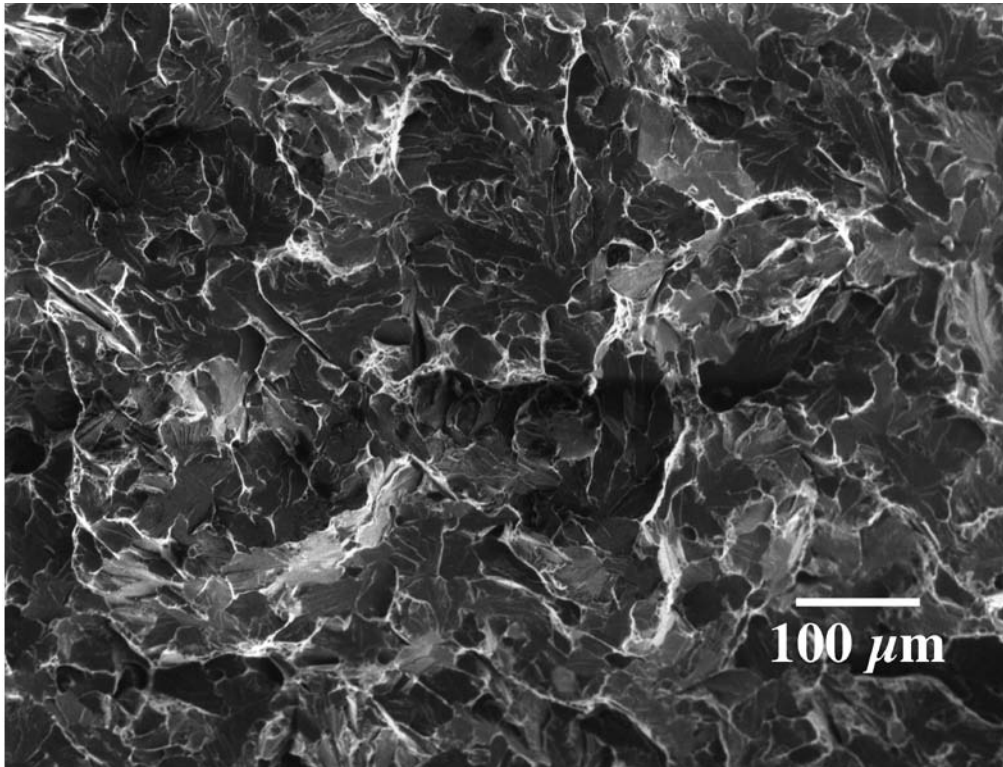
Fracture surfaces cut from the Charpy test specimens tested from the 1996 plate were examined in the scanning electron microscope. Fracture was entirely transgranular (figure 3), with no evidence of fractured grain boundaries. This is significant, in that if the cause of limited fracture ductility of the steel (as evidenced by the absence of microvoids) had been sulfur embrittlement, we would expect sulfur segregation to the grain boundaries and intergranular fracture facets. At ice-brine temperatures, the fracture was nearly entirely brittle, with the ductile portion of the fracture surface estimated to be less than 5 percent (figure 4). Cleavage patches on the surface, made up of 4 to 15 cleaved grains, were seen to originate at fractured MnS particles, as evidenced by tracing river lines on the facets. This indicates that in some cases the MnS particles acted as initiators, but the incidence of these nucleated patches amounted to less than 10% of the surface area of the Charpy bar fracture surface.

Figure 3: SEM fractograph of Charpy bar fracture surface (LT) from a sample fractured at 0° C. Note the presence of cleavage facets and absence of fracture grain boundaries. One or two cleavage patches nucleated by MnS particles can be identified in this image.

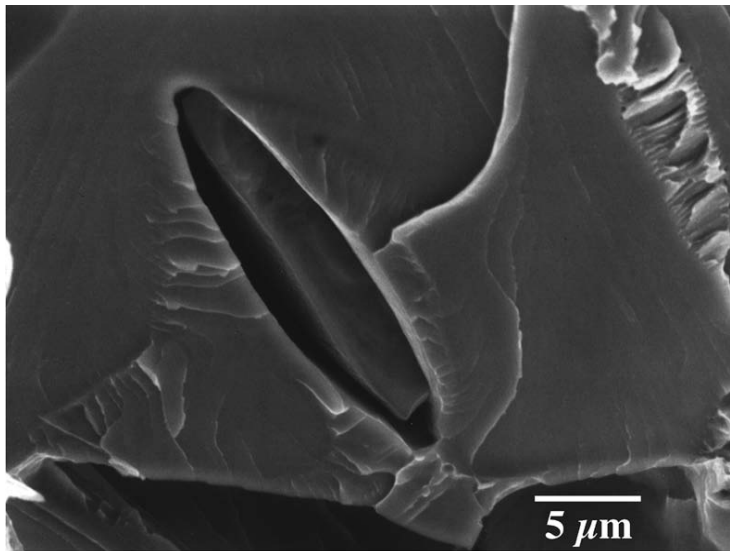
Figure 5: SEM fractograph showing the MnS particle that fractured and nucleated a patch of 15 cleaved grains. This was determined by tracing river lines within the patch. Note the lenticular shape of the particle, the cleavage river lines emanating from the particle, and the fractured course pearlite colony in the upper right corner.

The presence and large size of the MnS particles are considered deleterious to fracture resistance, as they act as crack initiators within the steel at temperatures near the lower shelf [19]. It was seen that the plate recovered in 1996 exhibited 5% ductile fracture during Charpy tests at ice-brine temperatures, and that MnS particles, upon examination of the fracture surface, nucleated a few patches of cleavage. However, the plate recovered in 1991 was 100% brittle even at room temperature [20], placing it firmly in, not near the lower shelf regime. Thus MnS particles would have little to no effect on toughness in this plate. The presence of MnS particles and their effect on crack growth have been found to be much more important at high temperatures than lower temperatures. Their effect on the fracture behavior of both the material in this study as well as the 1991 study [2] are considered negligible. Although cleavage patches have been identified on the fracture surface as having come from the fracture of a MnS particle, and thus the formation of a process-zone would have begun, the occurrence of this was relatively rare. It is believed that the fracture mechanism that controlled at -2°C would have been weakest-link [18], where the first fractured microstructural feature would have precipitated failure. And as the population of large carbides, in the form of thick pearlite lamella, is many times that of large sulfides, it is more likely that a fractured carbide would precipitate failure.

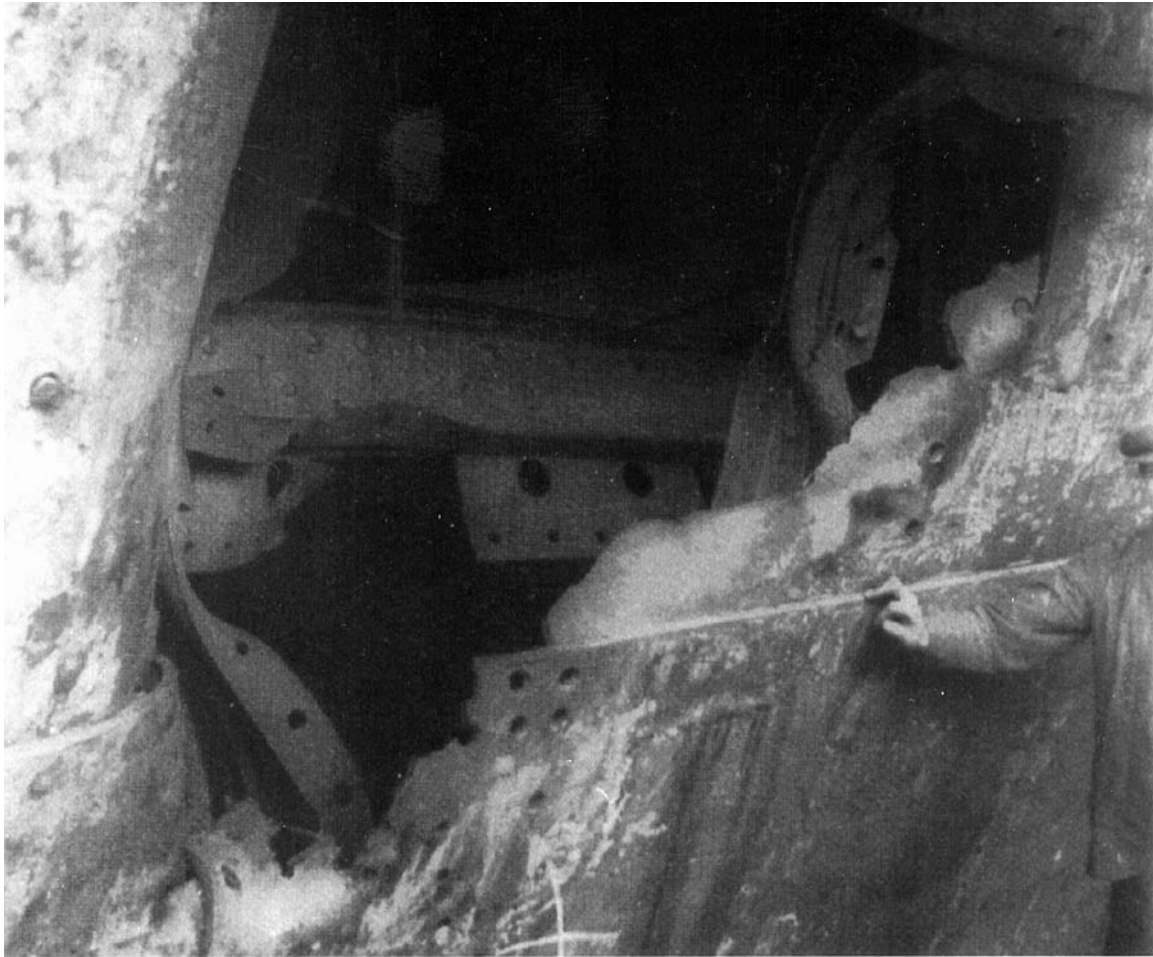
ship with the iceberg at 20+ knots would have occurred at strain rates more in line with a Charpy impact test. At this rate, the steel would exhibit more brittle behavior. Additional evidence comes from photographs of damage to the *Titanic*'s sister ship, *RMS Olympic*, after collision in Belfast harbor with a Royal Navy cruiser, *HMS Hawke* [25] (figure 5). A close examination of the photos show considerable bending of the plates around the hole, while reports of the physical damage include a mention of a triangular piece of hull that fractured into the ship. This would be consistent with a high strain rate impact causing fracture, and then progressively slower deformation as the two ships pressed together, causing bending instead of cracking.

Figure 6: A close-up of the damage to the *RMS Olympic* due to collision with the *HMS Hawke* in the Solent in 1911. Note the man for scale. A considerable amount of plasticity in the hull plates is indicated by the bending and twisting seen in the picture. Note missing rivets. Photo from [25].

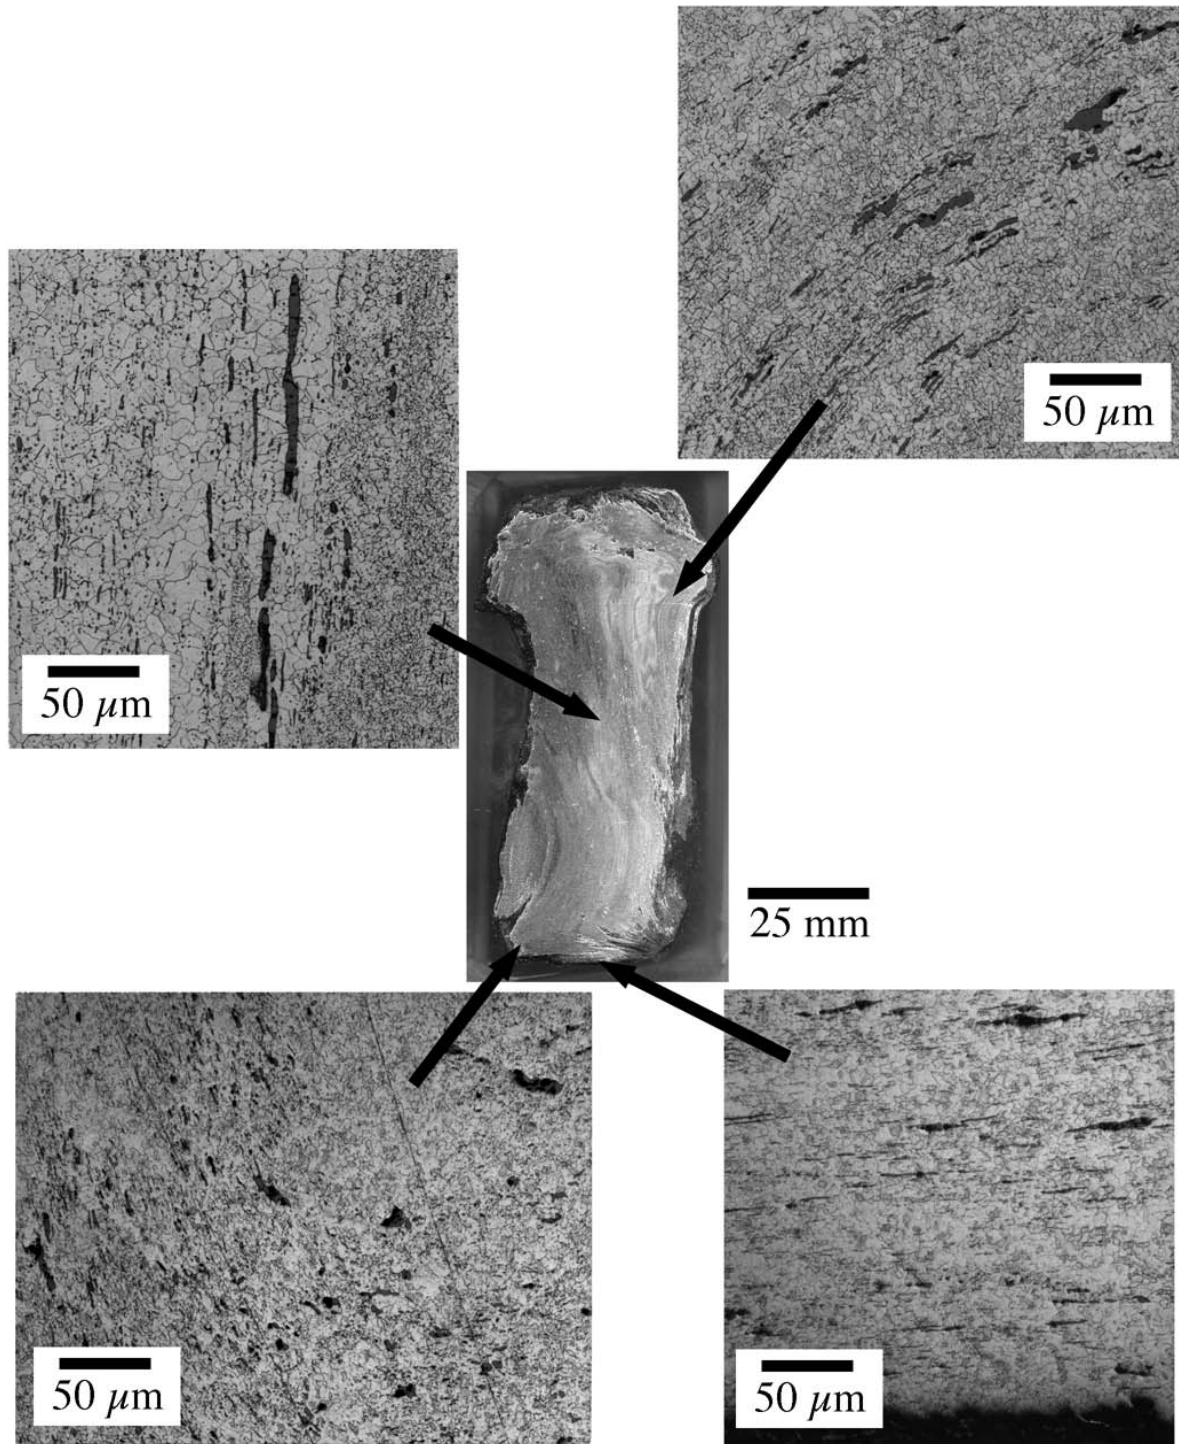
These rivets were made of wrought iron, which consists of a relatively pure iron matrix containing 2-3% (by volume) iron silicate slag. A micrograph of the structure can be seen in figure 7. Quantitative metallography was performed on a cross-section of a hull rivet that had been cut and polished. This showed that this rivet contained 9.3% \pm 0.3% slag on average, which is more than 3 times the amount normally expected in wrought iron [27]. This slag had an almost bi-modal-type distribution of sizes, ranging from a large amount in very long stringers ($>200\text{ }\mu\text{m}$ long) to a large number of small oblate spheroid particles ($1\text{ }\mu\text{m}$ to $5\text{ }\mu\text{m}$ diameter).

The two hull rivets in possession have been sectioned and examined. Both exhibit the above-mentioned orientation distribution of slag stringers within the rivet, an increased amount of incorporated slag, and are both missing the inner head. These metallurgical factors would have degraded the mechanical performance of the rivet. If additional samples are obtained during an expedition planned for August of 1998, further work will be performed to determine if this was a major factor in the sinking of the ship. Rivets from an intact section of a lap joint will be sectioned to see if rivets that did not fail contain elevated slag levels and transversely-oriented slag stringers. It is important to reiterate that only two rivets have been sectioned to date, out of 3,000,000, some minority percentage of which held the hull together.

Figure 7: Montage of micrographs showing the orientation of silicate slag at various locations within a cross-section of a *Titanic* hull rivet. Note that in the upper pre-formed head (formed onto a hot rod of wrought iron prior to cutting the rivet to length), the slag spreads out evenly into the head like the branches of a tree. At the bottom, where the inner head popped off, very near the fracture surface the stringers are oriented perpendicular to the tensile axis. This occurred presumably when the inner head was formed.
