Pathological Manifestation and Restoration Procedures Analysis of the Historic Building, located in Belém-PA

Catarina de Nazaré Pereira Pinheiro, Adriene Rodrigues Barbosa.

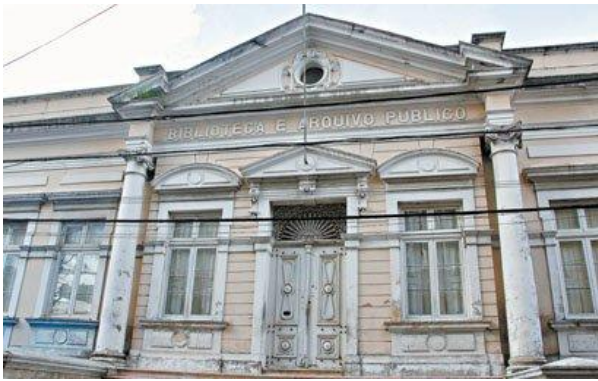
Despite its historical and cultural significance, the building that shelters the archive was in a precarious situation (Fig. 3). In 2012, due to problems with of vulnerability of the installations, presence of humidity and lack of proper labor conditions, a group of historians mobilized a public act in favor of the protection of the documents and

Fig. 03: Library Arquivo Público in 2014 (Source: Agência Pará)

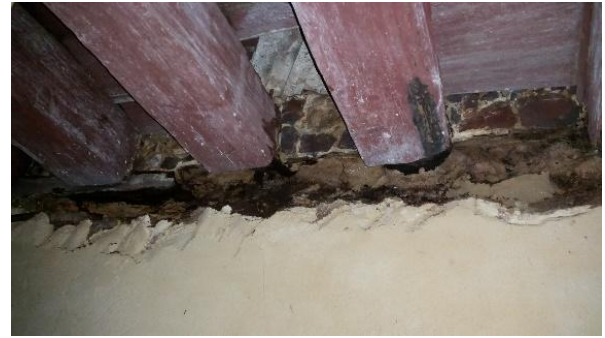
The main structural issues identified in the building were related to the ground floor's support beam (Fig. 4), shears, rafters and slats supporting the roof (Fig. 5), lintels for crack prevention. All these structures were made of wood, and the main cause for the pathologies were biological agents (termites).

The wooden structures were widely used during the period the building was constructed (19th century) due to the high availability in the market. According to [4] the wood is a hygroscopic material, that is, it is able to absorb water either by chemical or physical reactions. Therefore, this material has many disadvantages such as the greater susceptibility to biotic agents like xylophagous insects [6]. In site, they were found termites nests inside the previously mentioned structures.

Fig. 4: Floor's support beam (Source: Author's Collection, 2014)

To solve the pathologies found in the support beams, shears, rafters and slats supporting the roof and lintels, it was performed a termite termination, replacement of the compromised pieces and reinforcement of the damaged beams and shears with metal sheets. (Fig. 10 and 11)

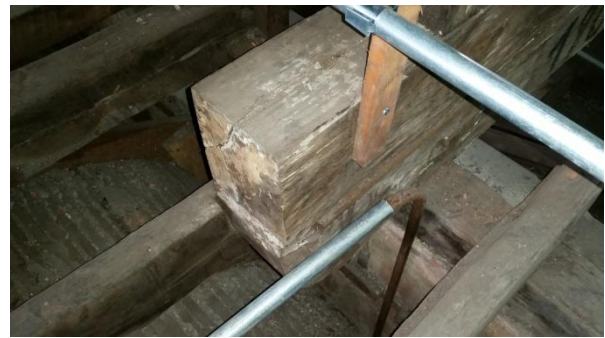
Fig. 5: Slats supporting the roof (Source: Author's Collection, 2014)

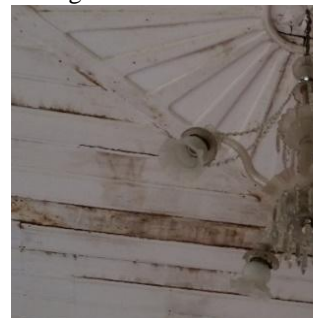
The wooden ceiling on the ground floor was damaged due the presence of humidity coming from the leaks on the roof (Fig. 6). The plaster ceiling at the main room was also damaged due to water infiltration.

Fig. 6: Ceiling (Source: Author's Collection, 2014)

The damaged pieces of the ground floor wooden ceiling were replaced, grinded and repainted. The plaster ceiling had its damage parts repaired and the frames were rebuilt. (Fig. 19)

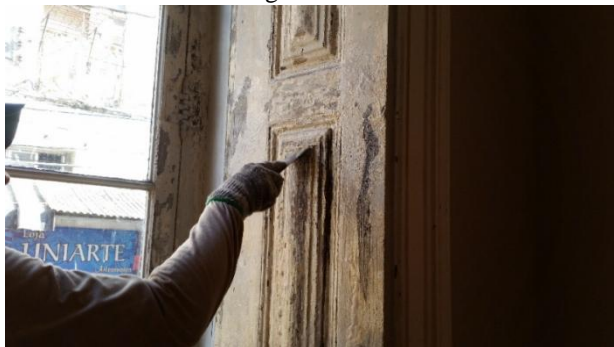
Most of door and window frames of the building had pathologies related to abiotic and biotic agents, presence of humidity and termite proliferation (Fig. 7). Moreover, most of the hardware was damaged.

Fig. 7: Window Frame (Source: Author's Collection, 2014)

To solve the pathologies encountered in the door and window frames, it as performed a termite termination, replacement of the damaged pieces, removal of the painting with spatulas and chemical products, puttying, grinding and painting of the frames.

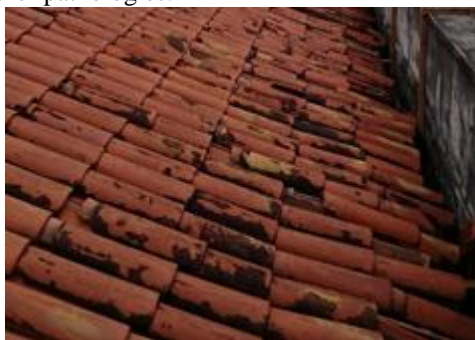
The building's roof showed precarious conditions due to damage roof tiles, absence of waterproof cover and gutter (Fig. 8). These pathologies increased the occurrence of infiltrations inside the building, being the main cause for many other pathologies.

Fig. 8: Roof (Source: Author's Collection, 2014)

The pathologies found on the roof of the building were fixed through the application of an asphaltic membrane (Fig. 21), replacement of damaged titles and cleansing of the roof pieces. Furthermore, it was constructed a metal gutter to channel the rainwater. (Fig. 22)

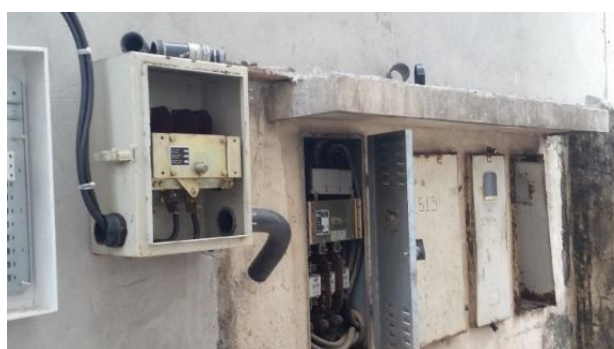
The electrical installations were in a bad conservation state (Fig. 9), threatening the collection in the building due to the increased risk of fire. This condition was worsened due to the inefficiency of the firefighting system. Concerning the hydraulic installations, the absence of a drainage system stands out. The cooling system was ineffective in the basement, which harmed the proper conditioning of the documents.

Fig. 9: Electrical installations (Source: Author's Collection, 2014)

The electrical installations were replaced and adjusted to today's pattern. In addition, it was created a system to prevent damages caused by electrical discharges (Fig. 23). The firefighting system and cooling system were adjusted. A drainage system was built, and the hydraulic installations were realigned to match the alterations made in the original project. (Fig. 24)

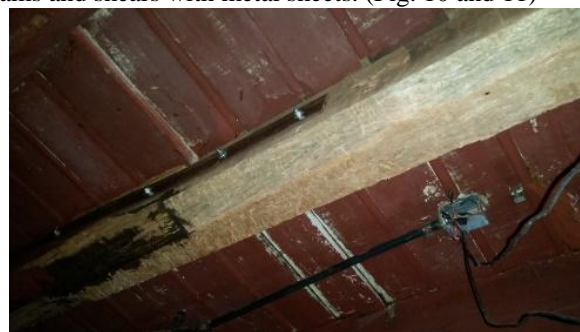
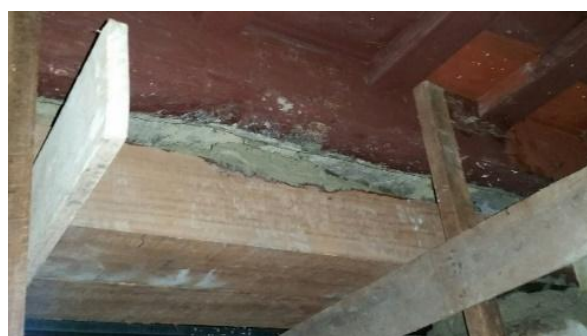
Fig. 10: Support beams (Source: Author's Collection, 2014)

Fig. 11: Support beams (Source: Author's Collection, 2014)

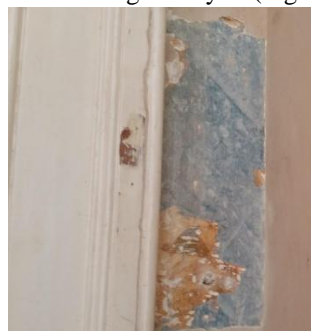
Fig. 12: Layers of wall (Source: Author's Collection, 2014)

The continuity of the constructive techniques was necessary to maintain the historical heritage. To evaluate the best restoration method, it was developed a diagnosis through the sampling of the original material and subsequent laboratory analysis. This procedure was used for both internal and external plaster. To select the paint, the method was the prospection, removing all the layers of wall paint to find the original layer. (Fig. 12)

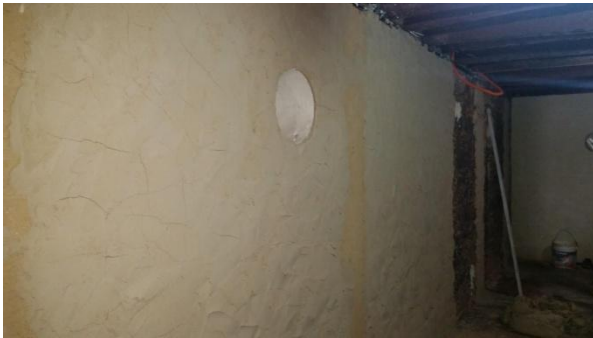
Fig. 13: Basement walls (Source: Author's Collection, 2015)

After evaluation of the ideal mix design of the plaster for the stone base, the walls of the basement level were plastered using lime, cement and clay, approaching the executive process used in the historical period of the construction, finishing with sealer to maintain the rustic original appearance (Fig. 13). On the ground floor, the damaged original plaster was removed and a new plaster was executed, removing the superficial layer of paint, puttying and painting the walls. (Fig. 14)

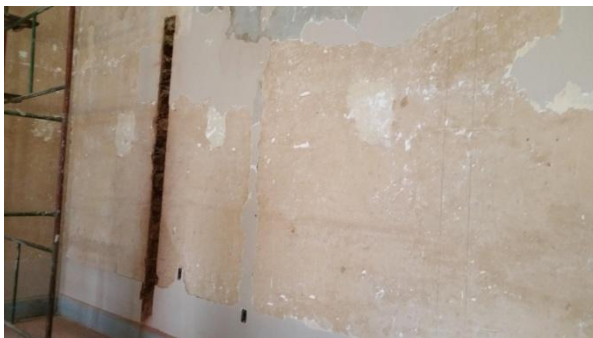
Fig. 14: Walls (Source: Author's Collection, 2015)

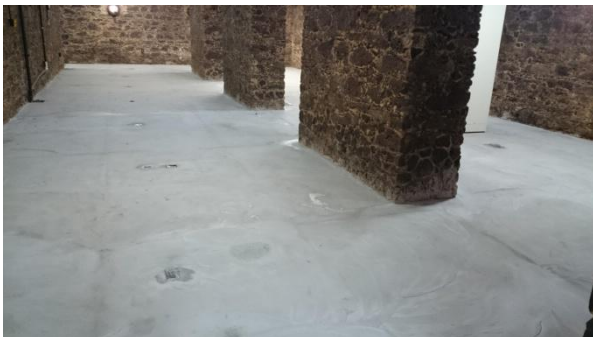
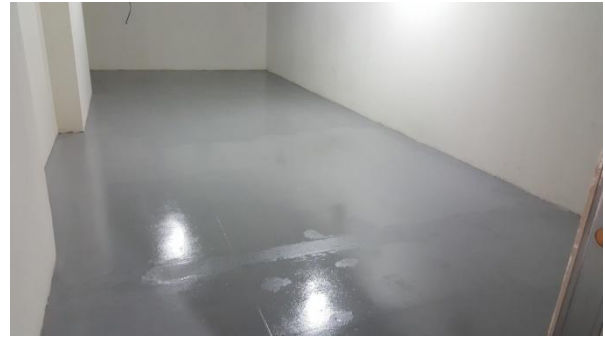
Fig. 15: Korodur floor (Source: Author's Collection, 2014)

Fig. 16: Application of floor resin (Source: Author's Collection, 2016)

Due to the high compromising of the korodur floor, it was applied a new layer of the material mixed with cement and water. After the curing process, the floor was polished, and a floor resin was applied to facilitate the maintenance. (Fig. 15 and 16).

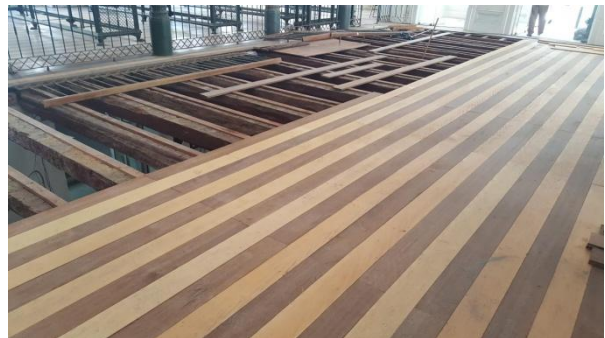
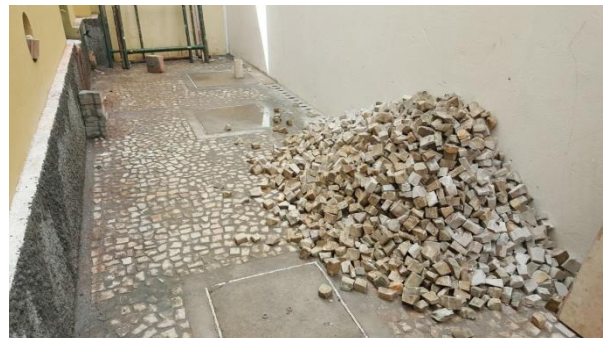
Fig. 17: Wood floor (Source: Author's Collection, 2016)

Fig. 18: Floor in Portuguese stone (Source: Author's Collection, 2016)

Concerning the wooden floors, the technique used was the replacement of the deteriorated pieces, application of abrasive papers, caulking, polishing, finishing with a layer of wood varnish. The leveling of the floor in Portuguese stone was performed in the external area through the removal and subsequent cleaning of the pieces, compaction of the sand layer and replacement of the clean pieces (Fig. 17 and 18).

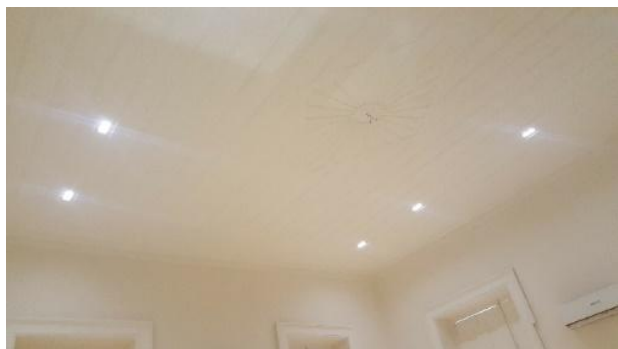
Fig. 19: Ceiling (Source: Author's Collection, 2016)

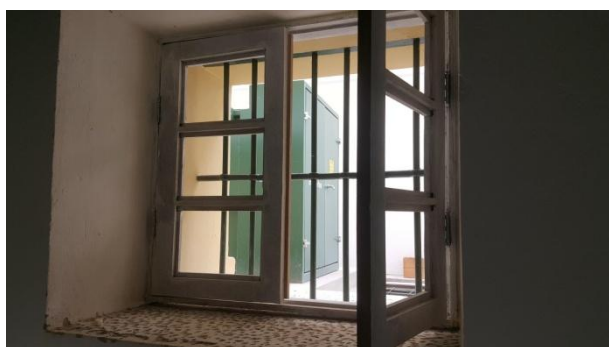
Fig. 20: Restoration of windows (Source: Author's Collection, 2015)

Moreover, the hardware was replaced to match the original design of the building, according to architectural studied made.

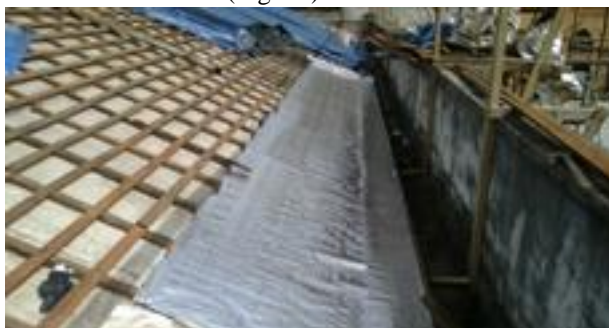
Fig. 21: Application of an asphaltic membrane (Source: Author's Collection, 2014)

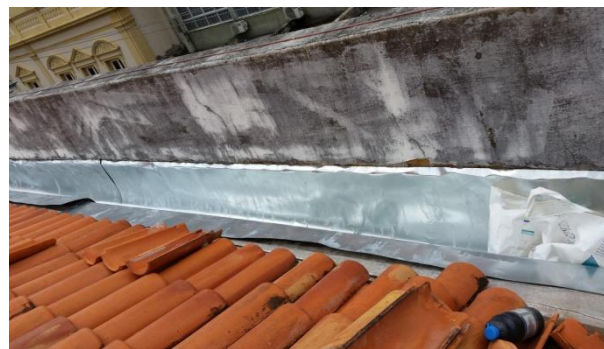
Fig. 22: Metal gutter (Source: Author's Collection, 2015)

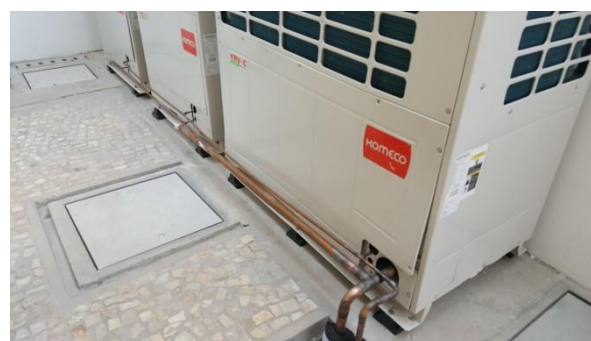
Fig. 23: Electrical Buildings (Source: Author's Collection, 2016)

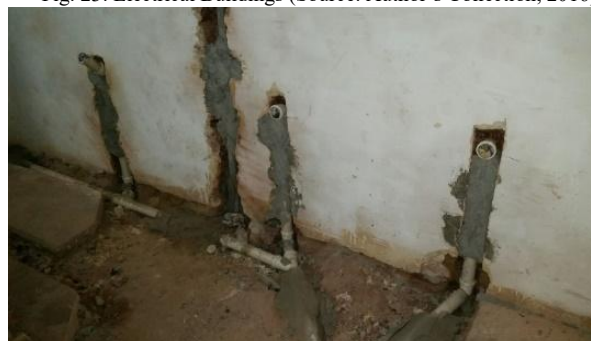
Fig. 24: Hidraulica Buildings (Source: Author's Collection, 2016)

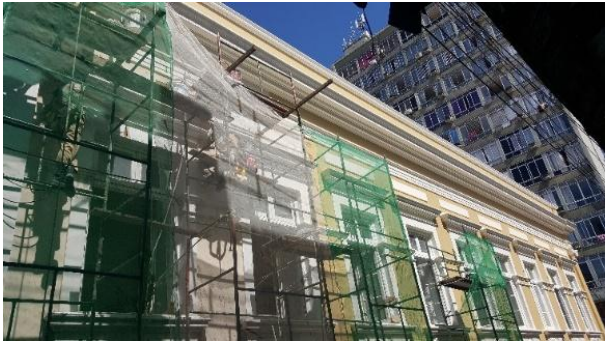
Fig. 25: Building's facade (Source: Author's Collection, 2016)

The building's facade had its frameworks rebuilt with suitable mortar and the ornament pieces were remade utilizing silicon molds similar to the originals. Furthermore, the facade was painted using the original colors obtained during the prospection process. (Fig. 25)

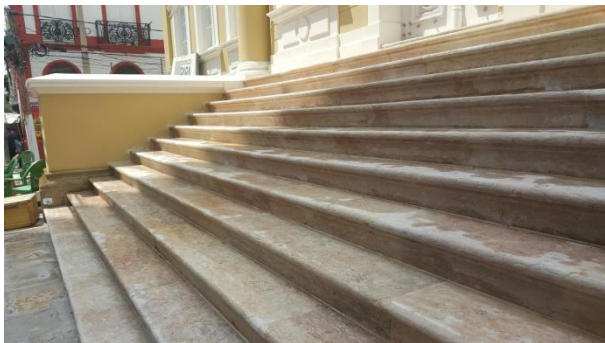
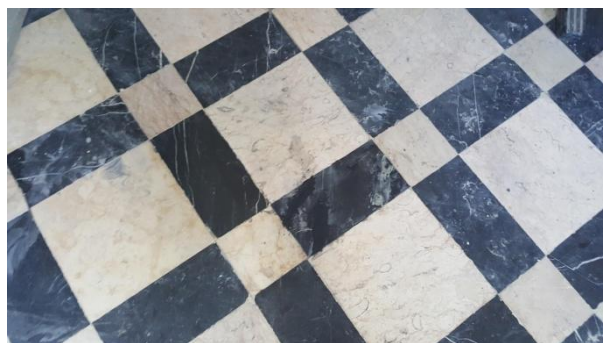
Fig. 26: Ladder in lioz (Source: Author's Collection, 2016)

Fig. 27: Marble floor (Source: Author's Collection, 2016)

The access ladder in lioz stone was repaired using material like the original, polishing and resin application. The same process was performed on the marble floor on the main hall, using the adequate materials. (Fig. 26 and 27)

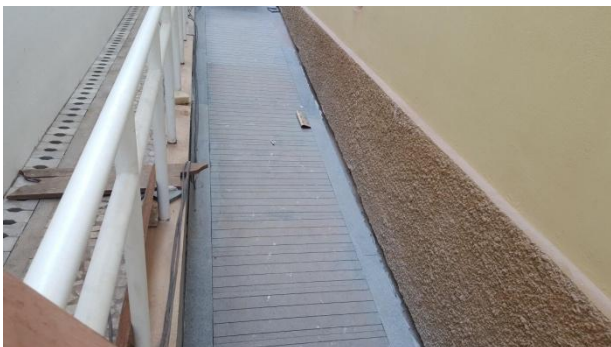
Fig. 28: Access ramp (Source: Author's Collection, 2016)

Aiming the improvement of the accessibility to the building, some changes on the original architectural project were made. The permutation of restrooms, kitchen and DML to improve the comfort of visitors, the construction of a access ramp (Fig. 28) and installation of an elevator to people with special needs are the highlighted alterations made.

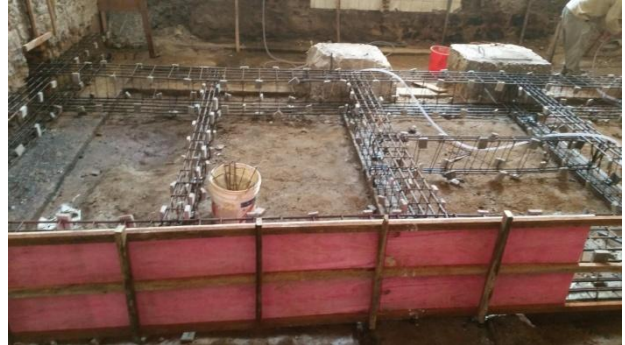
Fig. 29: Foundations, metal beams and pillars, concrete slab (Source: Author's Collection, 2016)

Due to the process of permutation of rooms, alterations on the structural system were necessary. New foundations, metal beams and pillars, concrete slabs (Fig. 29) and metal ladder were executed, the hydro-sanitary and electrical systems were realigned and new installations were finished. (Figuras 30).

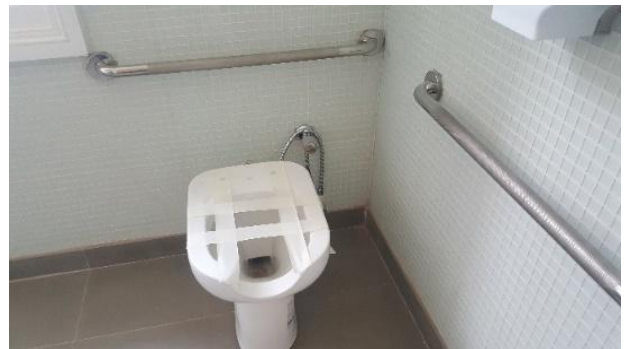
Fig.30: Hydro-Sanitary installations: Ba (Source: Author's Collection, 2016)
