Annals of Warsaw University of Life Sciences – SGGW
 Land Reclamation No 39, 2008: 95–101
 (Ann. Warsaw Univ. of Life Sci. – SGGW, Land Reclam. 39, 2008)

Ploughed-on terraces in loess landscape of strongly developed high plains

Abstract: *Ploughed-on terraces in loess landscape of strongly developed high plains.* The ploughed-on terraces were one of the techniques for agricultural use of steep slopes in loess landscapes of developed high plains, the example of which is described fragment of the valley in Bartomiejowice near Nałęczów. Giving up the agricultural use makes disappearance of those anthropogenic-erosion relief forms in the landscape structure. The authors postulate to protect – by restoring the meadow-pasture use – the characteristic enclaves of loess landscapes with ploughed-on terraces.

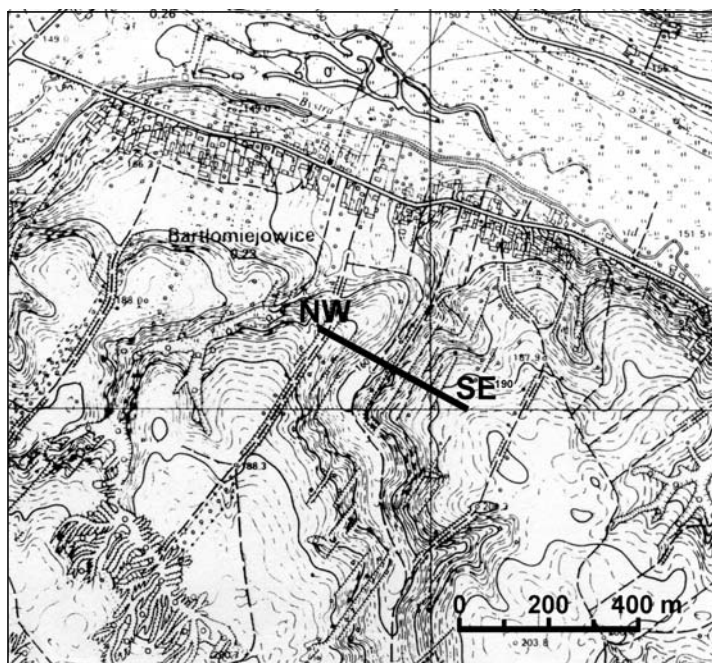
FIGURE 1. Research site: NW-SE – the cross section presented at Figure 2

The studies were carried out in the estuary of dry valley (Fig. 1) cutting slope of the Bystra river valley, on fields belonging to Bartłomiejowice village, about 7 km west from Nałęczów. The total area of the dry valley catchment is 105 ha, and average inclination 4.9% (Zubala et al. 2006).

Levelling section A-B perpendicular to the valley and ploughed-on terraces was made in 2006 (Fig. 1). The land use on terraces was recorded and compared with records on land registration maps from 1991. The condition of terraces scarps protection was assessed and their heights out of levelling section were measured.

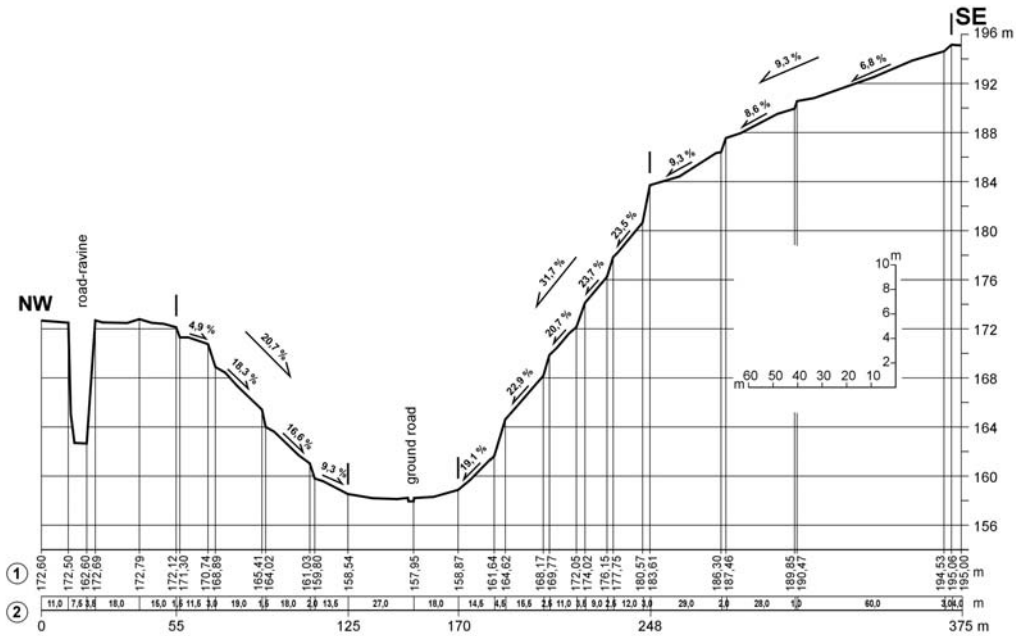
The levelling section is presented in Figure 2. There is a ground road of 4.5 m width deepened to about 0.5 m at the valley bottom. It drains the water runoffs from the whole catchment.

FIGURE 2. The cross section of slope valley (according to localization given at Figure 1): 1 – height above sea-level; 2 – distances

(10 m) road ravine (Fig. 1 and 2). The south-eastern slope (SE) is of almost 32% mean inclination at 78 m distance (from the valley bottom) and changes into relatively flat slope of slightly over 9% inclination. Both slopes, at whole distance, are terraced due to transverse cultivation forced by property boundaries. Particular terraces, at whole distance (200–250 m), have constant width. Their boundaries (scarps) are perpendicular to general slope direction. However, the slopes are cut with small valleys, which makes that such parameters as longitudinal and transverse inclinations of benches as well as scarps heights and inclinations change greatly within particular terraces (Phot. 1 and 2). In places where terraces are localized across to valleys cutting the slopes (Fig. 1, Phot. 1 and 2), the longitudinal

There are 4 terraces on NW slope, including the lowest one (along the valley bottom edge) without bottom scarp. Bench of this terrace was formed due to ploughing along the field's upper boundary. Widths of benches are 11.5–19.0 m, and their mean cross-falls from about 5% to over 18%. All terraces platforms, within about 3-meter wide band, along the scarps bottoms have lower inclinations resulting from the cultivation erosion. Along the levelling section, scarps are of about 0.8–1.8 m height and 1:2–1:1 inclination.

9.0–15.5 m wide, and from about 19% to almost 24% inclined. Due to a large cross-falls of benches, there are not bands with apparently lower inclination along scarps bottoms. Their heights within that slope fragment are from 1.6 to about 3 m at 1:1.5–1:1 inclination. Upper part of the slope is divided into 3 wide (28–60 m) terraces with relatively low scarps (0.5–1 m). The mean benches inclinations are 7–9%, but as the result of ploughing and water runoff there are erosion landforms below as well as accumulation above terraces scarps (Fig. 2).

especially on its slopes including ploughed-on terraces. According to land registration maps from 1991, terraced slopes and valley bottom were under plough tillage. In 2007, all terraces on a steep fragment of SE slope (31.7% of mean inclination – Fig. 2) were sodded on the whole length (Phot. 2). Also higher terrace (with 9.3 % inclination) was sodded. The plough tillage was performed only in the upper parts of the slope on 6.8% and 8.6% inclination terraces (Fig. 2). On NW slope in spring 2006, the 18.3% inclined terrace was about 3-year-old fallow land, and on lower 16.6% inclined one the field was not cultivated (Fig. 2, Phot. 1). Plantations of berry fruits in the sod were set on those terraces in 2006–2007. Highest localized terrace (4.9% inclination) is partially grown with pines. The lowest situated terrace (9.3% inclination) and valley bottom (NW side of the road) is used as plough land, except a narrow band along the road grown with fruit shrubs (Phot. 1). At the other side of the road (SE), the valley bottom is sodded. Trees grow onto the terraces benches, especially at the scarp's bottoms on SE slope (wetter sites). In general, they are small groups of several-year-old trees (mainly birch), including some covering several acre areas.

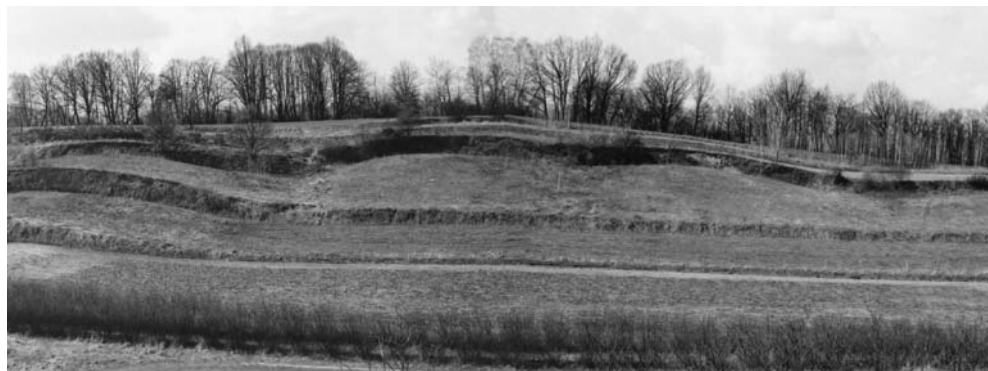
The north-western slope (NW) is 70 m long and average inclination almost 21% (Phot. 1). It sharply changes into relatively flat part of a ridge cut by a deep

PHOT. 1. The north-western slope (NW), in the background – plantings along road ravine (spring 2006)

and their inclinations were lower than 1:1. However, in some places, they reach 3.5 m height (SE slope). In general, scarps inclination is not more than 1:1, but on NW slope (insolated exposure), there are almost vertical scarps up to 4.5 m height on short fragments. Most scarps are very well fixed by green plants, mainly grasses. Blackberries climbing even the vertical scarps cover a significant percentage of NW slope. On SE slope, an intensive shrubs and trees growing can be observed (Phot. 1 and 2).

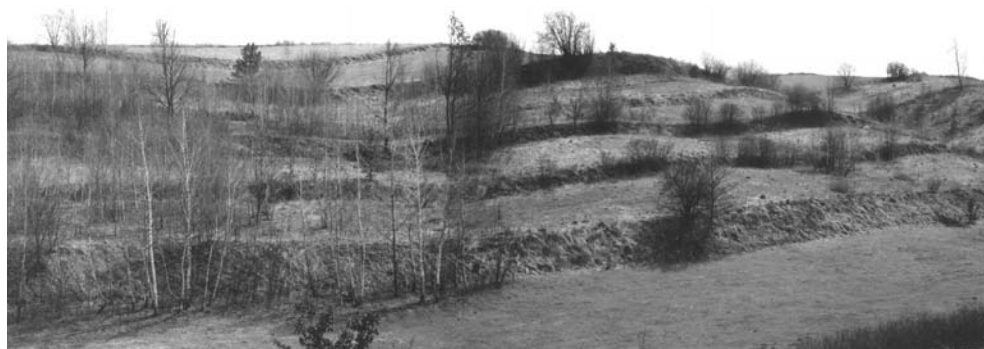
PHOT. 2. The lower (steep) part of south-eastern slope (SE) – spring 2006
