Geotechnical Reconnaissance of the 2021 Western European Floods

Flood Event: July 14-15, 2021

Flood locations: Germany, Netherlands, Belgium, and Luxembourg

Reconnaissance Visit: August 9-18, 2021

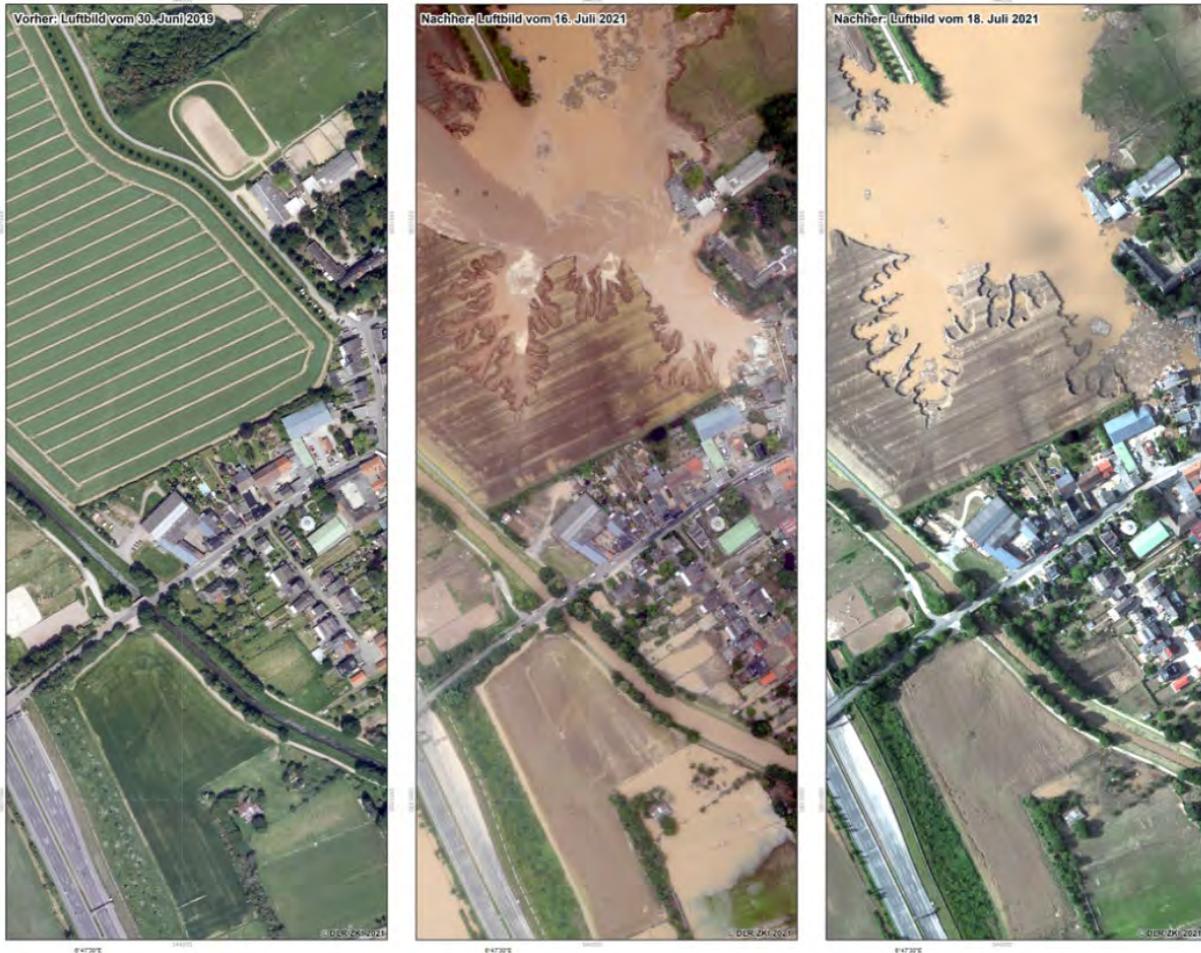
Figure 1.5. Aerial imagery example of damaged locations as available from public resources. Here: Ertstadt-Blessem obtained from https://activations.zki.dlr.de/images/products/ACT152/P30/2021_DLR-ZKI_004_P30_V01_Germany_Flood_beforeafter_3_timestamps_Blessem_300

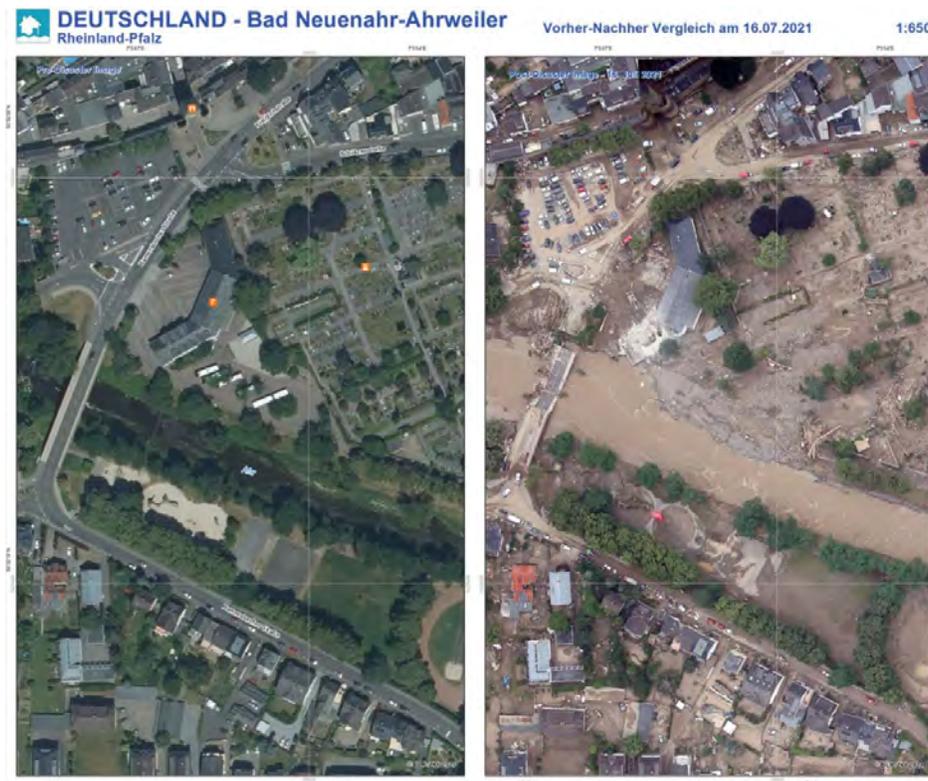
Figure 1.10. Before (left) and after (right) imagery obtained from along the Ramersbacher Strasse and the Ahr river in Bad Neuenahr-Ahrweiler, Germany. (Source: ZKI/DLR, accessed through dlr.de).

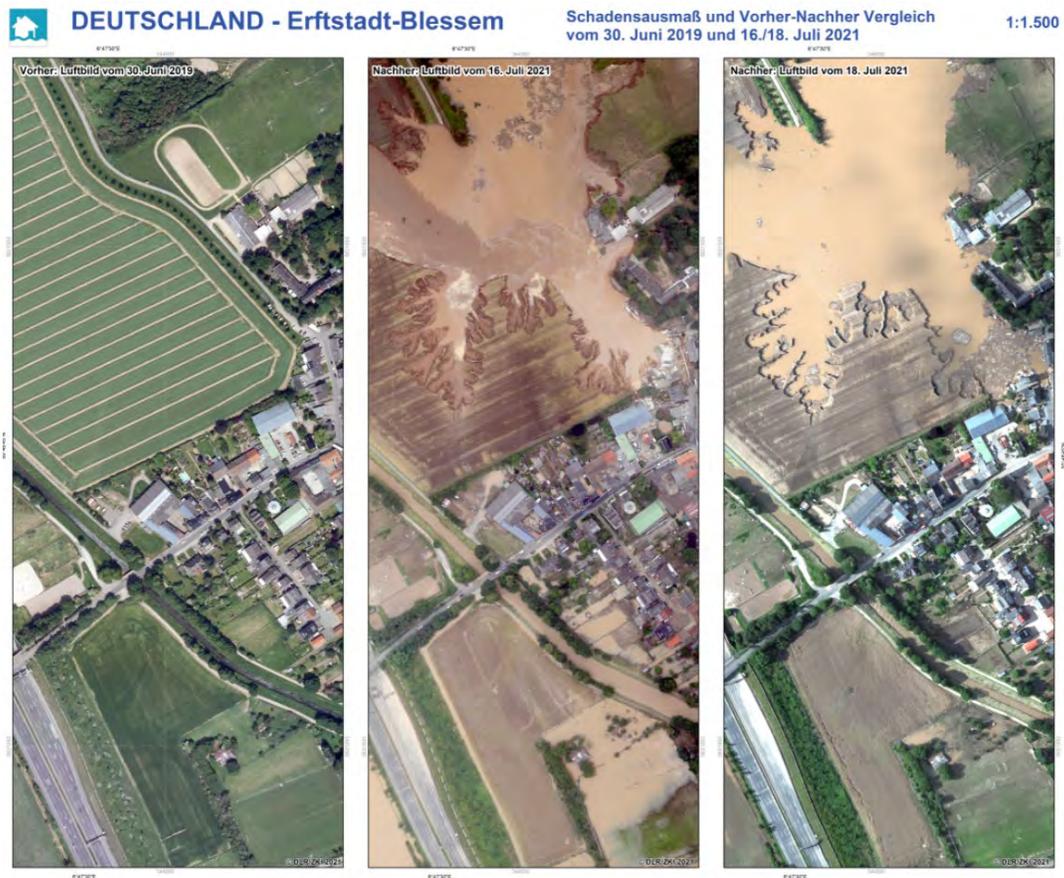
Figure 1.12. Aerial imagery obtained from Ertstadt-Blessem from June 30, July 16, and July 18, 2021. Source: ZKI/DLR, accessed through <https://activations.zki.dlr.de/>.

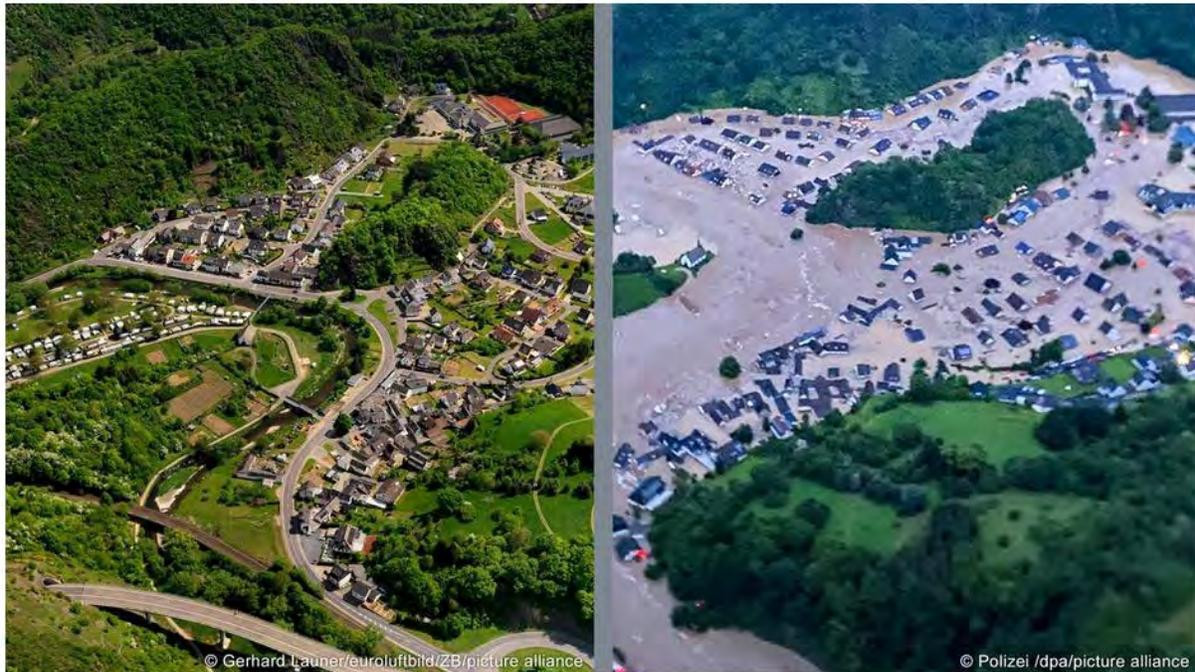
Figure 1.13. Before and after imagery of Altenburg (district Altenahr) published by the ARD Tagesschau and accessed through <https://www.facebook.com/tagesschau>.

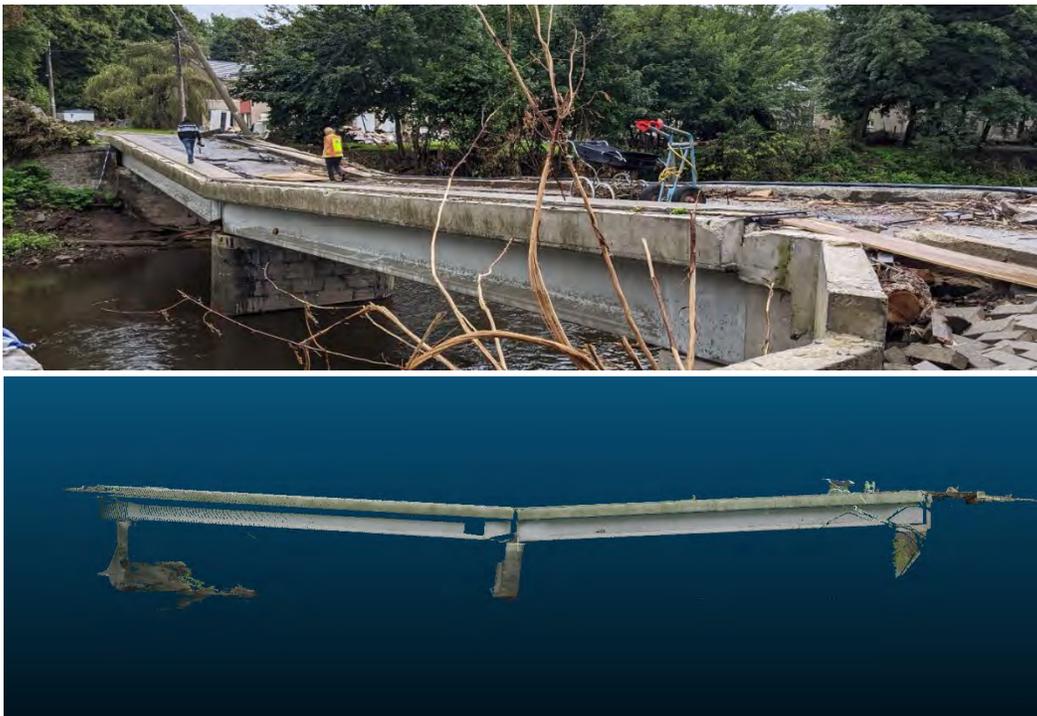
Figure 2.1 shows a bridge in Trooz Belgium, which suffered damage to the middle pier and the bridge abutments. Scour likely caused settlement of the middle pier, inducing rotation and damage to the bridge deck. The bridge was passable for pedestrian traffic; however, restricted for motorized vehicles. The team took extensive photography and obtained LiDAR scans of the bridge from 2 locations.

Figure 2.1. Photograph (top) and Lidar model (bottom) of road bridge crossing the river Vesdre in Trooz, Belgium.

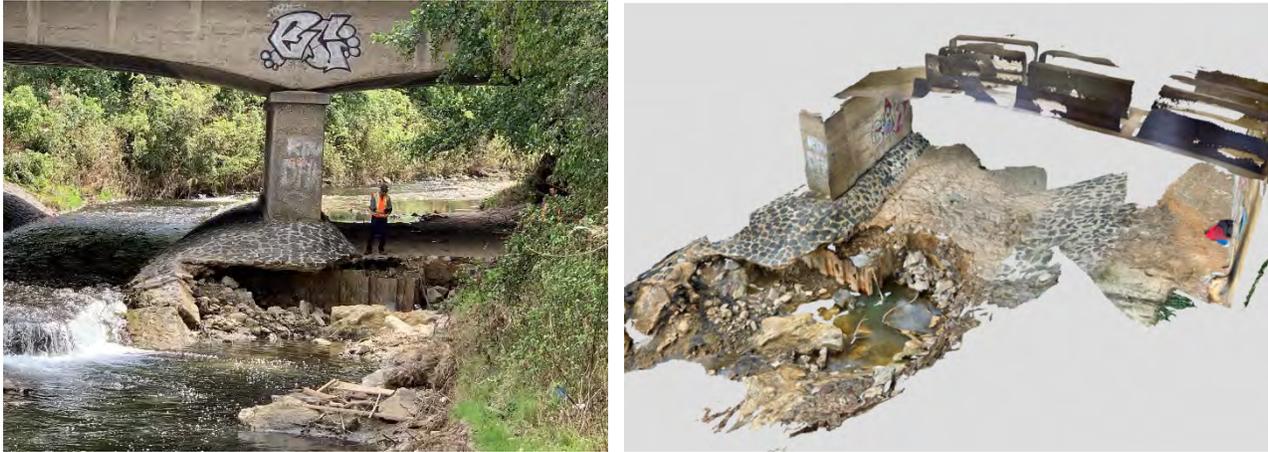
Figure 2.2 shows scour on the downstream side of a railroad bridge pier crossing the Erft River near Kölner Straße in Euskirchen, Germany. The armorings, which consisted of a hardened concrete-rock cap, was eroded and undermined exposing the pile walls surrounding the bridge pier. The exact failure mode could not be deduced, however hard armorings such as this is brittle and subject to cracking. Cracks can allow hydraulic jacking of sections of the concrete-rock cap (the same process that can occur in concrete spillway chutes, like the Oroville Flood Control Outlet Spillway in California, USA during the 2017 flood events).

Figure 2.2. Photograph (left) and LiDAR model (taken with the iPad Pro 2020) (right) of scour damage at foundation level of railroad bridge crossing river Erft, parallel to Kölner Straße

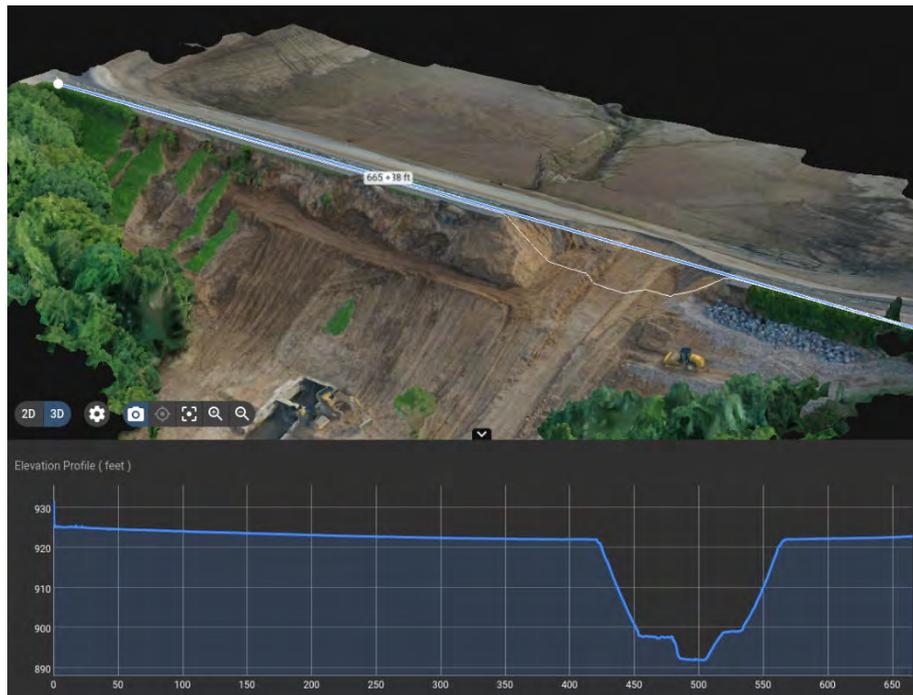
Figure 2.4. shows a structure from motion (SfM) model generated from UAV-collected images. The SfM model is of the Steinbachtalsperre, located between Euskirchen and Bad Muenstereifel. The SfM models created of this dam had ~2cm resolution with measurement error of approximately 8 cm in plan and 13 cm in vertical. Images were collected using a DJI Mavic2 drone with both manual image collection and autopilot missions planned using Pix4Dcapture. For the images collected to create this model, approximate flight time was 40 minutes. The SfM model shown in Figure 2.4 was created in Pix4D using 288 images.

Figure 2.4. Structure for Motion model of Steinbachtalsperre

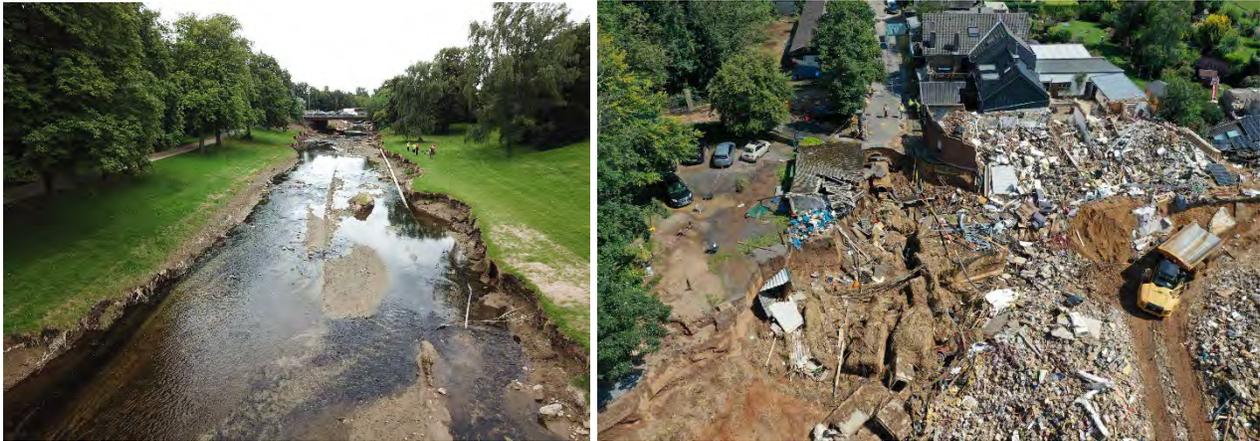
Standard UAV imagery was collected using two DJI Mavic2 drones, operated by the team on the ground. Still image and video footage was captured to provide an aerial view of damage. Figure 2.5 (left) shows an aerial photograph of a riverbed near Euskirchen, which documents the extent of riverbank erosion and

exposure of critical infrastructure; Figure 2.5 (right) shows an aerial photograph in Blessem near the gravel mine, where access was entirely restricted due to ongoing rescue and cleanup activities.

Figure 2.5. Sample UAV photos taken, Left: Erft river in Euskirchen, Crossroad Kölner Straße; Right: landslide damage triggered through inflow into the Blessem gravel mine

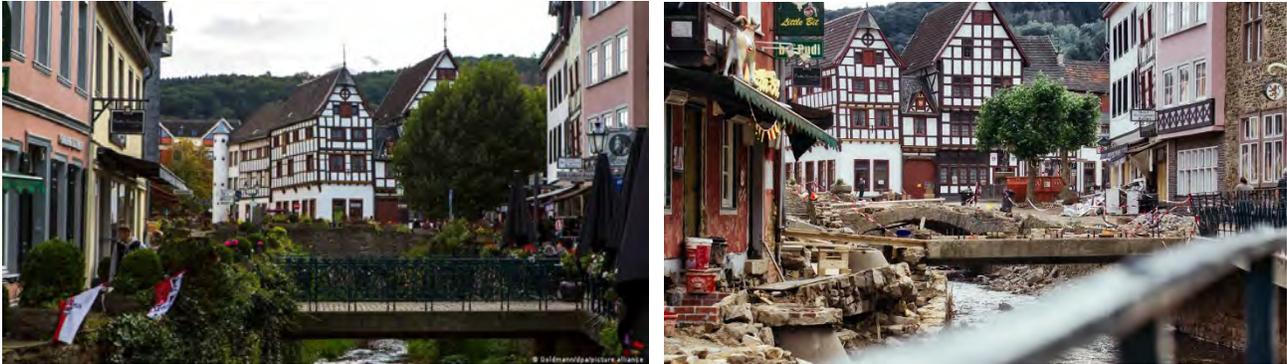
The team started its investigations near the Orchheimer Tor and walked the city center to document damage. Figure 3.3 shows a before and after photograph of the historic downtown area. Substantial damage was observed to houses (basements and ground level stories), embankments, historical bridges, roads, and utility services.

Figure 3.3. Before (left) and after (right) photograph of the city center Bad Münstereifel, Source: <https://www.dw.com/en/flooding-in-germany-before-and-after-images-from-the-ahr-and-eifel-regions/a-58299008>

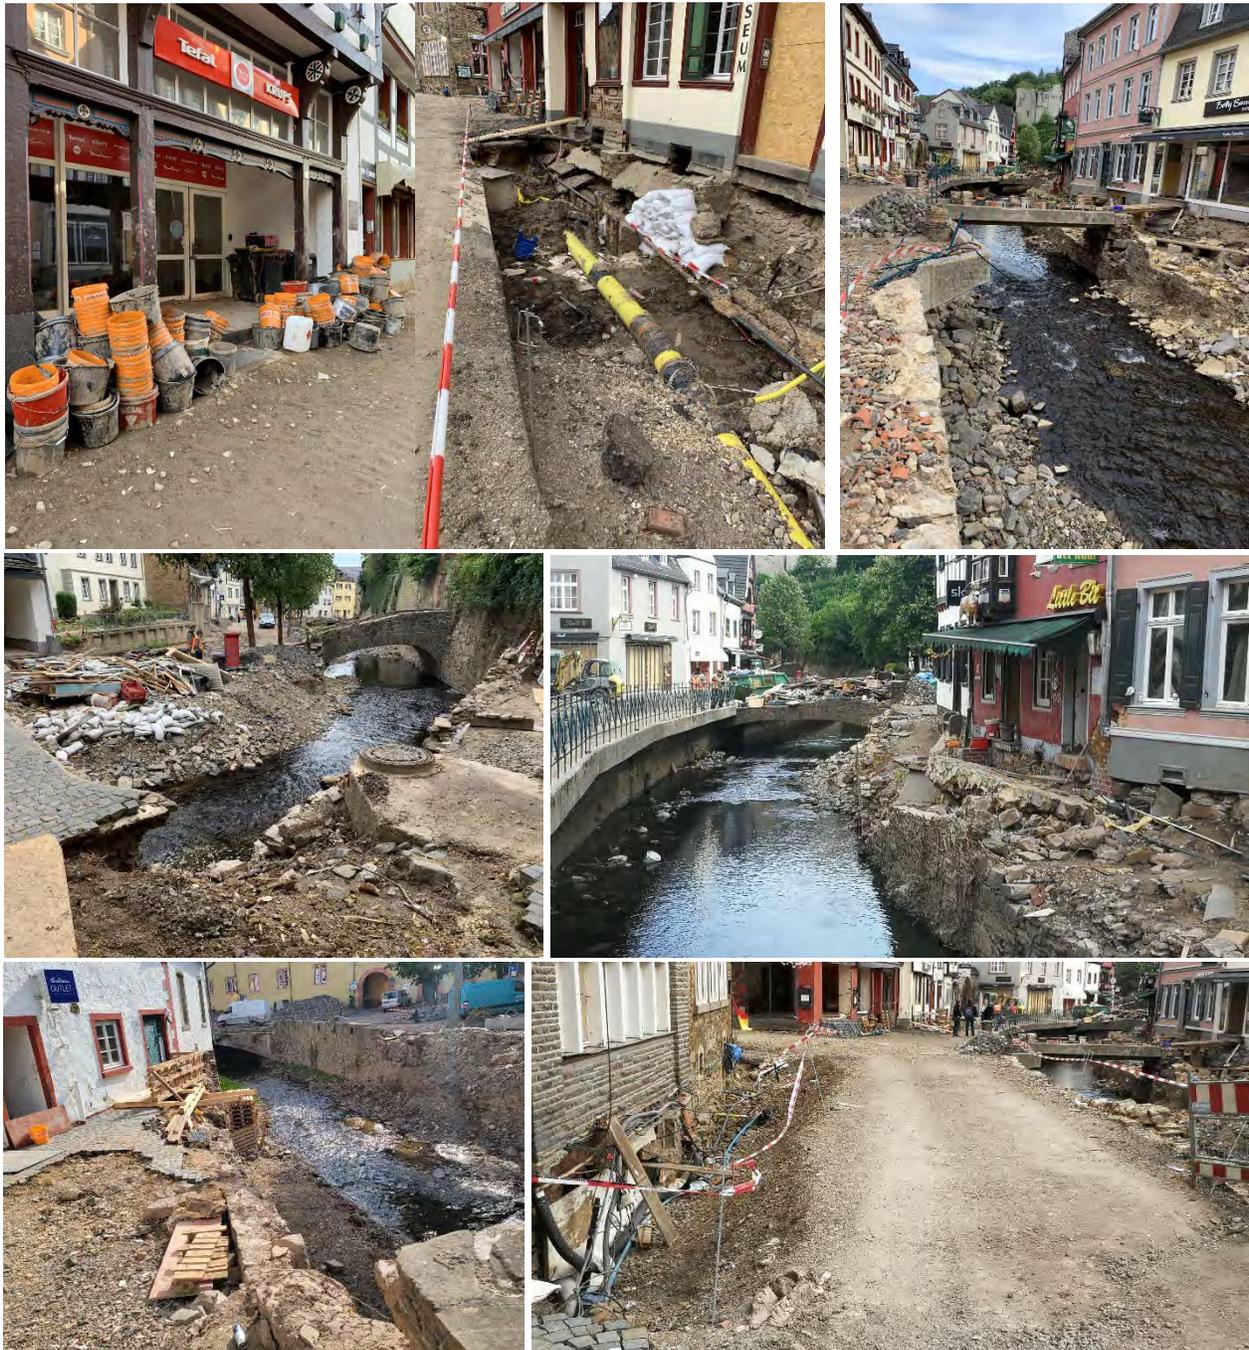
Figure 3.5. Damage to embankments, bridges, utility lines along the Ertf in the historic center of Bad Münstereifel (all photos by the GEER team)

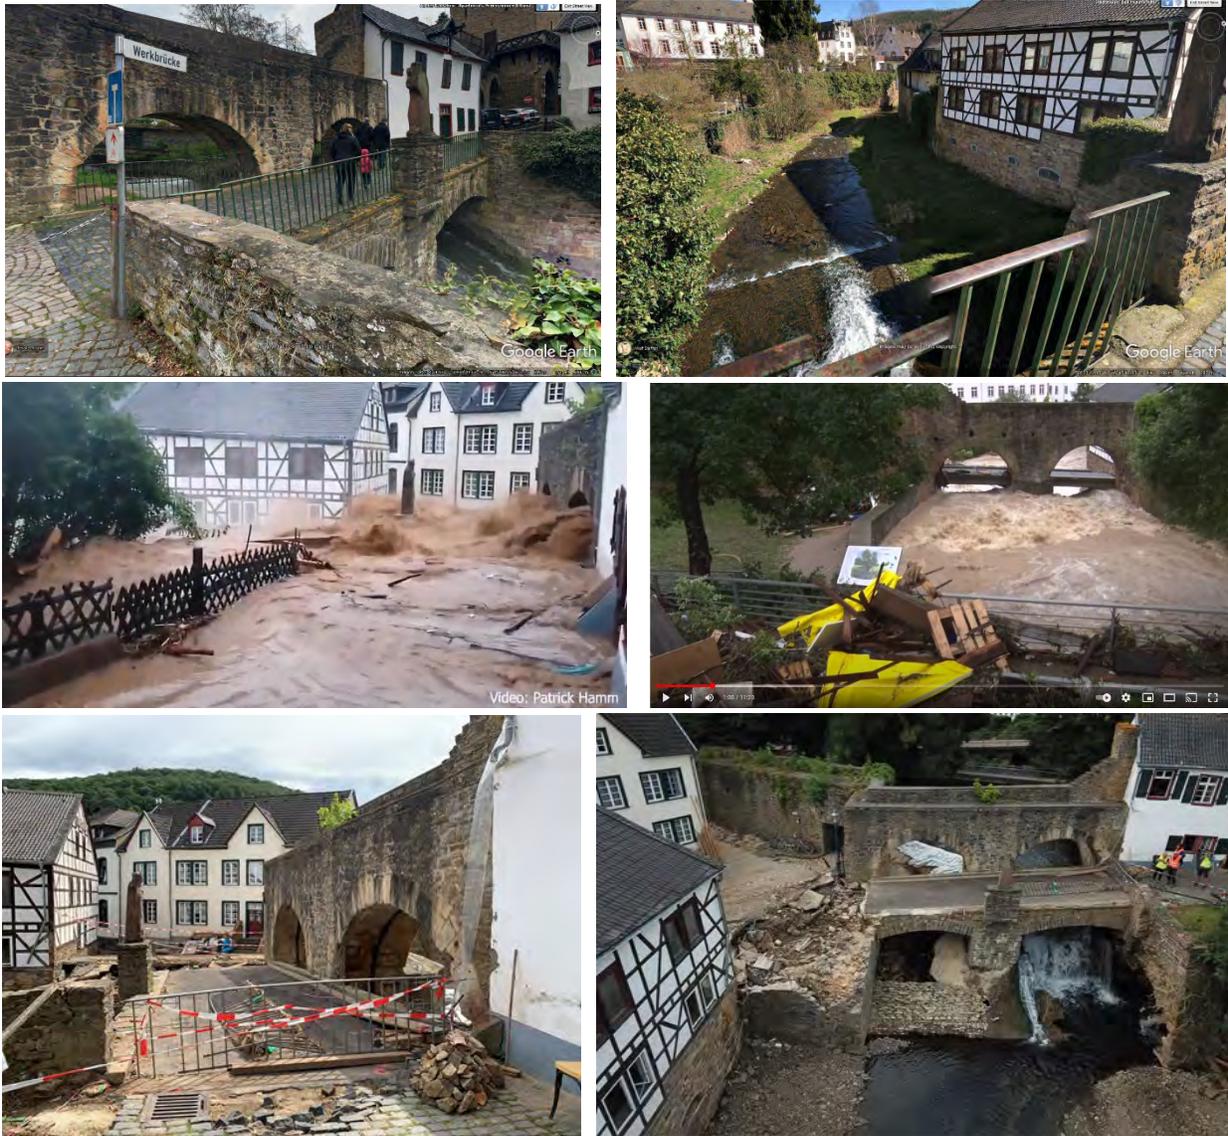
The Werkbrücke is located right in front of the Bad Münstereifel Stadtmauer (the wall that encompasses the city center), built in the 13th century and the first half of the 14th century. It is 1.6 km long and has several passages for the Erft river. Figure 3.6 shows a set of photos before and after the flood event which depict the Werkbrücke and Stadtmauer prior to the flood (top, and center left) during the flood event (Source: Twitter, Bad Münstereifel), and at the time of the team visit (Fig. 3.6 bottom row).

Figure 3.6. Picture of the Werkbruecke: Top row: Before flood (Source: google earth); Center: during flood (center) Source: Patrick Hamm one day after flood (July 16th), Source: https://www.youtube.com/watch?v=7mZDH_P_1q4 , Bottom photos: at time of teams visit, August 9th, 2021

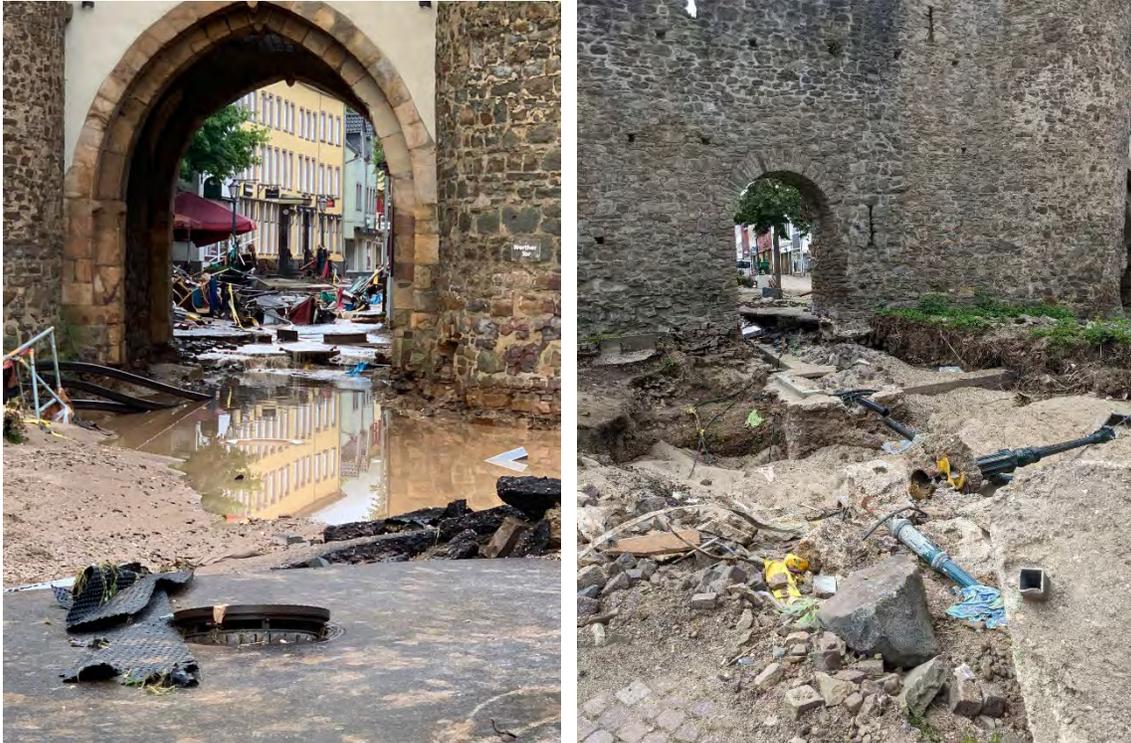
As the youngest of the four city gates, the Werther Gate was rebuilt in 1416. Its predecessor was washed out by the flood of July 1416 and collapsed. The gate did not experience any substantial damage during the 2021 flood and remained structurally intact. However, water masses rushing through the gate removed and destroyed an entire house just northeast of the gate. Adjacent to the Werther Tor was another, smaller gate (unnamed), through which water exited with high velocities. Substantial road damage was documented just outside the gate, exposing utility networks.

Figure 3.7. Left: Werther Tor, immediately after the flood (Source: @AshfordTwinning, <https://twitter.com/AshfordTwinning/status/1415990484925919236>); Right: small gate to the left of Werther Tor, with substantial surface damage (50.557167, 6.765114)

Damage areas around the outskirts of the city wall are highlighted in Figures 3.7 and 3.8. The reconnaissance team investigated the bridge near the Werther Tor and adjacent surface damage as shown in Figure 3.7.

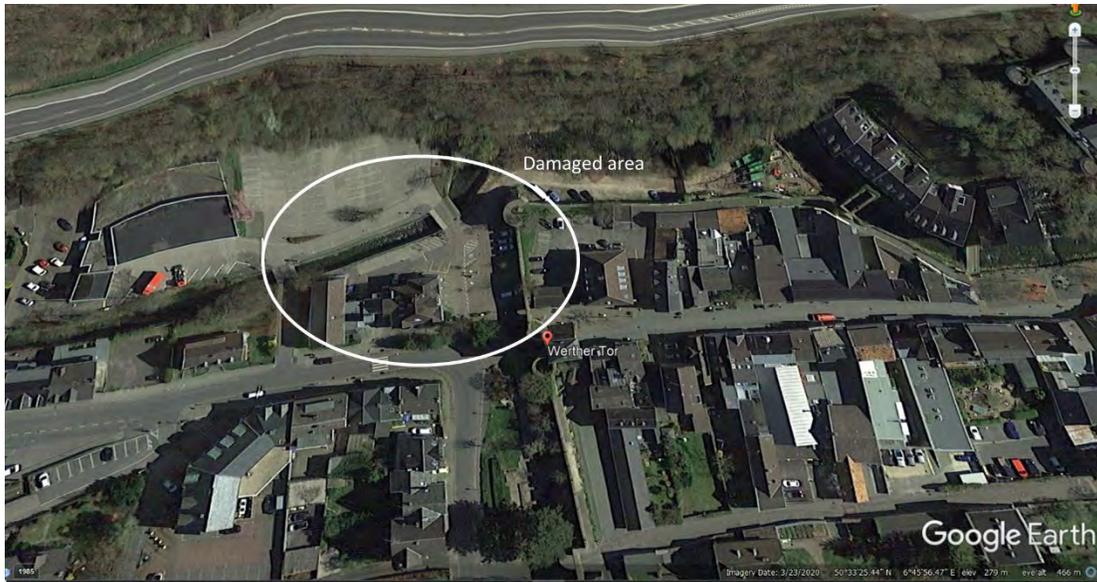
Figure 3. 8. Bridge and surface damage outside the Bad Muenstereifel Stadtmauer, near Werther Tor

As shown in Figure 3.8, the bridge itself was passable and structurally intact at the time of the teams visit, however, all on-ramp and off-ramp infrastructure was washed out. Much of the soil surface adjacent to the bridge (right side in the photograph below) is post-flood fill material. The surface of the parking lot on the left-hand side (Fig 3.9) was eroded as well. Figure 3.10 shows a wide-angle view of the destroyed area, including the washed-out bridge support.

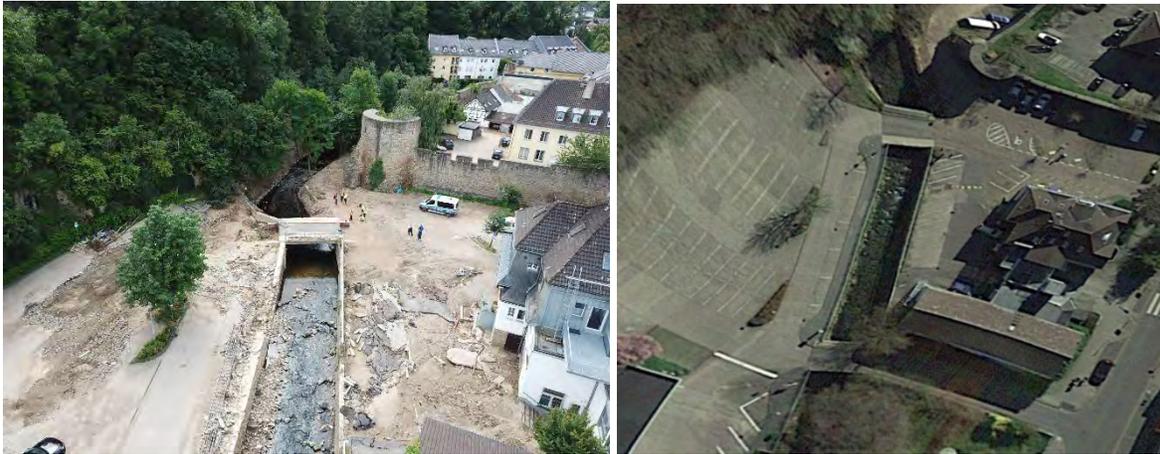
Figure 3.9. Bridge near Werther Tor, at time of reconnaissance visit (left) and google earth picture showing pre-flood condition (50.557369, 6.76584576)

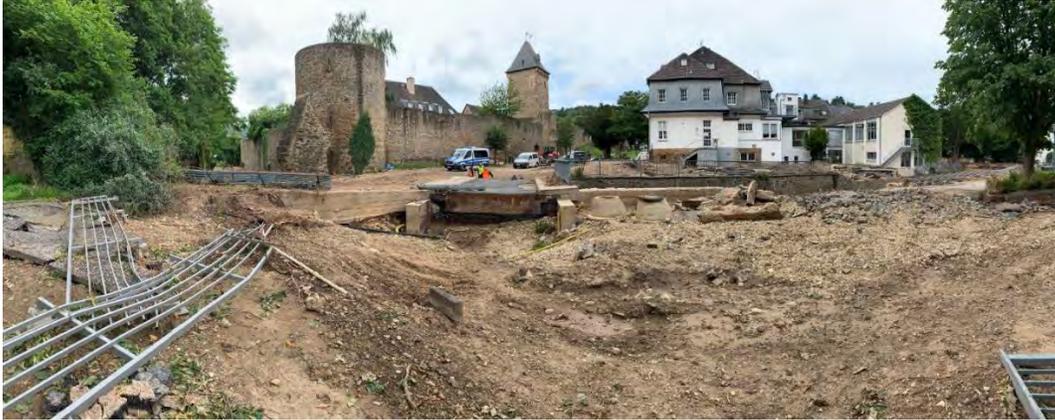
Figure 3.10. Aerial photo showing extent of damage to adjacent parking lot and erosion of soil material within bridge abutment area (50.557486, 6.765991).

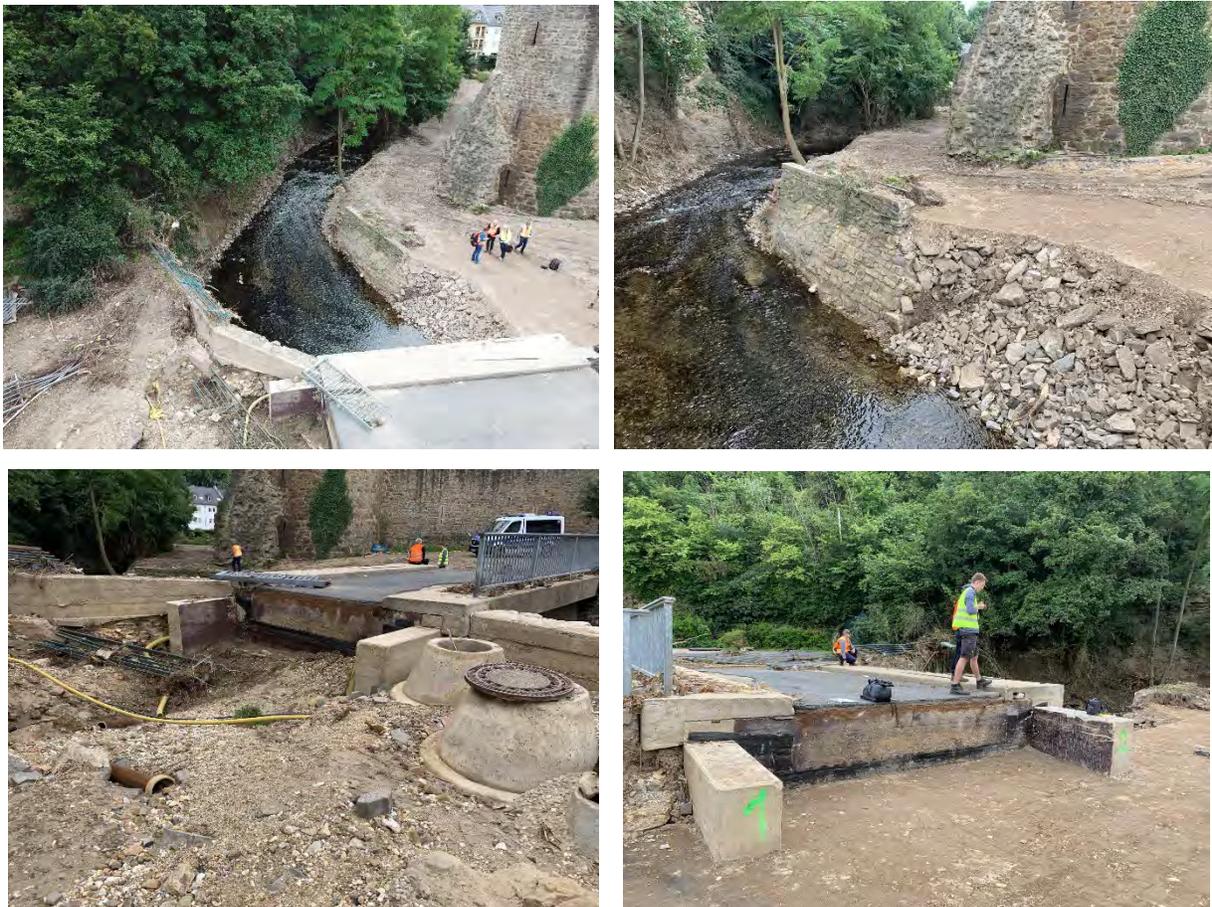
Figure 3.11. Damage around the bridge, riverbank damage (top row), bridge on-ramp and off ramp damage with severely scoured surface material and exposed manholes (50.557325, 6.7658949)

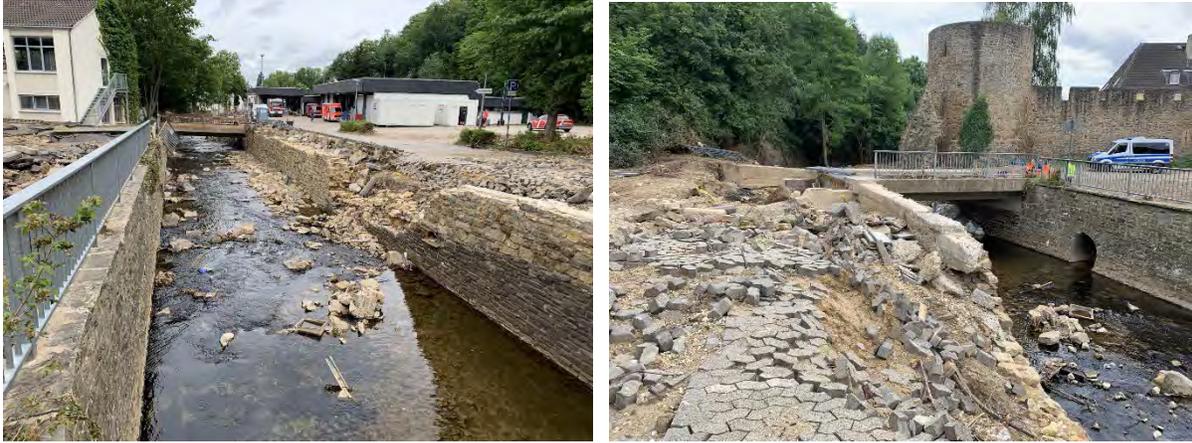
Figure 3.12. Embankment damage just below the bridge structure (50.55748613, 6.7659919).

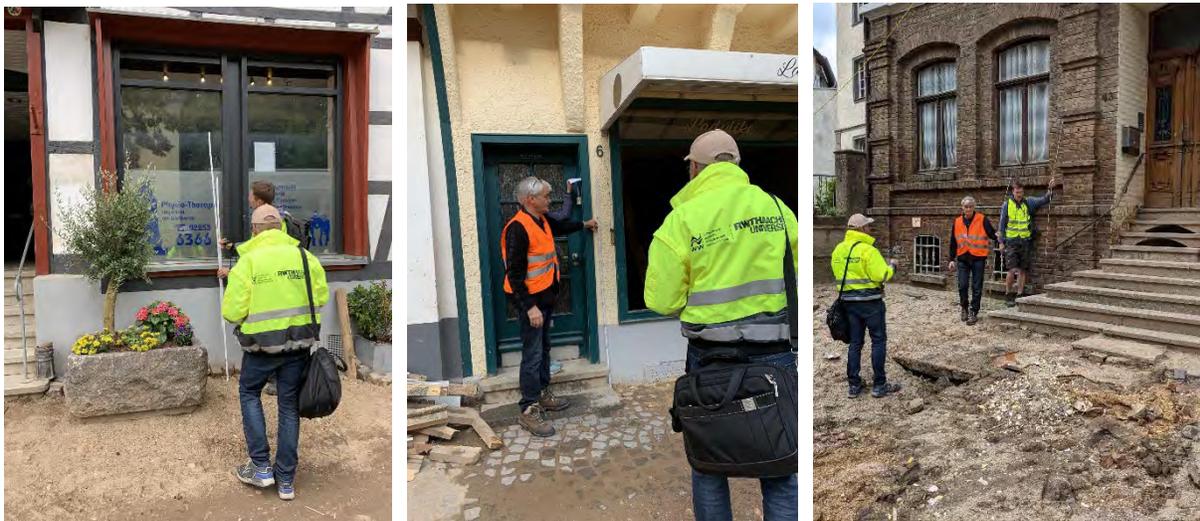
Water level measurements were taken at several locations throughout Bad Münstereifel. These included primarily visible water line marks at houses. Figures 3.1 displays several photographs of team members recording water marks at houses based on dirt lines in windows or wet marks along a brick façade. Figure 3.14 shows the water level rise in downtown Bad Münstereifel, indicating an estimate rise of up to 4.0m at the location shown in the photograph.

Figure 3.13. Examples of watermark recordings along Wertherstrasse in Bad Münstereifel

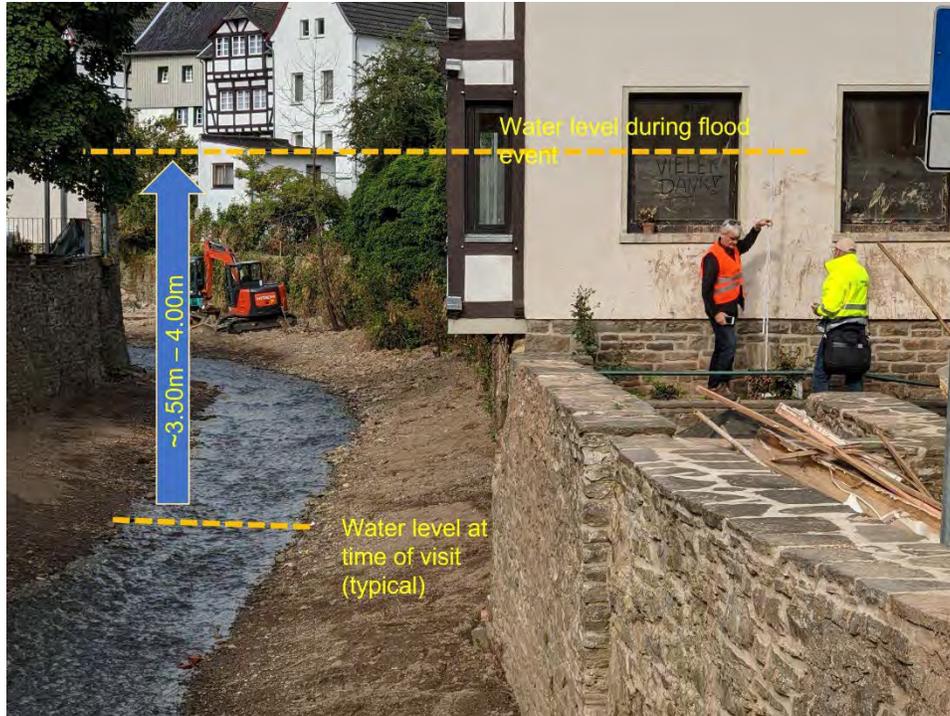
Figure 3.14. Example of water level rise of the Erft in the city center of Bad Münstereifel (50.5536697, 6.7626261)

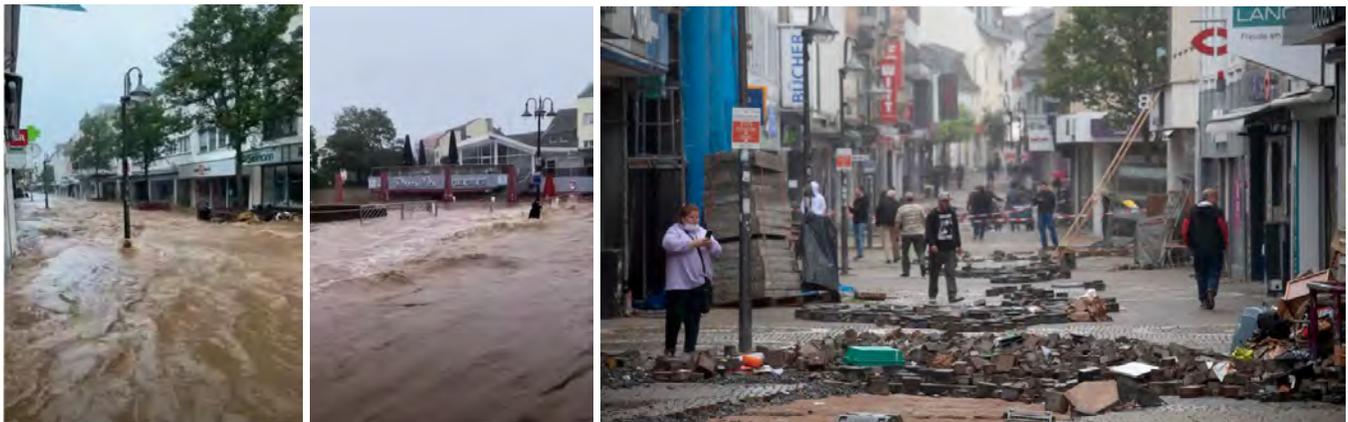
Severe flooding destroyed large parts of downtown Euskirchen causing damage to business and residential buildings in the city center. Figure 3.15 shows a photograph of Euskirchen taken during the flood event.

Figure 3. 15. Captures from online footage showing water rushing through the city center of Euskirchen, Source: https://www.youtube.com/watch?v=VA_BOmN11jl, Source of photo on the right: Spiegel.de, by Gabriel Rinaldi, 17.07.2021.

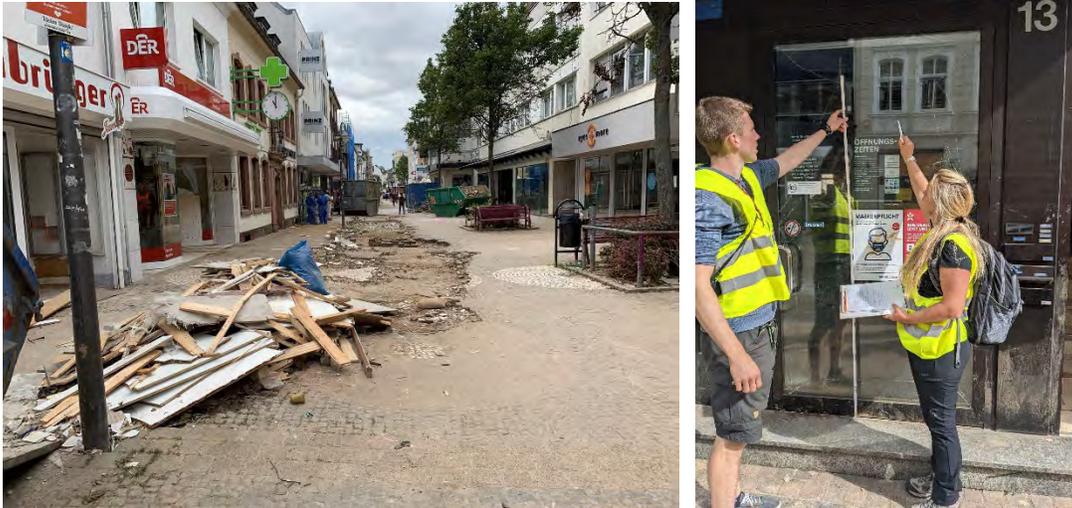
At the time of the team visit, most parts of the city center were in the progress of being cleaned up, with most of the larger debris removed. Stores along the city center’s pedestrian zone were almost fully flooded, construction and repair work was underway. Water levels in the downtown region were visually estimated and watermarks suggested water levels of nearly 2.0m above the ground surface.

Figure 3.16. City center (pedestrian zone along Neustrasse) of Euskirchen at the time of the team's visit (50.6602526, 6.7899711)

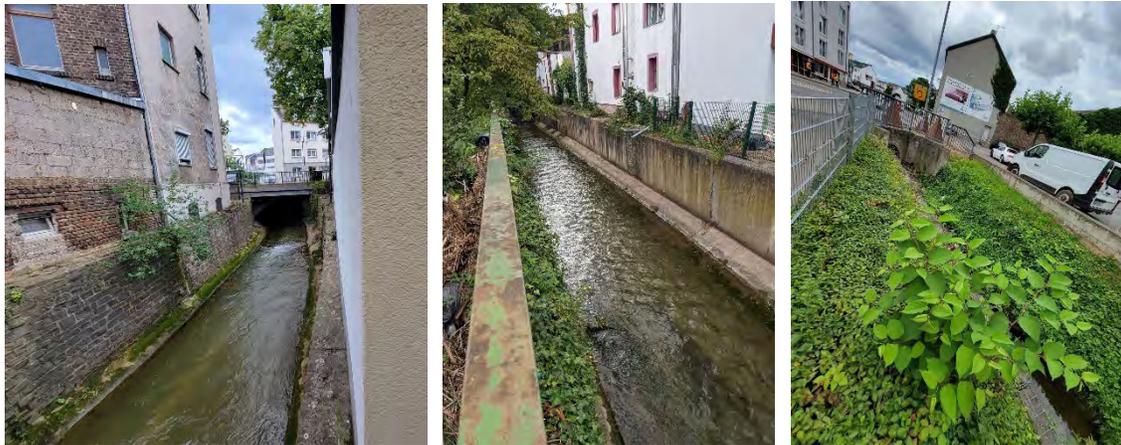
A large contributor to the flooding of Euskirchen's city center appeared to be the underground routing of the river Erft through tunnels and with many structural flow obstructions, as shown in Figure 3.17 and 3.18 below. Immediately next to (or rather behind) the bridge shown in Figure 3.18 was a Gabion wall, which was tilted and damaged at the time of the team's visit, likely due to the pressure of the water overflowing the channel.

Figure 3.17. Channel system of the Erft tributary "Mitbach" in the center of Euskirchen (50.657640, 6.7861305)

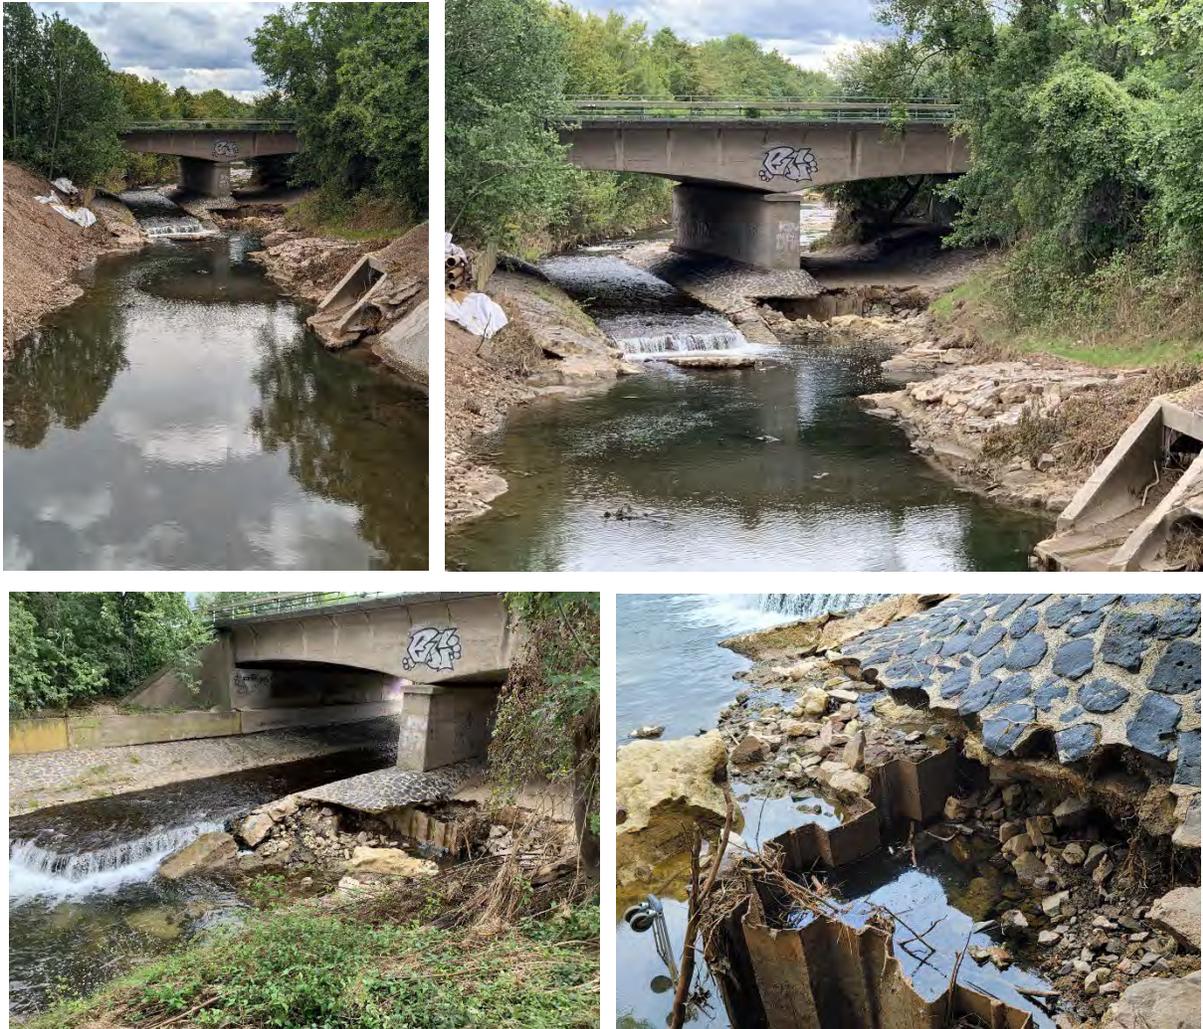
Figure 3.20. Foundation damage at middle pier of railway bridge (50.660347, 6.805227)

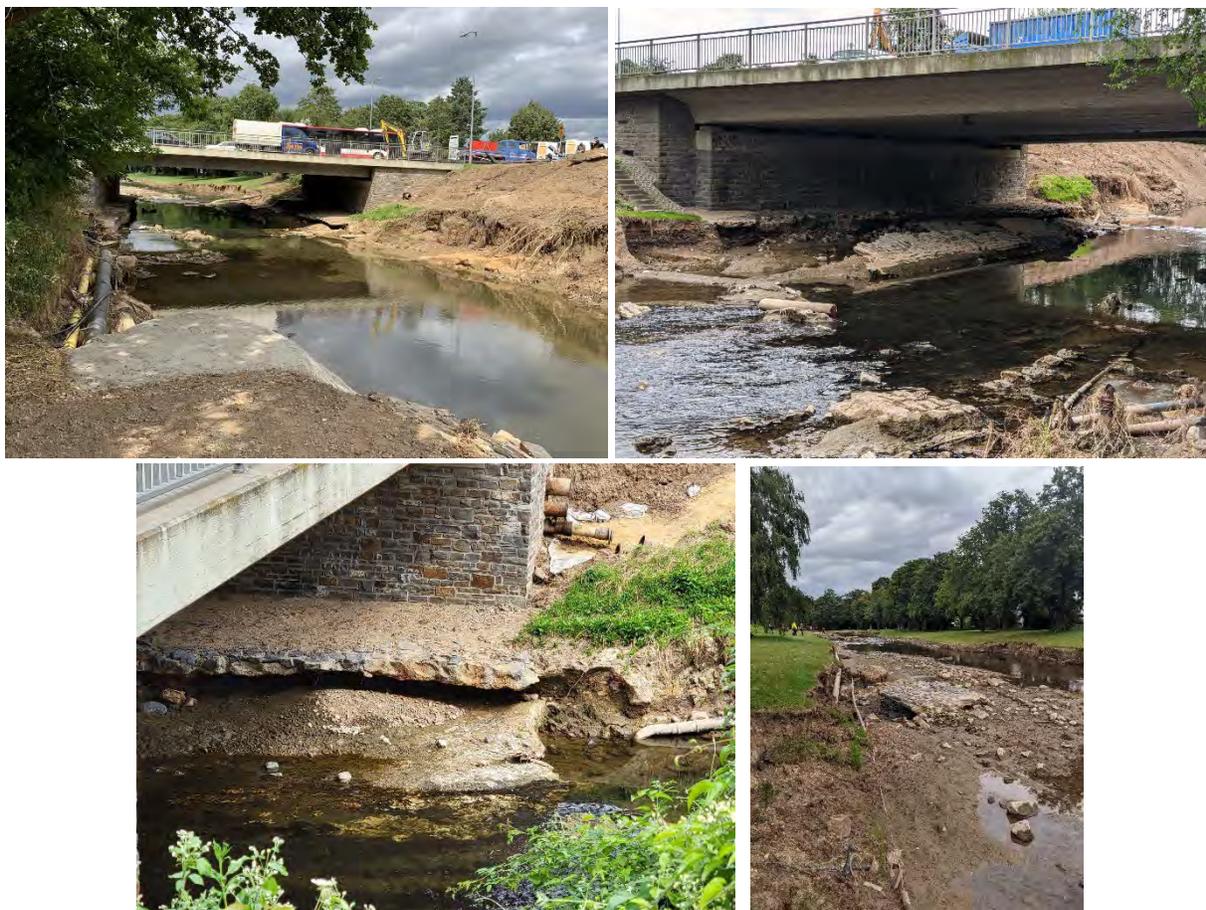
Figure 3.21. Scour damage at the foundation level of the Road bridge across the Erft @ Kölner Strasse (50.660347, 6.805227).

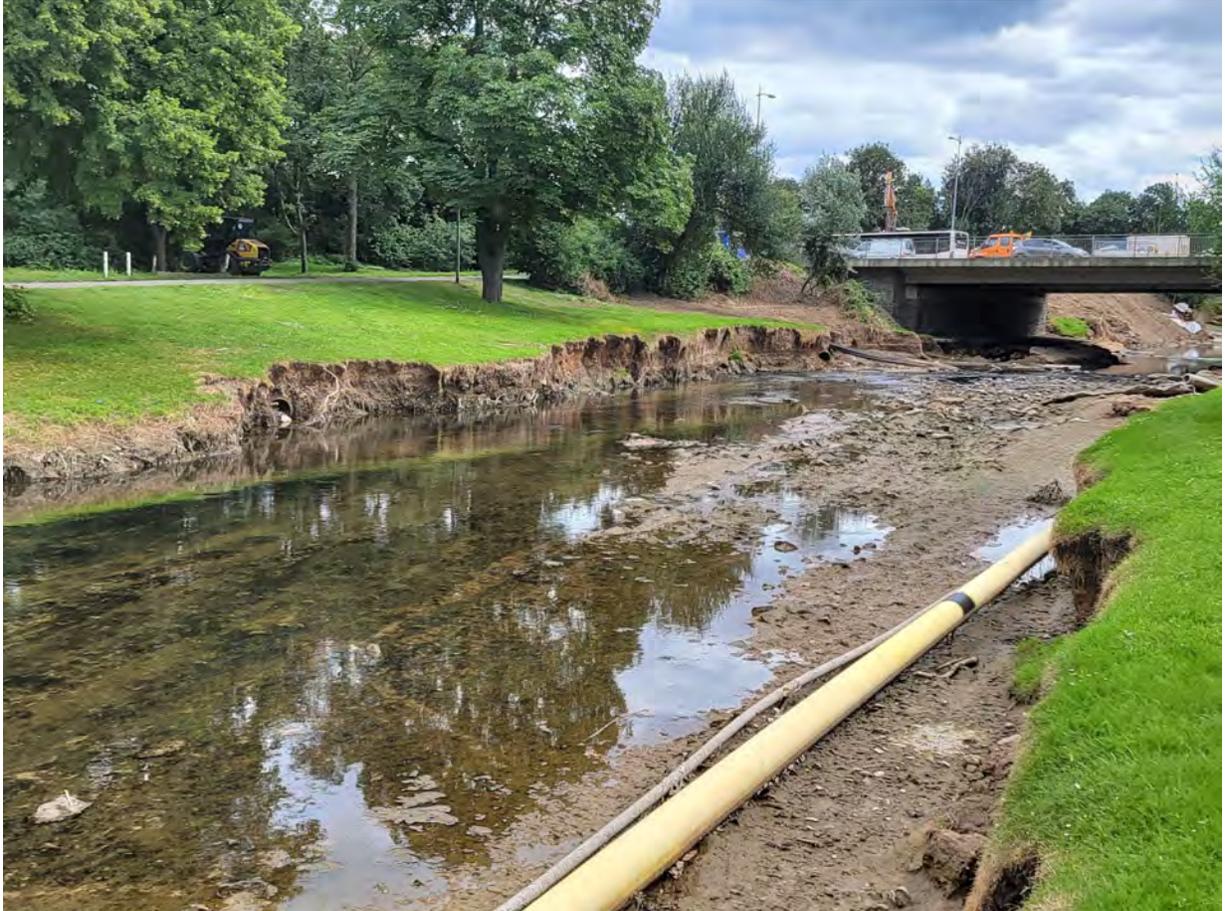
Figure 3.22. Riverbank erosion along the Erft river near Kölner Str in Euskirchen (50.661315, 6.8048277)
