Geotechnical Reconnaissance of the 2021 Western European Floods

Flood Event: July 14-15, 2021

Flood locations: Germany, Netherlands, Belgium, and Luxembourg

Reconnaissance Visit: August 9-18, 2021

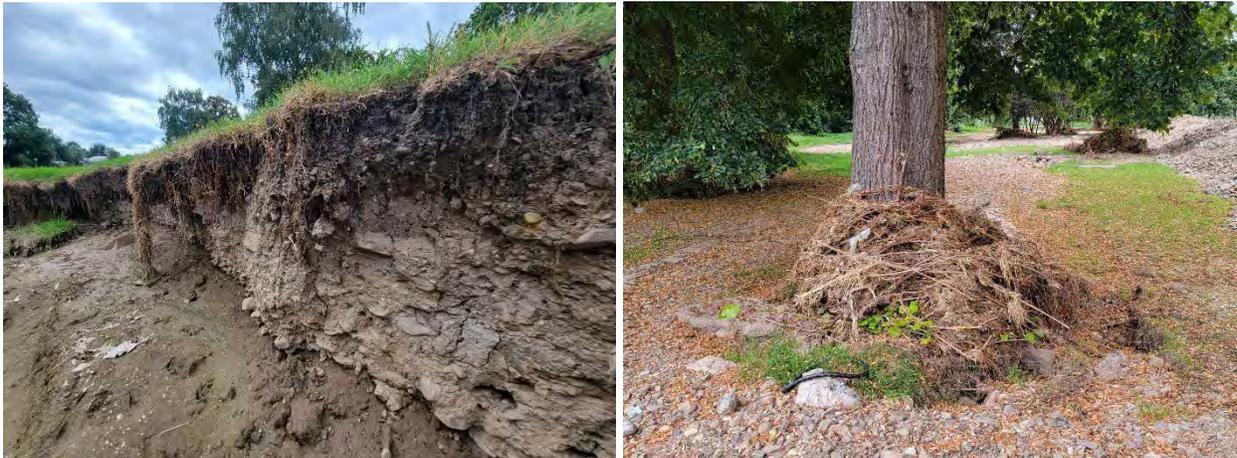
Figure 3.23. Left: Close-up of eroded Erft riverbank scarp. Right: Organic debris and gravel deposits around trees (50.6628713, 6.8038167).

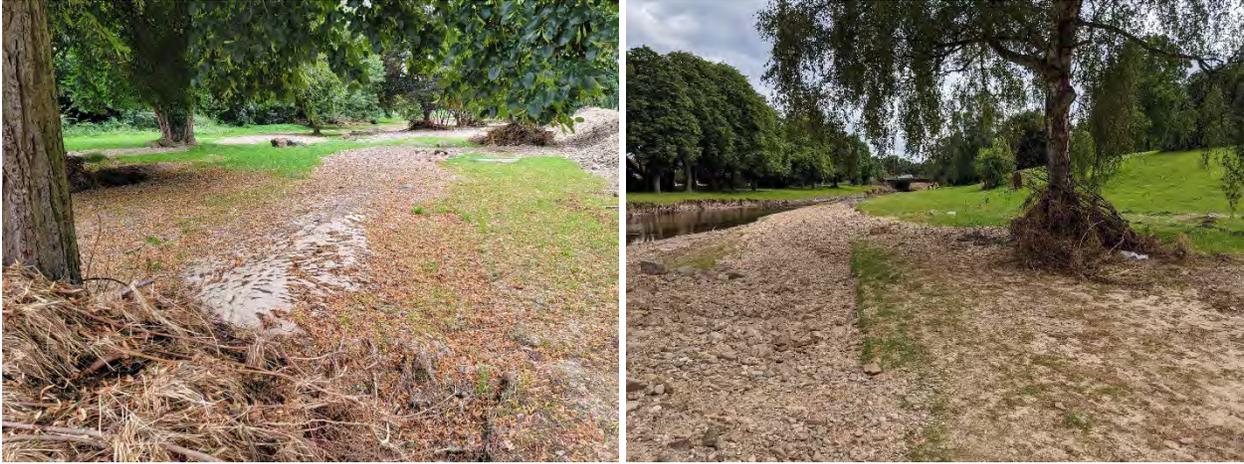
Figure 3.24. Fine sediment on coarse sediment deposition stretched meters in the downstream direction from trees, particularly when organic debris was wrapped around the tree base (50.6628713, 6.80381670).

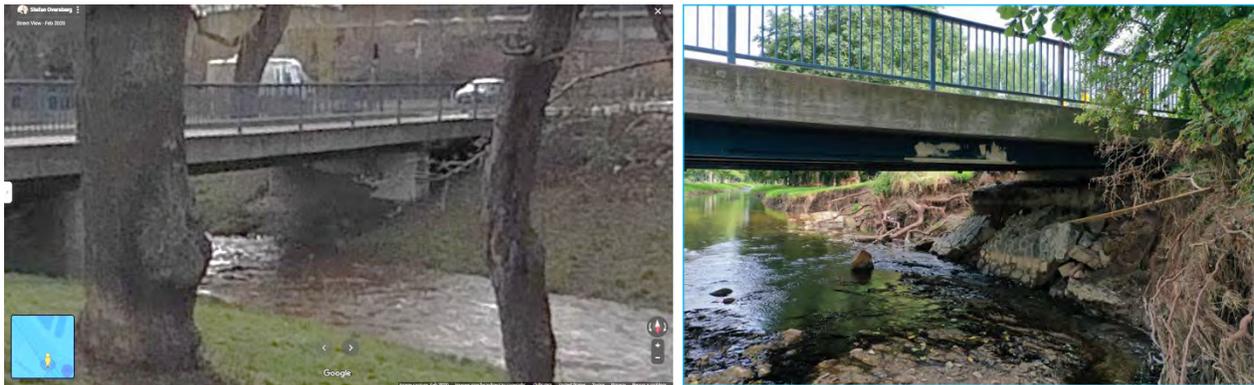
The bridge on Erftstrasse crossing the Erft was blocked for any car sized vehicle traffic at the time of the team visit. The bridge was missing one of its supporting elements which appeared to be an abutment wall; the remaining pier experienced substantial tilt (50 cm of horizontal movement below the bridge girder), only poorly supporting the bridge on an edge. The bridge had consequently sagged, but not failed. Before-After imagery obtained from Google maps is shown in Figure 3.25.

Figure 3.25. Bridge Crossing before flood per Google maps (left), Bridge after flood at time of teams visit (right). (50.6668240, 6.7988197)

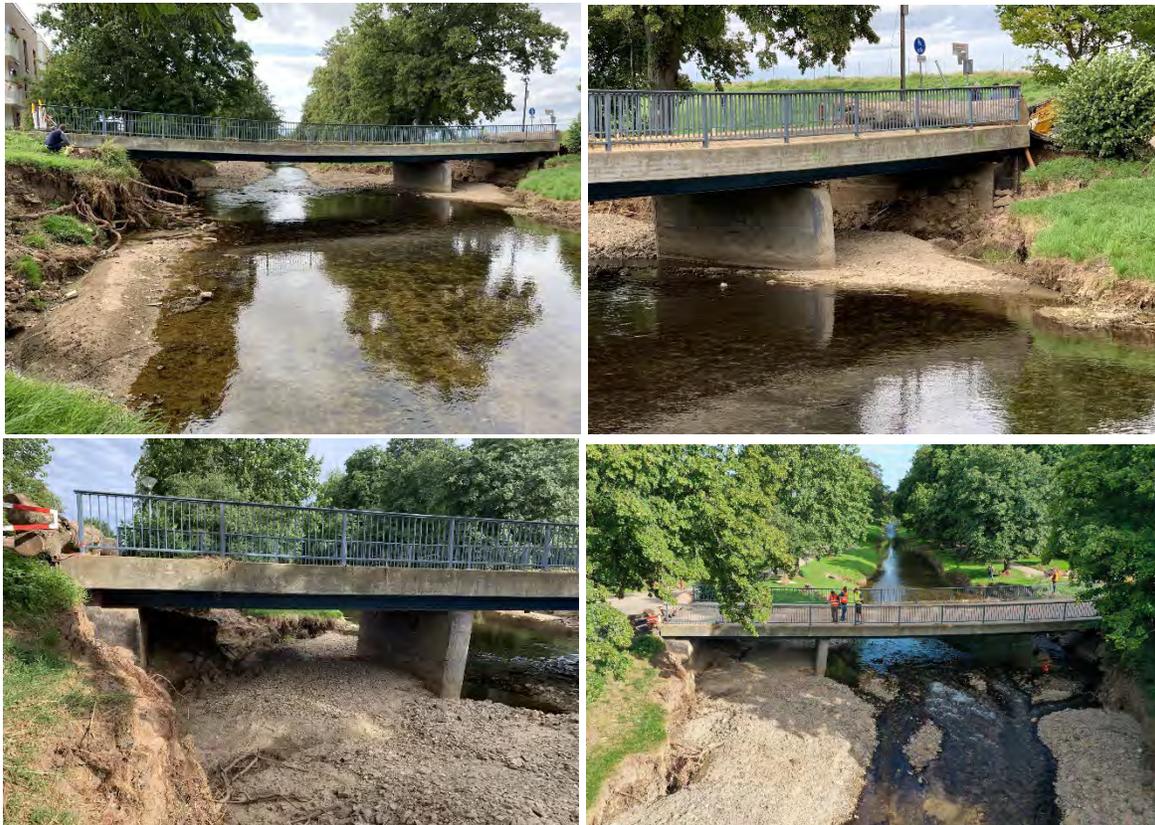
Residents reported that people had still driven personal car size vehicles over the sagged bridge before it was blocked. Scour development was visible at the river center side of the still standing pile and of the missing pile. Interestingly, deposits seemed more prominent on the riverbank side of the piles, instead of a traditionally expected upstream/downstream focused differentiation of scour evolution. Erosion at the abutments suggests that the river may have risen to or beyond the bridge deck height, raising the question if flotation of the bridge deck may have contributed to the structural response, and specifically the loss of

the bridge abutment structure and shift of the other. Erosion on the riverbank side of the lost abutment wall appeared more severe than on the other side where soil cracks suggested that a larger riverbank failure would have occurred soon, but eventually did not happen, likely also being related to the loss of the bridge abutment structure on the heavily eroded side versus the shifted bridge pile on the lesser eroded bank side.

Figure 3.26. Erft river bridge on Ertstrasse. Top left) Overview of damaged bridge highlighting severe erosion on the left riverbank side and the total loss of a bridge pile on the same side. Top right) Larger context of the shifted bridge pier showing distinct scour at the river center side and deposition on the riverbank side. Bottom left) Shifted and tilted bridge pile with gravel deposits on its river bank side, minor erosion at the foundation of the abutment and river bank erosion aligning well with the bridge abutment. Bottom right) Aerial image of the scene revealing river bank near gravel deposits. (50.666831, 6.798996)

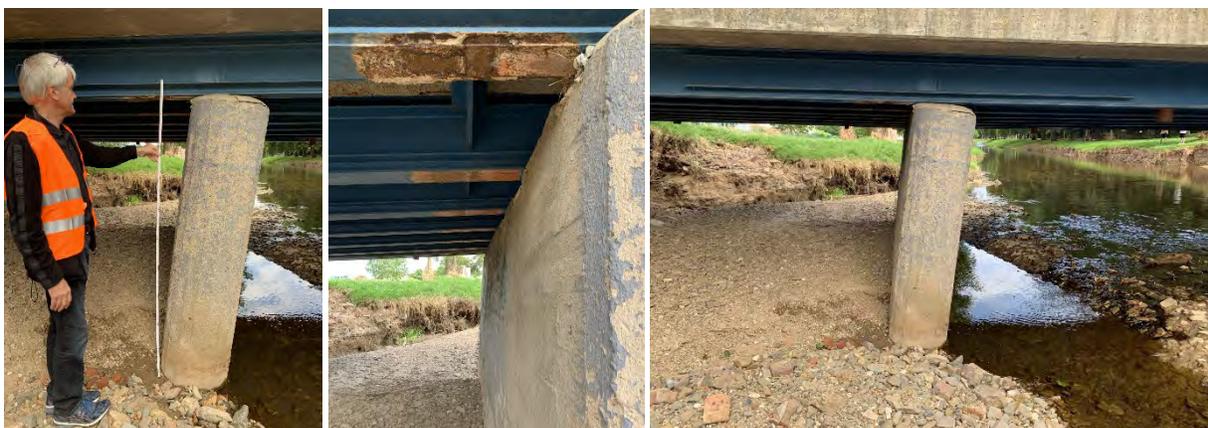
Figure 3.27. Shifted and tilted bridge pier with team member J. Stamm for reference (left). Horizontal movement of pier at deck interface (center), tilted support pier (right). (50.6668317, 6.7989968)

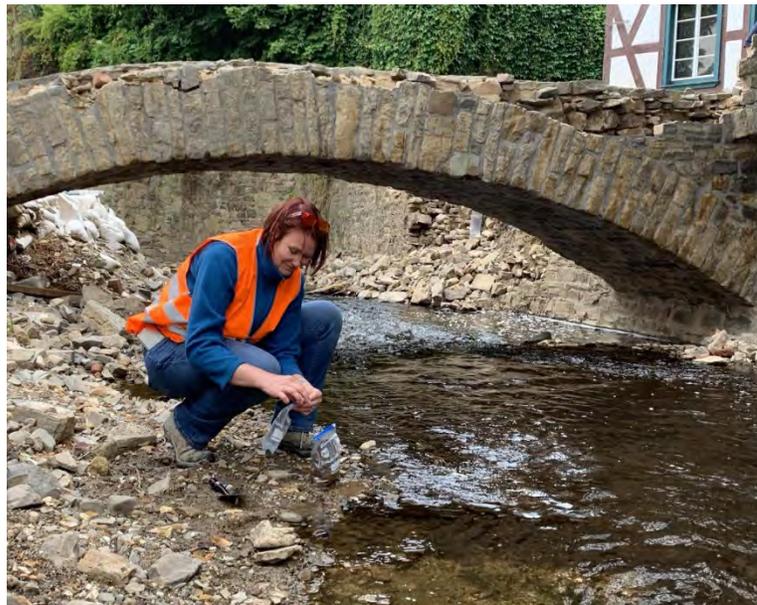
Soil samples were collected in Bad Münstereifel (BM) from within a parked car (Table 2.3), thus, representing sediment loads carried within the flood waters (BM1), from an eroded riverbank location near the Werkbrücke (BM2), and from within the Erft river in Bad Münstereifel downtown (BM3; Table 2.3). Sieve analysis and Atterberg tests were conducted for BM1. Limited soil material allowed Atterberg tests only for BM2, and sieving was only performed on BM3. For BM1, sieve analysis suggested 63.31% fines, 35.5% sand, and 1.2% gravel. Atterberg testing suggested a liquid limit of 35, a plastic limit of 28, and a plasticity index of 7. BM2 yielded a liquid limit of 54, a plastic limit of 35, and plasticity index of 19. BM 3 featured a median grain size of 3.76 mm with 0.11% fines, 93.7% sand, and 6.3% gravel, and with a coefficient of uniformity of 8.3 and a coefficient of curvature of 0.93. Water content measurements were taken with a Dynamax moisture gauge yielding $w = 41\%$ directly by the water, 30% at a distance of 50 cm away from the river, and approximately 1% near the road.

Figure 3.28. Team member N. Stark during sample collection in the Erft river in Bad Münstereifel's city center (50.556031, 6.7651736)

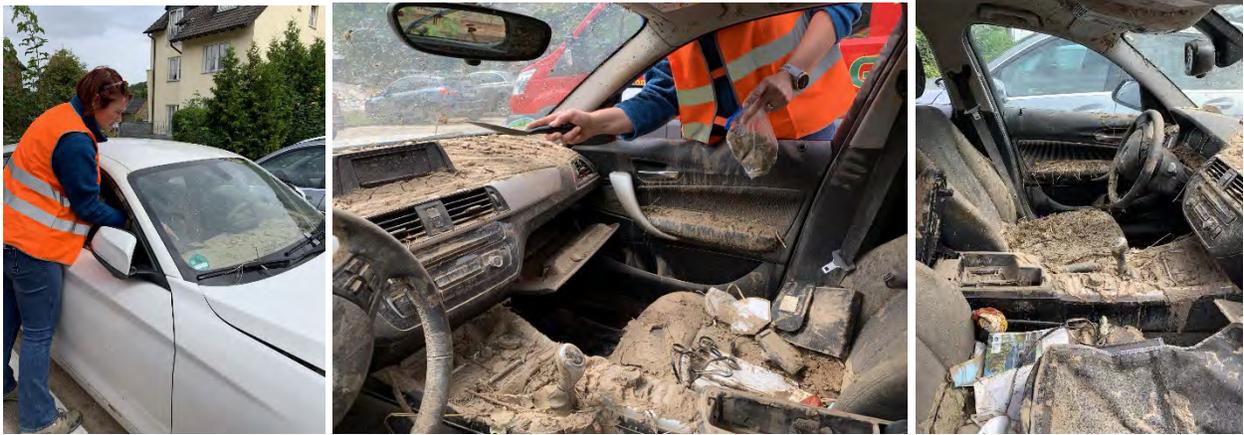
Figure 3.29. Team member N. Stark during sample collection from within a parked damaged car in Bad Münstereifel (50.5513042, 6.76283450)

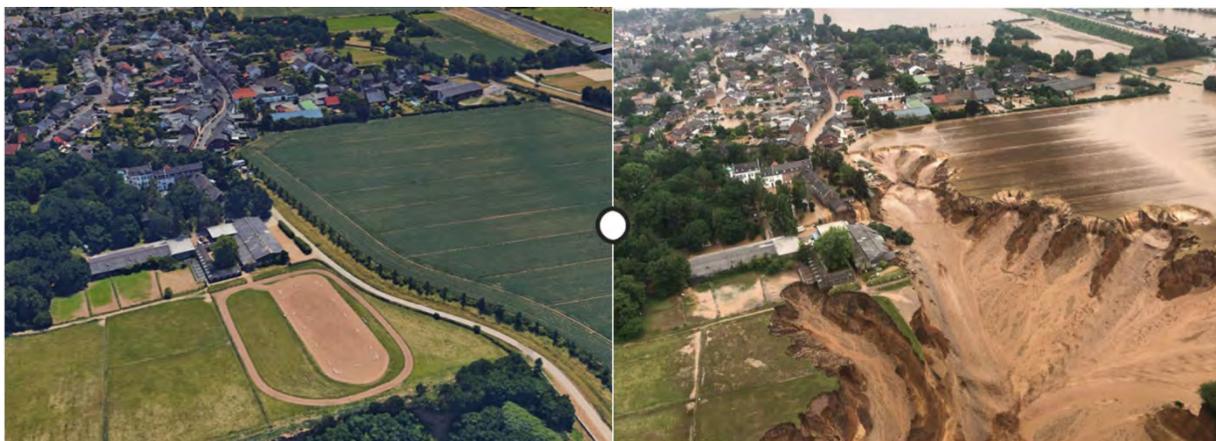
The flooded and eroded area surrounding the gravel pit is shown in Figure 3.34. Figure 3.35 shows before and after aerial photographs depicting the landscape near the residential area.

Figure 3.35. Before and after photos (source: <https://reportage.wdr.de/hochwasser-nrw-vorher-nachher-fotos#chapter-140>)

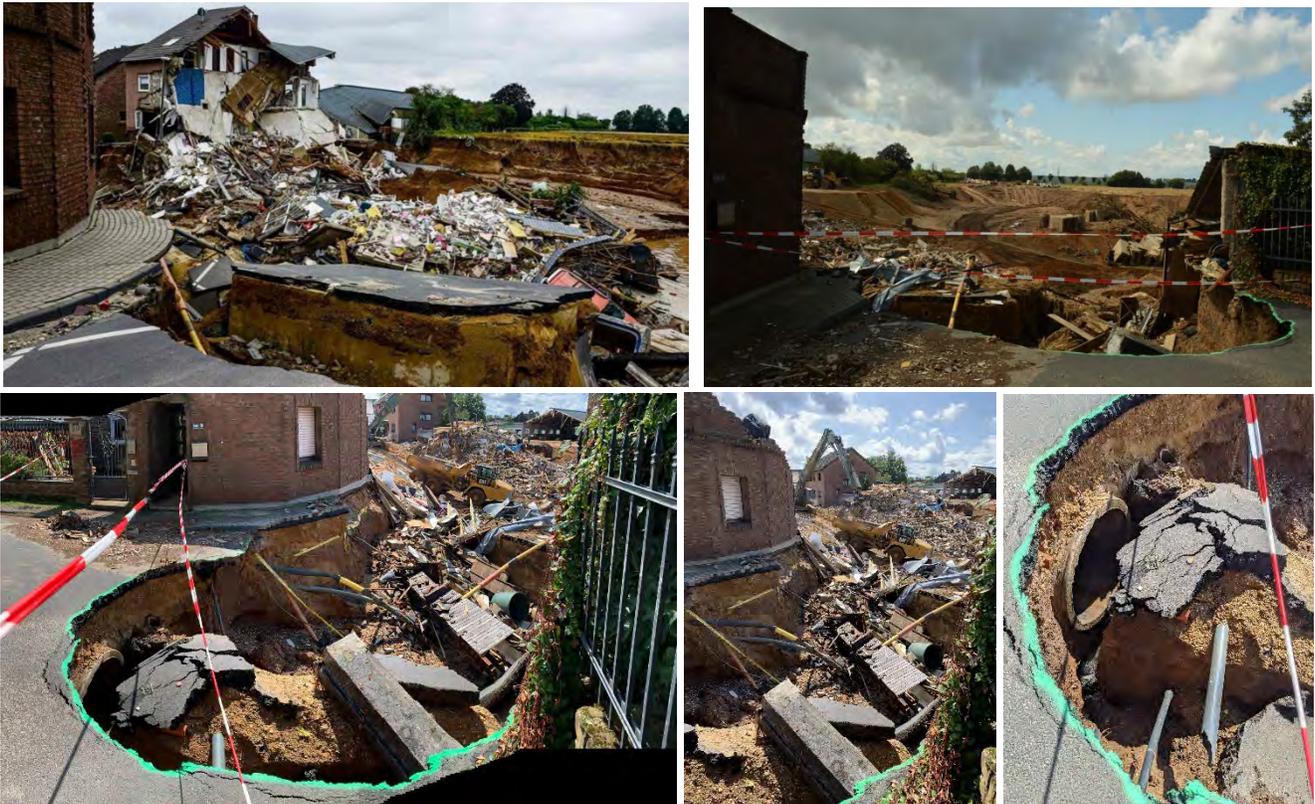
Figure 3.36 shows the corner Radmacherstrasse in Blessem on August 10th, the day of the teams visit. A large amount of debris was being removed by onsite construction equipment. The UAV photograph shows the corner house (still visible in Figure 3.33) in the process of being demolished. The UAV image in Figure

Figure 3.36. On-site situation on August 10th, 2021 (50.813582, 6.7950140)

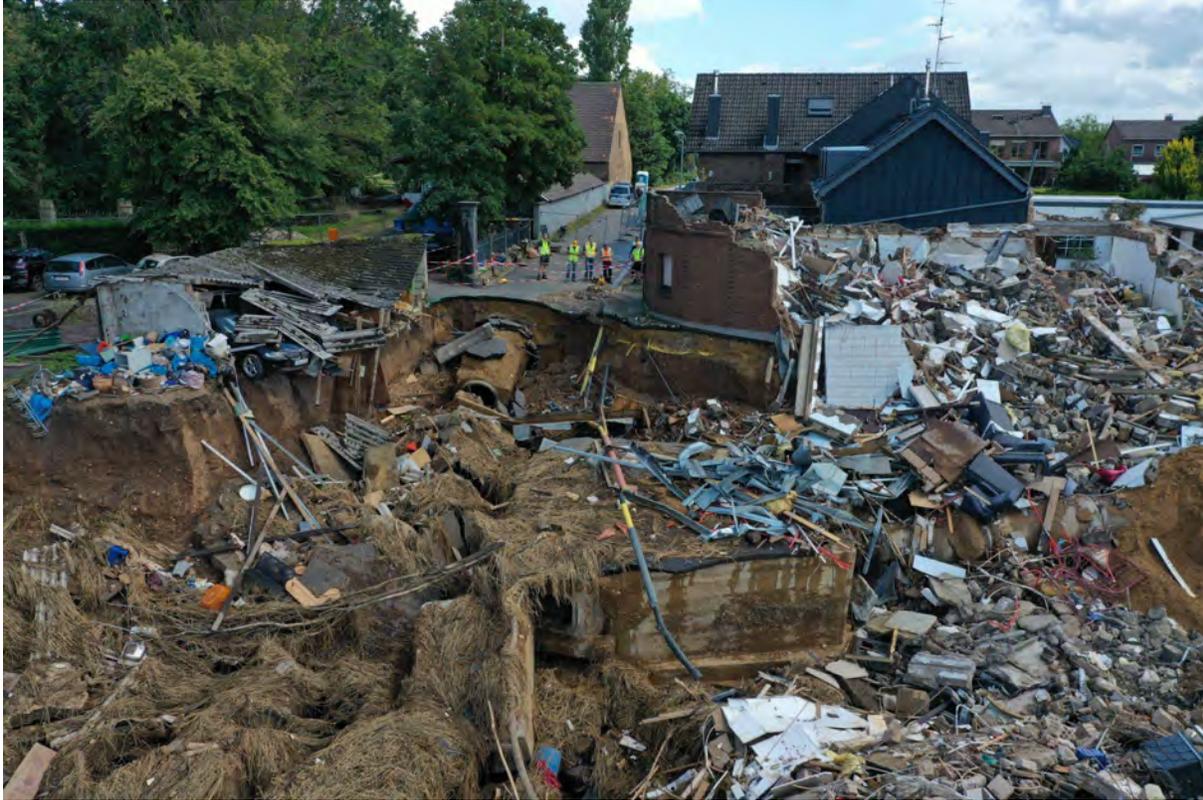
3.37 also shows the large, exposed wastewater and storm drain networks, and significant soil erosion depths.

Figure 3.37. UAV image of the reconnaissance team standing at the edge of the Radmacherstrasse, exposed utility networks underneath the street (50.813582, 6.7950140).

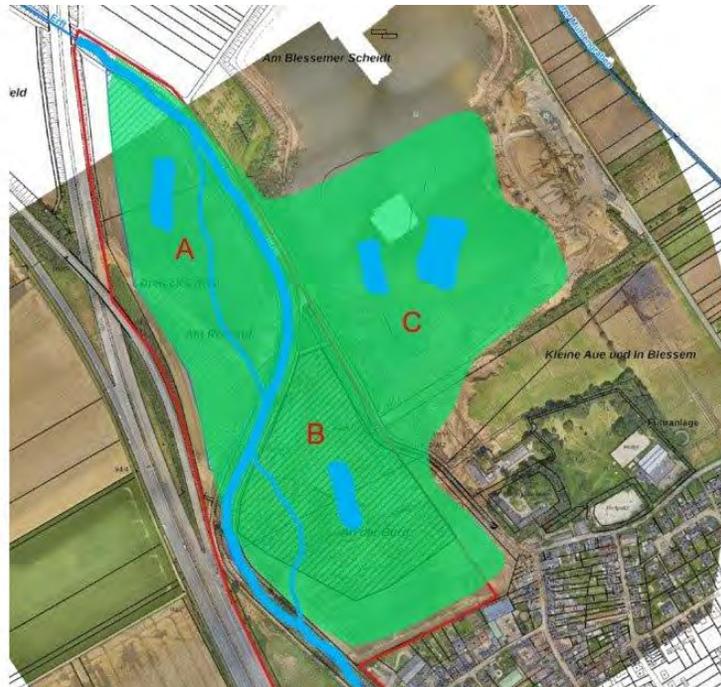
Figure 3.38. Rehabilitation plan with various sections for the remediation of the floodplain areas, source: Bundesregierungsanstalt, NRW, 2021

The Erftverband developed a secondary floodplain concept to rehabilitate and redesign the erosion area, to create a retention area, and to improve flood protection (Bundesregierungsanstalt, NRW, 2021). Figure 3.38 shows the rehabilitation plan. In the first section of the project (A), the area between the Federal Highway 1 and the Erft River is to be lowered by approximately one meter to serve as a retention area, i.e., as a safe flooding area in the event of possible floods. In the second section (B), the deep cut in the terrain created by the flood between the northern edge of Blessem, the Erft and the open pit is to be filled in again, and the southern slope of the gravel pit is to be restored. As a third section (C), the new "secondary floodplain" is to be extended around the current settling basin as an additional flooding area as part of the recultivation of the open pit. Extensive backfilling is required for this. (Bundesregierungsanstalt, NRW, 2021).

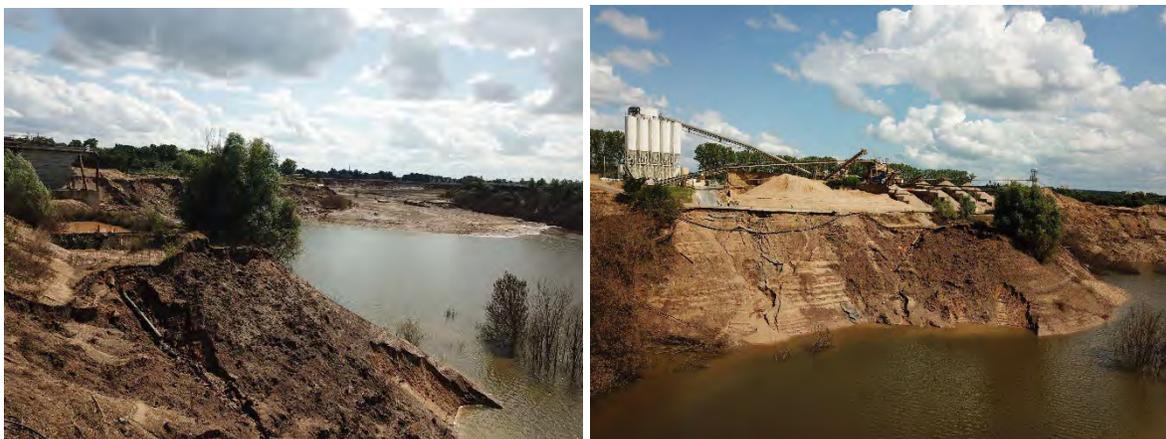
The reconnaissance team was able to visit the gravel mine and walk inside the open-pit facility. At the time of the visit, water had returned to regular water elevations. Substantial erosion was observed along the pit slopes (Figs. 3.39 – 3.41)

Figure 3.39. Inside the Blessem gravel mine, looking towards Blessem town and the inflow area (left) (50.818468, 6.794142)

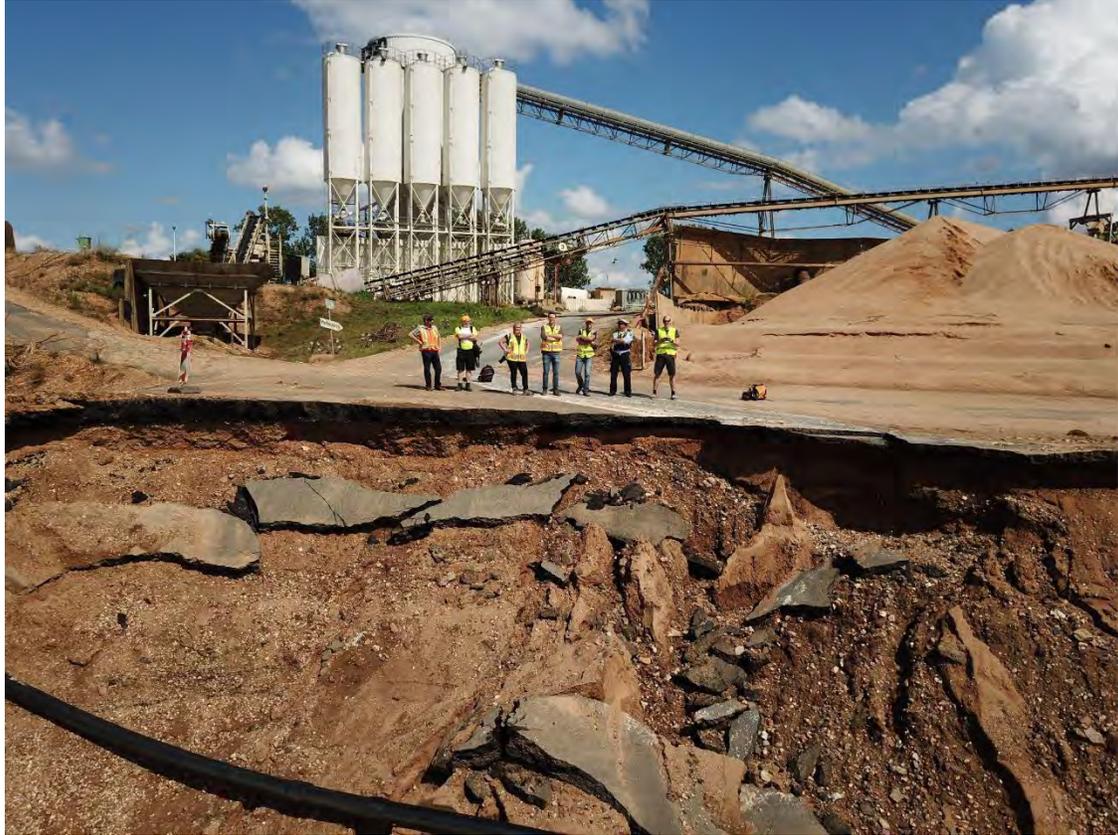
Figure 3.40. Reconnaissance team atop slop failure in the gravel mine (50.818468, 6.794142).

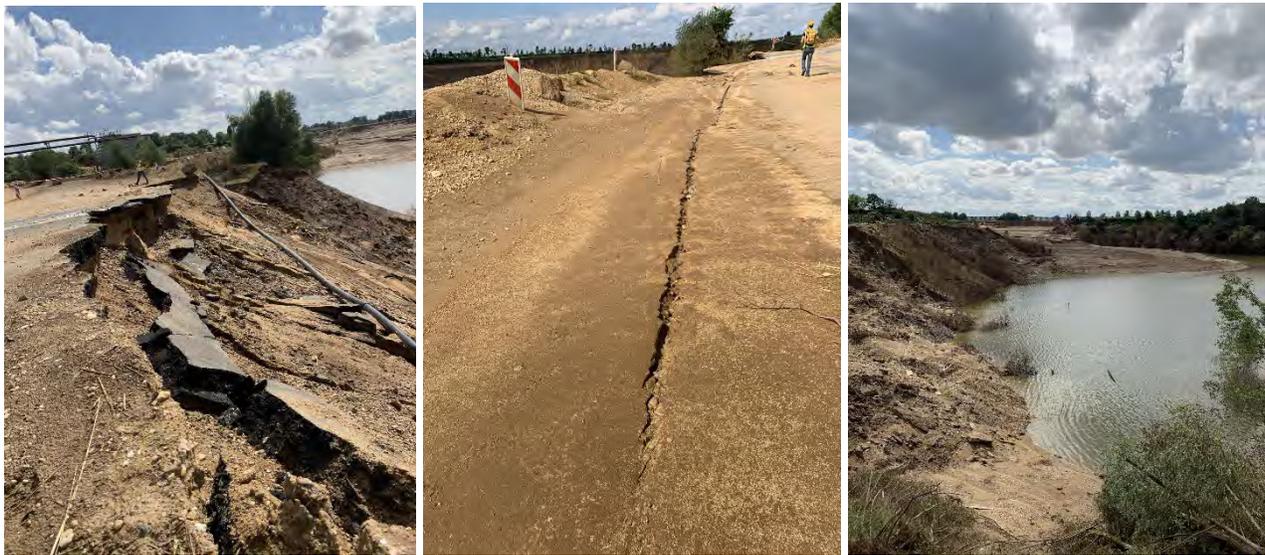
Figure 3.41. Left: Damage to asphalt gravel roads; Center: Soil cracks possibly indicated deeper seated slip surfaces; Right: Water levels of the gravel pit at the time of the team visit (50.818468, 6.794142).

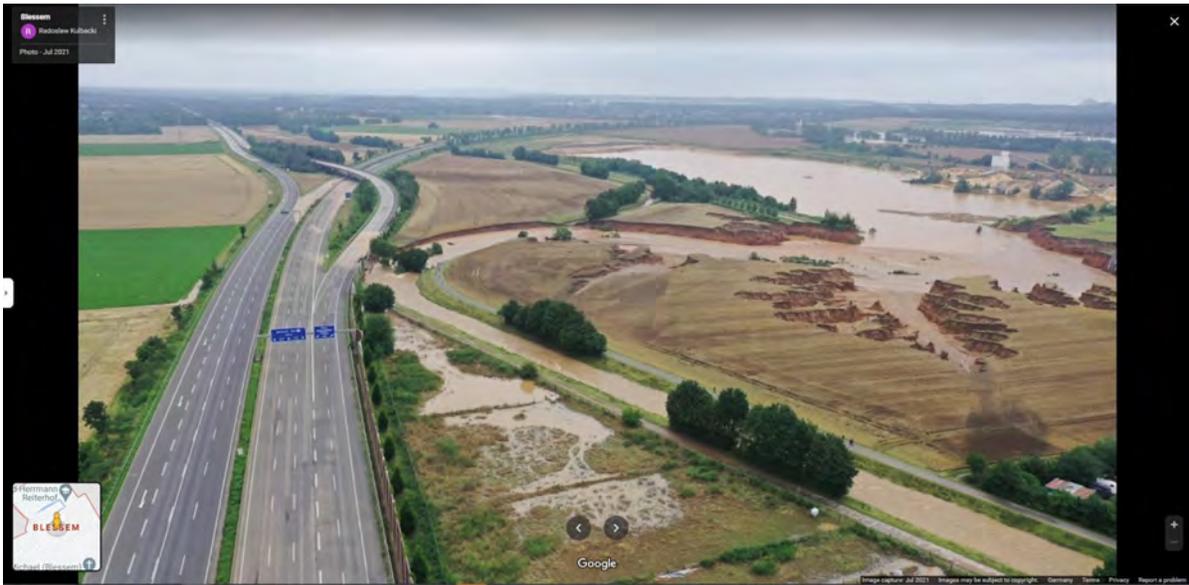
Figure 3.42. Aerial photograph of flooded fields and flooded gravel pit adjacent to the freeway A1/A62

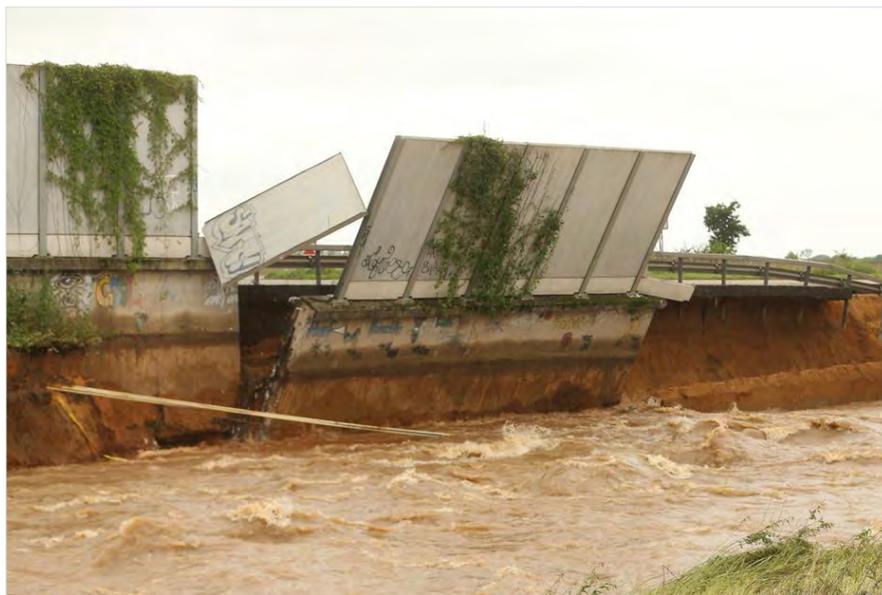
Screen Footage capturing the failure of a noise barrier wall along the A1 Autobahn on July 16th, 2021 is shown in Figure 3.45. Figure 3.45 also depicts the scouring and erosion underneath the freeway shoulder and lane.

Figure 3.45. Failure of noise barrier wall, captured on video, Source: <https://www.welt.de/vermischtes/article232546283/Hochwasser-in-Erfstadt- Standstreifen-der-A1-bricht-ab-und-stuerzt-in-die-Erft.html>

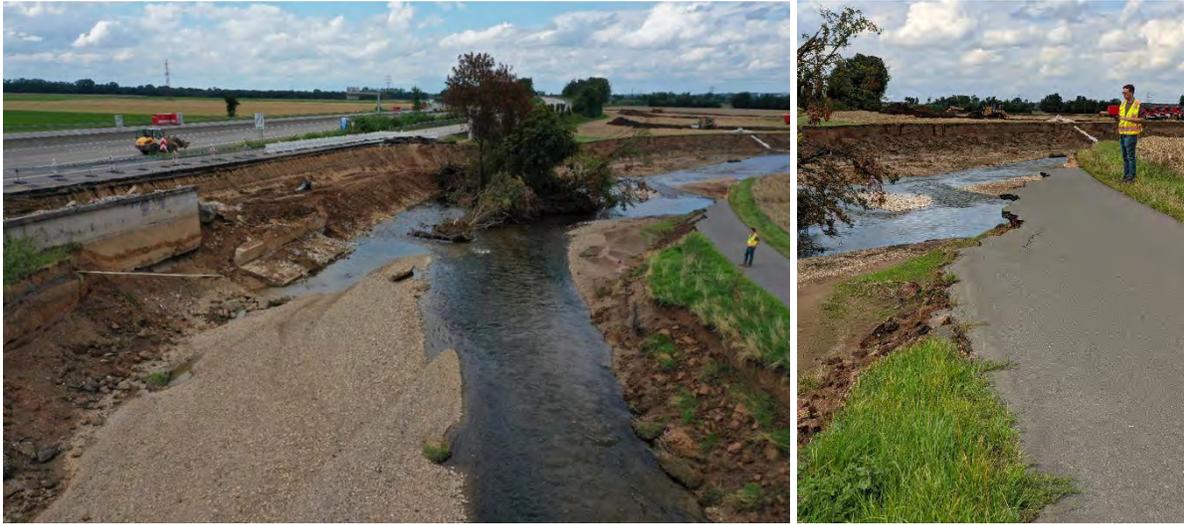
Figure 3.46 includes an aerial view of the of the damage along the A1/Erft. The pedestrian walkway/bicycle path shown to the right was completely damaged.

Figure 3.46. UAV photo taken during team's visit on August 10th, 2021(50.8134771, 6.7890135)

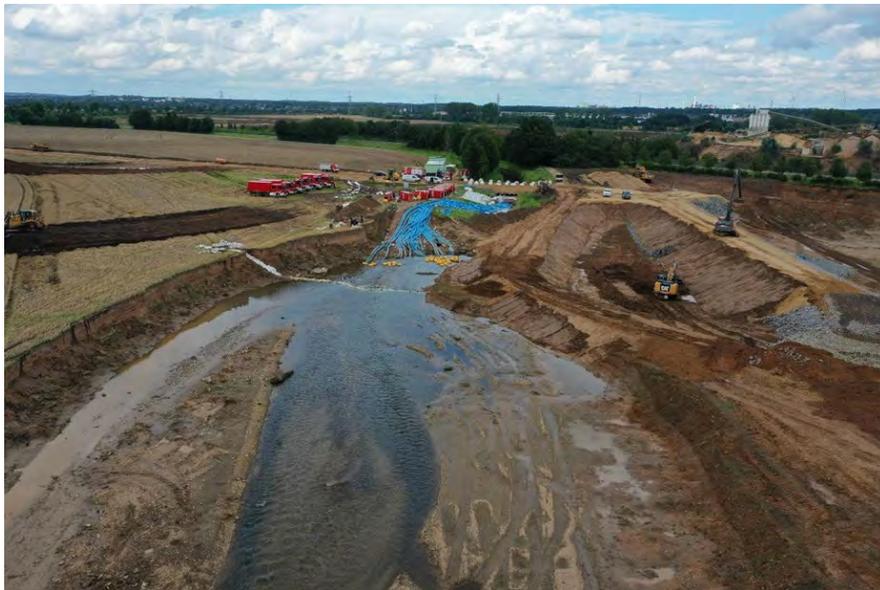
Figure 3.47. Aerial view of temporary dam and river rerouting by the Blessem fire department (50.8134771, 6.7890135).

As one of the first measures after the flood event, the German military (Bundeswehr) built a temporary dam made of big bags filled with gravel in the new riverbed of the Erft (Figure 3.47). This dam was significantly reinforced later. In the meantime, water from the newly created riverbed of the Erft has already started to be rerouted (see Figure 3.47) to its old riverbed (see red arrow Figure 3.47) (MRASEK, 2021). The goal of this measure is to stop the inflow to the gravel pit (see blue arrows Figure 3.44) and thus prevent further erosion, which should also prevent further damage to the highway (MRASEK, 2021). The highway was completely closed after the flood and the reconstruction of the roadway was started on October 12, 2021 (EPA, 2021).

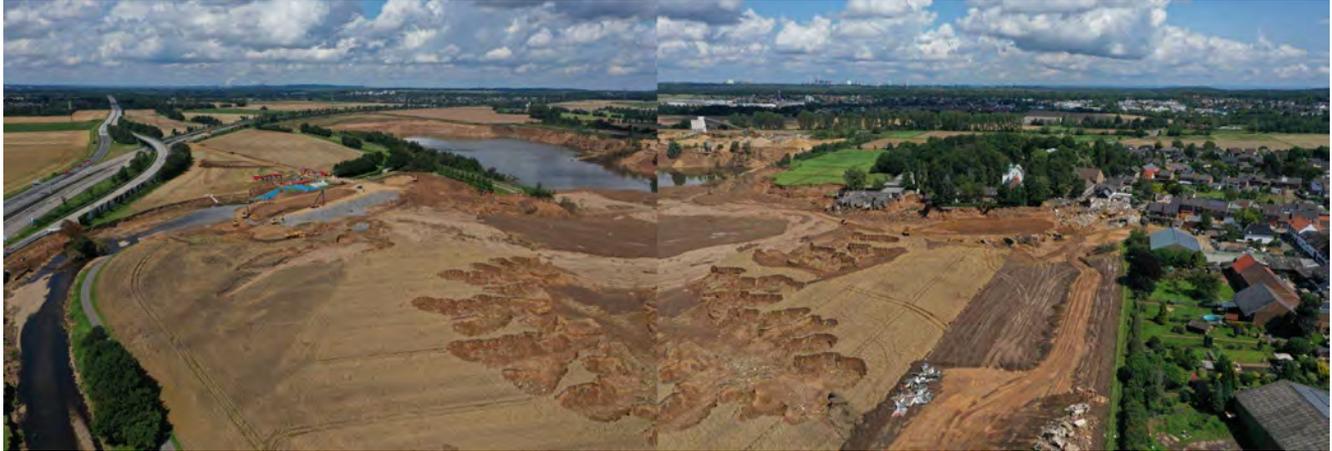
Figure 3.48. Aerial view of damage around gravel mine on August 10th, 2021 (50.8134771, 6.7890135).

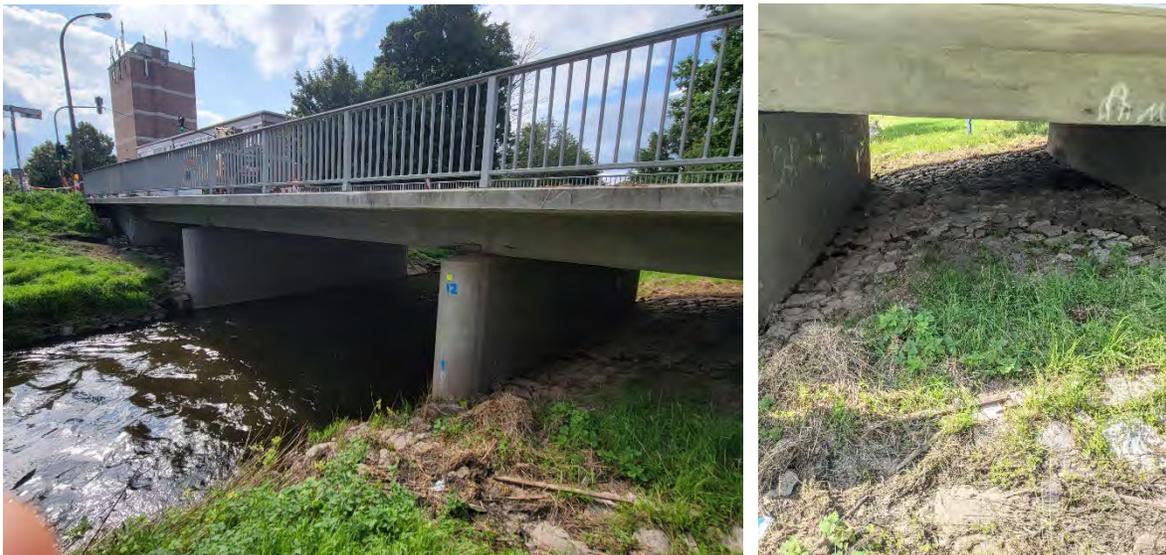
The team visited the bridge Merowingerstrasse, Bliesheim-Erfstadt crossing the Erft River (Fig. 3.49). At the time of the visit, the bridge was still closed to vehicle traffic, but accessible by foot. Cleaning up and repair work had already started here addressing erosion that led to damage to the pedestrian path on the bridge and cobble stone-based soil stabilization on the riverbank slope between the abutment and the bridge pier (Figs. 3.49 and 3.50). From the damage and erosion, it appears that significant water flow occurred from the bridge deck onto the riverbanks and into the Erft, eroding materials in its path.

Figure 3.49. Photos of the Merowingerstrasse bridge across the Erft river in Bliesheim-Erfstadt. Left) Flowpaths and erosion was visible parallel to the bridge down the riverbank slopes. Right) Soil erosion on the riverbanks near the bridge abutments and piles and possibly removal of cobble slope reinforcement between the abutment and the pile are visible (50.782199; 6.822505)

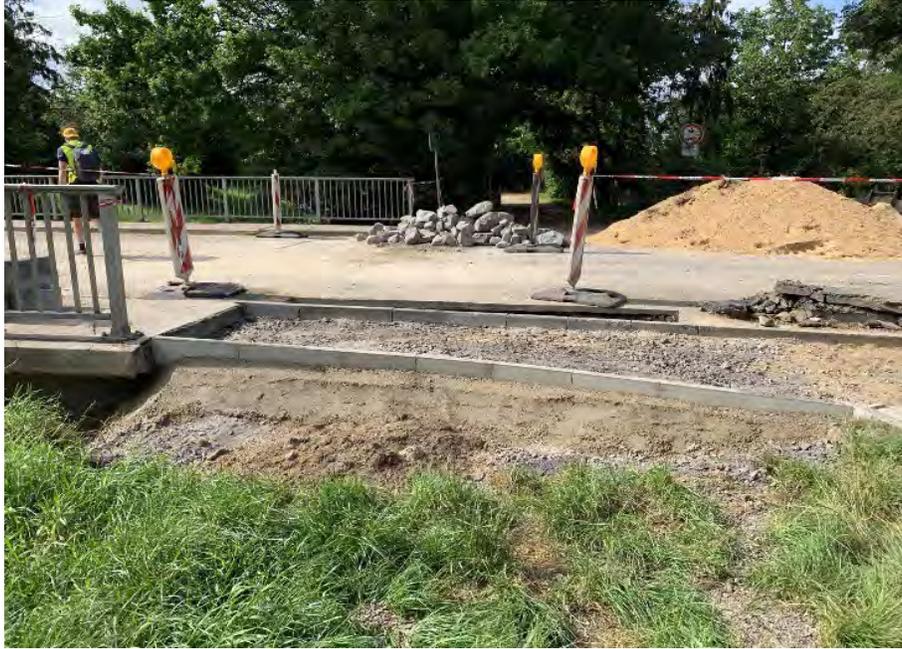
Figure 3.50. Erosion suggested flow from the road down the riverbank's slopes created damage to the pedestrian path of the bridge section connecting with the riverbanks (50.782199; 6.822505).

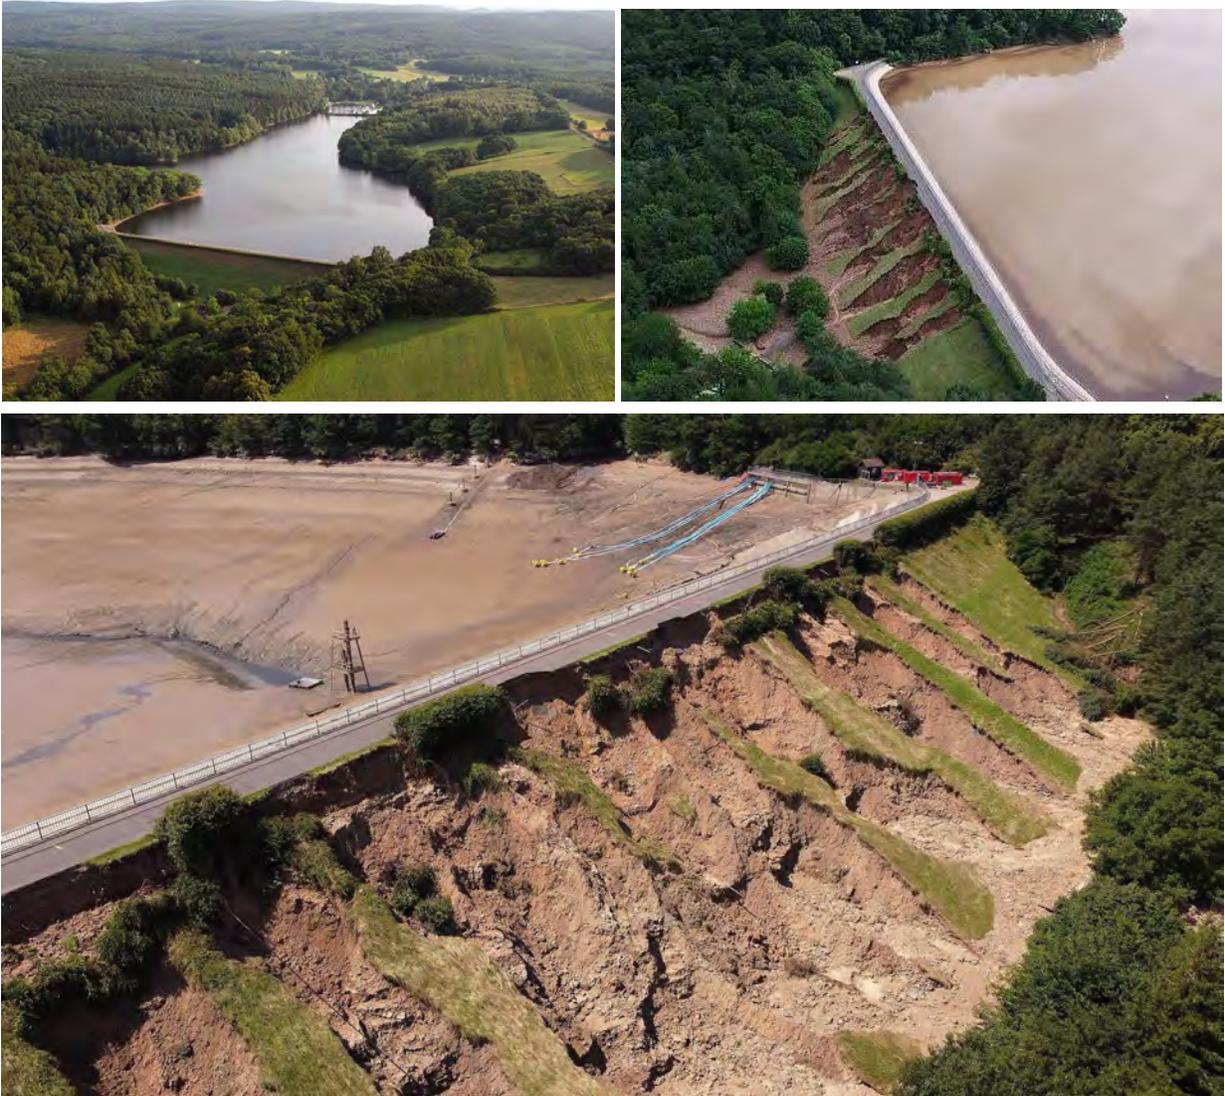
The Steinbachtal dam (“Steinbachtalsperre”) (Fig. 3.51) is located in Euskirchen, NRW, with a height of 23 m, a length of 240 m, and a crest width of about 5 m. The dam volume is estimated at 100,000 m³ and the total capacity of the reservoir is 1.2 million m³. The original dam construction started in 1934 with completion in 1936. The original dam purpose was to meet the local water needs that recently increased from the local textile industry. The dam was updated at the end of the 1980s with recommissioning in 1990.

The reservoir and spillway capacity was insufficient to accommodate the July 2021 flood event, leading to overtopping of the dam for a duration of about three hours. Additional blockage of the spillway made the situation more dire. Severe erosion occurred on the downstream side of the dam from the overtopping (Fig. 3.51). This represented an increased risk for dam failure under the continuing load from the flood, leading to the immediate evacuation of multiple communities downstream of the dam. First responders were able to remove the blockage, increasing controlled outflow again, and pumped water out of the reservoir. The dam did not fail, and the evacuation was lifted after five days. The presence of the hardened asphalt road across the length of the dam crest prevented down-cutting and likely prevented total failure of the dam. Additionally, the crest of the dam was relatively flat, as shown in a section through the SfM model in Fig. 2. 4, and further evidenced in the relatively evenly distributed eroded gullies across the downstream face, as shown in Fig. 3.51. This likely prevented significant concentration of flow. The eroded gullies on the downstream face of the dam exhibited a step-pool geometry caused by hydraulic jets plunging from step to step. This is a typical erosive pattern in more cohesive material.

Figure 3.51. Steinbachtalsperre; Top: before the flood event (top: <https://honnef-heute.de/steinbachtalsperre-unkritischer-wasserstand-erreicht-evakuierungsmaßnahmen-aufgehoben/>), immediately after the event (top right, Source: <https://www.24rhein.de/rheinland-nrw/hochwasser-euskirchen-rhein-sieg-kreis-steinbachtalsperre-trinkwasser-keime-katastrophenfall-90865213.html>), and after water release (bottom, photo by David Young/dpa, Source: <https://www.tag24.de/thema/hochwasser/steinbachtalsperre-drohte-beim-hochwasser-zu-brechen-jetzt-laufen-hier-krisen-besucher-durch-2075576>).

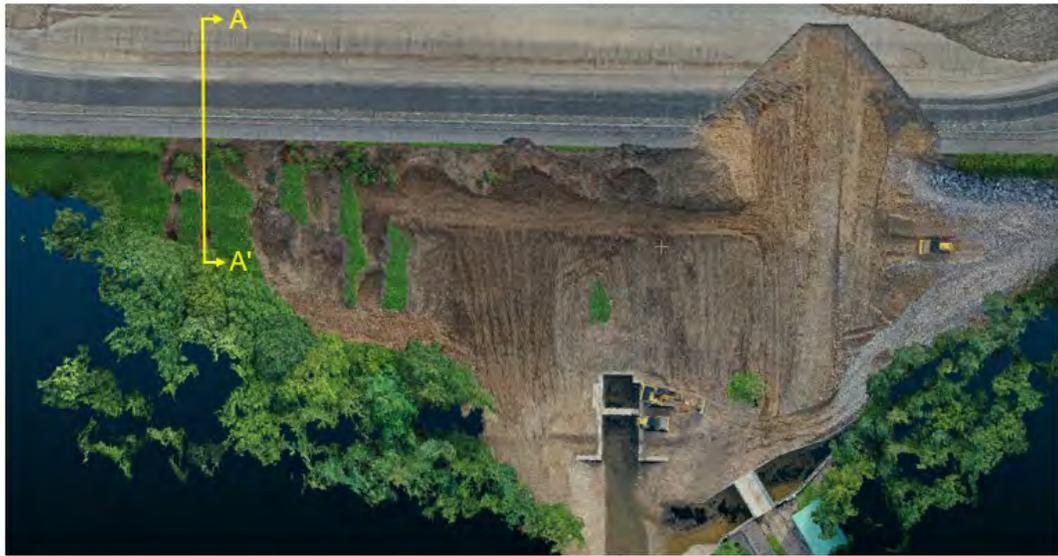
Figure 3.52. Cross-section of scoured gully on the downstream face of the Steinbachtalsperre showing step-pool geometry. Cross-section developed from the SfM model.

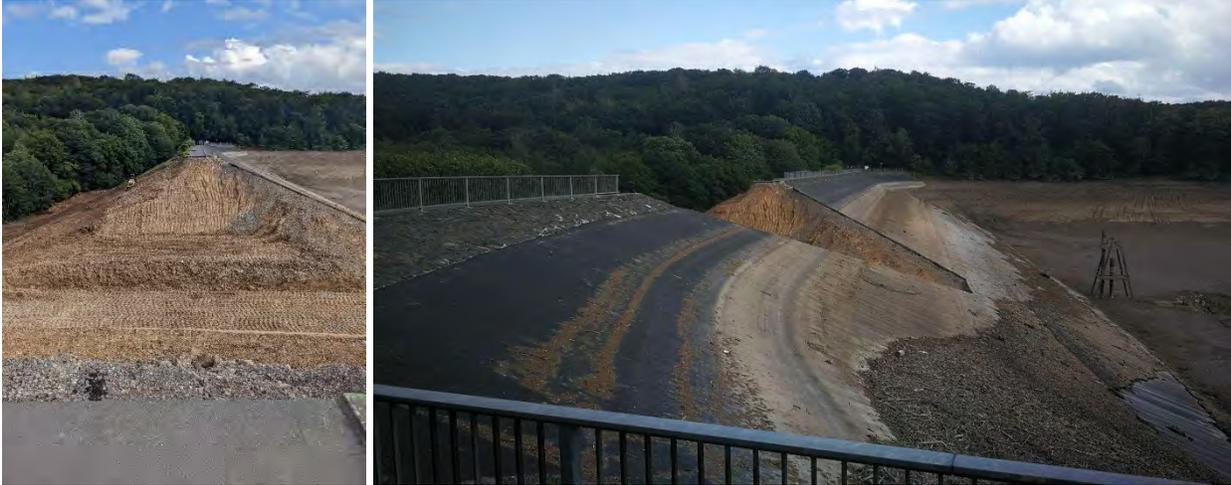
Figure 3.53. Left: Open cross-section of the Steinbachtalsperre during the team visit when repair was ongoing. Right: Reservoir-side view of the removed center part of the dam (50.594124; 6.838211).

At the time of the team visit, active repair of the dam was ongoing with a completely emptied reservoir. Particularly, the spillway section of the dam was removed and under reconstruction (Figures 3.53 – 3.54). Deep erosion channels were identified by the GEER team members downstream of the dam.

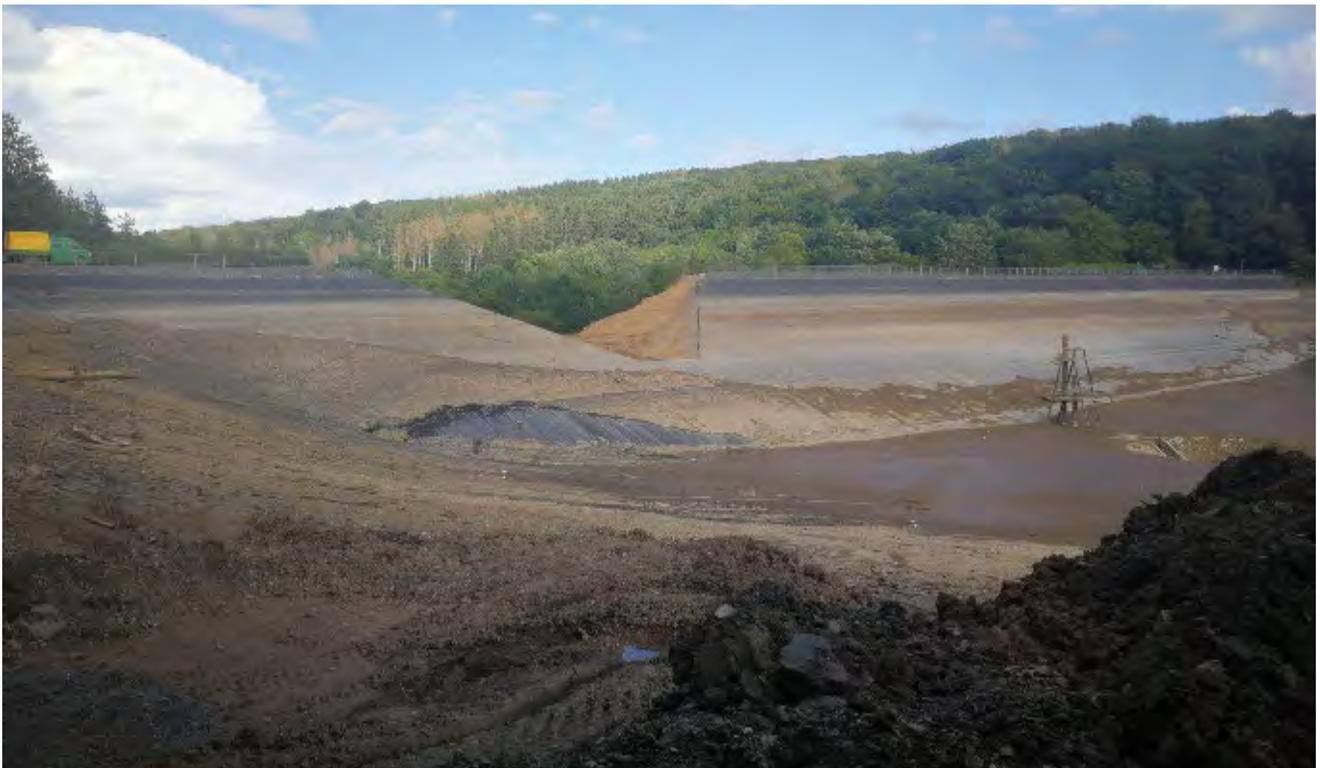
Figure 3.54. Photograph of empty dam at time of the team's visit (50.594124; 6.838211).

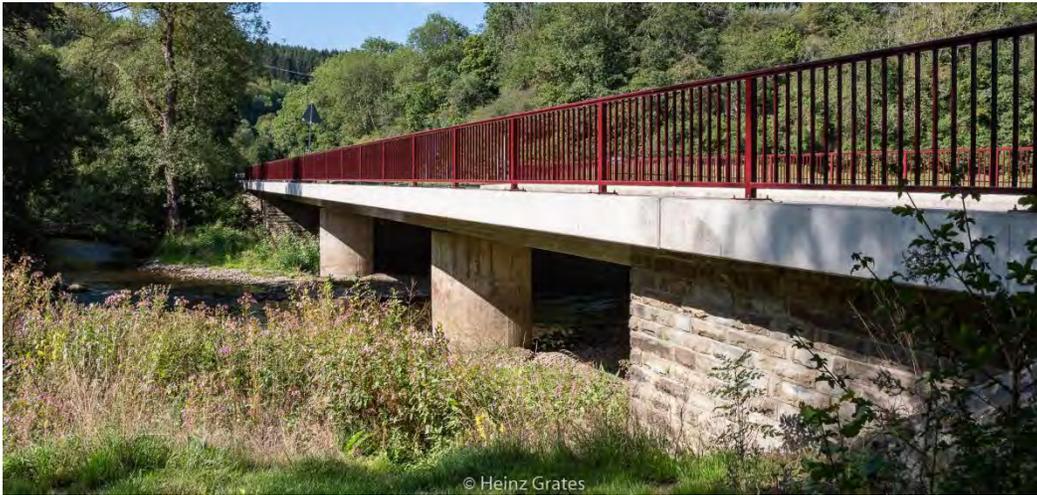
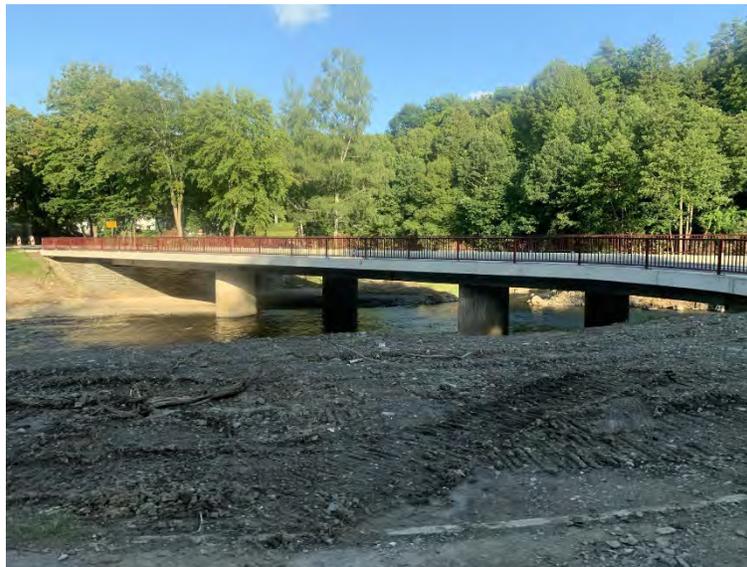
Müsch is located near the entrance to the Ahr valley, at the intersection of Bundestrasse B258 and the Ahrstrasse (L73), the primary road leading into the Ahr valley. Muesch has nearly 200 inhabitants; most of them were mildly affected by the flood according to local information available at the town's homepage. Figure 3.56 shows the road bridge at the intersection of B258 and L73. This bridge experienced no damage and appeared structurally and visually intact.

Figure 3.56. Road Bridge across the Ahr at the intersection of B258 and L73; Top: before flood event (picture credit Heinz Grates, via <https://www.aw-wiki.de/w/index.php?curid=67214>); Bottom: Post flood on August 9th, 2021(50.385609, 6.827283)
