Geotechnical Reconnaissance of the 2021 Western European Floods

Flood Event: July 14-15, 2021

Flood locations: Germany, Netherlands, Belgium, and Luxembourg

Reconnaissance Visit: August 9-18, 2021

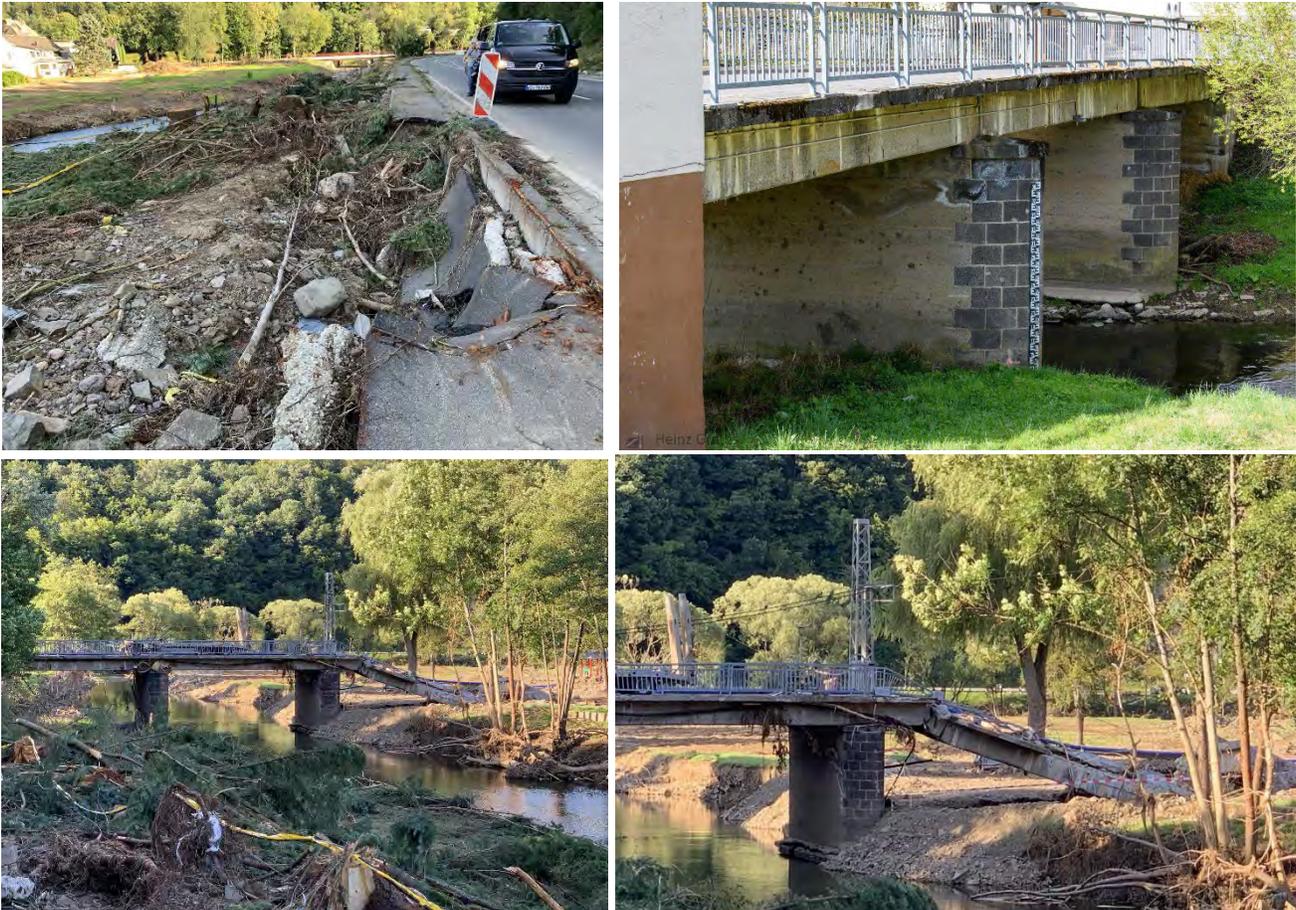
Figure 3.57. Road and Bridge damage in Müsch. Top left: Road damage along the L73, Top right: Bridge prior to flood, Bottom left: damaged bridge in August 2021, Bottom right: close up of missing abutment and collapse of bridge deck (50.385952, 6.8288141)

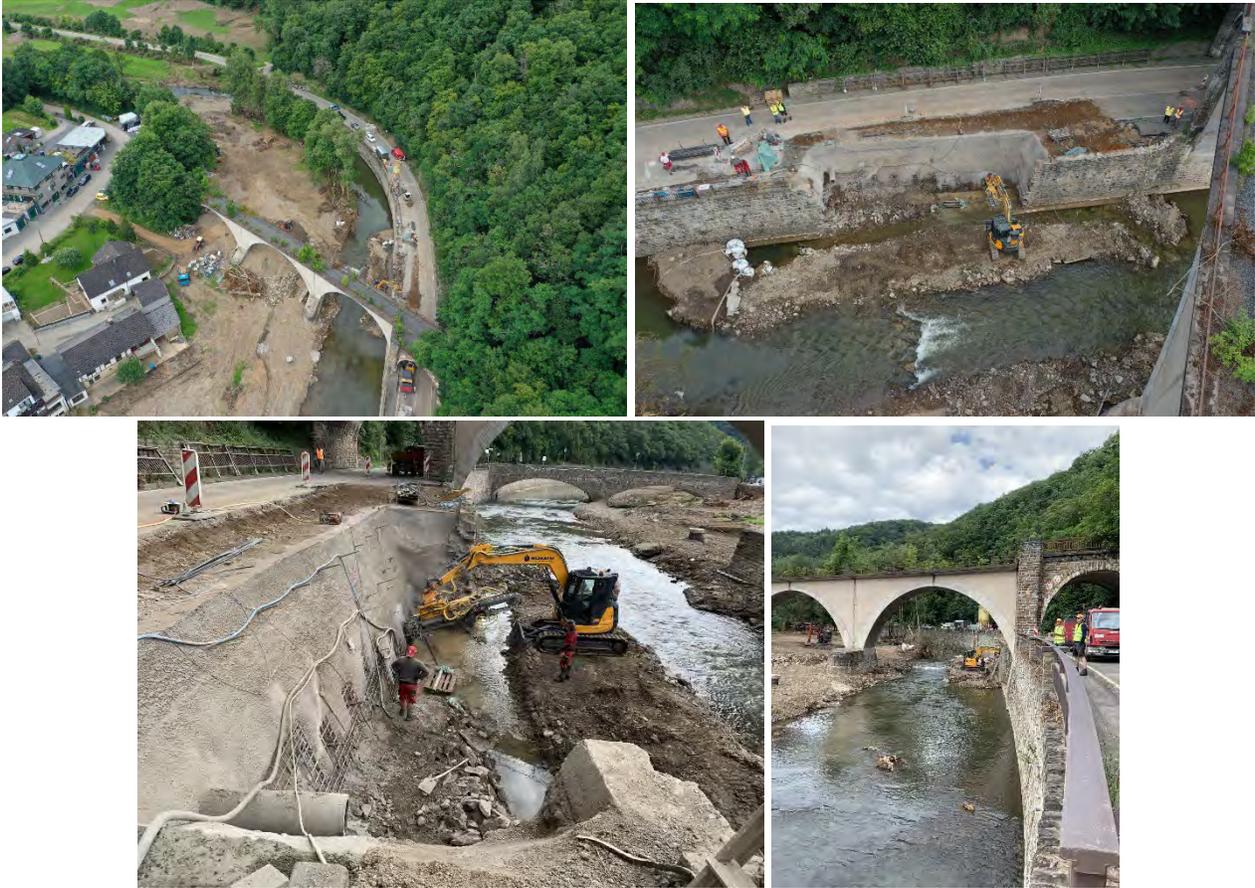
Figure 3.58. Localized Embankment failure in Fuchshofen and ongoing repair work (50.429957, 6.850187)

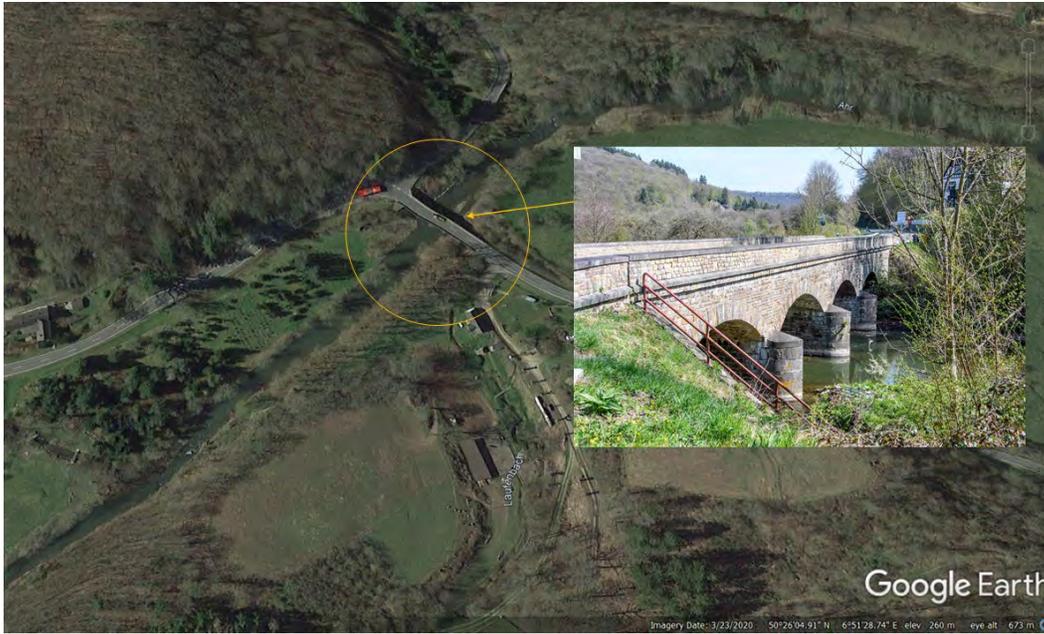
The bridge in Wershofen was a critical crossing over the Ahr as the L73 road represents the only access road to Schuld from the upstream direction of the Ahr (Figure 3.59). The team was able to speak with local residents who worked alongside construction workers to reestablish access across the bridge. The last arch of the bridge as well as the bridge abutment was completely destroyed, as captured by the local resident and shared with the team.

Figure 3.59. Bridge at the intersection of the L73/L74 in the district of Wershofen before the flood event (Source: <https://www.aw-wiki.de/w/index.php?curid=41580>)

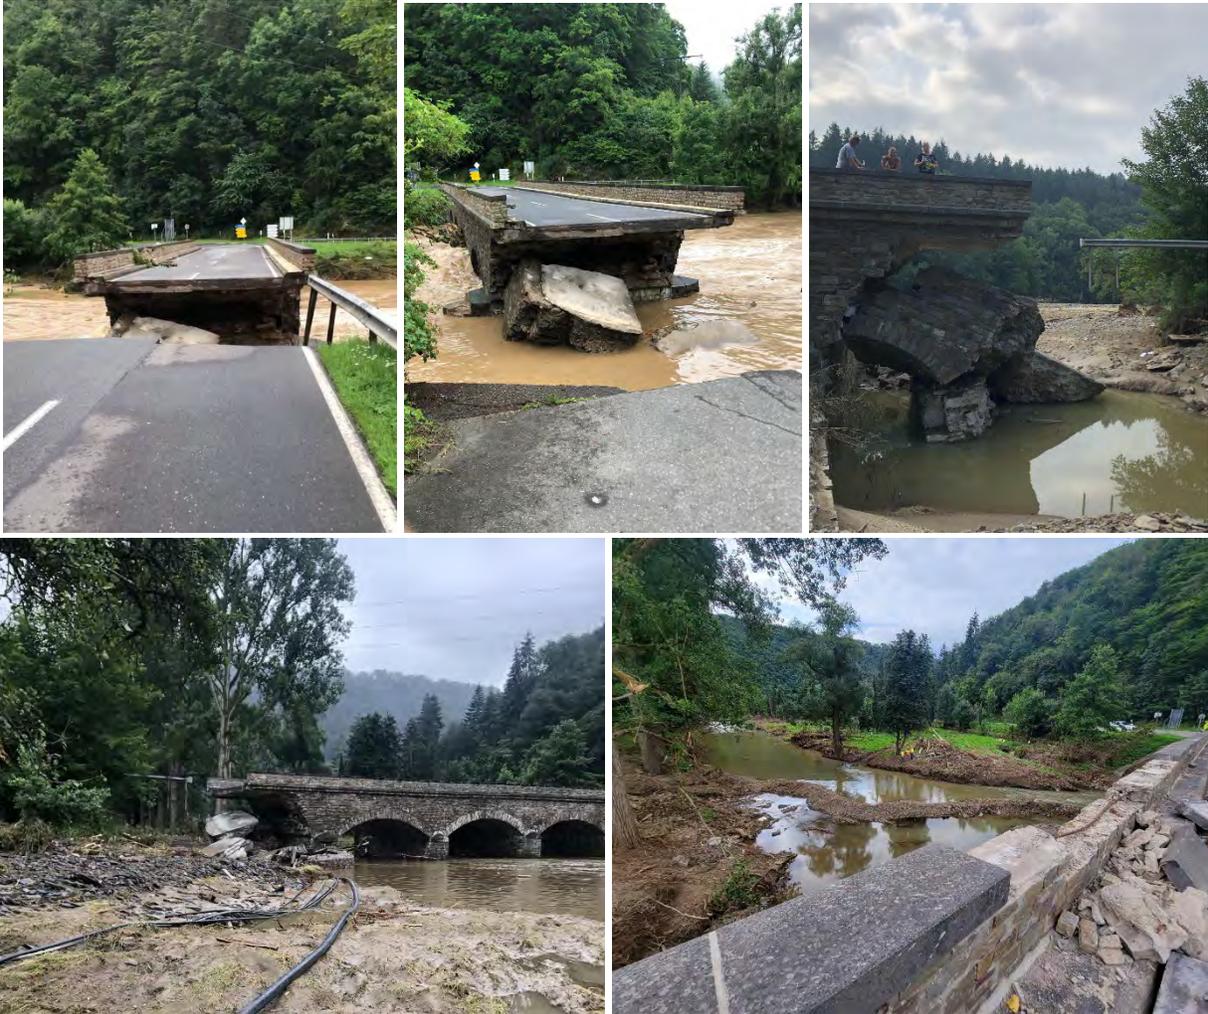
Figure 3.60. Bridge damage in Wershofen (photo credit top and bottom left: local resident, anonymous; 50.432840, 6.858008)

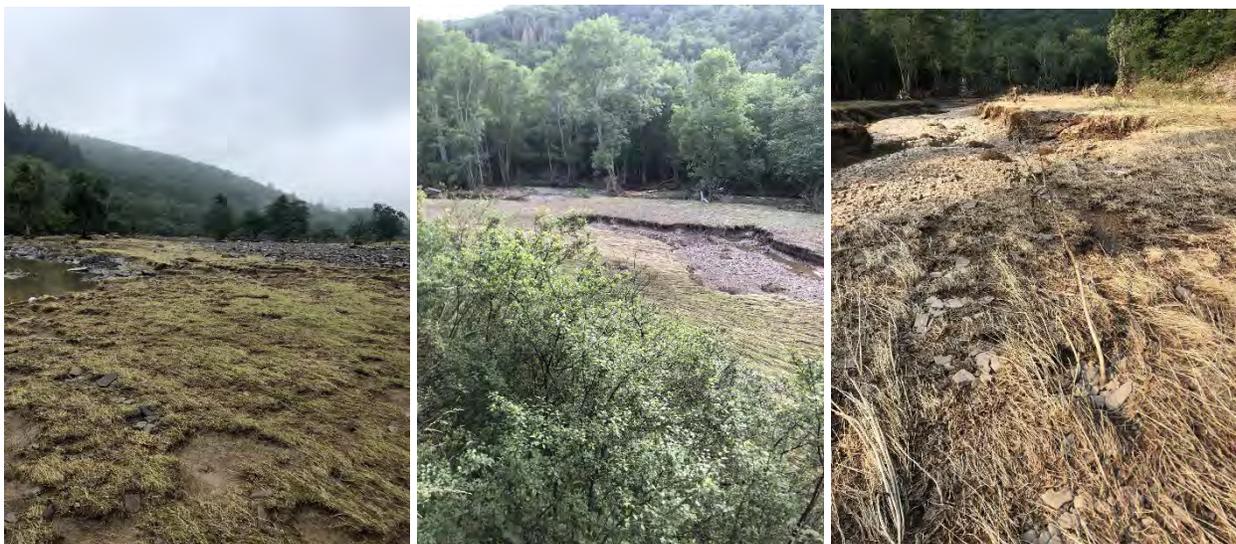
Figure 3.60 shows photographs taken on July 15th, after the first day and night of the extreme rainfall. Figure 3.61 shows several photographs of the adjacent floodplains in the vicinity of the bridge and along the river Ahr. Deep cuts are visible in the surrounding fields. Figure 3.62 shows an estimated water level rise just upstream of the bridge, estimates are based on debris and clothing visible in the trees following the flood as well as slope failures along the river.

Figure 3.61. Floodplains and deep surface cuts after water receding (50.433086, 6.857974)

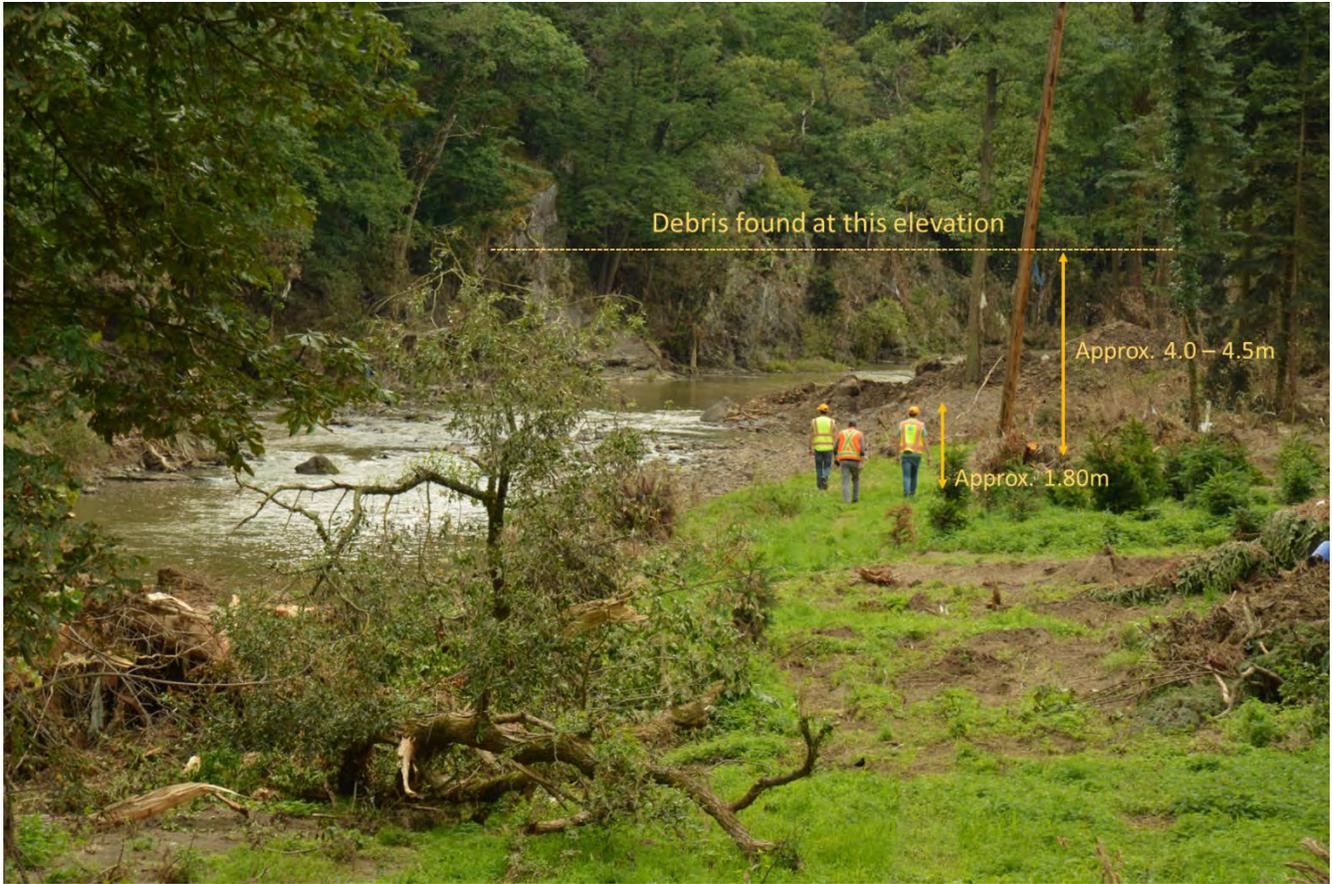
Figure 3.62. Team members walking upstream of the bridge inspecting damage and debris deposits along the riverbanks (50.43275924, 6.85851324)

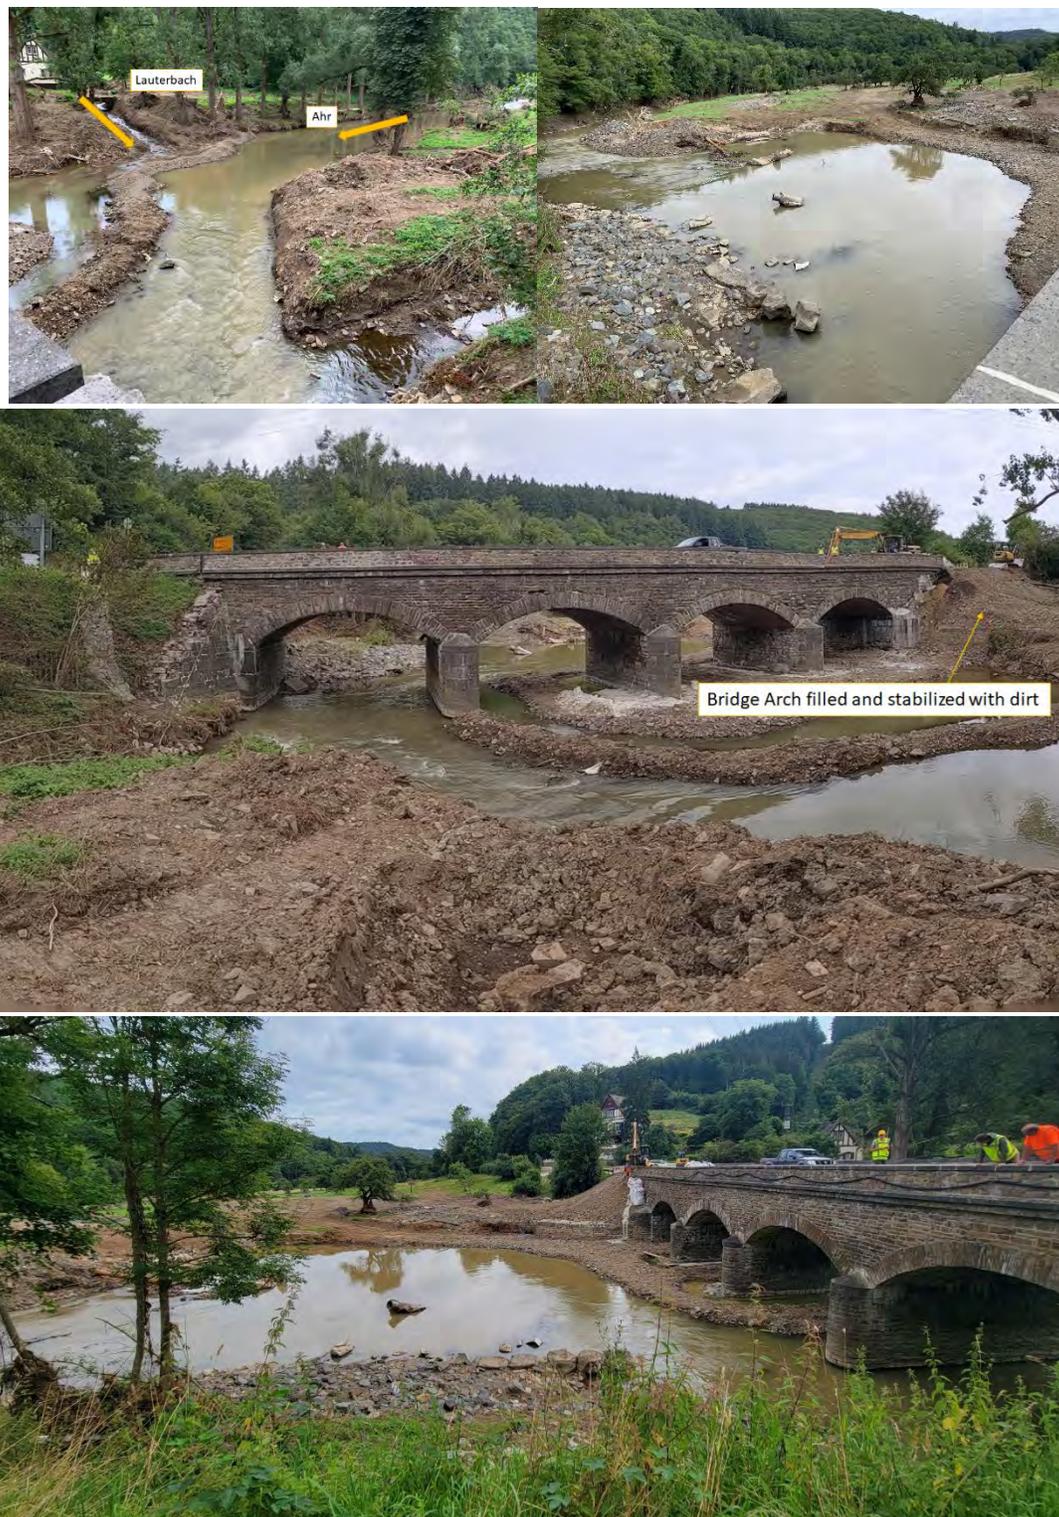
Figure 3.63. Upstream (top) and downstream (bottom) side of the bridge showing fill soil in lieu of bridge arch (50.432840, 6.858008)

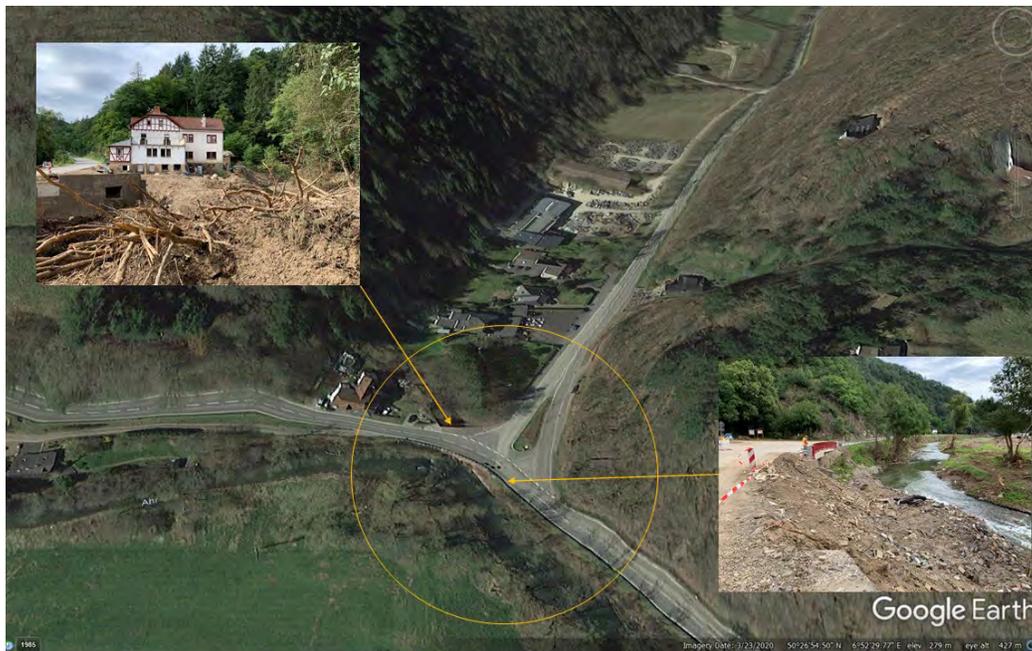
The team visited the destroyed intersection at the entrance to the town of Schuld (Figure 3.64). This location was popular as motorcycle meetup. At the time of the team’s visit, the intersection was stabilized with fill material after substantial erosion destroyed the road. Specifically, damage was caused by the creek “Armuthsbach”, which is indicated in the bottom of Figure 3.65. The creek flows into the river Ahr through a small bridge with 2 narrow arches, as shown in Figure 3.66 left. As flood waters became too large for the discharge cross-section, the water flooded the surface road, eroding most infrastructure around the inlet.

Figure 3.64. Location of damaged area immediately outside Schuld

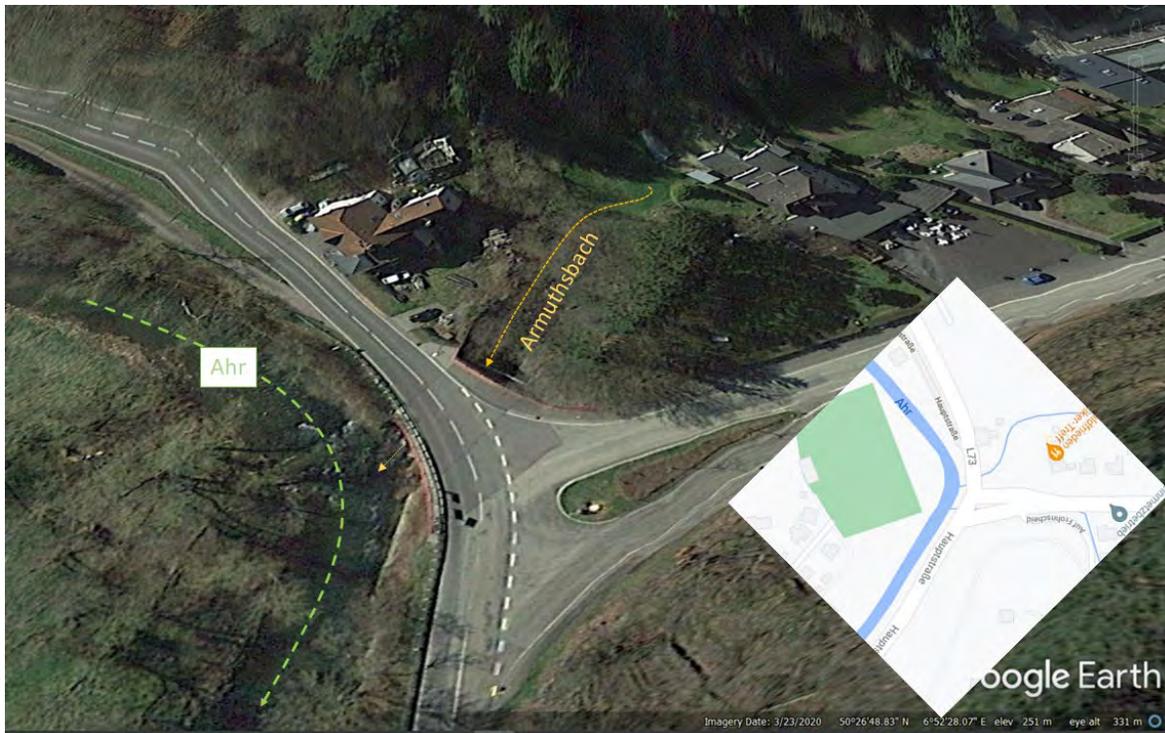
Figure 3.65. Location of merging point between Armuthsbach creek and Ahr river

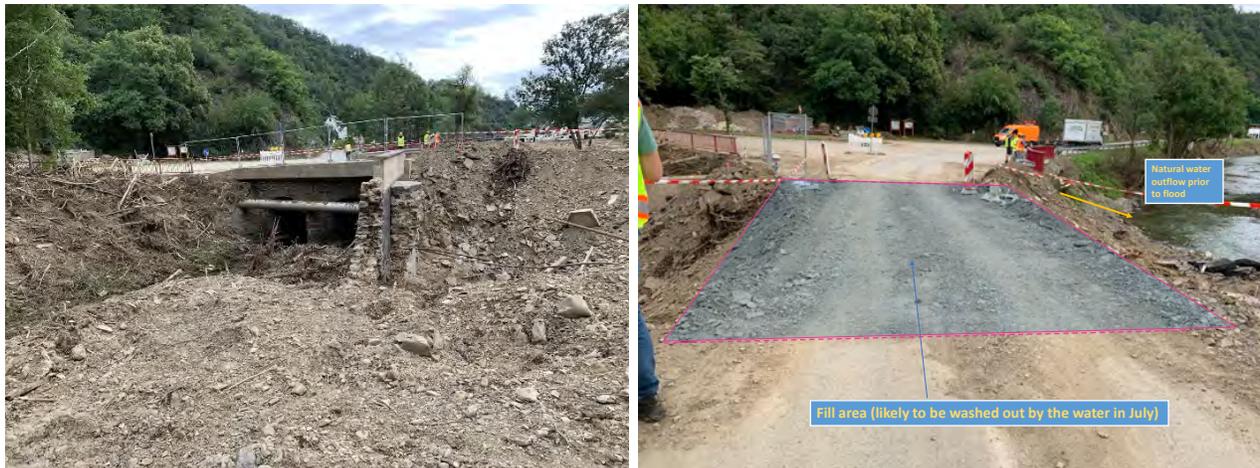
Figure 3.66. Bridge structure with 2 inlet arches (left), and destruction of surrounding areas; Dirt fill to re-establish road across bridge where waters have eroded the road and slope into the Ahr (right) (50.4470071, 6.8753387)

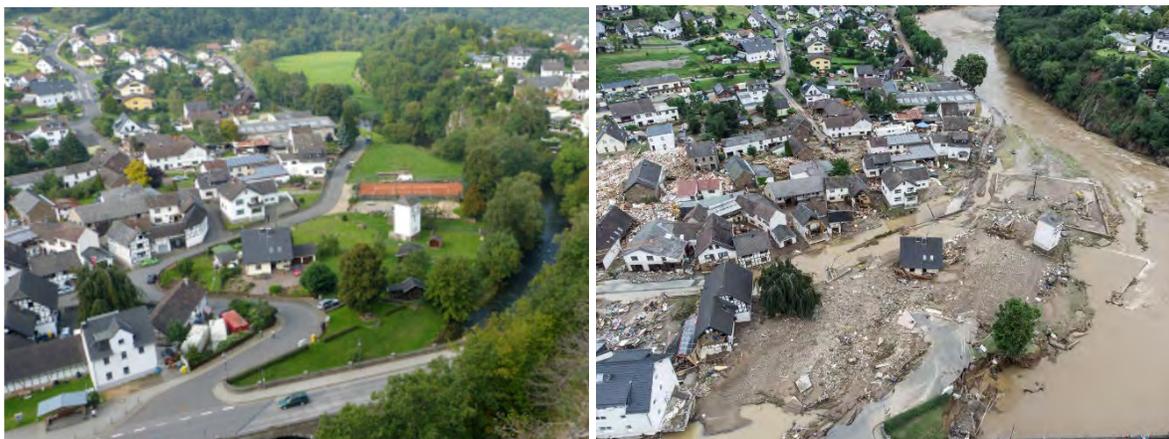
Figure 3.68. Aerial view, Schuld, showing town condition in September 2014 (left, Source google maps) and August 2021 (right, Credit: Roessler/dpa/Archivbild, accessed through: <https://www.wn.de/nrw/merkel-kommt-in-hochwassergebiete-nach-rheinland-pfalz-2004374>)

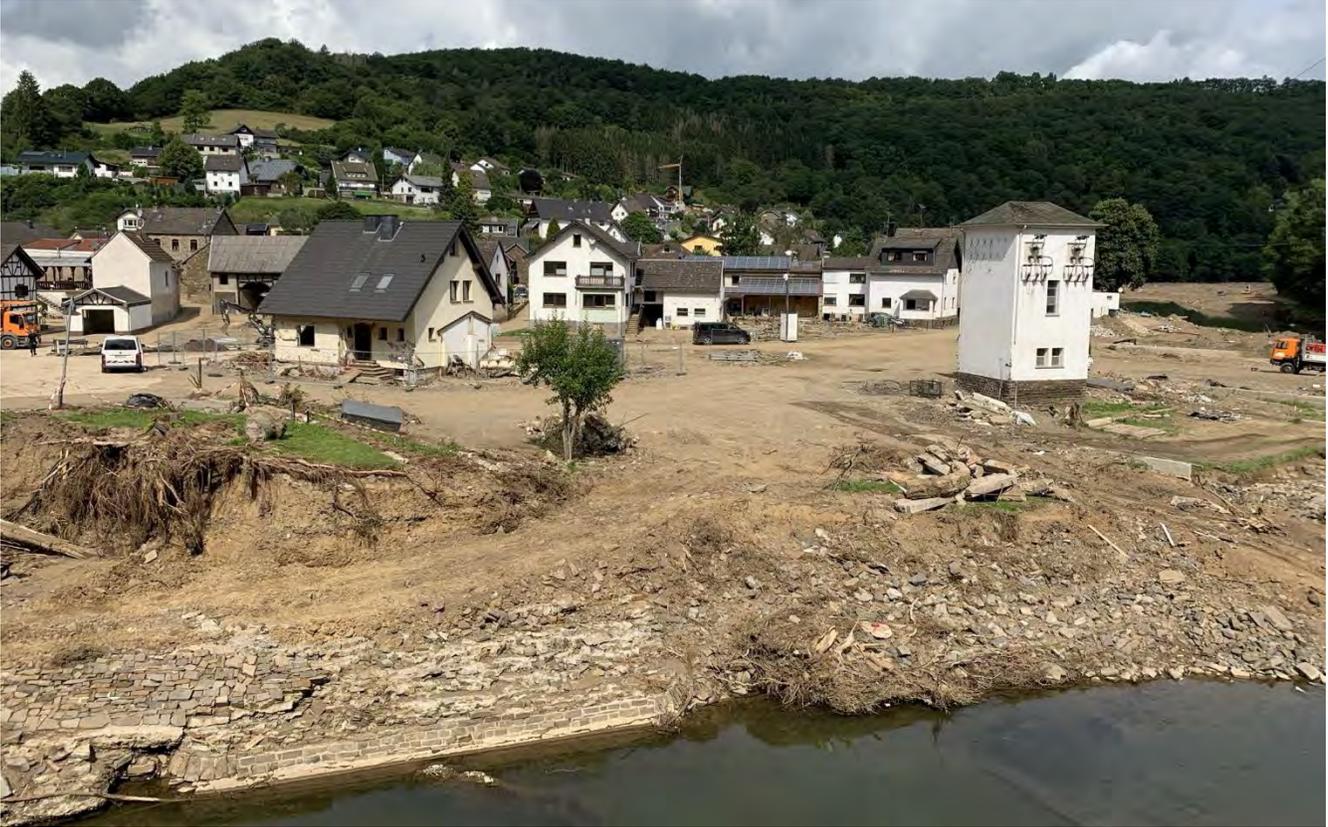
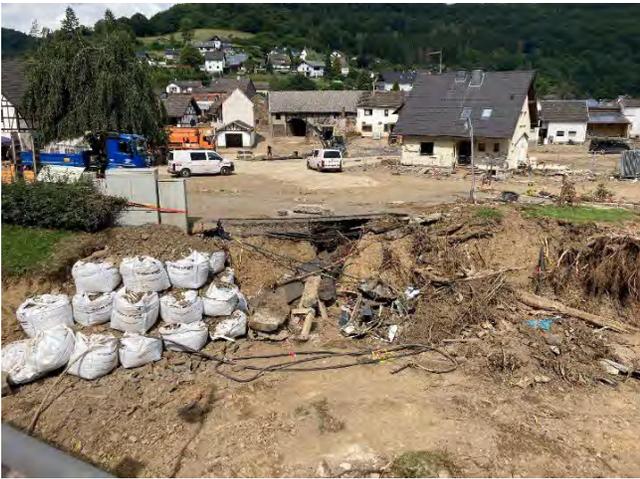
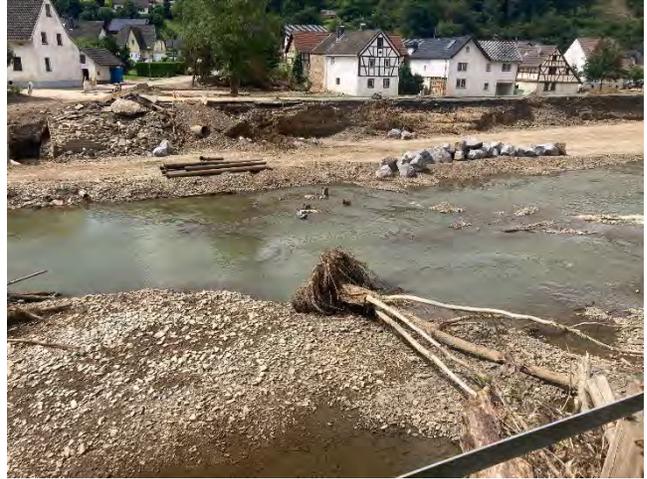
Figures 3.70 – 3.71 show several images along the walking path (marked in Fig. 3.67) of the GEER team. The photos depict the extent of soil erosion, exposure of utility infrastructure and much of the backfill placed for temporary stabilization, temporary dirt roads, and re-construction of the original riverbed.

Figure 3.70. Photographs of Schuld taken by the GEER team (50.44635960, 6.8871441)

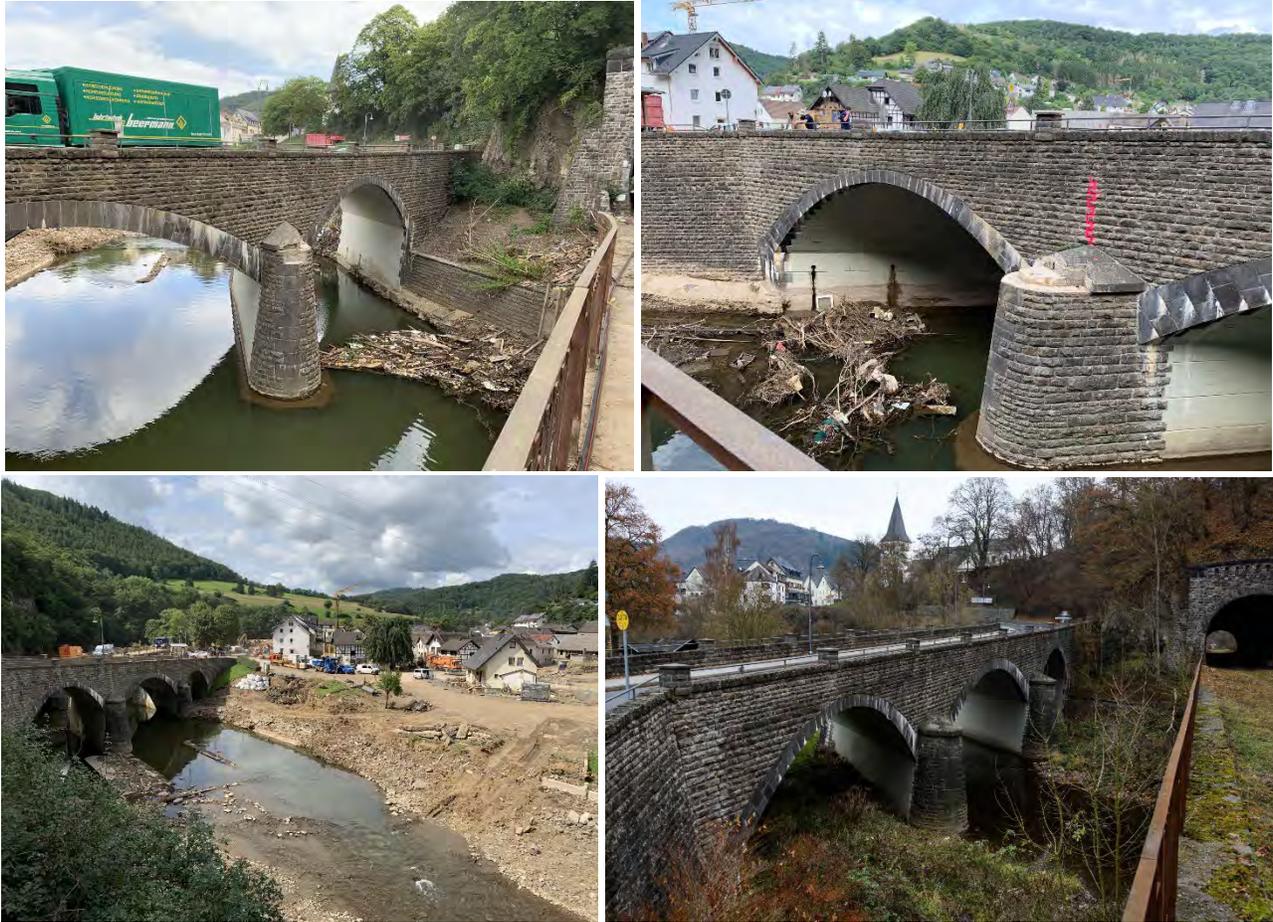
The town of Schuld has a total of four bridges. Two bridges (both historic bridges) remained intact. At the time of the team's visit, diving inspections were underway to investigate potential damage to the bridge foundations. The road bridge across the Ahr (Hauptstrasse) remained open for vehicular traffic (Figure 3.71), the adjacent railroad bridge was closed in 2020, but remained in use for pedestrians only. The bottom right photograph of Figure 3.71 shows the road bridge while standing on the former rail bridge into the tunnel prior to the flood event.

Figure 3.71. Top (left, right) and bottom left: historic road bridge along Hauptstrasse in Schuld, opened post flooding for regular traffic. Bottom right: view of road bridge prior to flood (source:google street view); (50.4459658, 6.8877725)

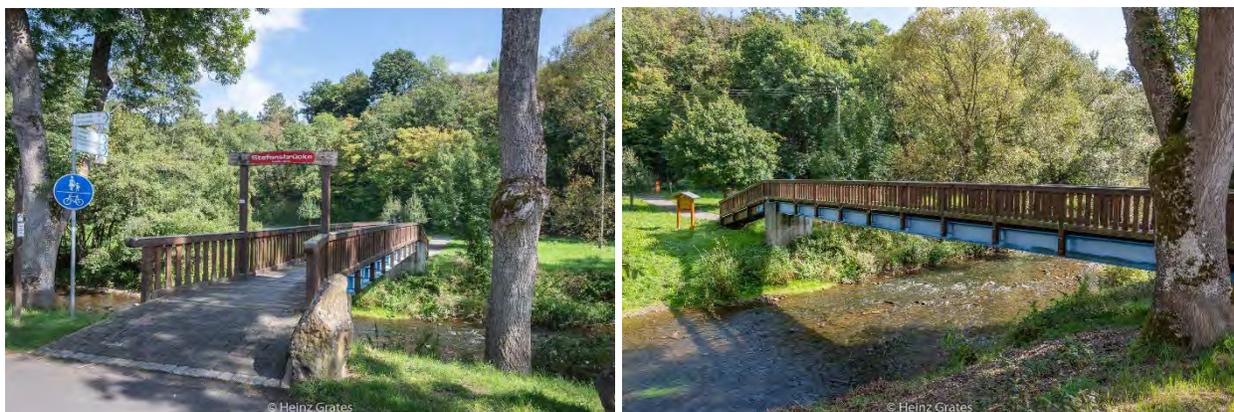
A smaller bridge, used as bicycle and pedestrian bridge along the Ahrstrasse was entirely washed away. This bridge is called Stefansbruecke and is located along the Ahrbend (Ahrschleife) in Schuld. The team spotted remains of one of the abutment structures. Figure 3.72 shows the bridge prior to the flood for reference:

Figure 3.72. Stefansbruecke in Schuld, Photos by Heinz Grates, Source: <https://www.aw-wiki.de/w/index.php?curid=67210>

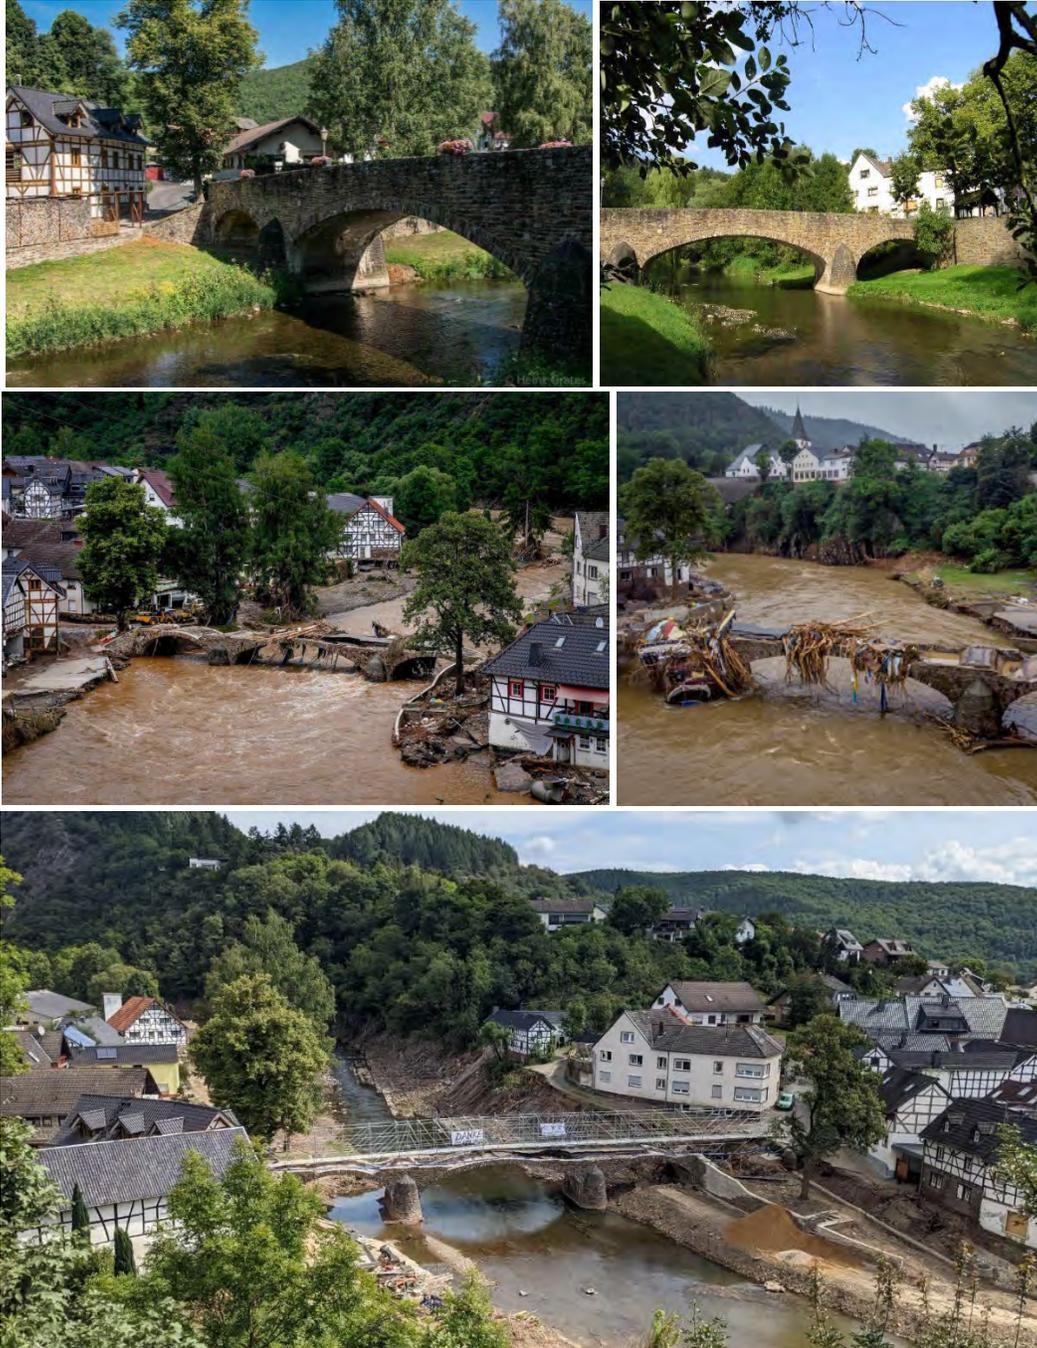
A fourth, historic bridge along Domhofstrasse (Figure 3.73) suffered severe damage but remained structurally intact. The bridge was reopened for pedestrian traffic at the time of the team's visit. Temporary scaffolding erected in lieu of the bridge deck allowed for bridge crossing. Figure 3.73a shows the bridge at Domhofstrasse prior to the flood. Figure 3.73 center shows the bridge one day after the flood, and Figure 3.73 bottom shows the bridge at the time of the team's visit.

Figure 3.73. Top: Bridge along Domhofstrasse prior to the flood. (Fotos by Heinz Grates, source:<https://www.aw-wiki.de/w/index.php?curid=35184>), Center: Bridge at Domhofstrasse immediately following the flood, source: CNN on Facebook, Bottom: Bridge at Domhofstrasse on August 11th, 2021 at the time of the team visit., (50.4481131, 6.8901355)

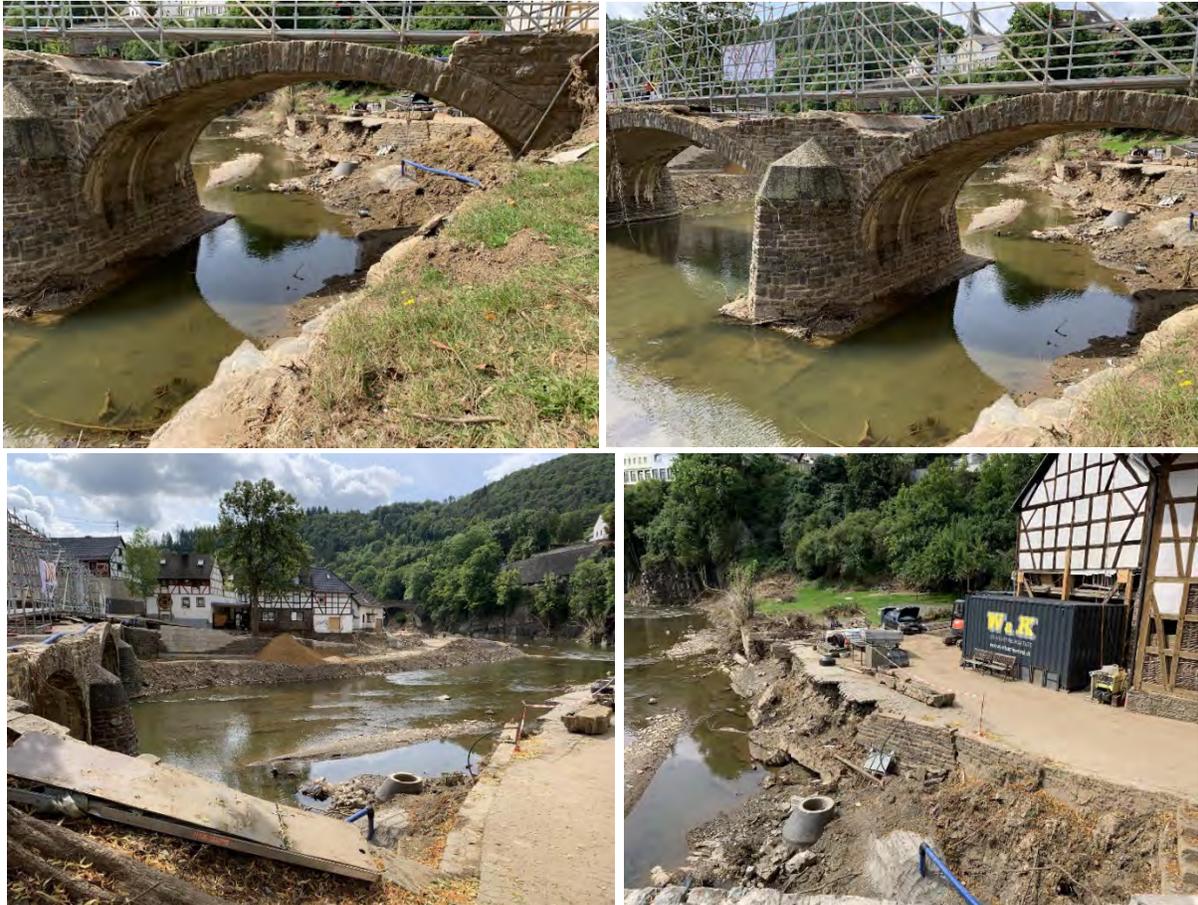
Figure 3.74. Top: damage around the bridge superstructure, bottom: massive amounts of riverbank erosion and the temporary fill (bottom left); (50.4481131, 6.8901355)

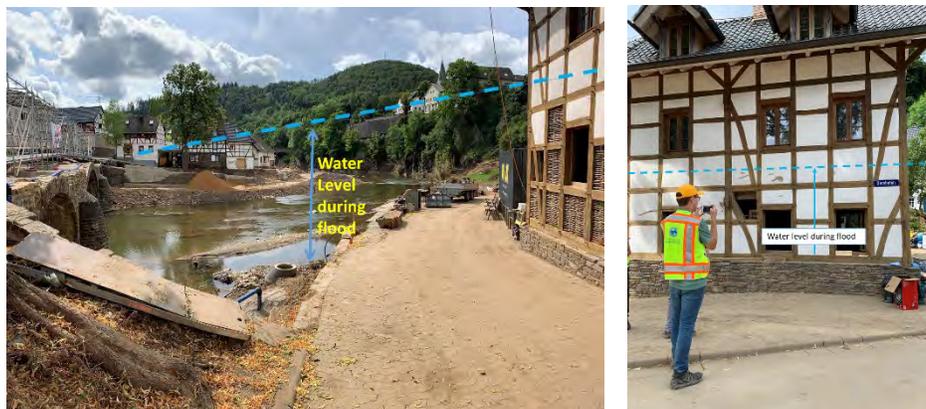
Figure 3.74 shows close-up photos of the structural integrity of the bridge (top), along with the riverbanks in downstream direction of the bridge. Any slope stabilization and earth retention structures have been washed away or largely damaged. Figure 3.75 shows the high water marks from the flood event. The house is adjacent along the Domhofstrasse, adjacent to the bridge with temporary scaffolding.

Figure 3.75. Water levels near Domhofstrasse (50.4480798, 6.8898841)

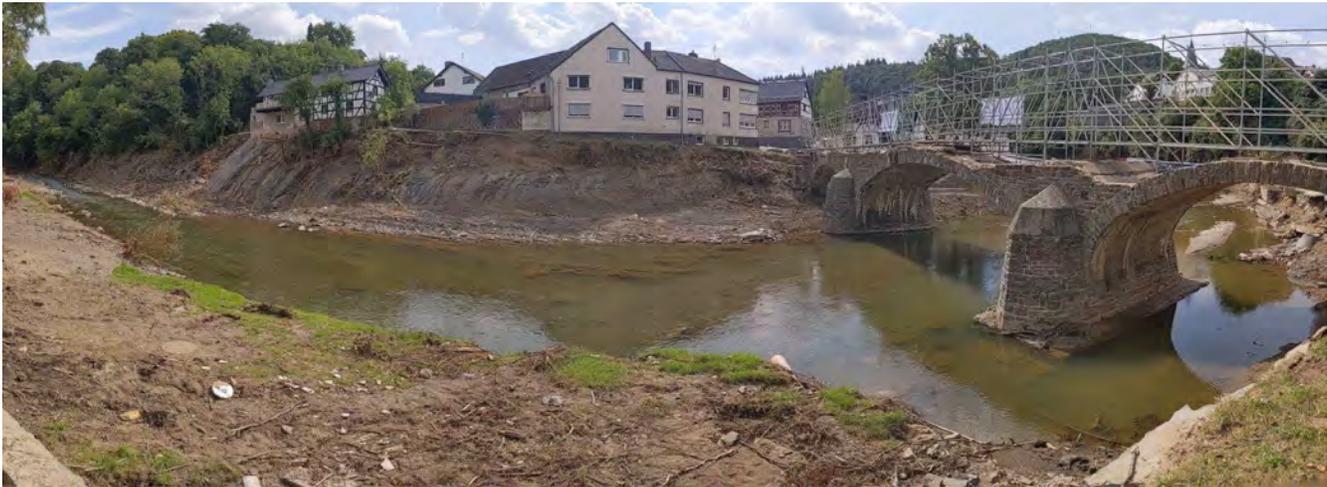
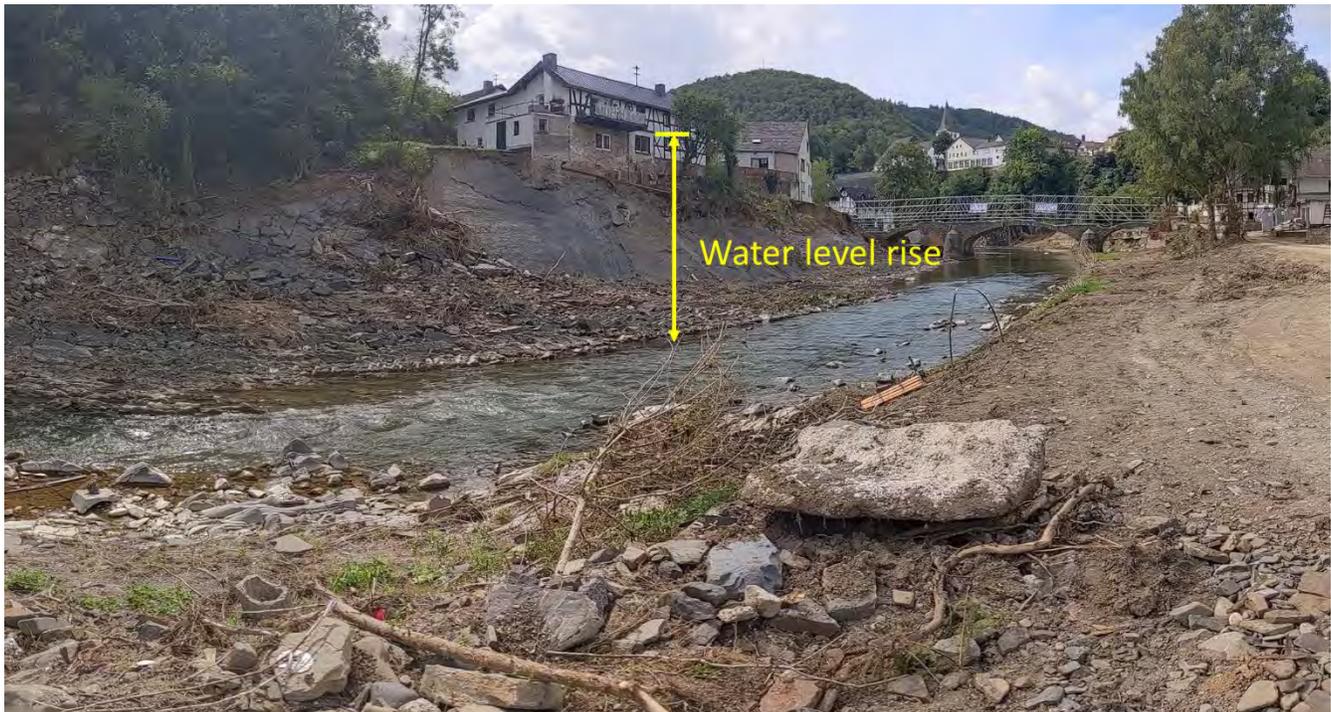
In the upstream direction (of the bridge at Domhofstrasse), substantial erosion down to bedrock was visible. (Figure 3.76)

Figure 3.76. Substantial soil and rock erosion along riverbank (50.4482905, 6.890290)

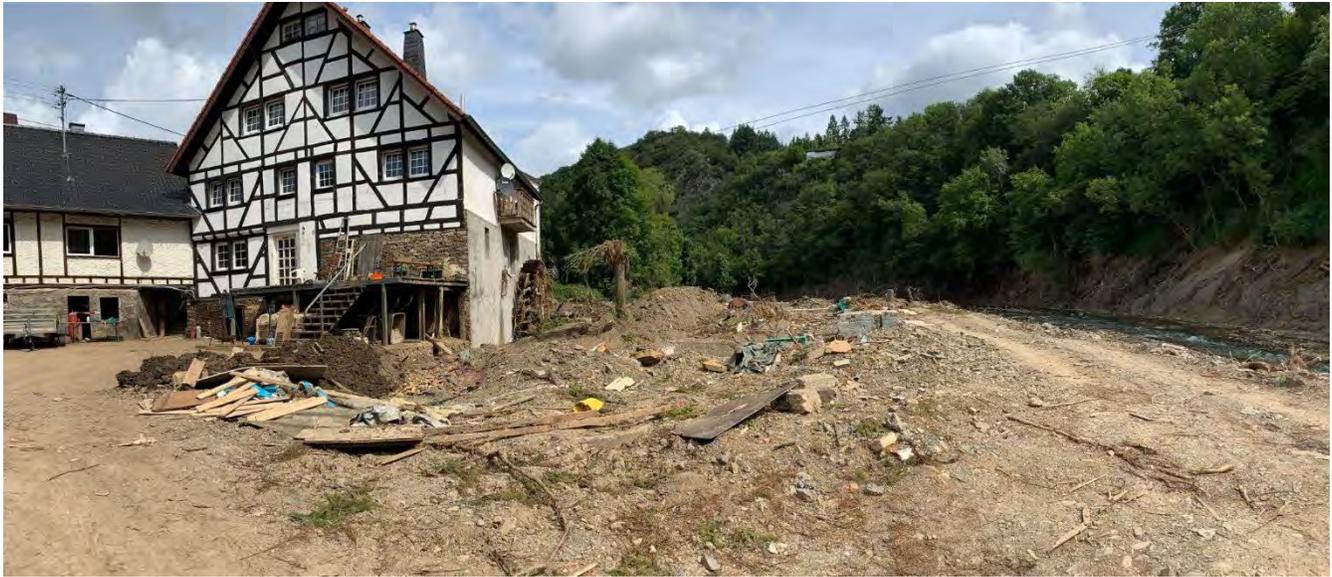
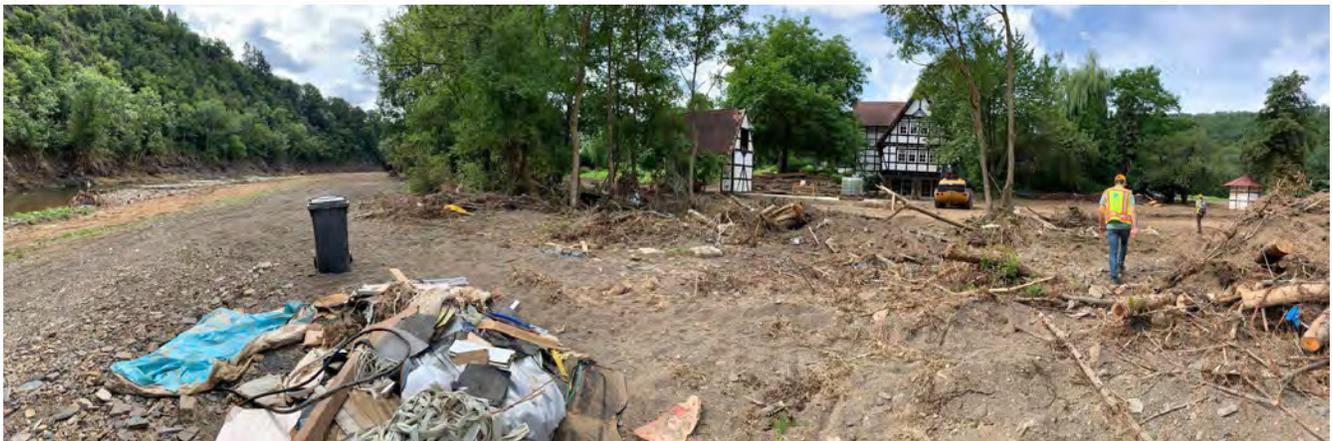
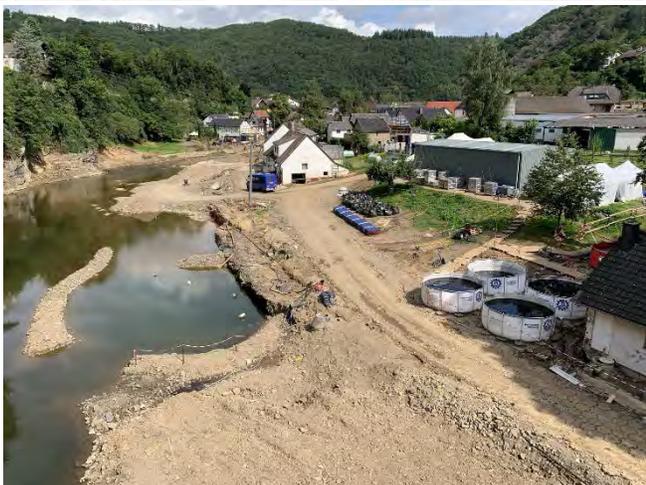
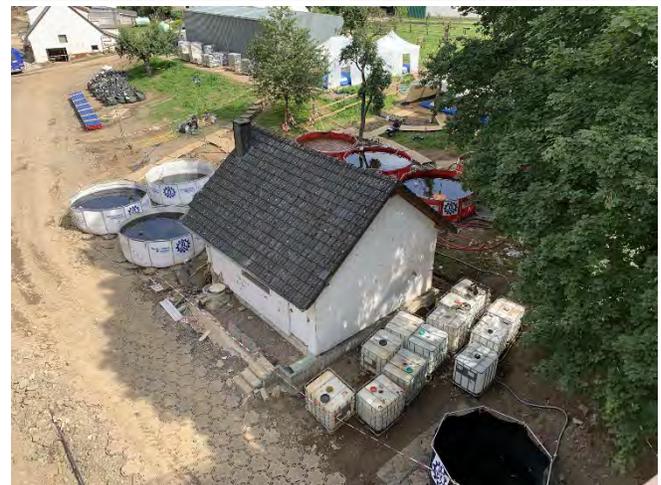
Following the walking path of the team, substantial erosion and redeposition was also visible along the entire stretch of the river, consisting of mixtures of soil, rock, tree debris, and remaining trash. The fish hatchery located along the Ahrbend, which included three large fishponds was completely destroyed. At some locations along the river the THW placed filter tanks to separate oil and other contaminants from the water (Figure 3.77).

Figure 3. 77. Top: destroyed residential houses and dirt landscape along the river; Center: former fishery business (destroyed) (50.449709854, 6.8919458); Bottom: THW clean up and filtration tanks (50.4467077, 6.890212)
