Geotechnical Reconnaissance of the 2021 Western European Floods

Flood Event: July 14-15, 2021

Flood locations: Germany, Netherlands, Belgium, and Luxembourg

Reconnaissance Visit: August 9-18, 2021

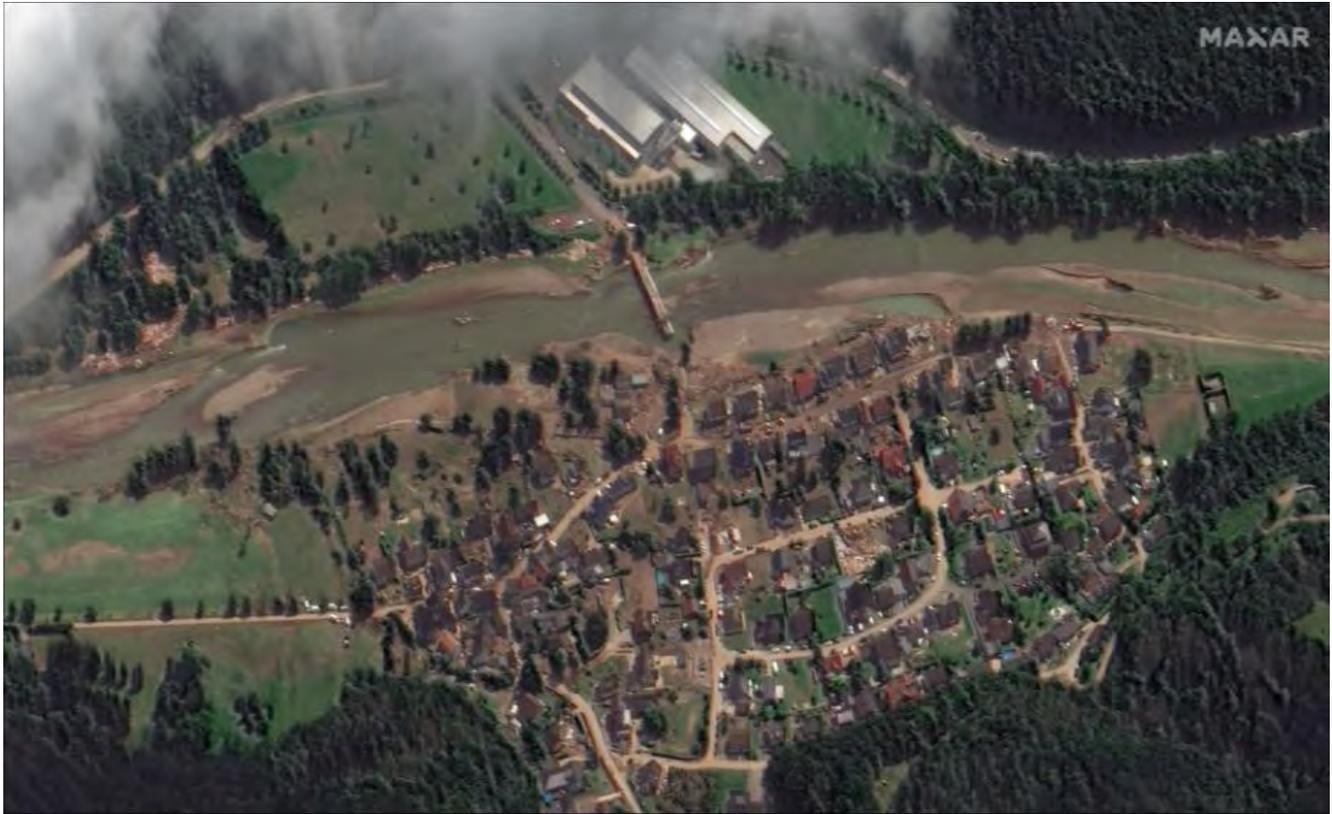
Figure 3.79 shows a satellite image of Liers. The extent of flood damage can be seen by the widening of the Ahr river and the adjacent mud-covered areas. Figure 3.80 shows the flood areas in front of the residential housing. Most houses were flooded (at the basement level), some experienced flooding up to the ground level floors (Erdgeschoss). No casualties have been reported in Liers.

Figure 3.79. Aerial view of Liers after the flood, obtained from <https://www.thesun.co.uk/news/15629211/pics-shows-germany-floods-chaos/>

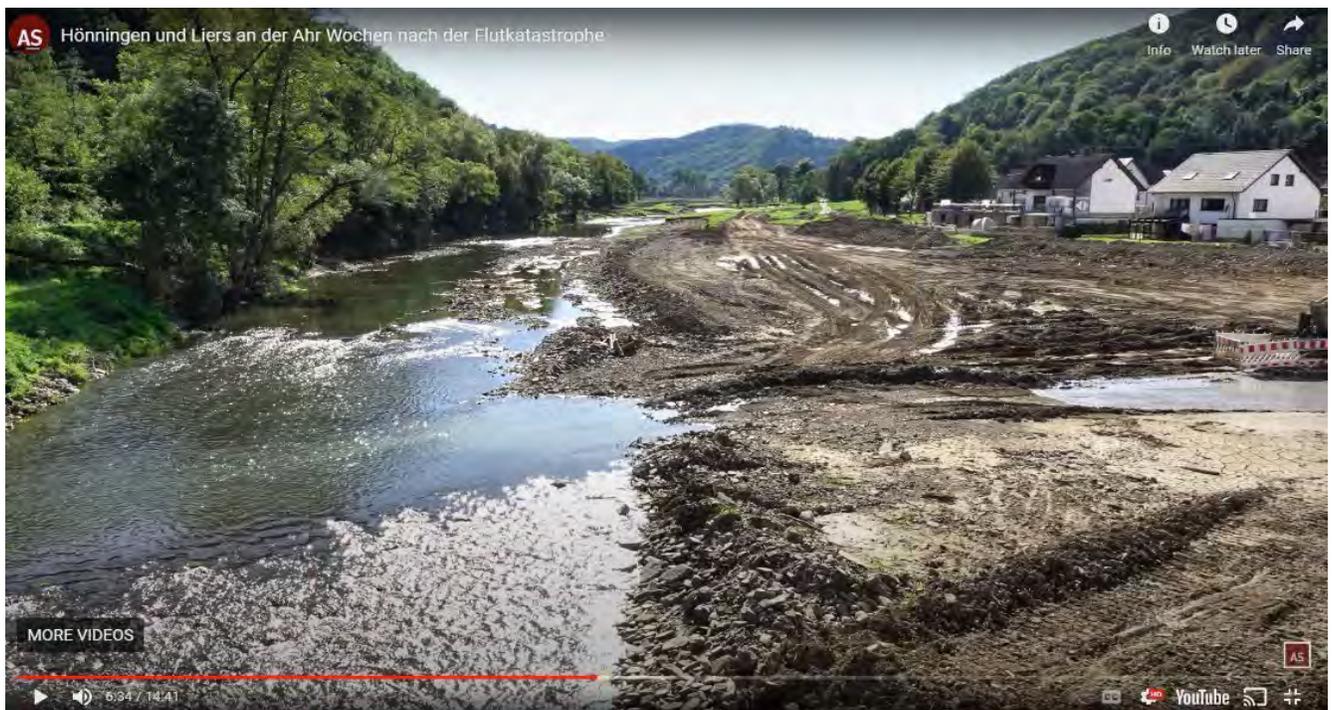
Figure 3.80. Extent of flood plains adjacent to the Ahr river, Source: Screenshot of video footage filmed by Alois Sheuer, source: <https://www.youtube.com/watch?v=6EXwo6ZxrFs>

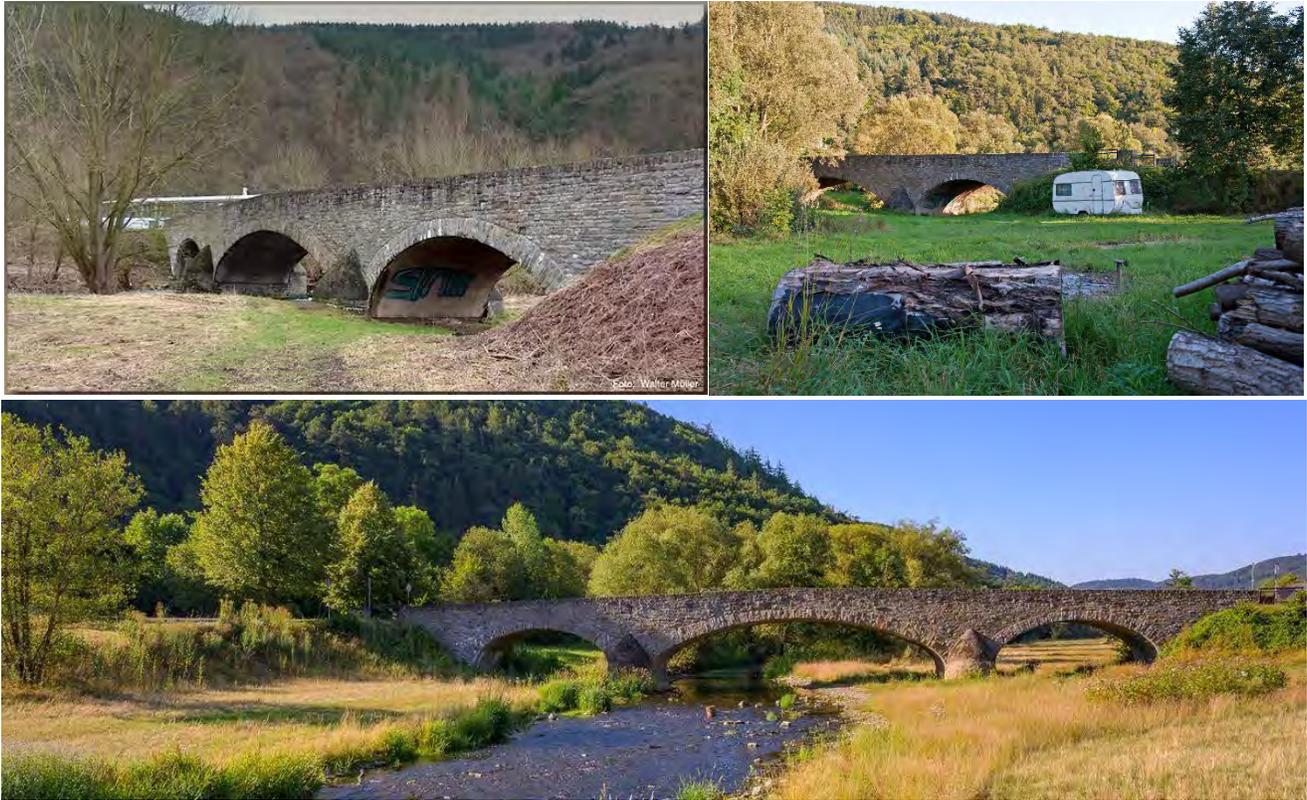
The Ahr bridge of Liers connects the town with highway 271. It is triple-arched and has rounded pier foreheads covered with semicone-shaped hoods made of basalt lava. The parapets are masonry. The bridge was built in 1881, replacing the then existing wooden bridge. During the flood of 1910 one of the arches was destroyed and subsequently repaired. The bridge also suffered damage during World War II, when it was hit by bombing in 1944. It took until 1954 until damages were repaired. In 1997/1998 the bridge underwent a general retrofit consisting of extensive maintenance and some strengthening work of the piers (Figure 3.81).

Figure 3.81. Ahr bridge in Liers @ Josef Emmerich Strasse before flood, source: <https://www.aw-wiki.de/w/index.php?curid=15614>, <https://www.aw-wiki.de/w/index.php?curid=58526>

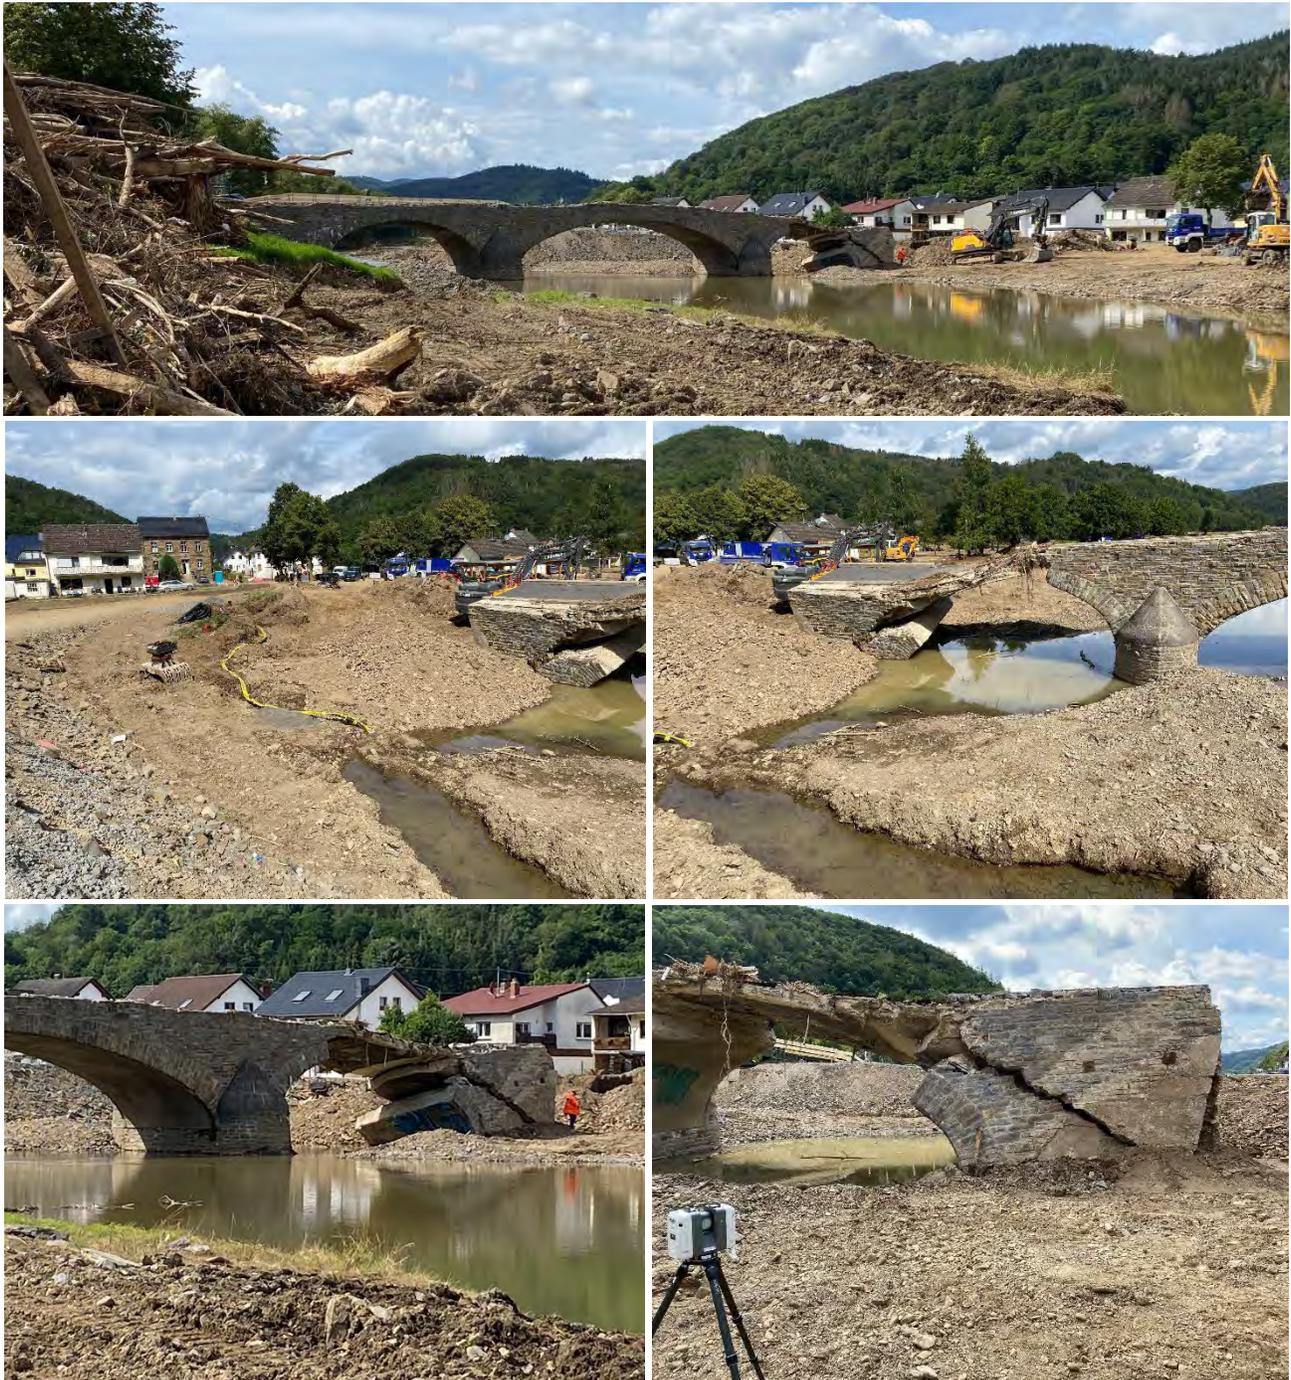
Figure 3.82. Bridge damage at the time of the team's visit (Aug 11th, 2021), (50.4568710, 6.9458676).

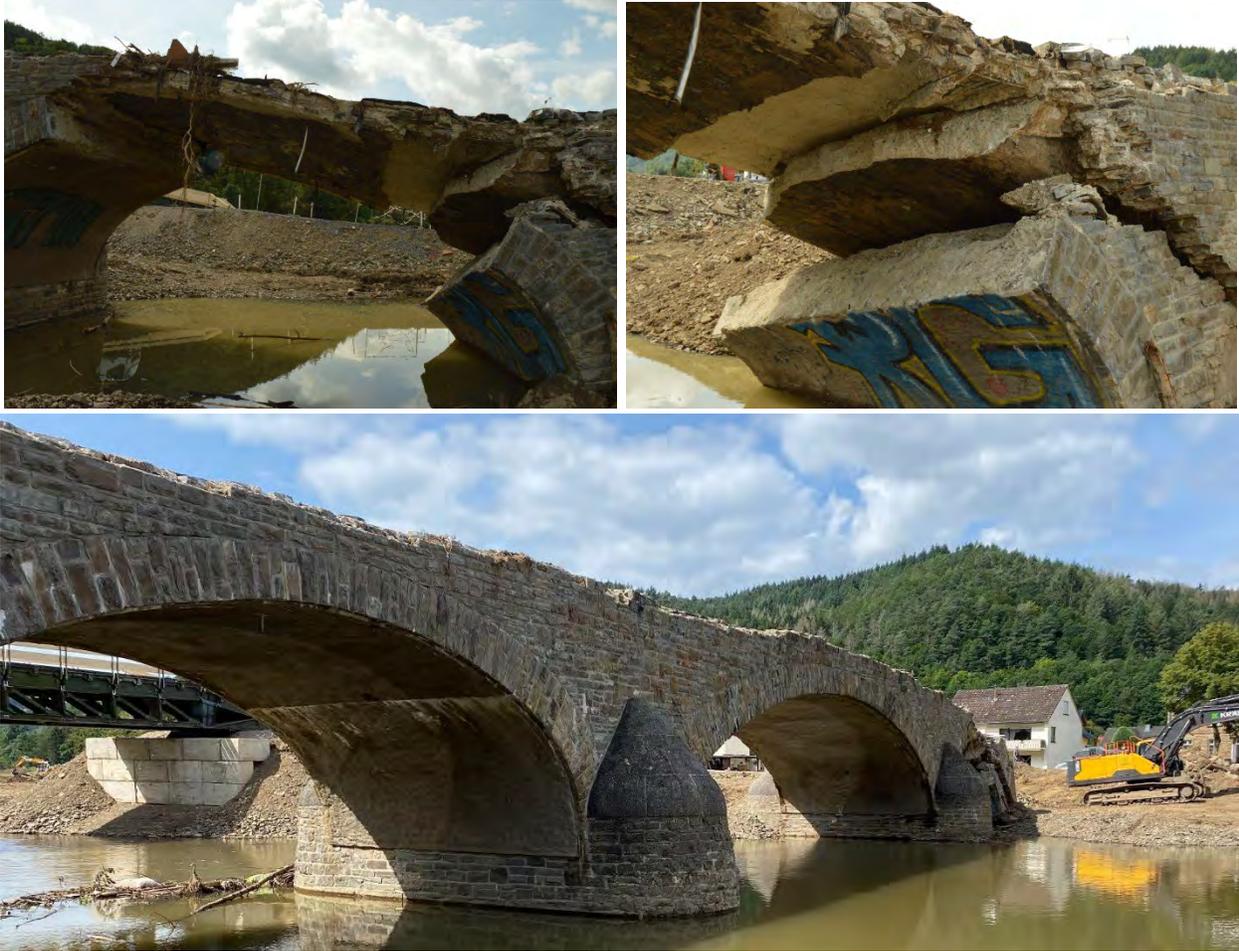
The bridge experienced substantial damage during the 2021 flood, which again destroyed one of the arches and the abutment area of the bridge. Similar to other bridges affected by the flooding, the abutments of the bridge were damaged by overtopping. Looking in the downstream direction, soil was eroded from the right abutment with extensive scour on both the upstream and downstream sides. The left side of the bridge experienced the most damage where the entire abutment was destroyed (Figure 3.82). The left abutment appears to have displaced downstream and destroyed the immediately adjacent arch in the process. Based on closer inspection of the abutment materials and discussion with locals, it appears that previous repairs had been done to the left abutment—it is not clear whether these repairs were performed in 1954 or if they were part of the 1997/1998 retrofit. These repairs consisted of unreinforced concrete, as shown in Figure 3.82-3.84. Additionally, parapet walls on top of the bridge were entirely removed from overtopping during the flooding. Similar to other old bridges, the large bridge piers and low arches led to a constricted cross-

Figure 3.83. Photographs by the GEER team documenting the damage on August 11th, 2021 (50.4568710, 6.9458676).

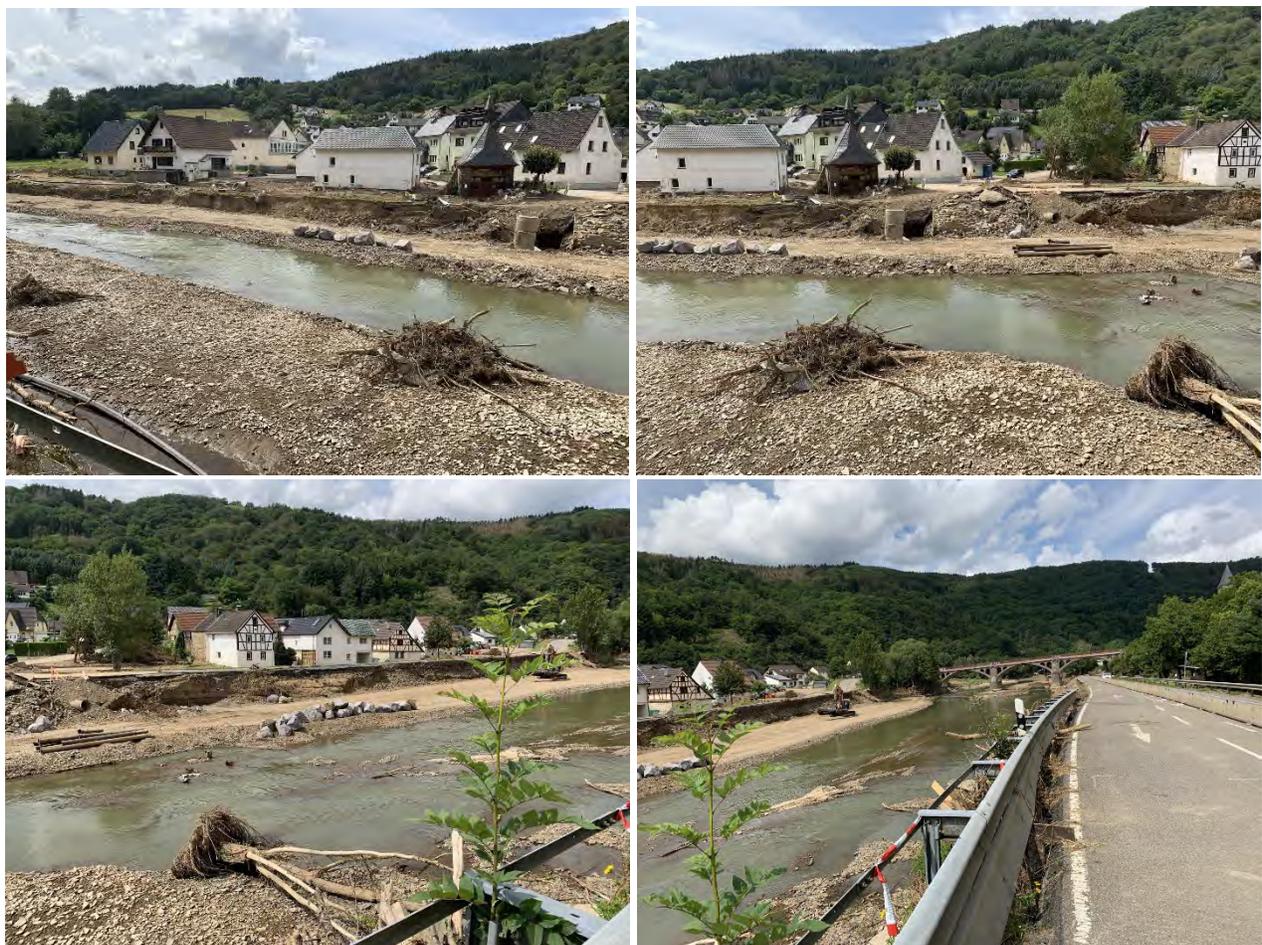
The team passed through the town of Hönningen, which is located between Liers and Brück (Figure 3.86). Substantial erosion along the riverbanks was observed as shown in Figure 3.87. The major highway 273 was only one-sided, the lane closest to the river was closed due to major embankment damage (Figures 3.87 -3.89).

Figure 3.87. Substantial erosion along Ahr river in Hönningen (50.4714083, 6.9494501).

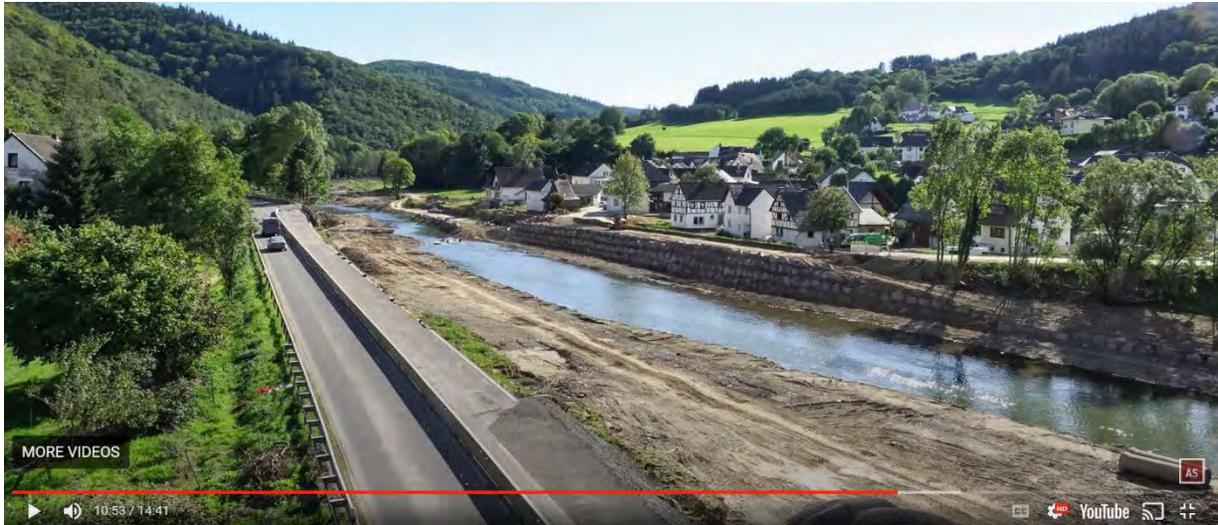
Figure 3.88. View of road 273 in Hönningen, October 2021, source: Screenshot of video footage filmed by Alois Sheuer, source: <https://www.youtube.com/watch?v=6EXwo6ZxrFs>

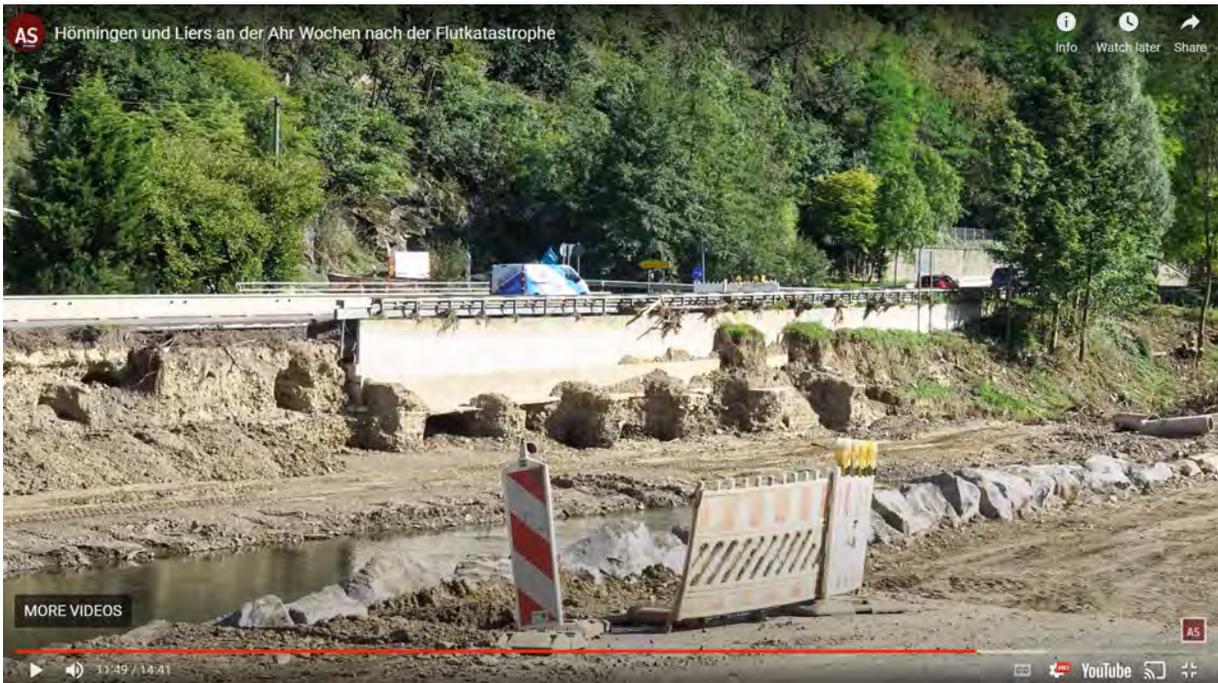
Figure 3.89. Embankment damage along road 273 in Hönningen, taken several weeks after the flood (source: Screenshot of video footage filmed by Alois Sheuer, source: <https://www.youtube.com/watch?v=6EXwo6ZxrFs>)

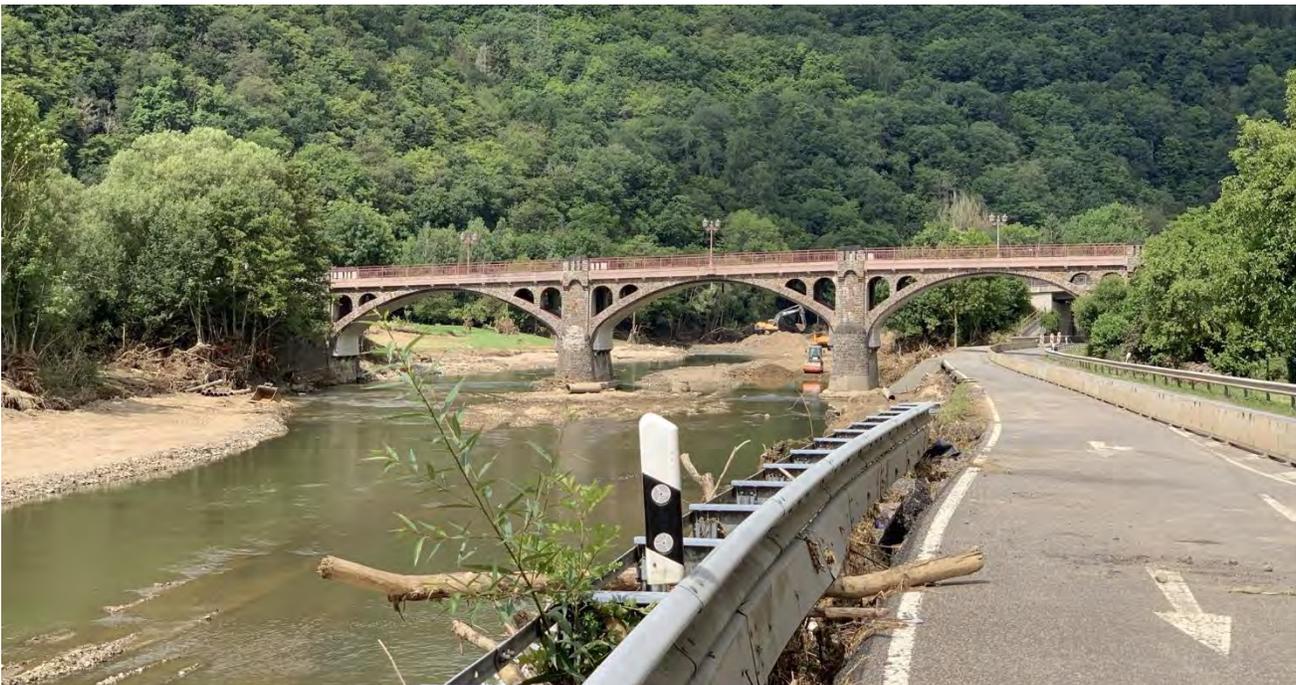
Figure 3.90. Ahr bridge at Kapellenstrasse, taken by the GEER team (50.4714083, 6.9494501)

The Ahr Bridge in Hönningen has a span of 104.70 meters and an overall height of 12 meters (Figure 3.90 and 3.91). It is the largest bridge crossing the Ahr. It has five piers and four round arches that span the Ahr and the bypass road (federal highway 257), the former railroad line, and the former mill stream. Due to its low, elongated structure, the building, which dates to 1912/13 and was extensively renovated in 1995, appears delicate and light. Instead of a parapet, the bridge has an iron railing interrupted by small stone pylons (WikiAW). The street leading over the bridge is called Kapellenstraße. Due to its elevation and large cross-sectional openings, the bridge did not experience any major damage. Road damage below the bridge is shown in Figure 3.92.

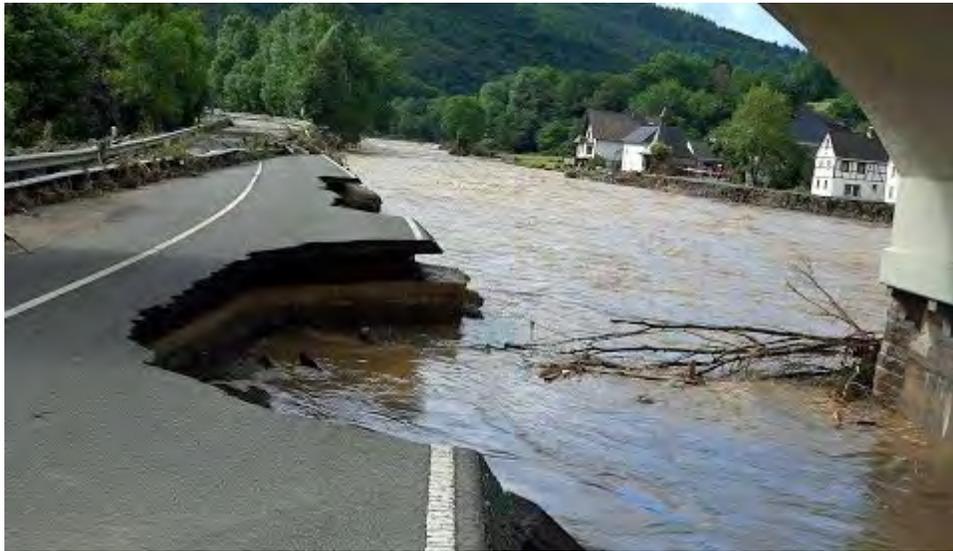
Figure 3.92. Road damage along the Ahr, underneath the bridge Kapellenstrasse (50.4709796, 6.9495415)

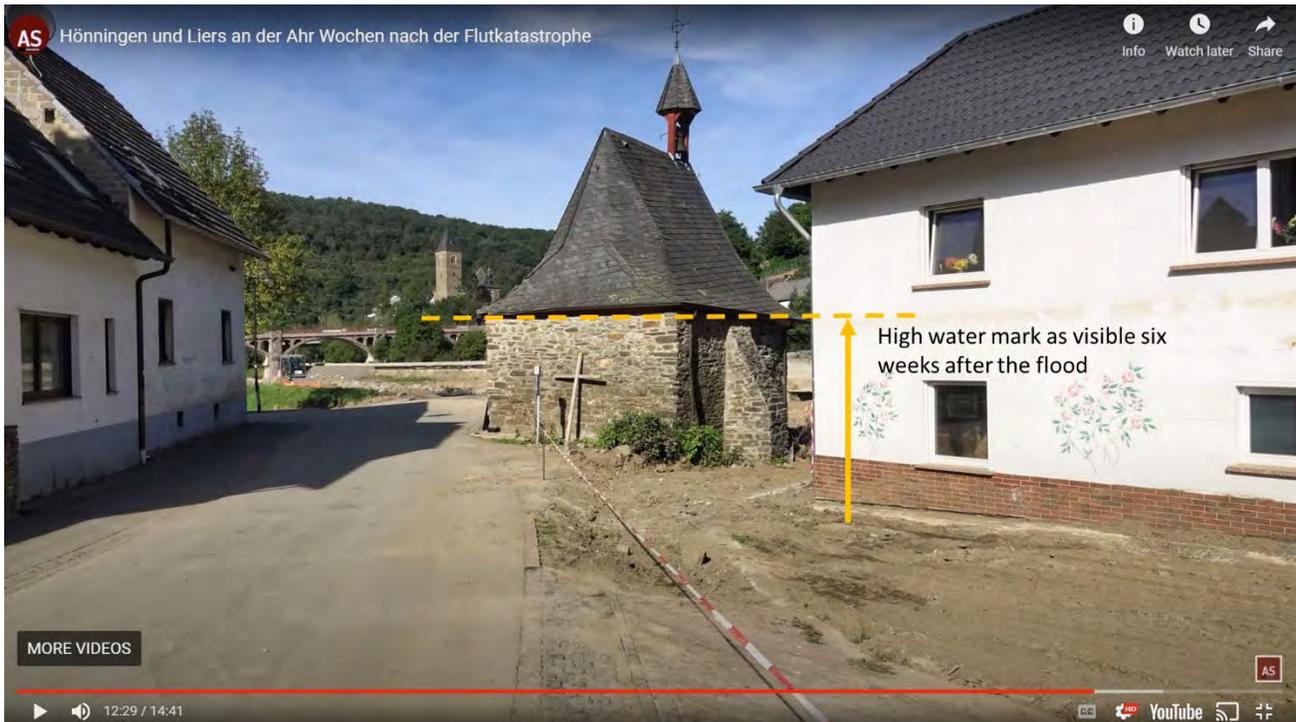
Figure 3.93 shows a residential building and a small chapel near the Ahr river. The house showed potential high-water marks based on the mud-colored line between the first and second story.

Figure 3.93. House in Hoenningen, with post-flood water mark visible on the outside stucco; Source: Screenshot of video footage filmed by Alois Sheuer, source: <https://www.youtube.com/watch?v=6EXwo6ZxrFs>

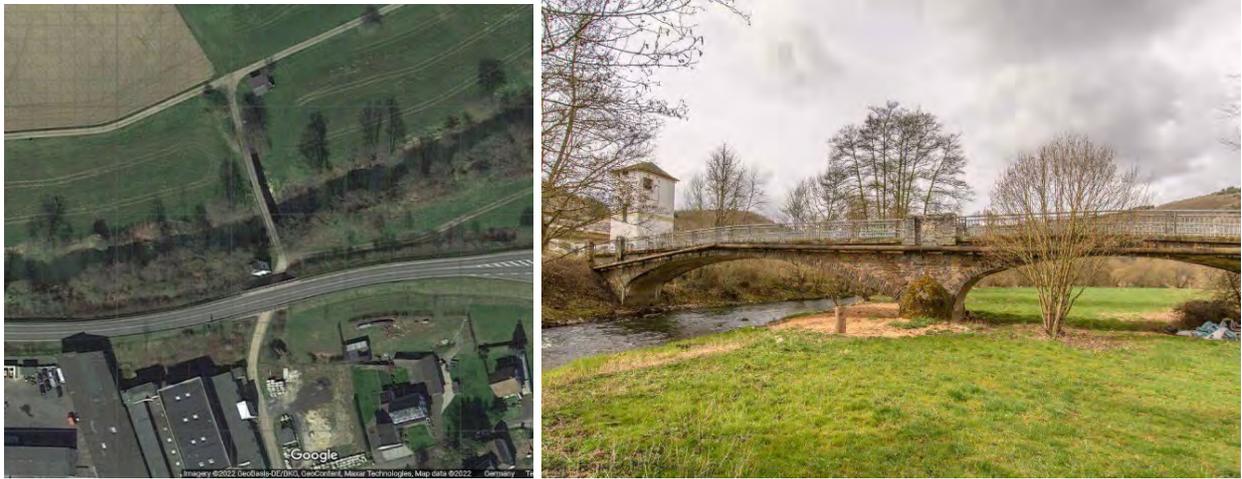
Hönningen's second bridge across the Ahr river was also a historic bridge (see Figure 3.94). No information was collected. Based on map updates in Google (2022), this bridge seems to be destroyed, and was removed from the maps.

Figure 3.94. Location of Ahrbrücke Hoenningen (left) and before flood bridge photograph (right), source: <https://www.aw-wiki.de/w/index.php?curid=40856>

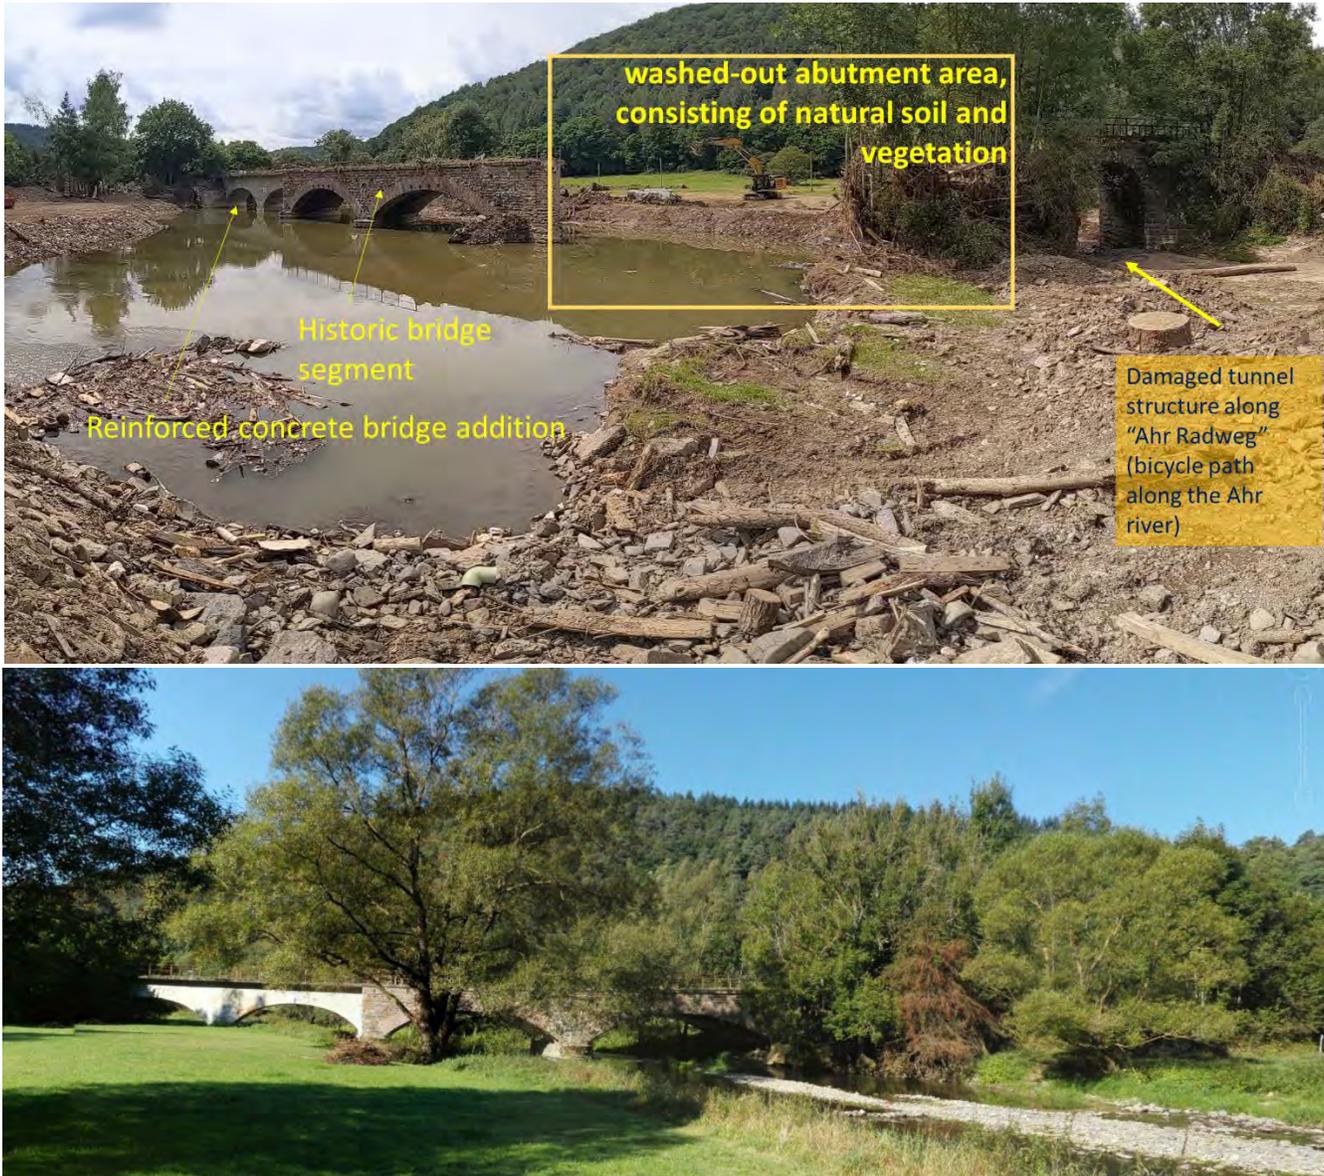
Even though the bridge appeared to be damaged at first, a closer inspection by the team on site and a comparison of before and after imagery following the reconnaissance visit suggested that the bridge sustained most of its integrity, and the abutment area adjacent to the bridge was washed out. This becomes furthermore apparent when comparing Figure 3.96 top and bottom. The bridge seemed to have directly

connected into natural soil at the site, with no structurally built abutment wall. The segment between the end of the bridge and the tunnel on the right side consisted of natural soil (perhaps stabilized, but unknown), covered partially with vegetation. The dam-shaped segment supported the railroad tracks (see highlighted area in Figure 3.96(top)). The tunnel structure to the right is part of the famous Ahr Radweg, a bicycle path that runs along the river Ahr for more than 60 km.

Figure 3.96. Comparison of post flood condition of the bridge and its surroundings (top, 50.480833, 6.968818) with pre-flood imagery obtained from google earth (bottom)

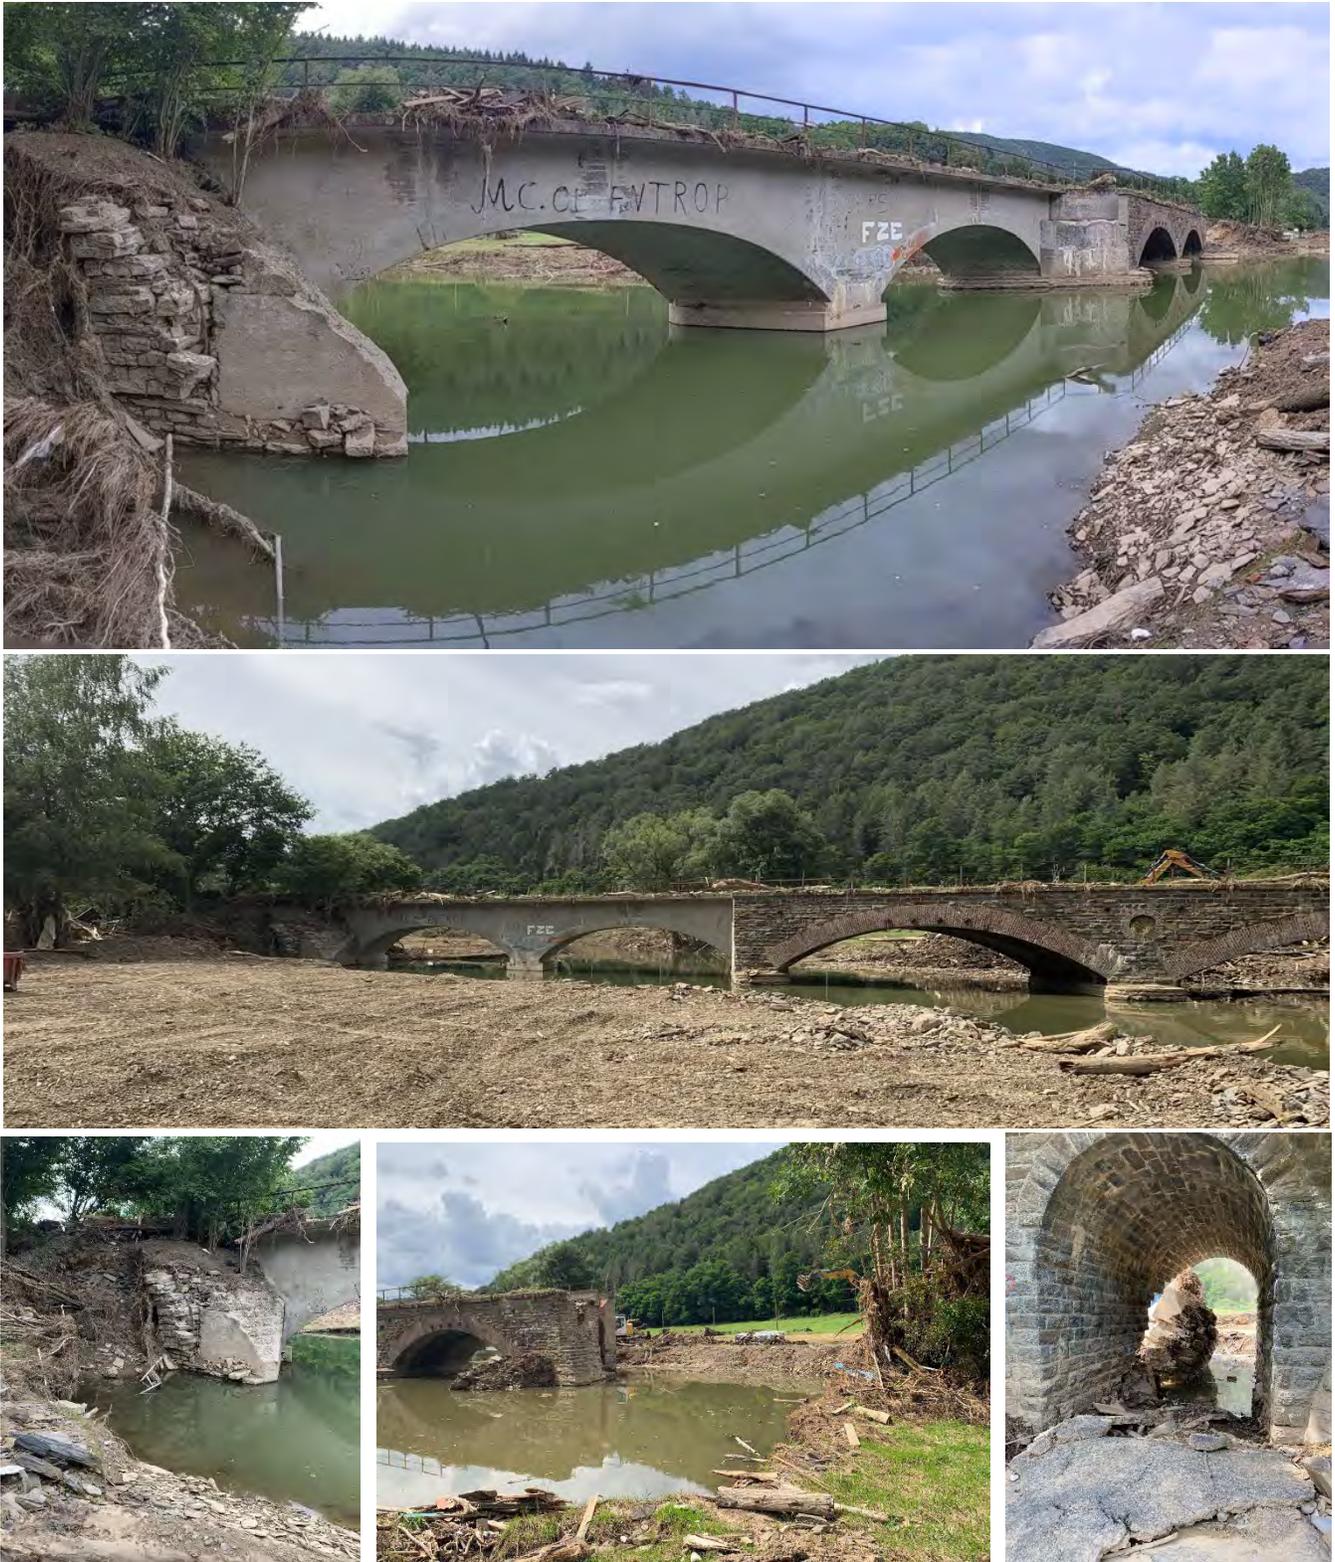
Figure 3.97 shows a set of photos taken by the team on August 11th, 2021.

Figure 3.97. Photographs of damaged bridge and surroundings on August 11th, 2021(50.480833, 6.968818).

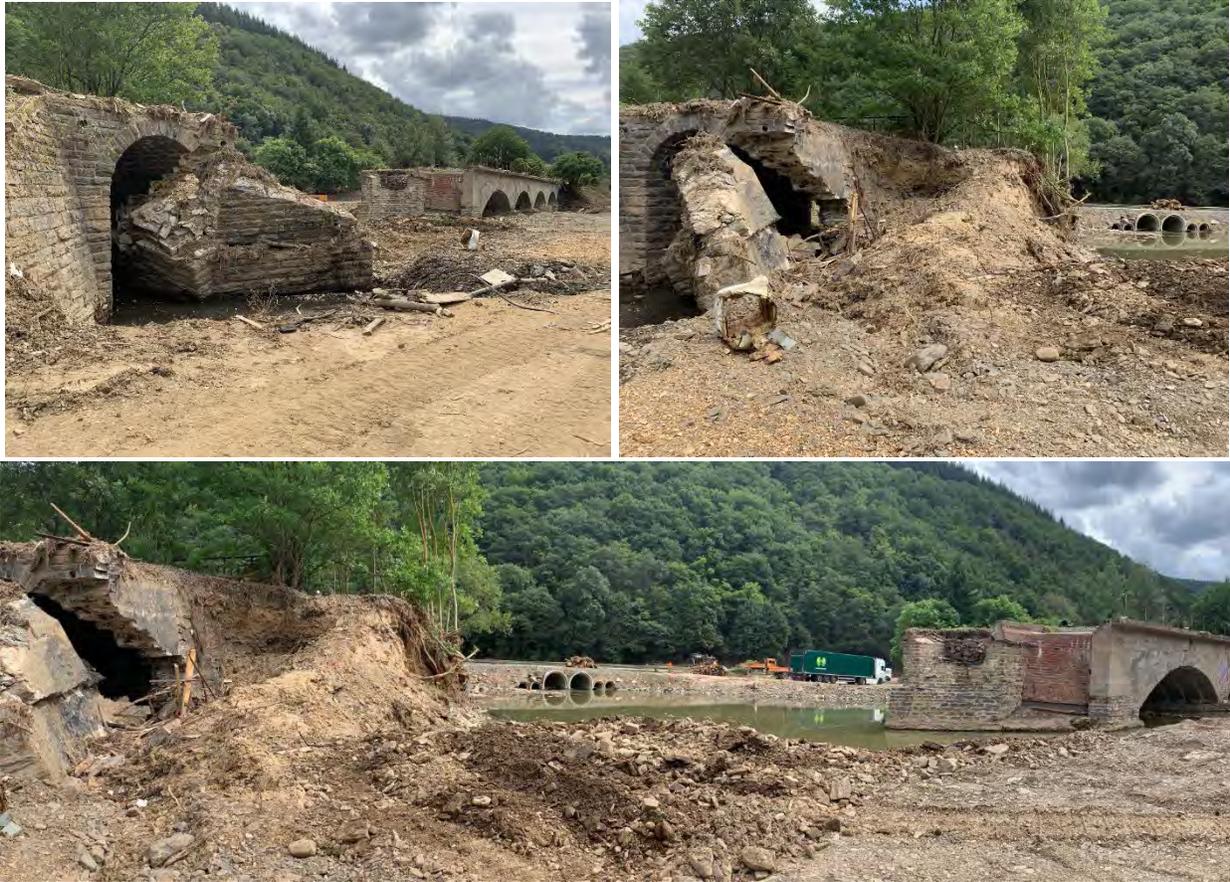
Figure 3.98. Photo of damaged bicycle tunnel from upstream direction showing washed out soil (dam) segment in between the two structures and the temporary water rerouting (pipes) in the background (50.480833, 6.968818).

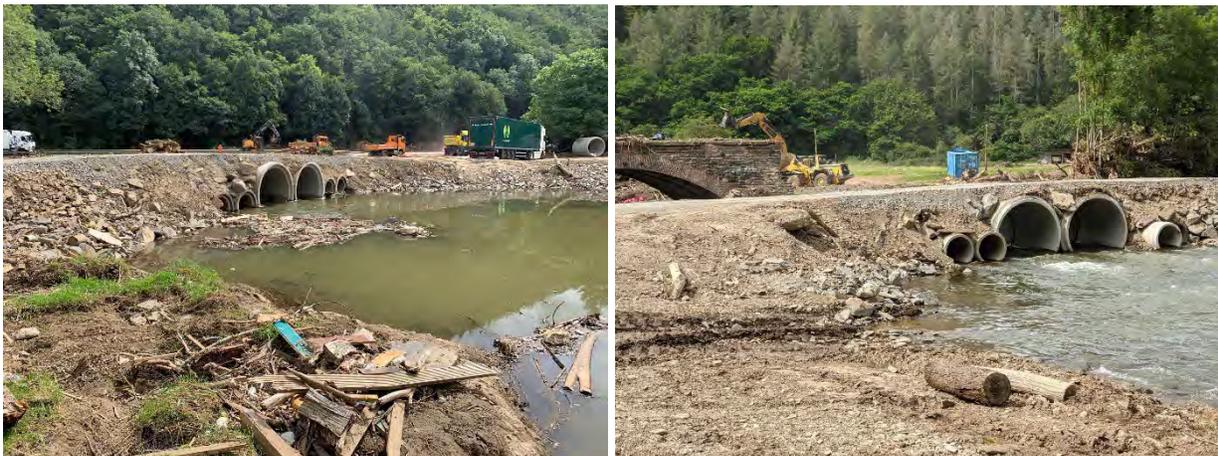
Figure 3.99. Concrete pipes and fill-based dam structure for temporary river crossing constructed by the Germany military; pipe inlet from upstream (left) and downstream (right) direction, (50.480833, 6.968818).

At the time of the team's visit, the German military finished the construction of a temporary river rerouting using an interim dam structure and concrete pipes (Figures 3.98 and 3.99). Simultaneously heavy equipment was used to re-establish the original river boundaries using fill material. Clean up of massive amounts of debris, soil deposits, trash and dead wood was also underway (Figure 3.100). While most

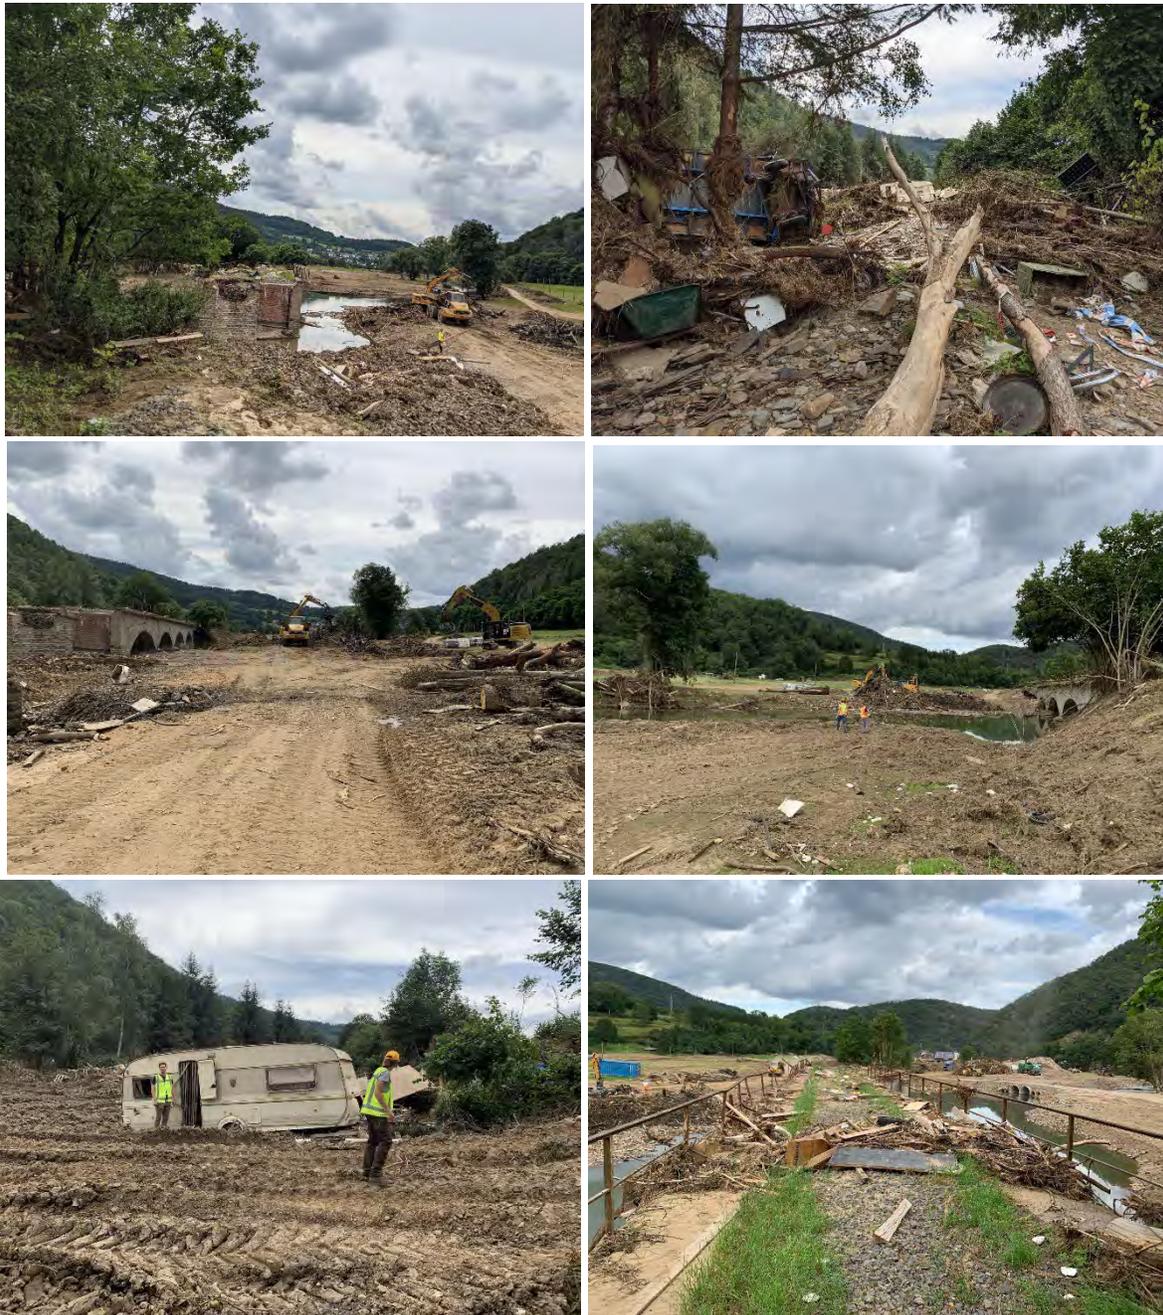
Figure 3.100. Destroyed landscape around bridge structure, showing debris, dead wood and temporary fills for dirt roads and emergency infrastructure. (50.48057075, 6.9684412)

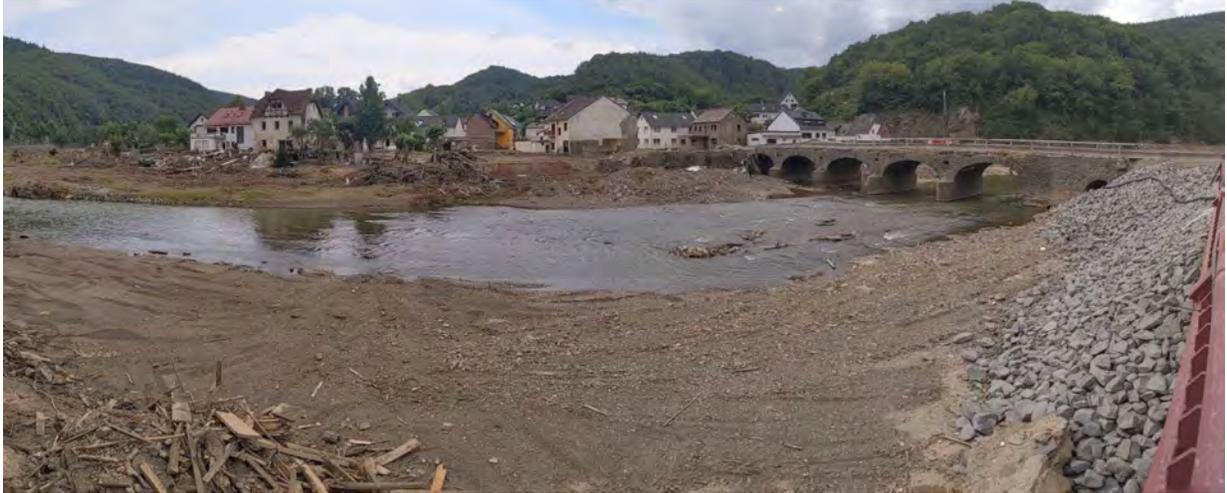
Figure 3.102. Ahr bridge Brück (road bridge) with temporary fill placed on the right arch to enable bridge passage (50.4866352, 6.9717177)

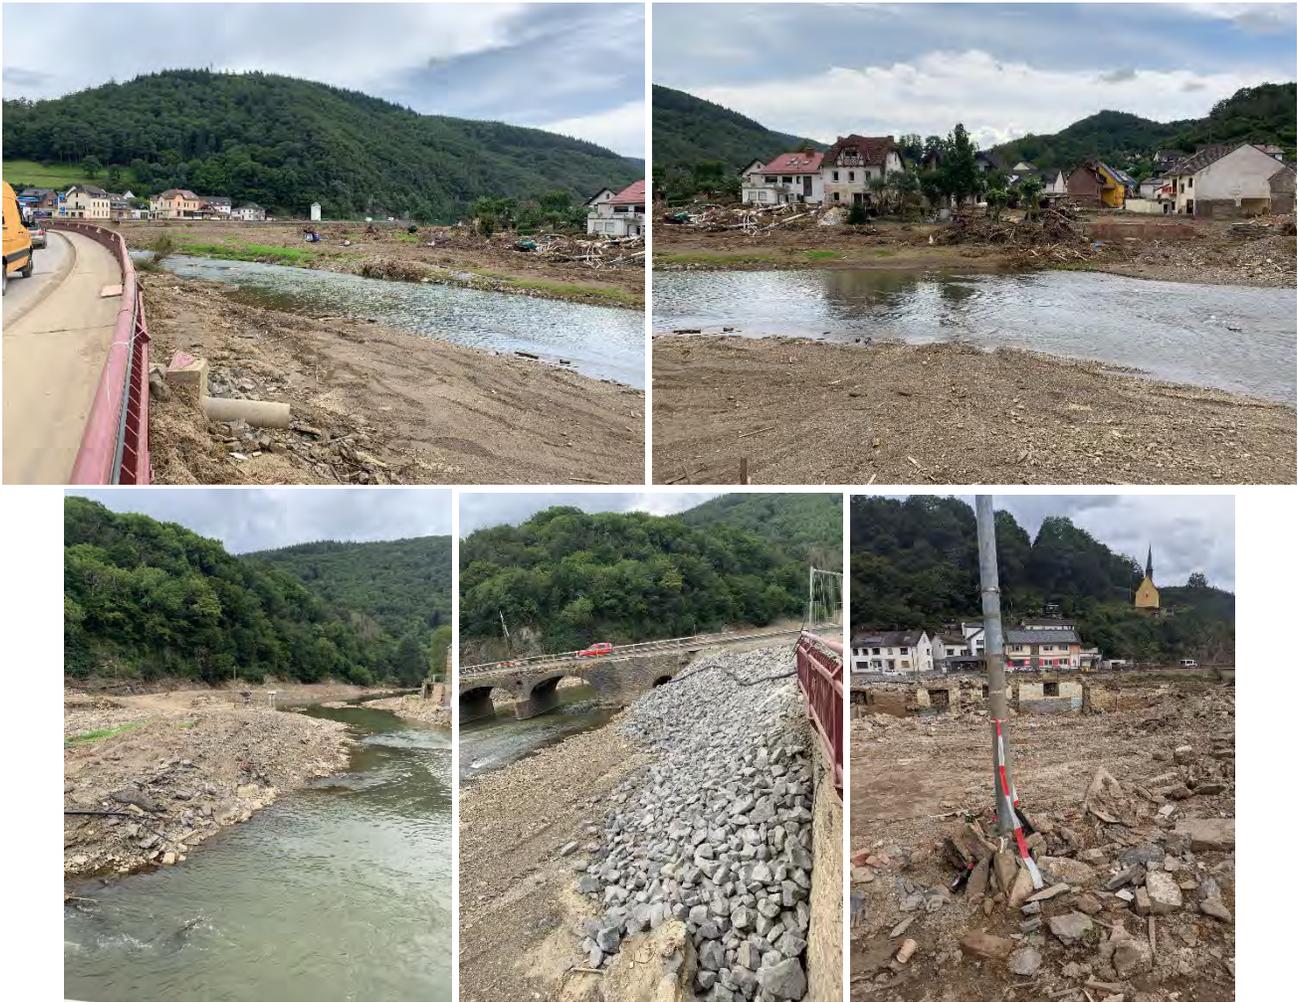
Figure 3.103. Floodplains and riverbanks around the Ahr bride and bridge abutment in Brück (50.4866352, 6.9717177).

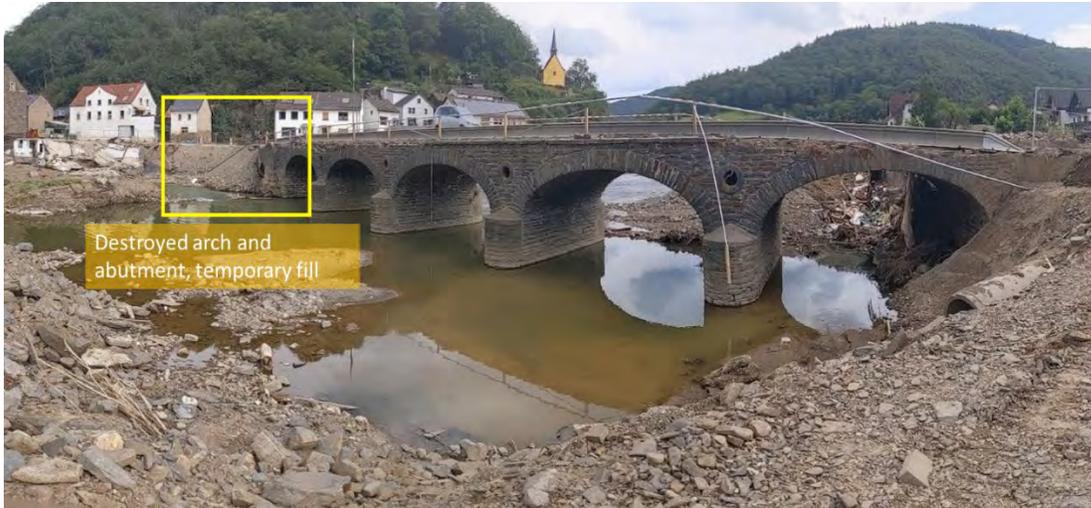
Figure 3.104. Bridge and temporary retrofit to missing arch and superstructure (50.4866352, 6.9717177).
