Geotechnical Reconnaissance of the 2021 Western European Floods

Flood Event: July 14-15, 2021

Flood locations: Germany, Netherlands, Belgium, and Luxembourg

Reconnaissance Visit: August 9-18, 2021

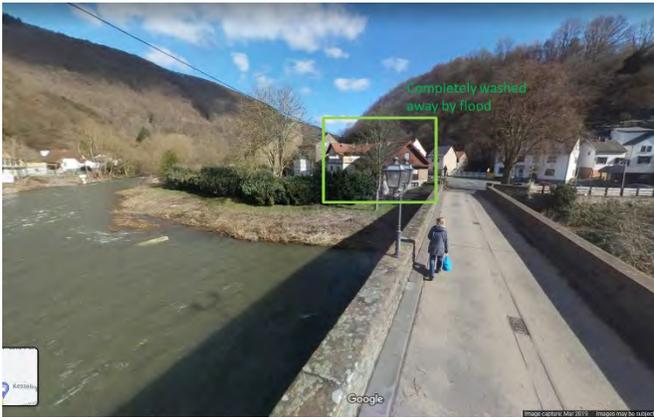
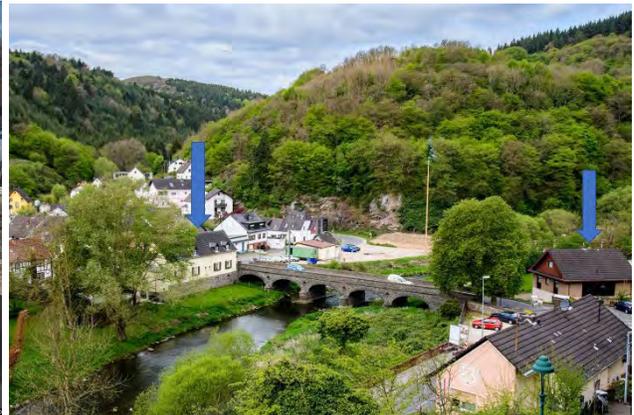
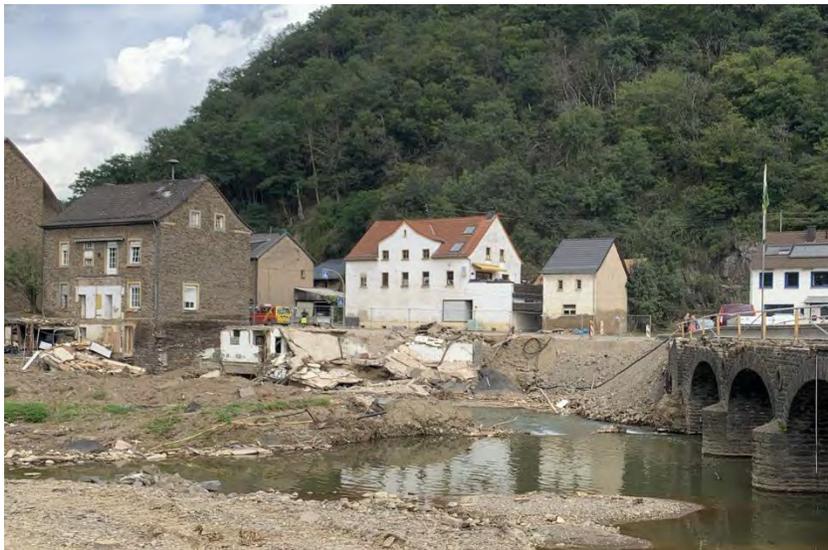
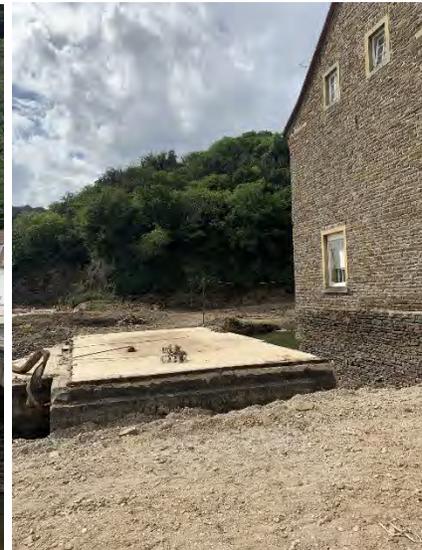
Figure 3.105. Before view of houses near Ahr embankment (top) Source: Google maps(left) and <https://www.aw-wiki.de/w/index.php?curid=42060>; same site with destroyed (missing) houses (bottom) - only the foundation slab of one of the buildings remained (bottom, right, 50.486959, 6.9717834)

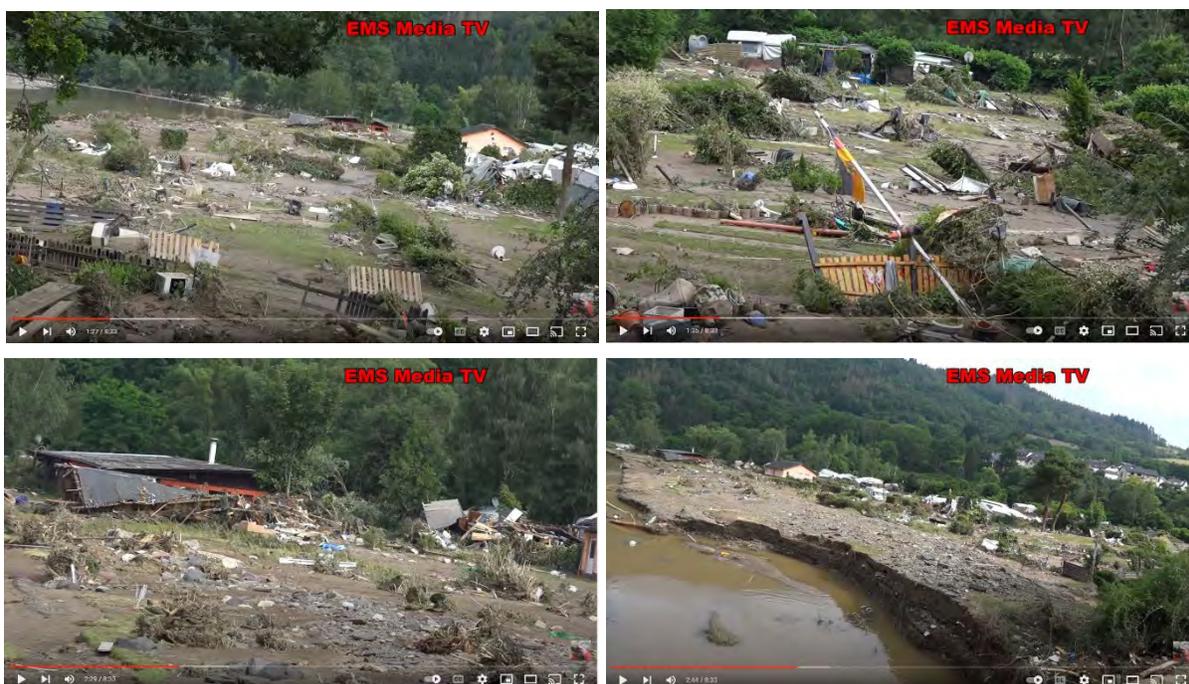
Figure 3.110. Images of the campsite immediately after the flood, Source: EMS Media TV, accessed through: <https://www.youtube.com/watch?v=MSrJRXL6dQA>

The campground was heavily destroyed during the July 2021 flood event. The campground owner told the team that most mobile homes were evacuated in the evening of July 13th, and the morning of July 14th, 2021. He drove most mobile homes to higher elevations, and parked them along the road to the chapel Maria Geburt Pützfeld (see Figure 3.106). There was only one fatality associated with the campground, namely an elderly man who decided to walk to the Ahrbrück train station and was caught in a flood wave from upstream. Figures 3.110 and 3.111 show the campground immediately after the flood. At the time of the team's visit, some of the debris depicted in Figure 3.112, as well as most of the caravans were removed from the campsite. Figure 3.113 shows the campground during the team's visit. The campground owner was waiting for heaving construction equipment to remove the remaining debris and to level the site. He is planning on reopening the campground, even though it is clearly located in the floodplains of the Ahr and permission to do so is still pending.

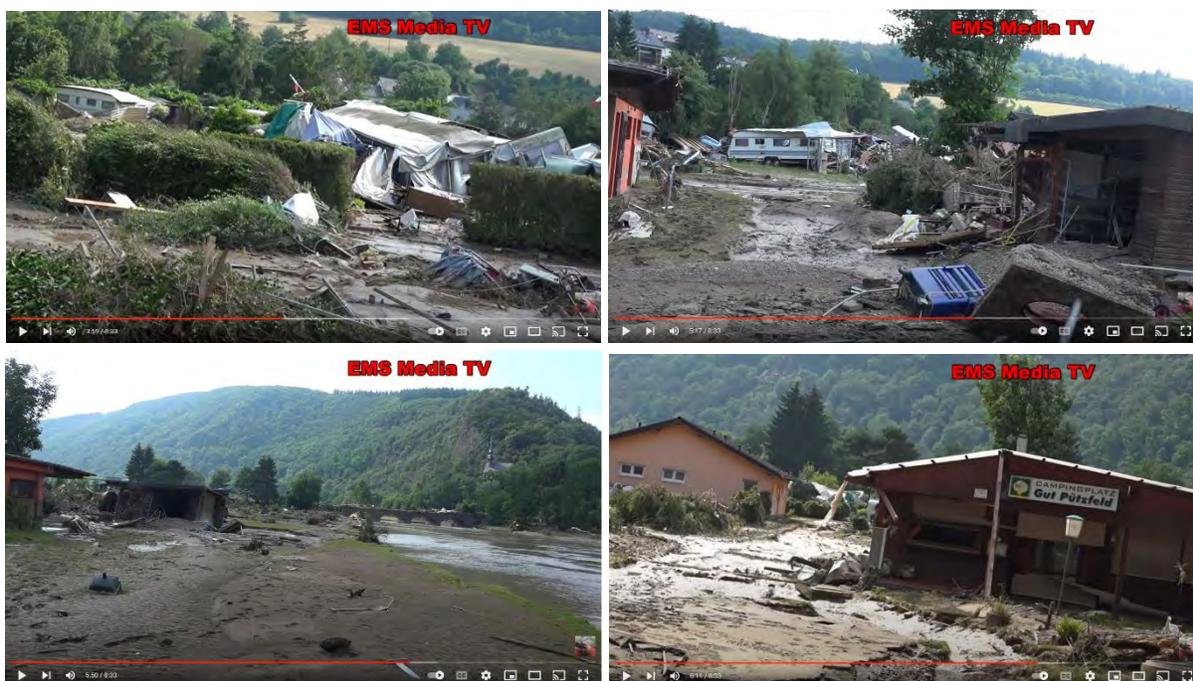
Figure 3.111. Additional images of the campsite immediately after the flood, Source: EMS Media TV, accessed through: <https://www.youtube.com/watch?v=MSrJRXL6dQA>

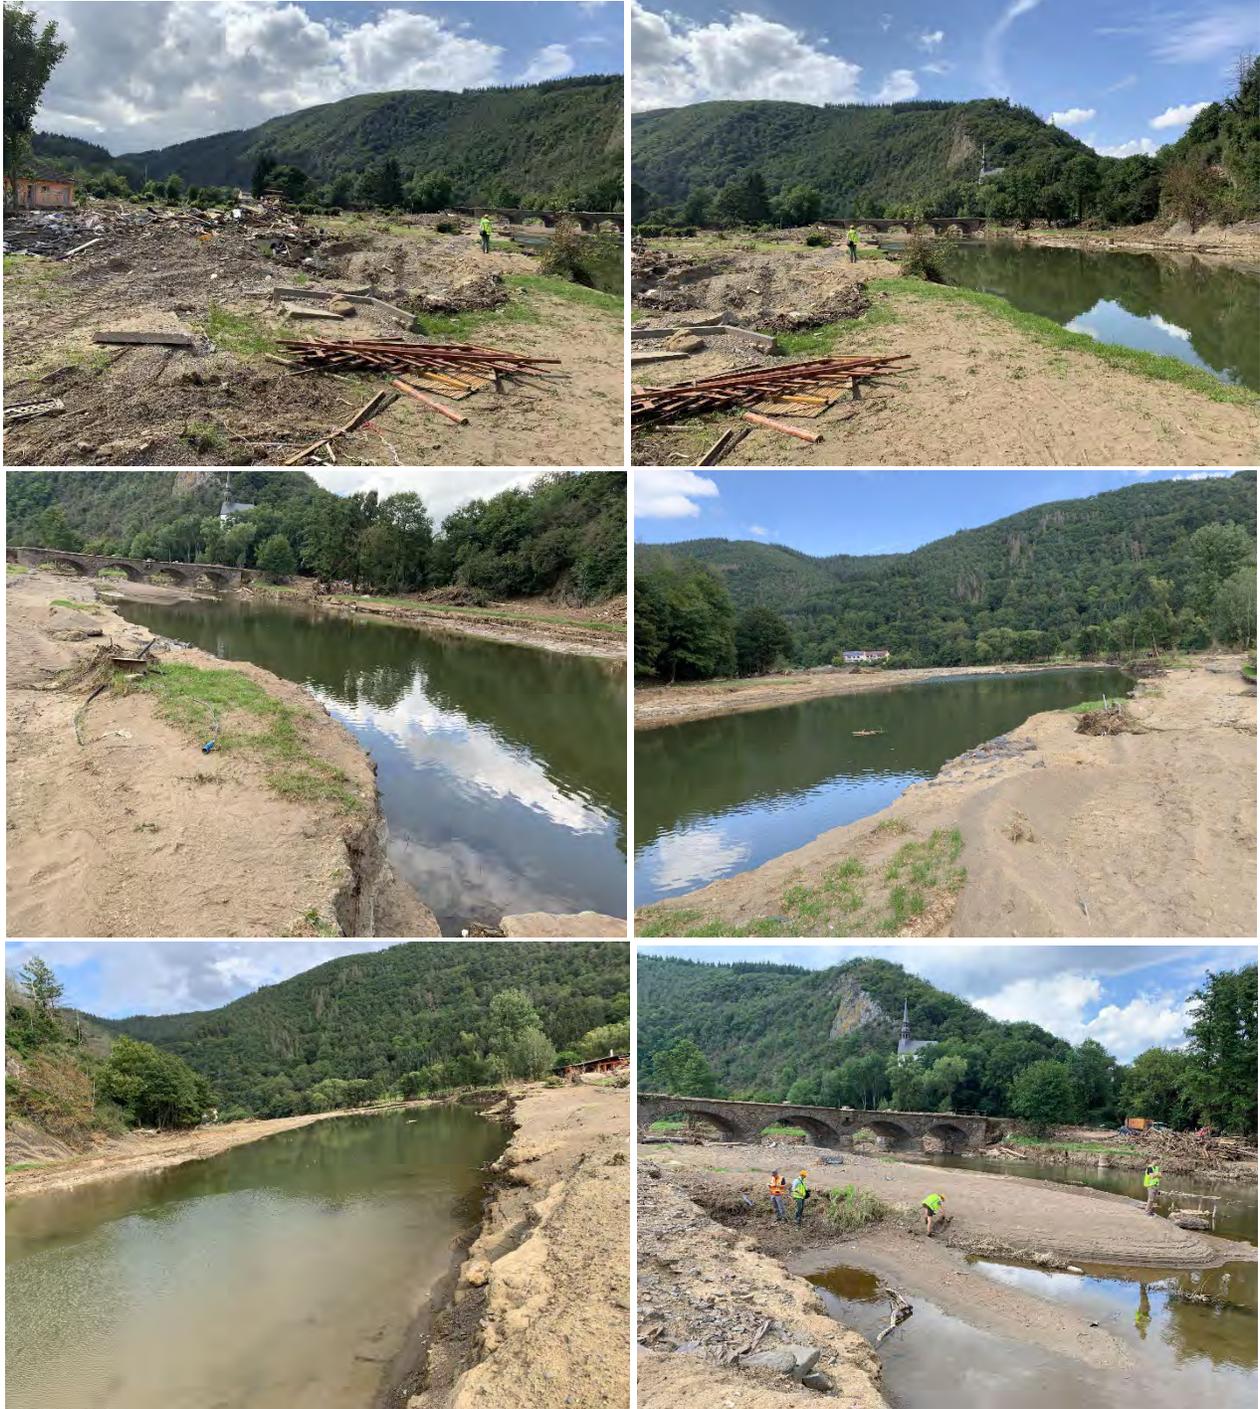
Figures 3.112 and 3.113 show the campsite with debris and soil deposits at the time of the team’s visit. Photographs at the center and bottom of Figure 3.112 depict the severe embankment erosion and soil redeposition. The bank erosion along the Ahr River near the Campingplatz Gut Pützfeld resulted in exposure of approximately 1.5 meters of historic sedimentary deposits (Figure 3.113). The cut in the right channel bank exhibited alternating layers of fine- and coarse-grained materials. Eight layers were exposed, with Layer 8 being the existing surface layer. Of particular interest are Layer 4 and Layer 6. Particles in these layers are larger in size (particularly in Layer 6) as well as less organized in depositional nature (e.g., compared to Layer 2 which shows greater imbrication). This suggests these layers were deposited quickly and in a more chaotic, high-energy, fluvial environment and most likely associated with prior extreme flood events on the Ahr River. These exposures, and others along the river reach, can be helpful in understanding characteristics of prior extreme flood events. A handheld LiDAR scan of the bank cut (Table 2.2.) was also taken from which grain sizes of the larger materials could be derived.

Figure 3.112. Pictures of the Campground Gut Pützfeld during the team's visit, along with riverbank erosion (50.4943691, 6.9822398)

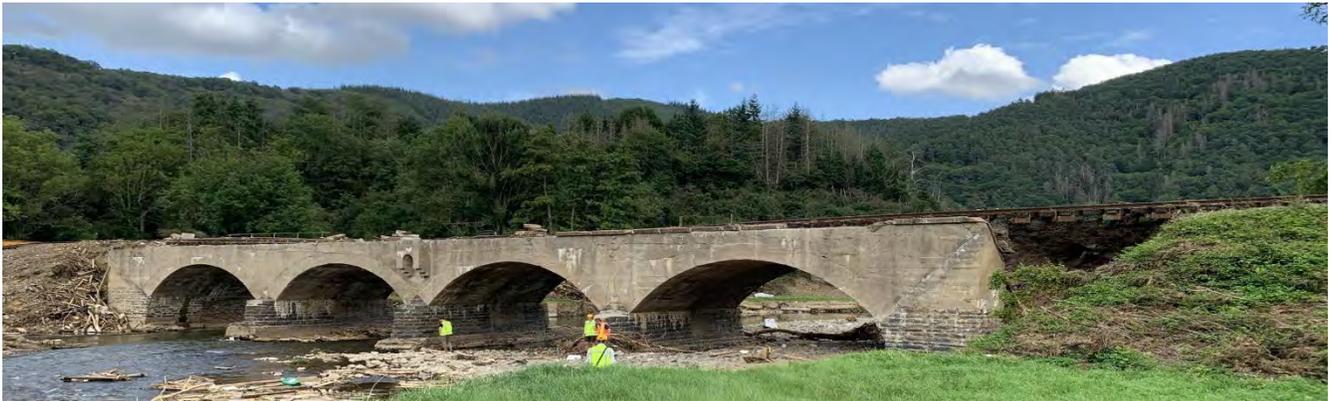
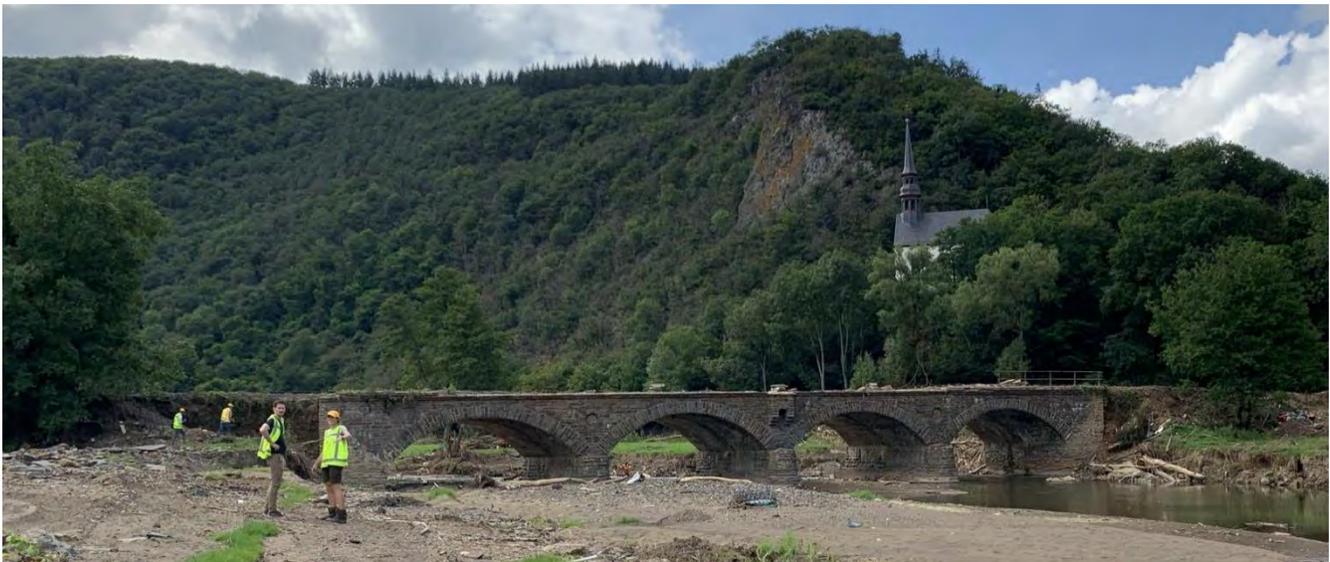
The railroad bridge adjacent to the campground was also damaged, particularly its abutment areas. Figure 3.114 shows the bridge from upstream (top) and downstream (bottom) direction. Figures 3.115 – 3.116 show three screenshots obtained from online video footage showing the bridge immediately after the flood, which highlights the amounts of debris and deadwood deposited on the bridge deck. Figure 3.117 shows close-up photographs of the damage near the bridge abutments.

Figure 3.114. Rail bridge at Campground Gut Pützfeld from upstream (top) and downstream (bottom photo) direction (50.4943691, 6.9822398).

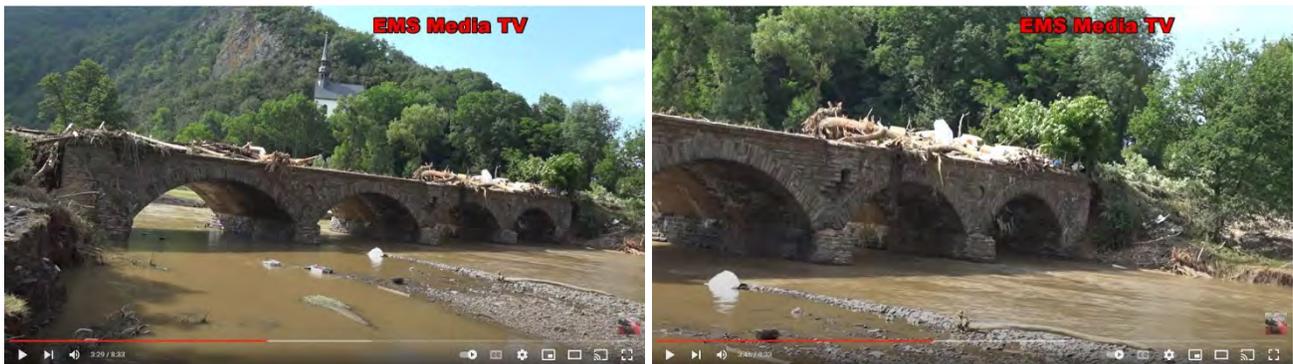
Figure 3.115. Railroad bridge from downstream direction shortly after the flood showing massive amounts of debris and deadwood piled up around bridge structure, Source: <https://www.youtube.com/watch?v=MSrJRXI6dQA>

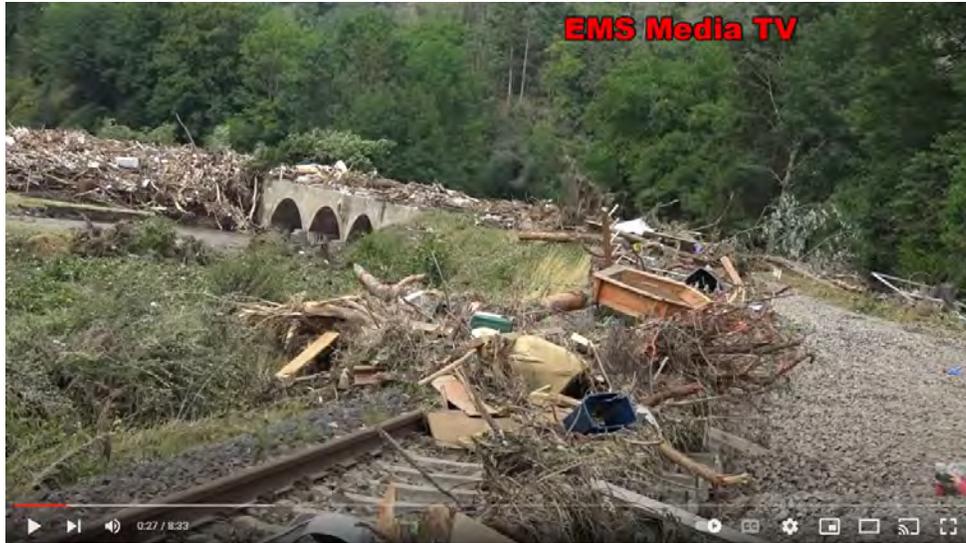
Figure 3.116. Railroad bridge shortly after the flood showing massive amounts of debris and deadwood piled up around bridge structure, Source: <https://www.youtube.com/watch?v=MSrJRXI6dQA>

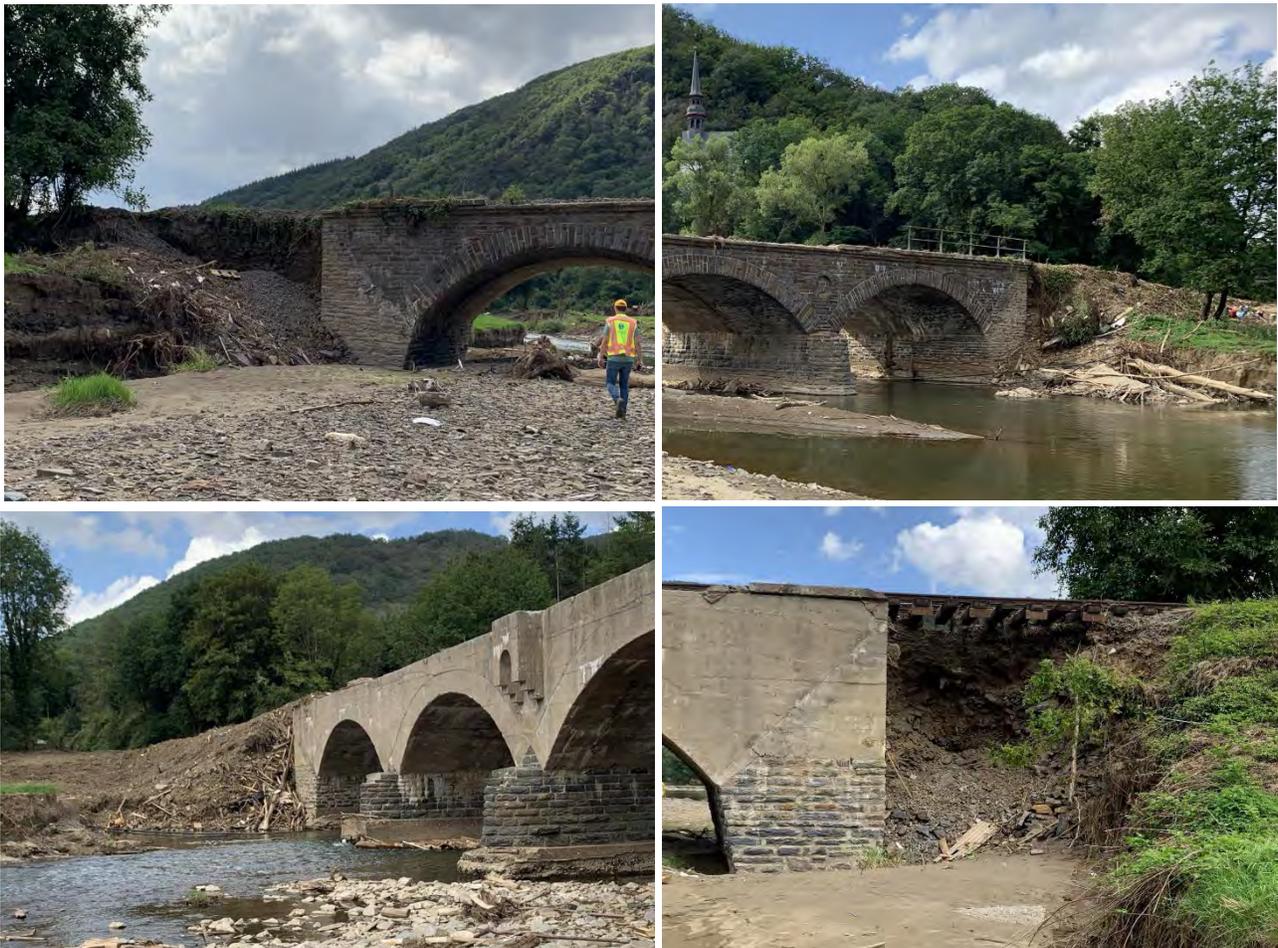
Figure 3.117. Damage and Erosion around the bridge abutments. From downstream direction (Top left and right) and upstream direction (Bottom left and right abutment), (50.4943691, 6.9822398).

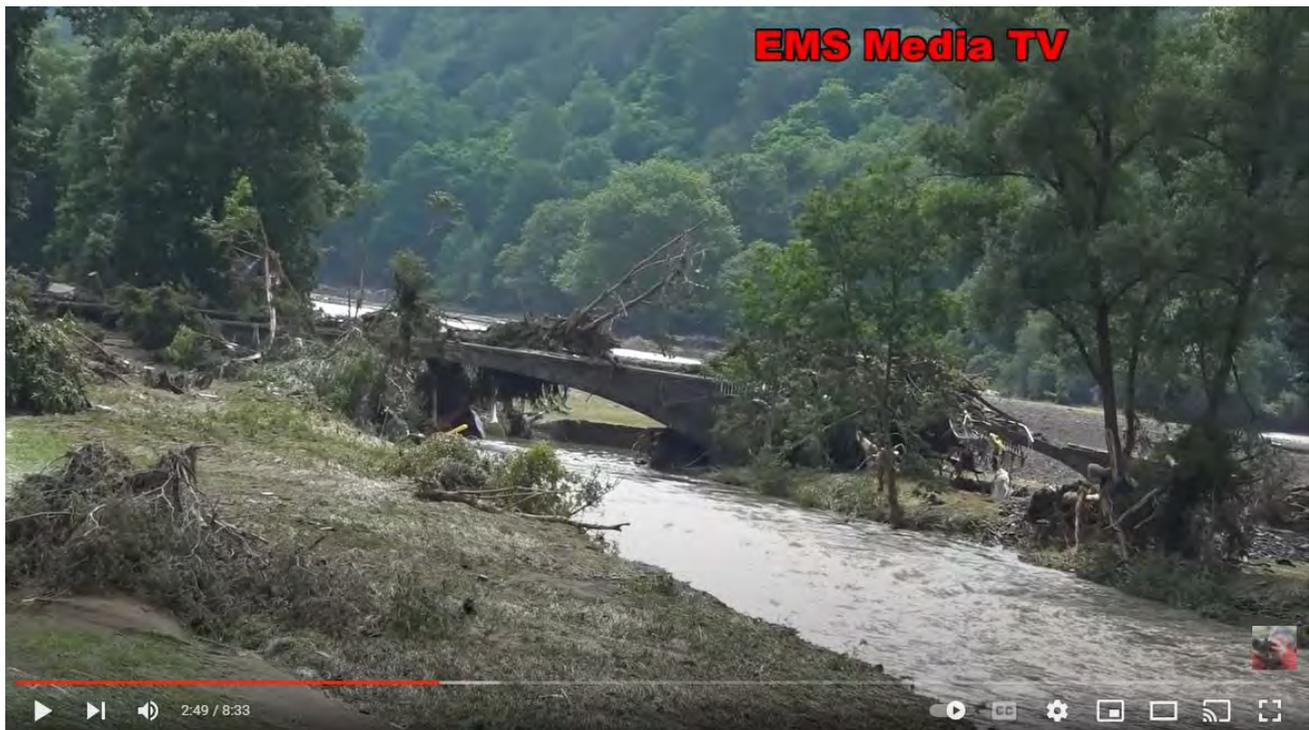
The bicycle and pedestrian bridge in close proximity to the campground was also damaged. This bridge is located on the hiking path to the Sancta Maria Immaculata chapel. The bridge is shown in its intact state in Figure 3.118. The bridge railing as well as part of the bridge deck was destroyed and washed away, and one of the arches was damaged as shown in Figures 3.119 and 3.120 bottom.

Figure 3.119. Bridge at Muehlenaue shortly after the flood, Source: Screen shot from online footage by EMS Media TV, accessed at: <https://www.youtube.com/watch?v=MSrJRXI6dQA>

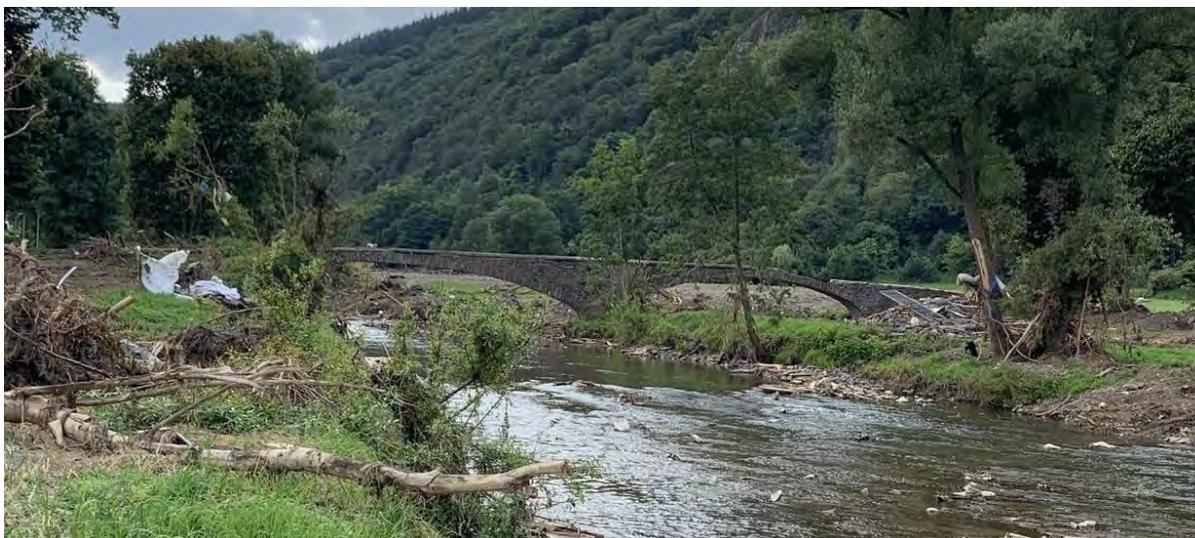
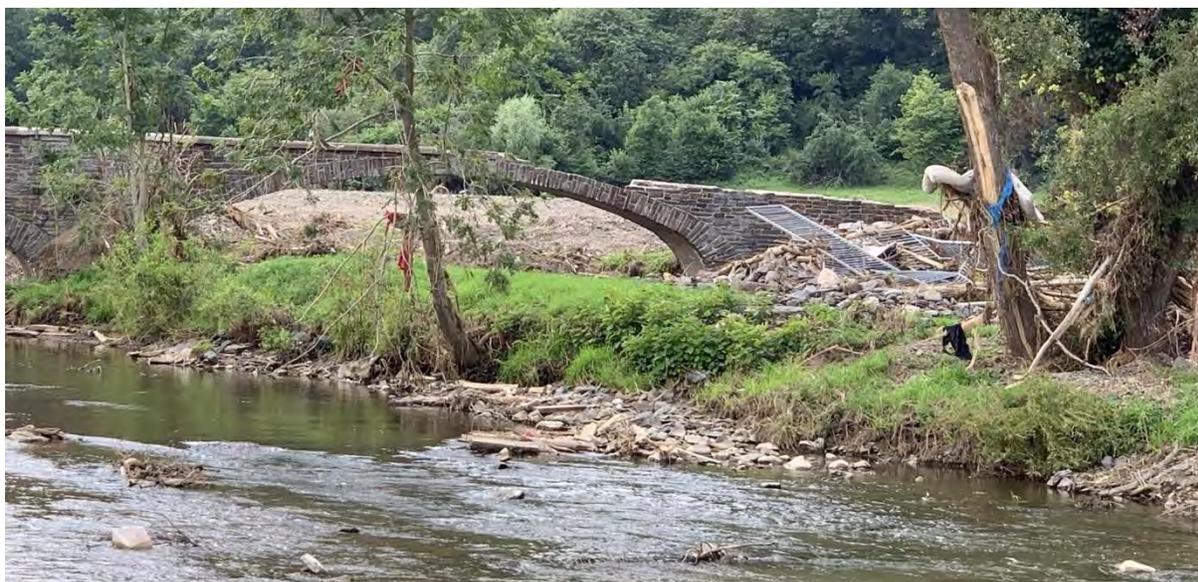
Figure 3.120. Damage to bicycle bridge Mühlenau in Pützfeld taken by the GEER team (50.49382, 6.97981128)

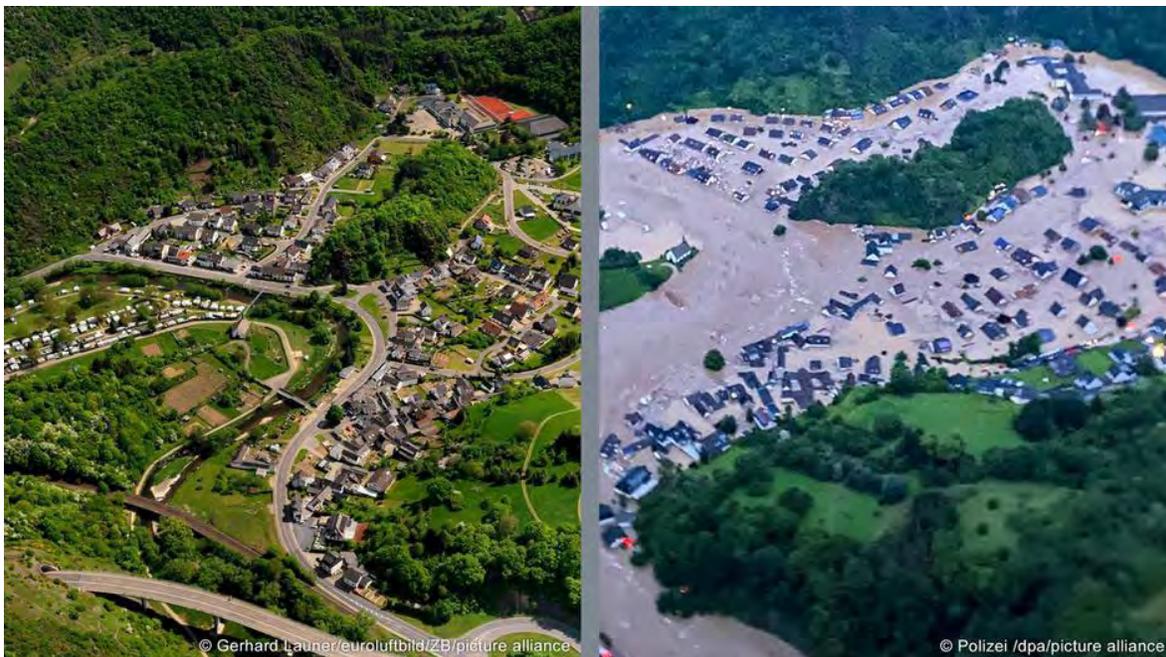
Figure 3.122. Aerial view of Altenburg before and during flood event, Source: <https://www.dw.com/en/flooding-in-germany-before-and-after-images-from-the-ahr-and-eifel-regions/a-58299008>

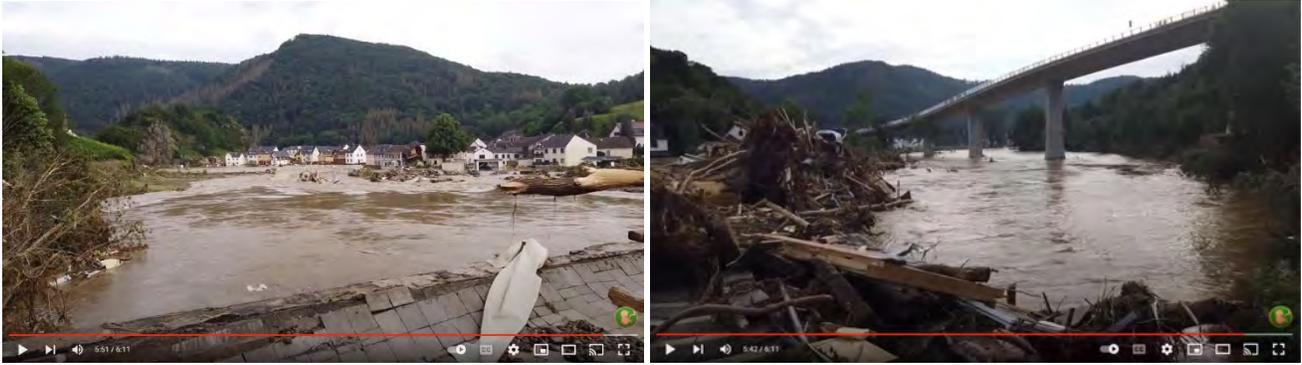
Figure 3.123. Close up few one day after the main flood event, Source: <https://www.youtube.com/watch?v=g09YLvd4xzk>

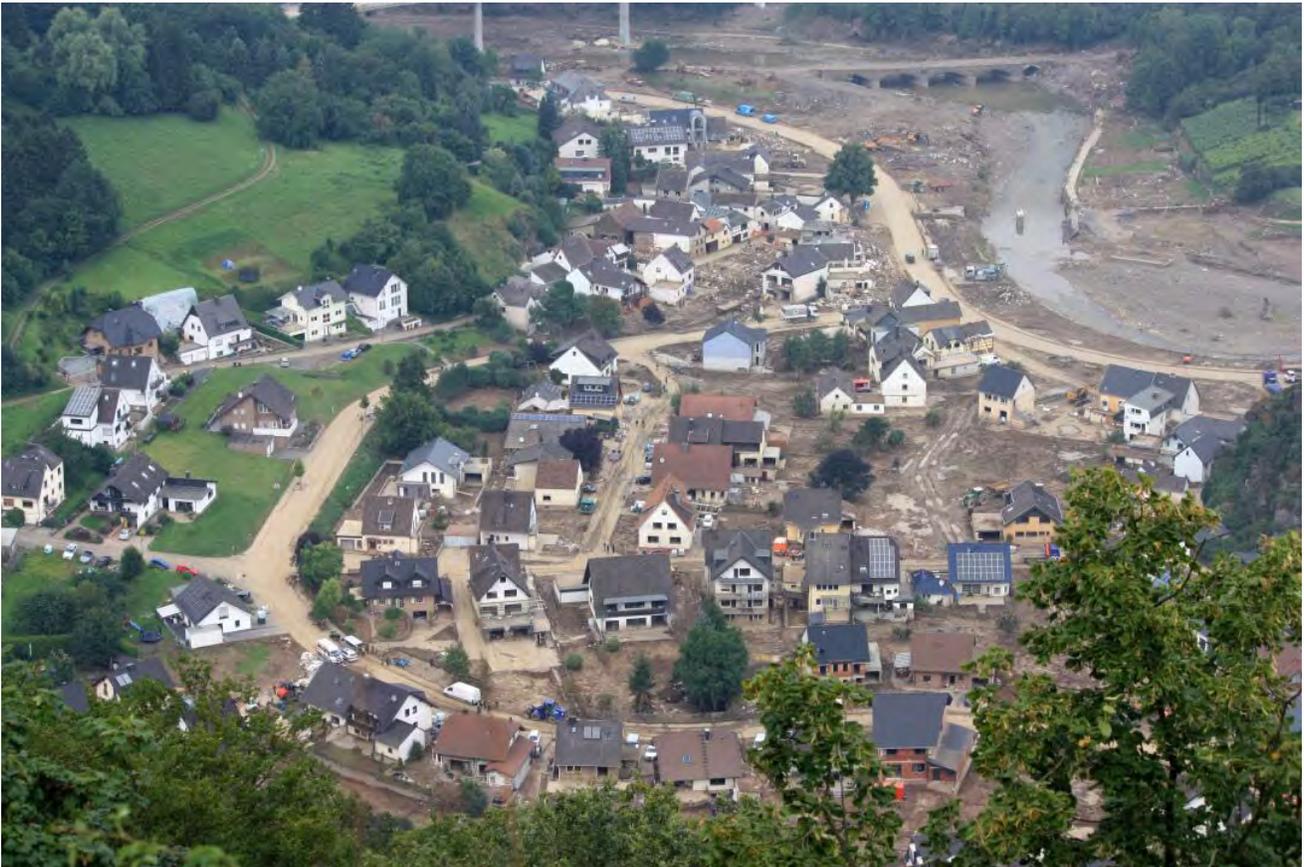
Figure 3.124. Aerial view of Altenburg shortly after the flood, Source: <https://blasorchester-altenahr.hpage.com/aktuelles.html>

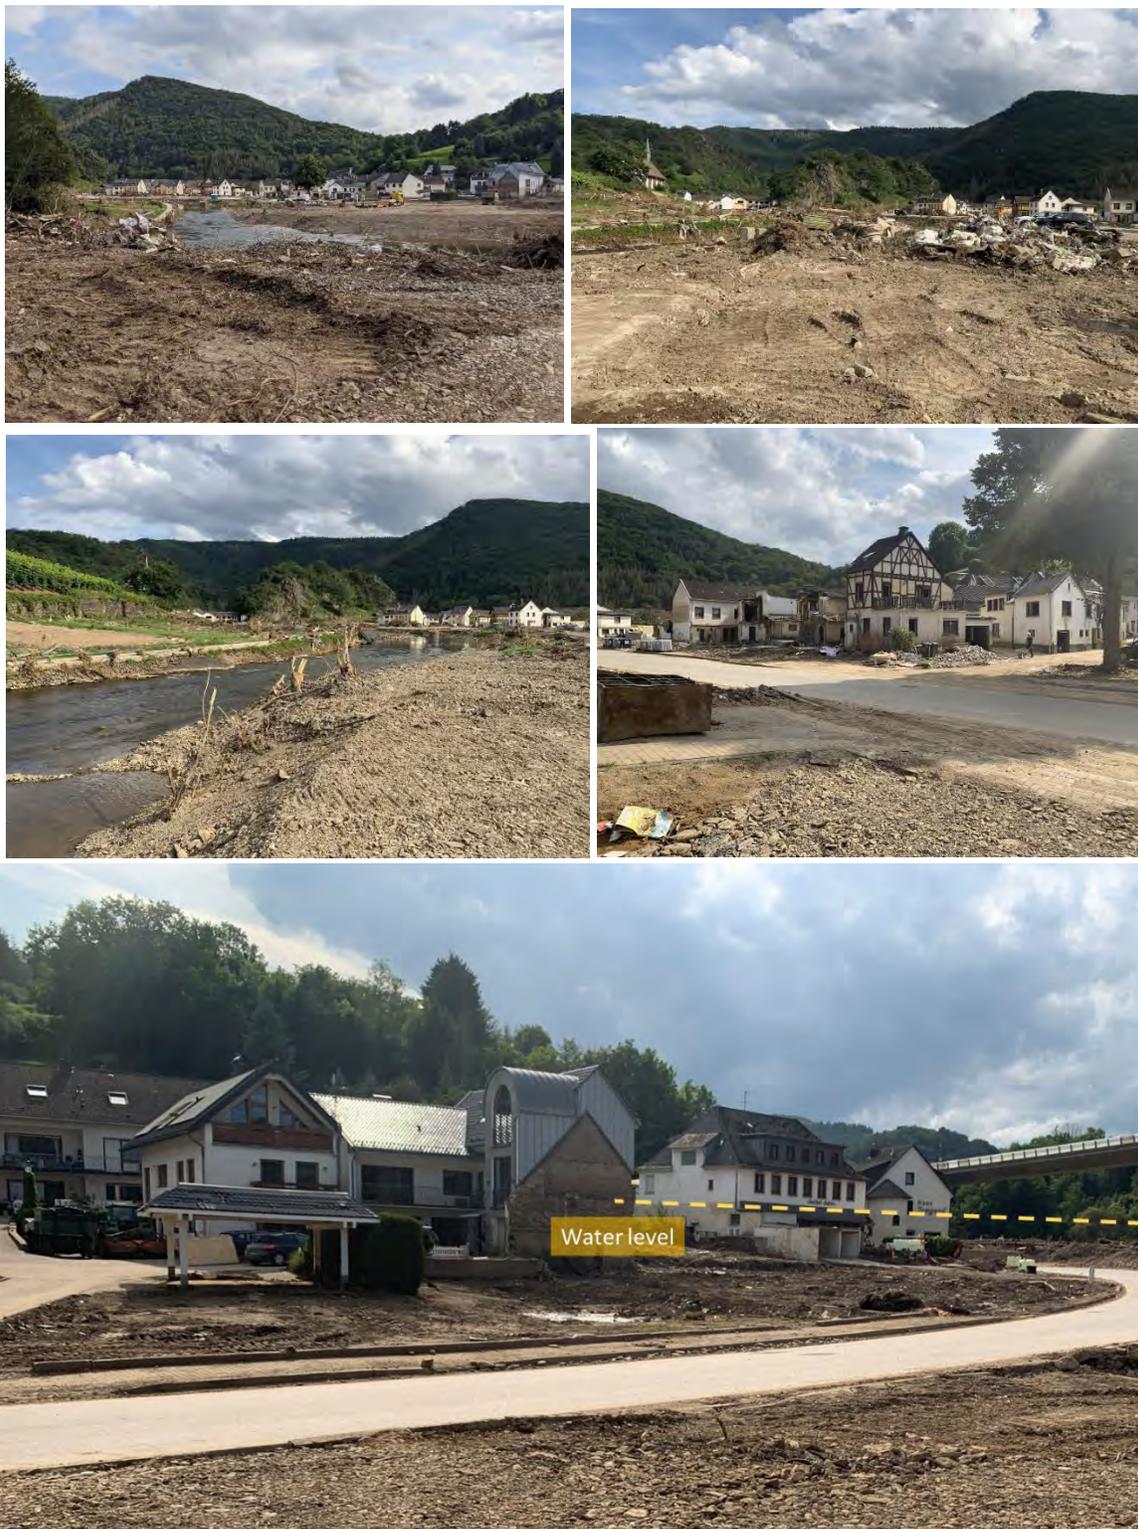
Figure 3.125 shows photographs taken by the team in Altenburg. The bottom figure includes the high-water marks on the remaining residential houses along the main street in Altenburg.

Figure 3.125. Flood damage adjacent to the Ahr in Altenburg, houses along the main road 267 (50.5117204, 6.9842627)

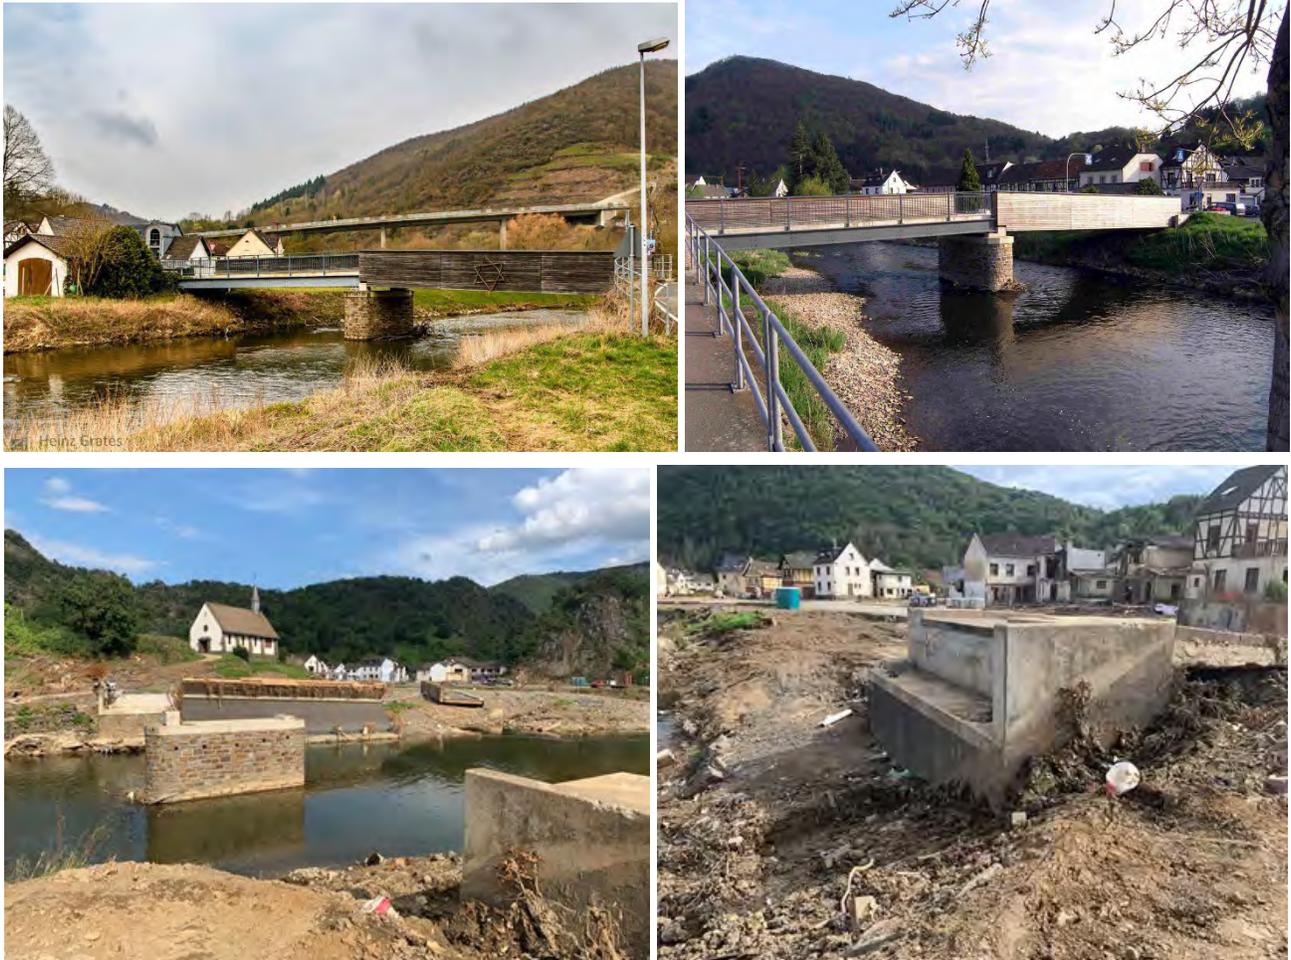
Figure 3.126 shows bridge damage in Altenburg. This two-span road bridge was constructed with precast concrete deck segments, which were found to be intact and washed away /relocated to the riverbanks (as shown in Fig. 3.126, bottom left). Both abutments and the middle pier were found to be intact. Rising water levels lifted the bridge deck up as there was no rigid connection between the superstructure and foundation elements (i.e., gravity supports only).

Figure 3.126. Top: Road bridge in Altenburg before flood (Source: <https://www.aw-wiki.de/w/index.php?curid=40670>) After: Bridge damage in Altenburg (GPS: 50.511551, 6.985069)

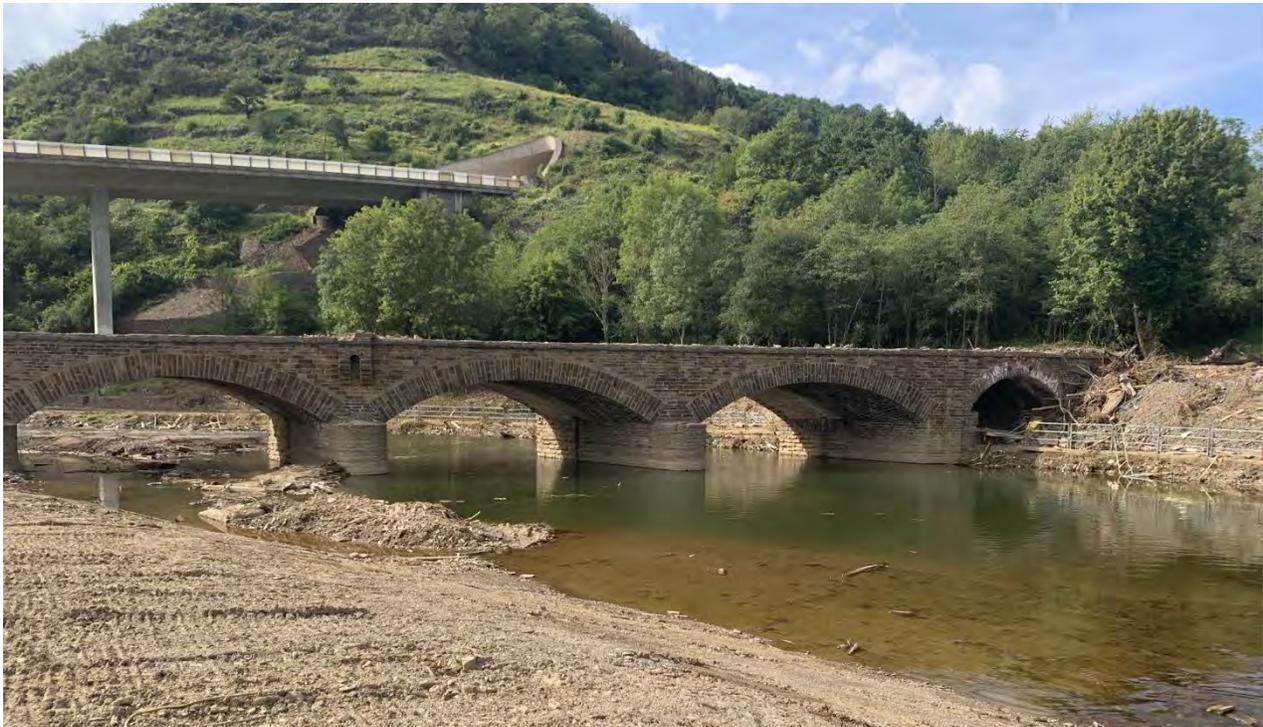
Figure 3.127 shows the rail bridge in Altenburg. This bridge suffered no structural damage. The rail track on the bridge was completely destroyed (see Figure 3.128). The bridge in the background, a road bridge part of Bundesstrasse 267, suffered no damage (see Figure 3.128).

Figure 3.127. Rail bridge in Altenburg (foreground), road bridge along Bundesstrasse 267 (background), (50.5117204, 6.9842627)

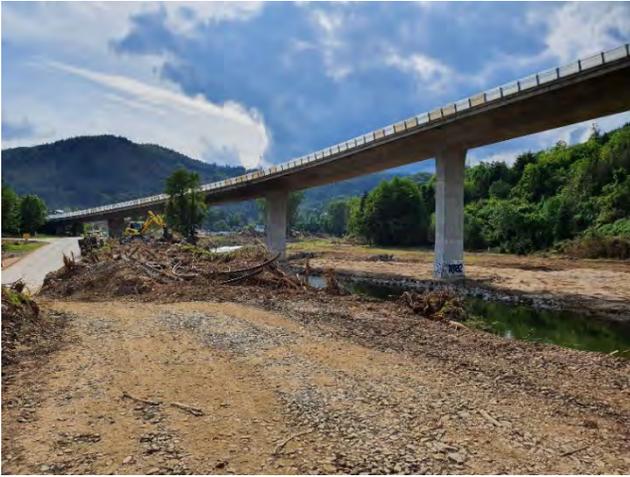
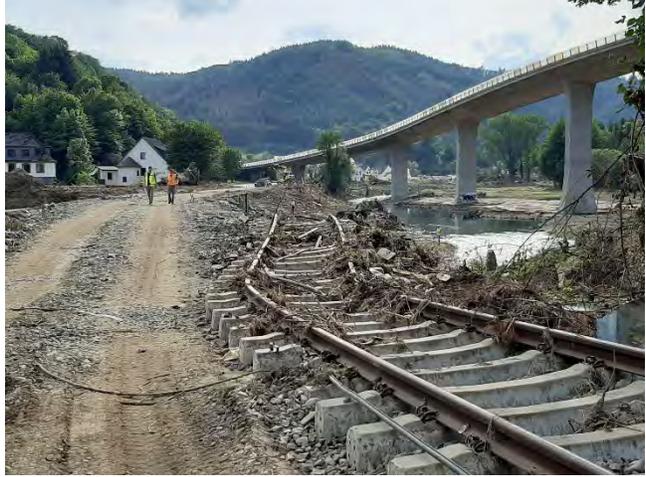
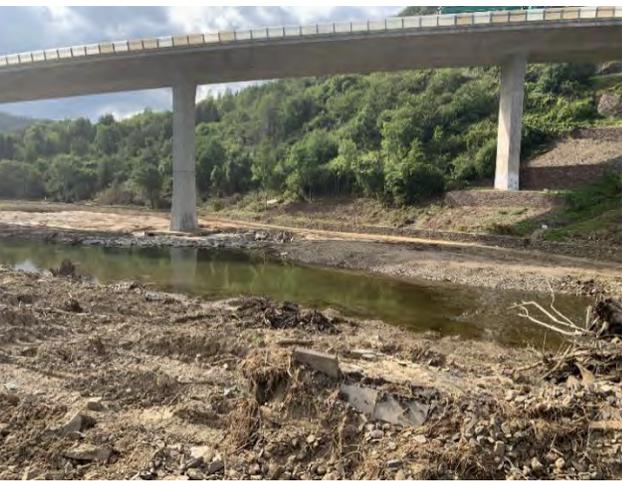
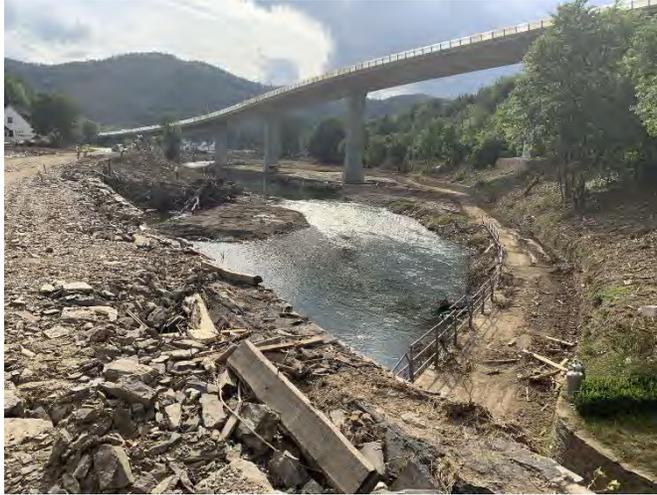
Figure 3.128. Area surrounding road bridge along Highway 267 (50.51283427, 6.9842112)

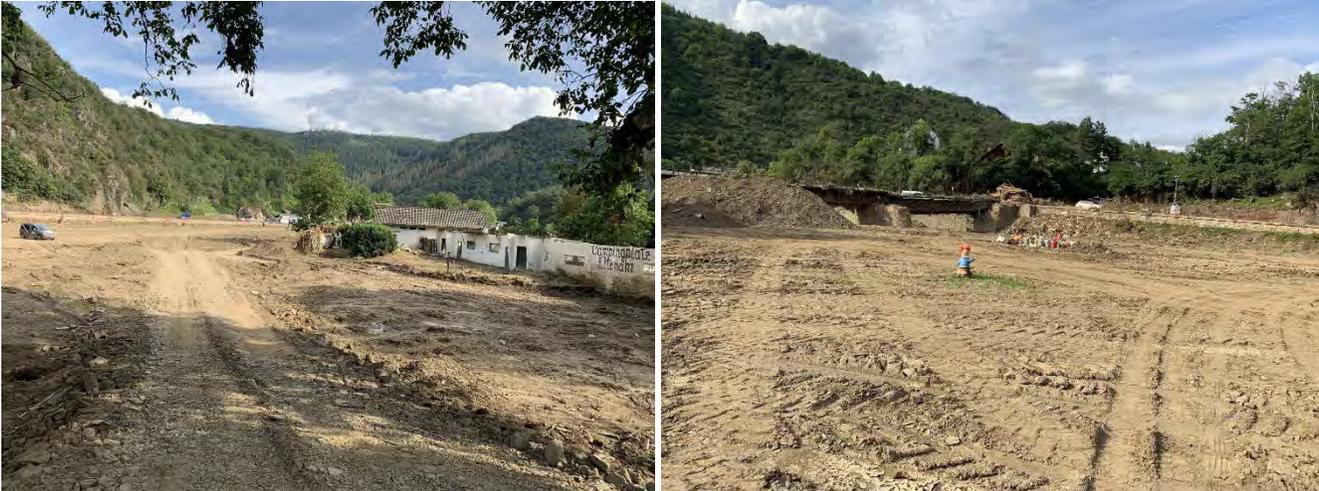
Figure 3.130. Campground Altenahr at time of team's visit, all camp infrastructure was destroyed (50.51427139, 6.9865368)

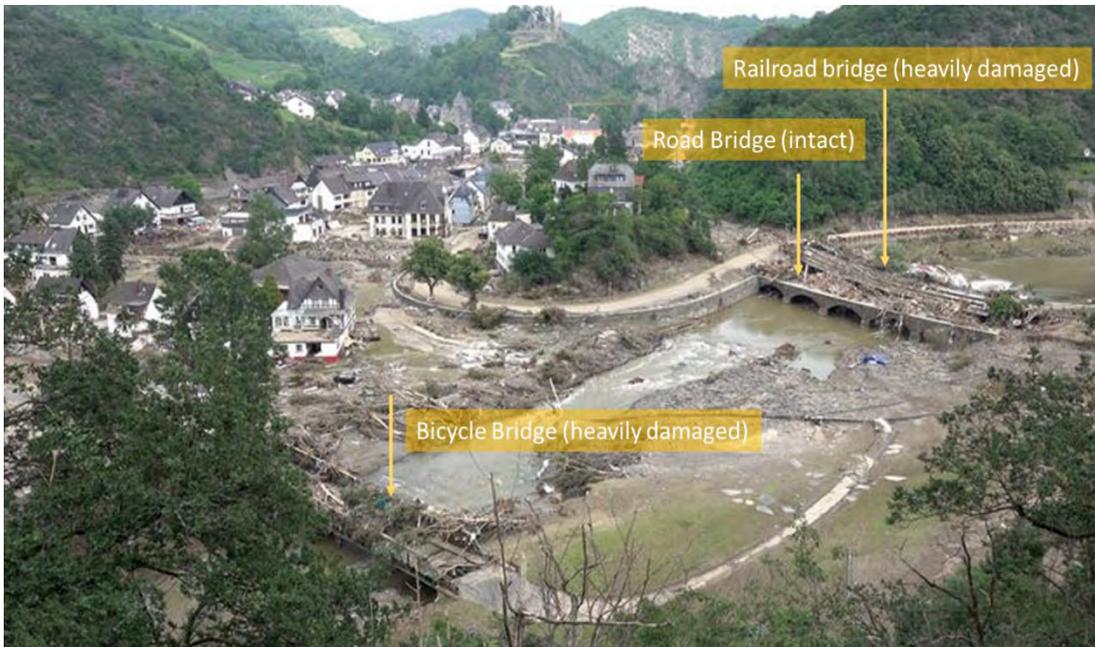
Figure 3.132. View of damaged bridges near campground Viktoria-Station, Altenahr (photo: picture alliance/dpa)

The rail and pedestrian bridge across the Ahr are depicted in Figure 3.131 prior to the flood. The rail bridge is upstream and the pedestrian bridge (formerly road bridge) is downstream. Consequently, the rail bridge was damaged most, catching much debris, camping caravans, tree logs and other items carried by the flood, as shown in Figure 3.132.

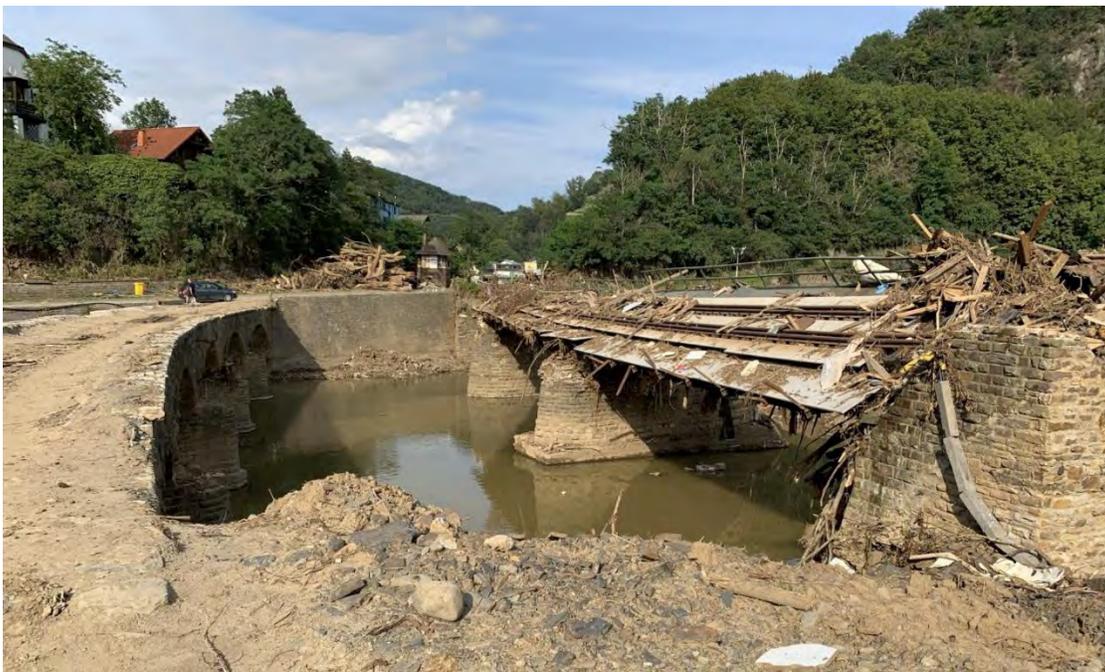
Figure 3.133 shows a photograph taken by the team on August 11, 2021. The superstructure of the rail bridge was completely destroyed, debris and tree logs were still present around the bridge structure. The pedestrian bridge (formerly road bridge) was passable and structurally intact and used as emergency access between part of the town.

Figure 3.133. Photograph of damaged rail and pedestrian bridge on August 11, 2021, (50.5147073, 6.9856677)
