Geotechnical Reconnaissance of the 2021 Western European Floods

Flood Event: July 14-15, 2021

Flood locations: Germany, Netherlands, Belgium, and Luxembourg

Reconnaissance Visit: August 9-18, 2021

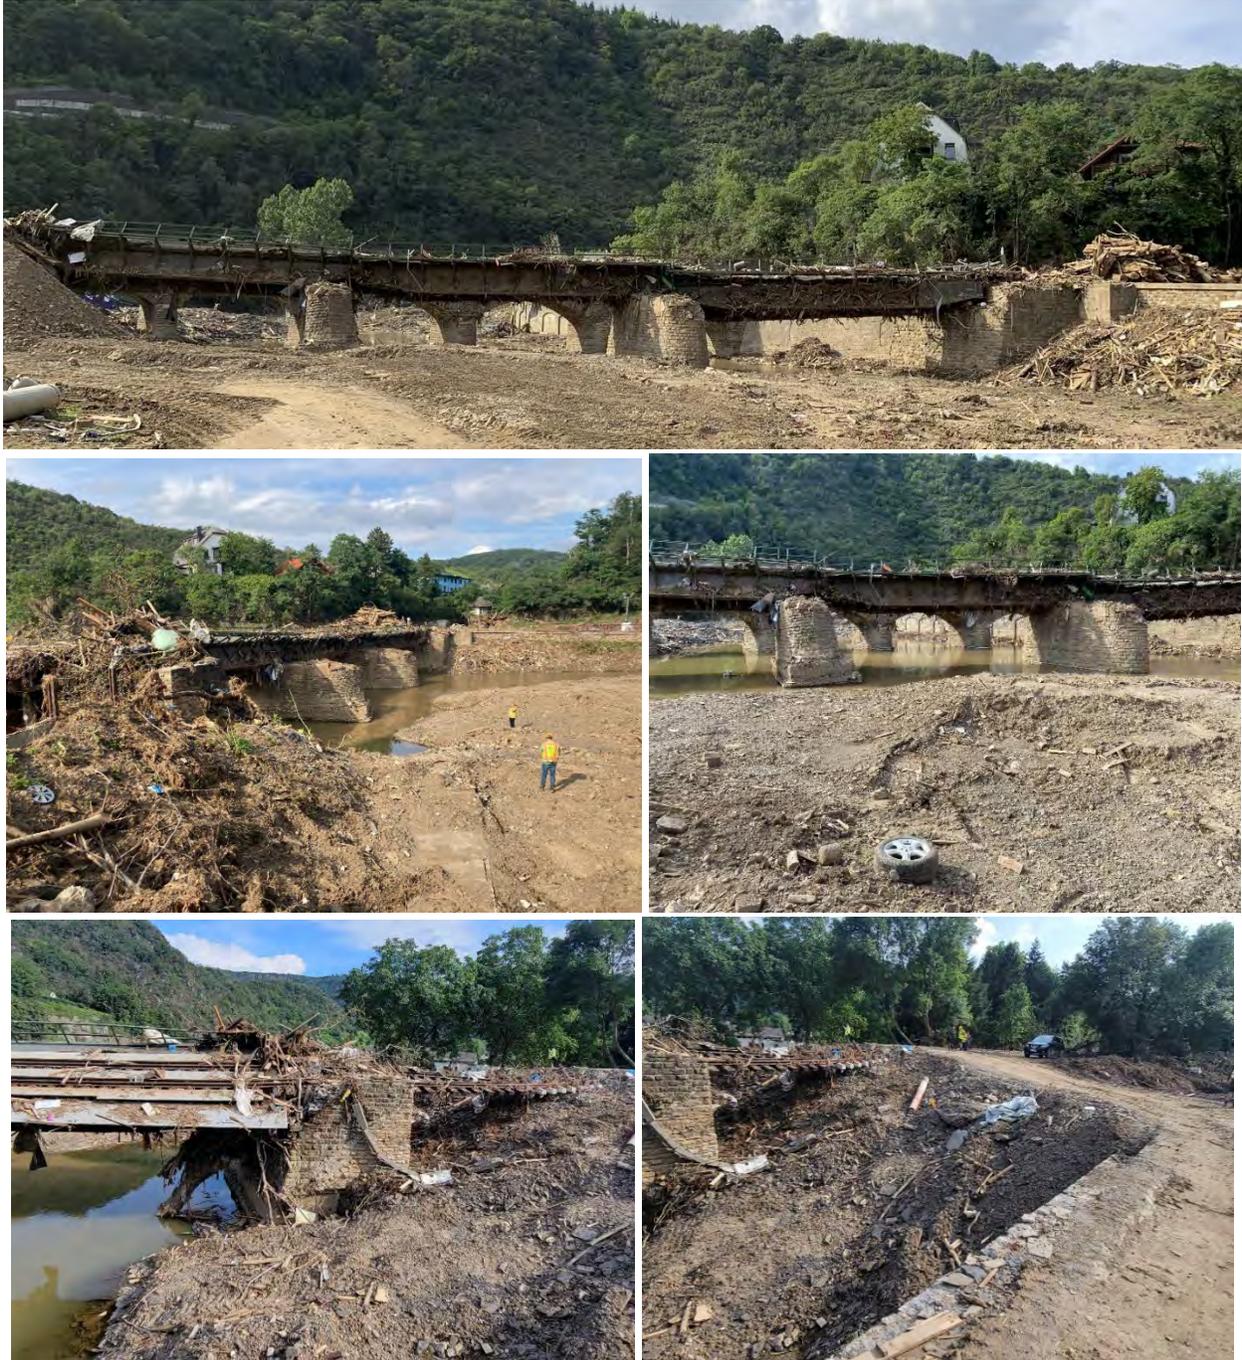
Figure 3.134. Photographs of the damaged rail bridge (top and center) and washed-out abutment region (bottom), (50.5147775, 6.98626321)

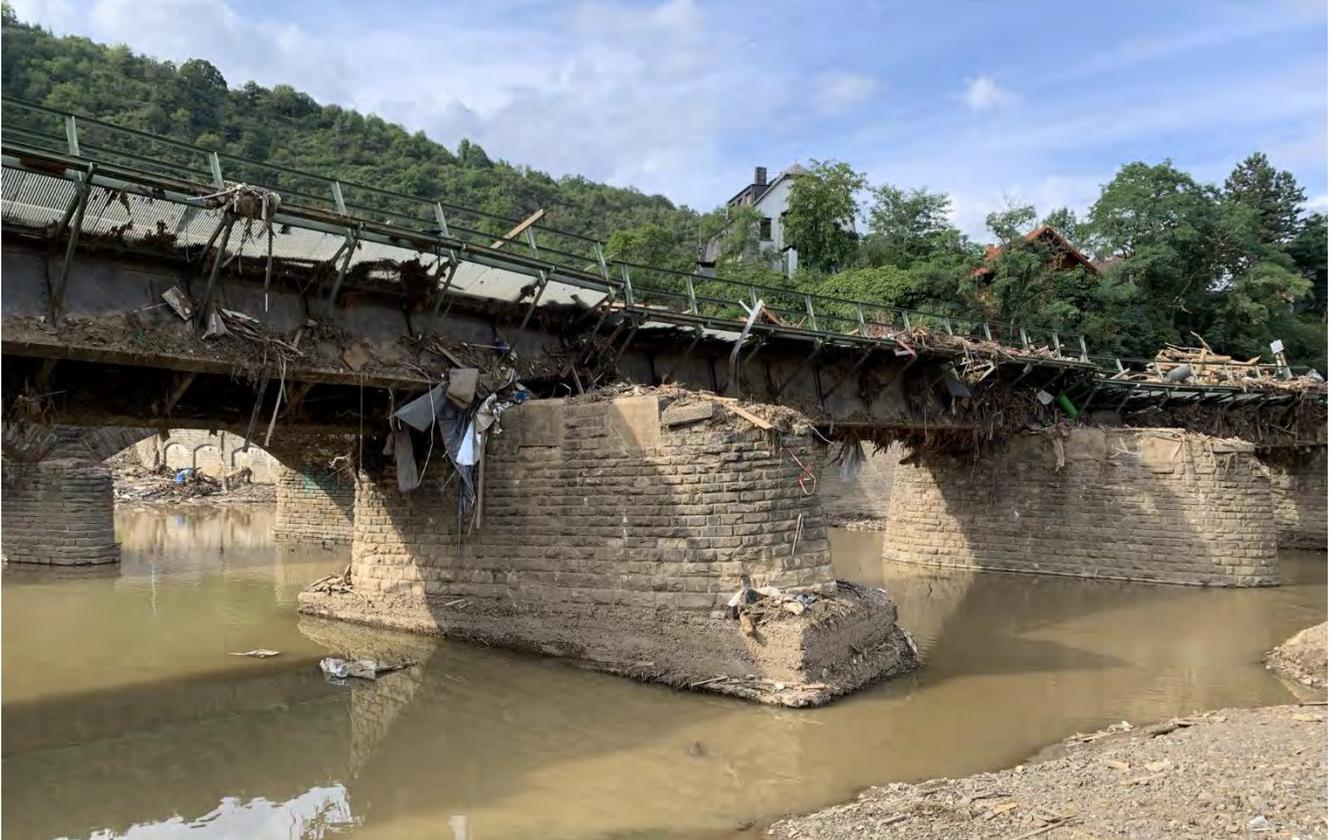
Figure 3.135. Rail bridge: damage to bridge deck and tilted pier wall foundation(50.5147775, 6.98626321).

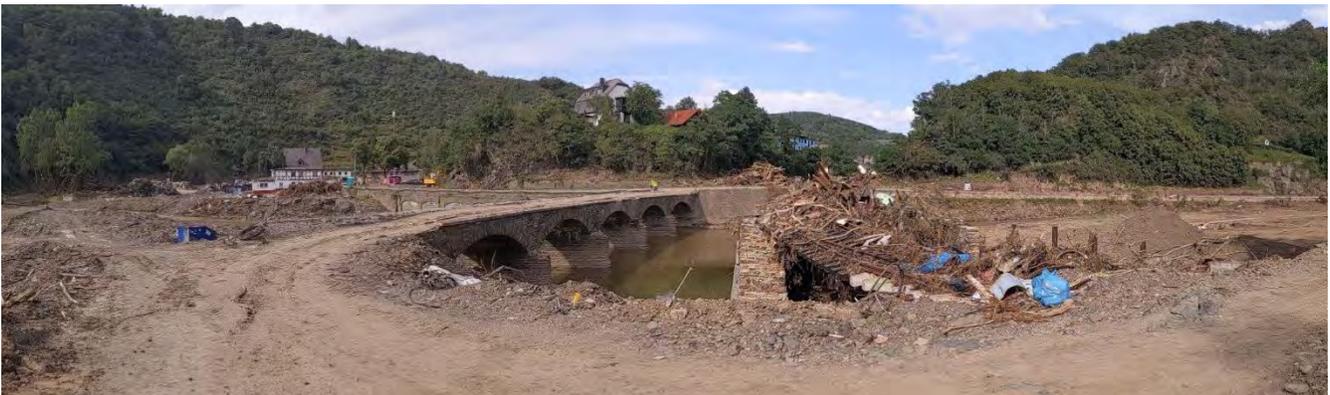
Figure 3.136 shows a panoramic view of both bridges presenting the massive damage to the rail bridge and the minimal damage to the pedestrian bridge. The pedestrian bridge is missing its railing. Also, shown in Figure 3.137, the pedestrian bridge did not suffer any damage at the foundation level. Much of the debris and material was stuck on the rail bridge, while water overtopped both bridges and the adjacent campground to make its way downstream.

Figure 3.136. View of both bridges on August 11, 2021, (50.5147775, 6.98626321).

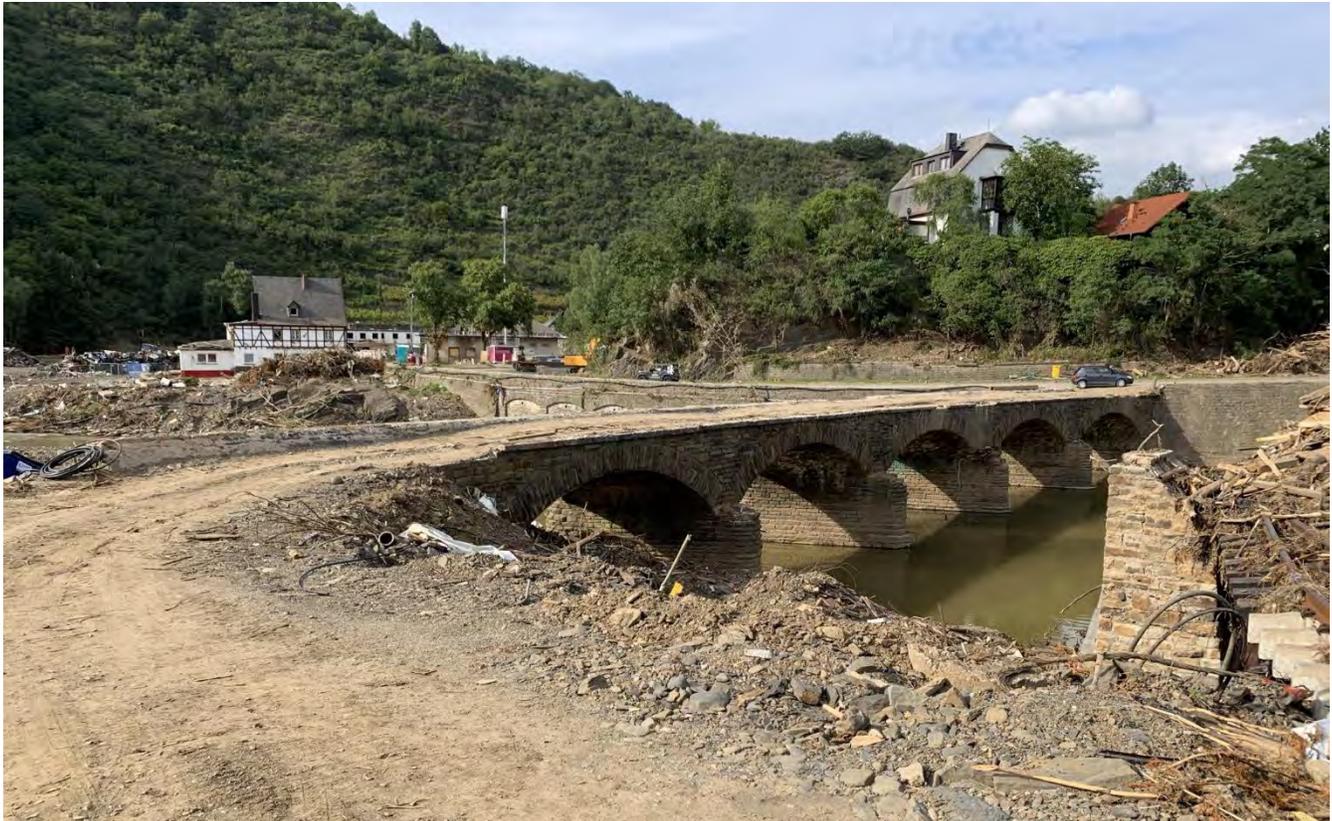
Figure 3.137. Photo of largely intact pedestrian bridge in Altenahr (50.51483562, 6.98577135)

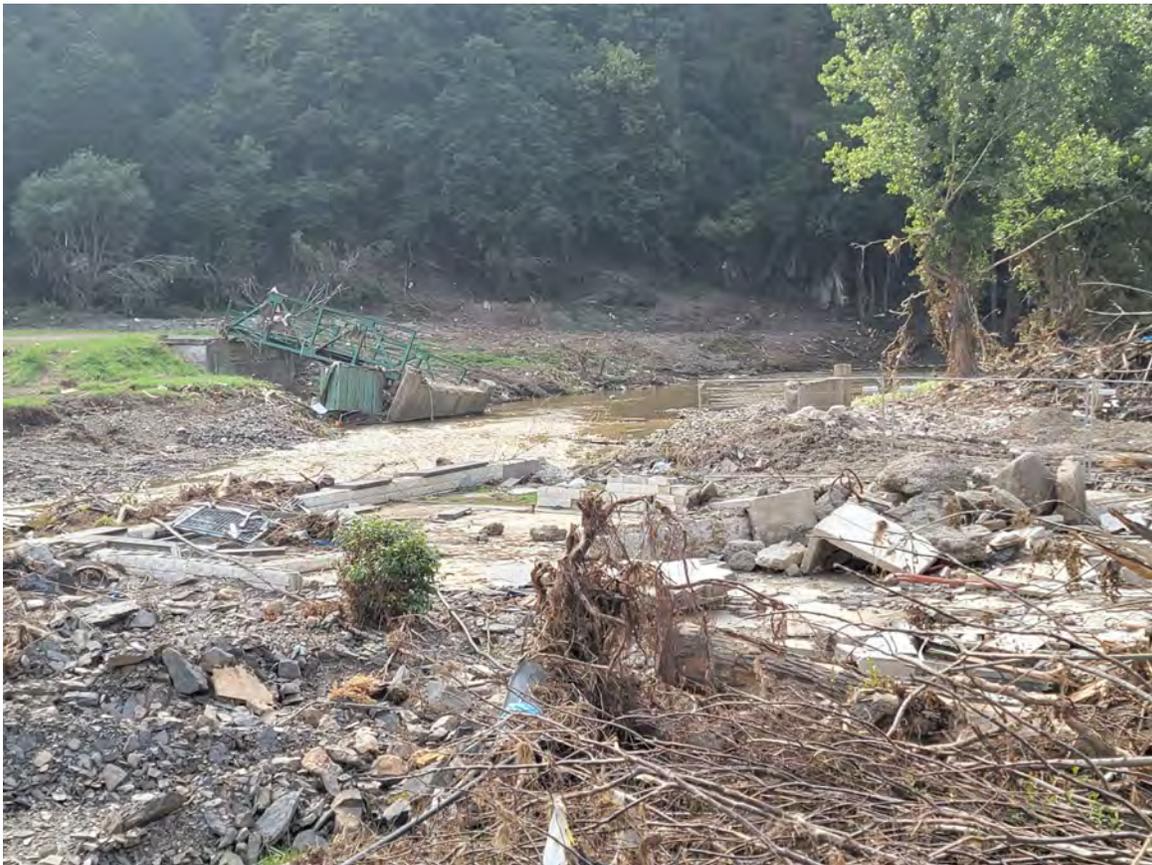
As shown in Figure 3.138, the adjacent bicycle bridge in downstream direction, just nearby the double bridge at Campground Viktoria-Station was heavily damaged and clogged with debris immediately following the flood. At the time of the team's visit, this bridge was either removed or collapsed. Two tilted bridge pier walls were visible (Figure 3.139) and one abutment inland, which remained intact. The lightweight superstructure, a steel truss was completely removed. The bridge deck likely only rested on the intermediate supports as well as on the abutment structure to the left of Figure 3.139. The bridge was loaded with limited debris (smaller tree debris as shown in Figure 3.139), however, the tilt and damage to the foundation walls likely led to the demolition of the bridge.

Figure 3.139. Destroyed bicycle bridge at the time of the team's visit (50.5152961, 6.9842002)

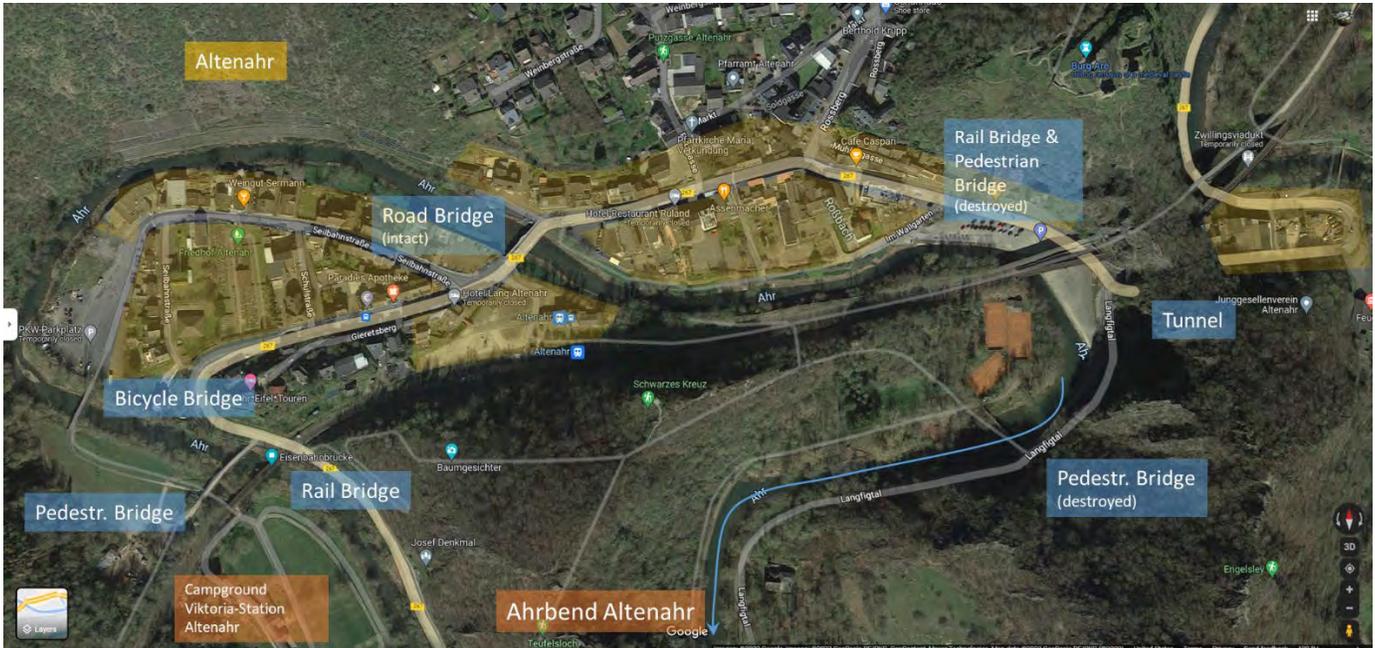
Figure 3.140 depicts the town of Altenahr. The yellow shaded areas were heavily damaged, and partially or fully destroyed. Some houses were washed away (Figure 3.141). Figures 3.141 – 3.145 demonstrate the extent of damage to the town of Altenahr, its businesses, infrastructure, residential housing and road and bridge structures. The only intact bridge within the town was the road bridge near the town center. Figure 3.141 shows online footage of the town center in the days after the flood. Streets were filled with cars, debris, and household objects.

Figure 3.140. Map showing town of Altenahr, highlighting damaged areas (yellow) and other landmarks

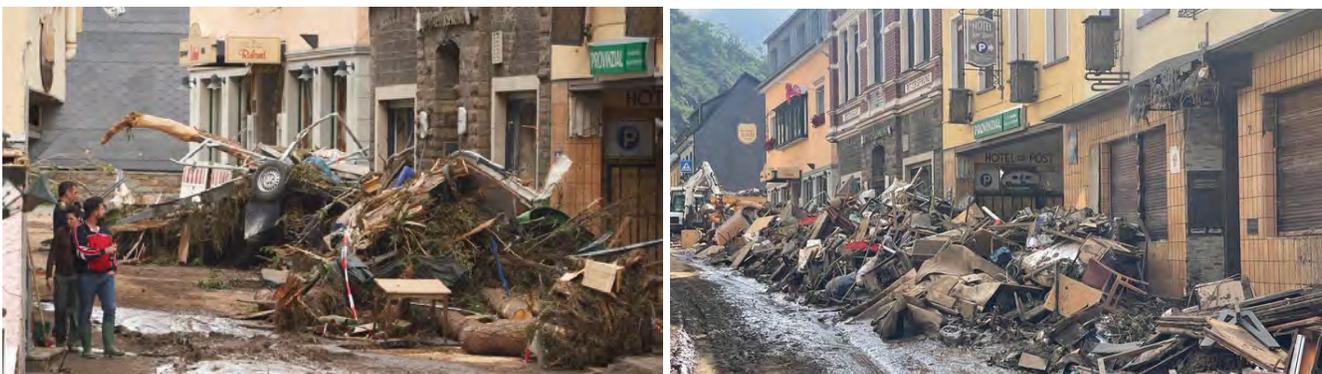
Figure 3.141. Photographs of the Main Road (Tunnelstrasse) in Altenahr shortly after the flood event. Source: <https://newsrnd.com/life/2021-07-20-altenahr-after-the-flood-disaster--%C2%BBi-expect-that-we-will-still-find-bodies%C2%AB.HkxNHLIVAd.html> (left) and <https://www1.wdr.de/nachrichten/unwetter-nrw-starkregen124.html> (right)

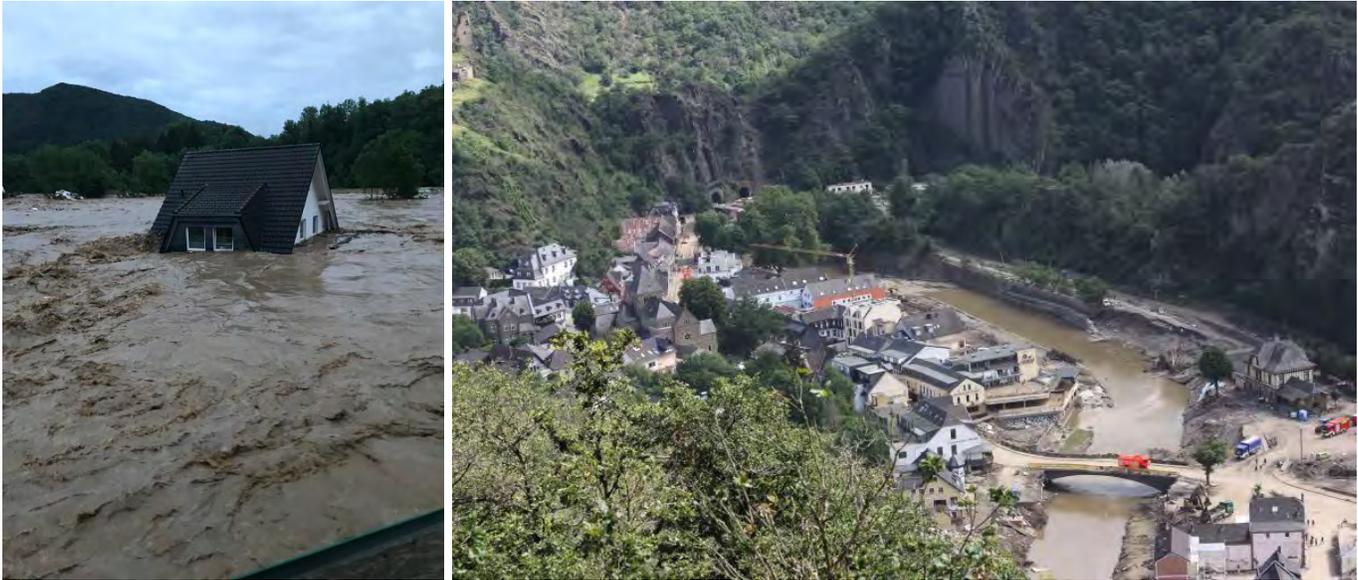
Figure 3.142 shows a photograph of a single family house near Seilbahnstrasse in Altenahr. This house was completely submerged and later on lifted up by the masses of water and transported away where it eventually

crashed into another house. This and many other eyewitness documentaries of survivors describing their night at room and the chimney of their houses can be found in the source link to this photograph and demonstrate the horrific circumstances most people endured fighting for their lives. Figure 3.142 right shows an aerial photograph after the waters receded and rescue teams arrived in Altenahr.

Figure 3.142. Left: residential home in Altenahr completely submerged (Source: <https://www.washingtonpost.com/world/2021/07/23/germany-floods-street-night/>), Right: Aerial photograph in Altenahr showing damage around the Ahr river (Source: unknown)

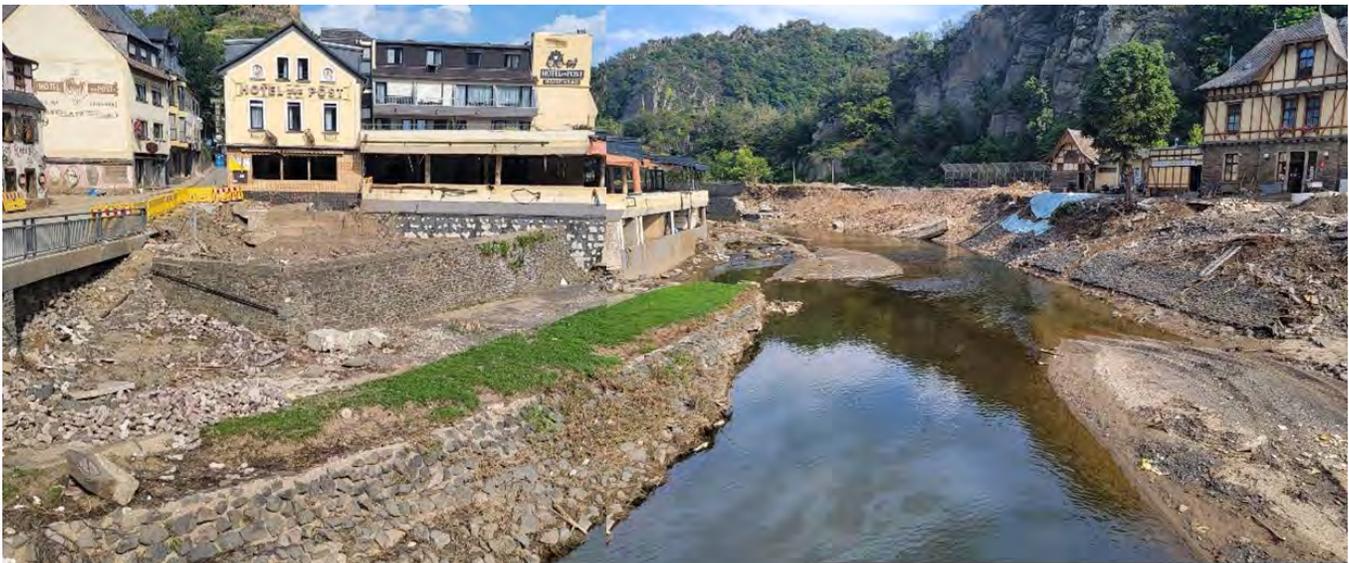
Figure 3.143. Photograph taken from the road bridge in the town center looking at the Ahr and the adjacent "Hotel zur Post"; embankment damage on both sides; Train station to the right (50.5165073, 6.98911282)

Figure 3.143 shows a photograph along the main street in Altenahr. To the left is the destroyed “Hotel zur Post” and to the right is the train station. Severe embankment damage is visible on both sides. News sources describe the water level to the rook of both buildings. Figure 3.144 top shows photos of the Altenahr train

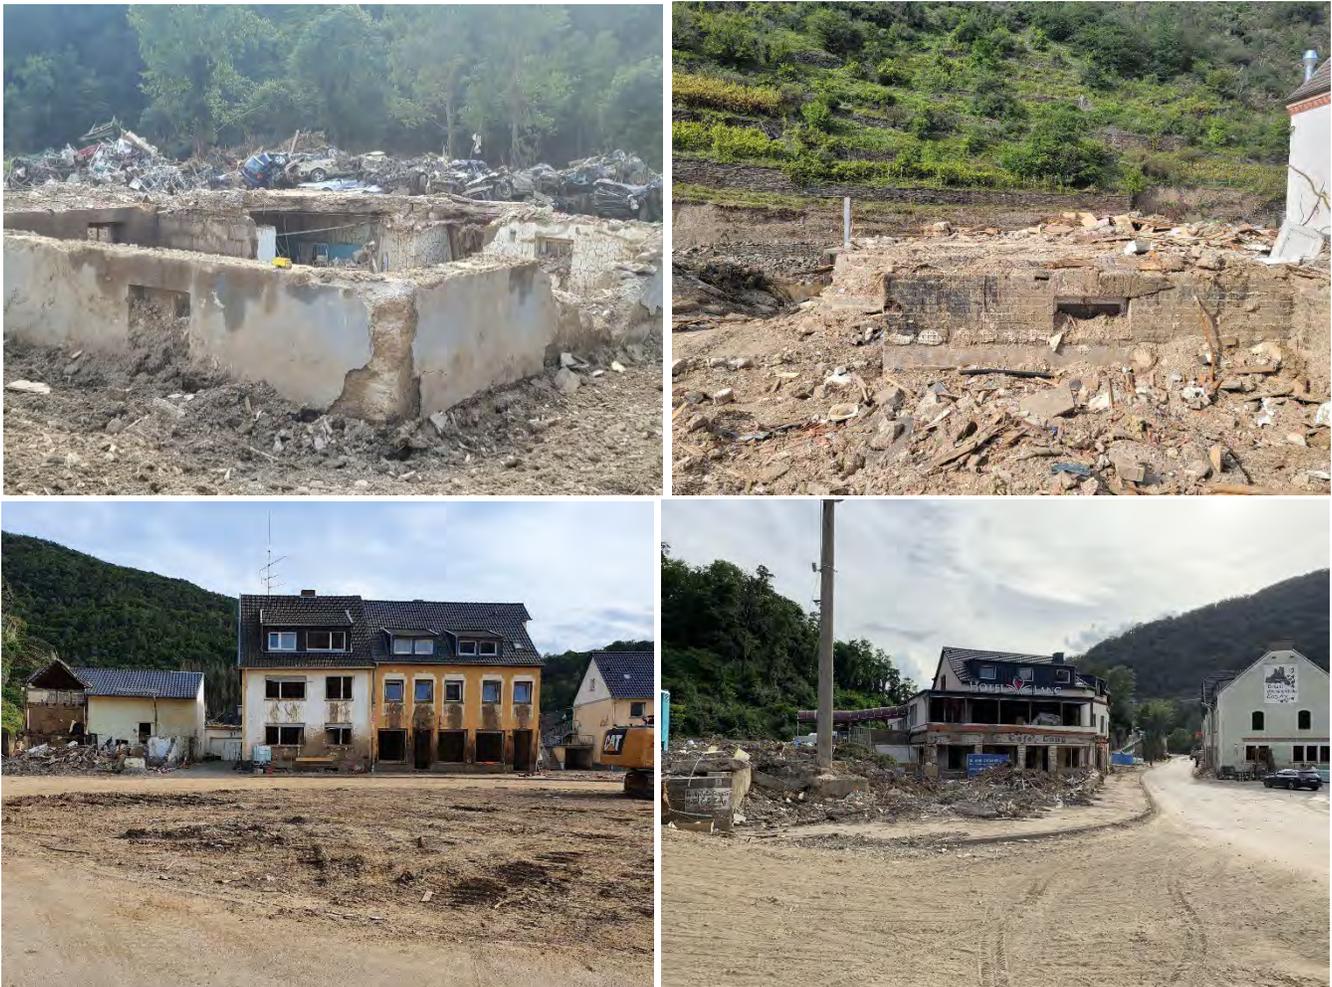
Figure 3.145. Photos of damage and destruction in the town of Altenahr by the GEER team; top: houses destroyed to the foundation level, bottom: houses flooded until roof level (50.51671855, 6.9903993)

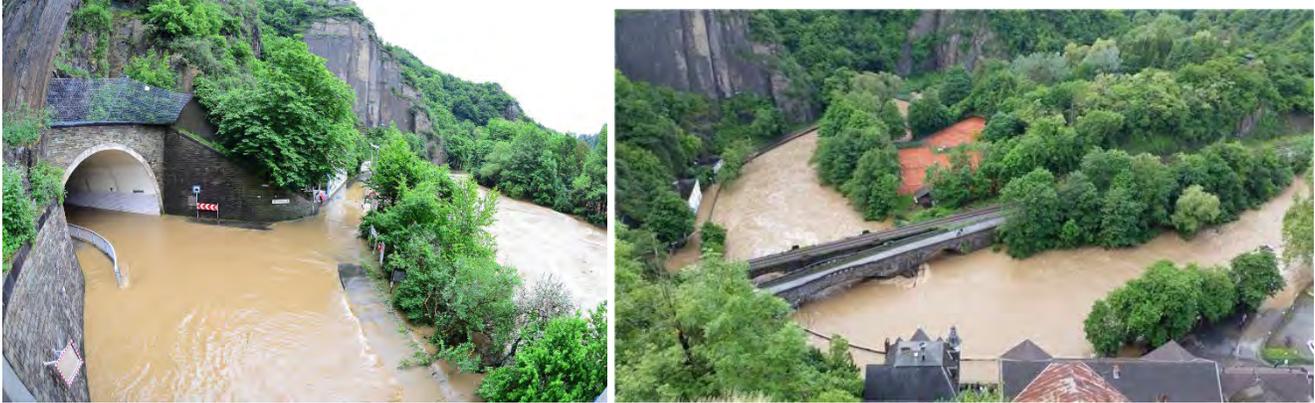
Figure 3.147 shows the tunnel entrance area in Altenahr during the 2016 flood event. The water levels were substantially lower, even though considerable amounts of water was flowing through the tunnel.

Figure 3.147. Tunnel entrance area during the 2016 Flood event (Source: https://www.rhein-zeitung.de/cms_media/module_img/3015/1507856_1_mrvwallpaper_crnthight129t8036231756384735502img.jpg)

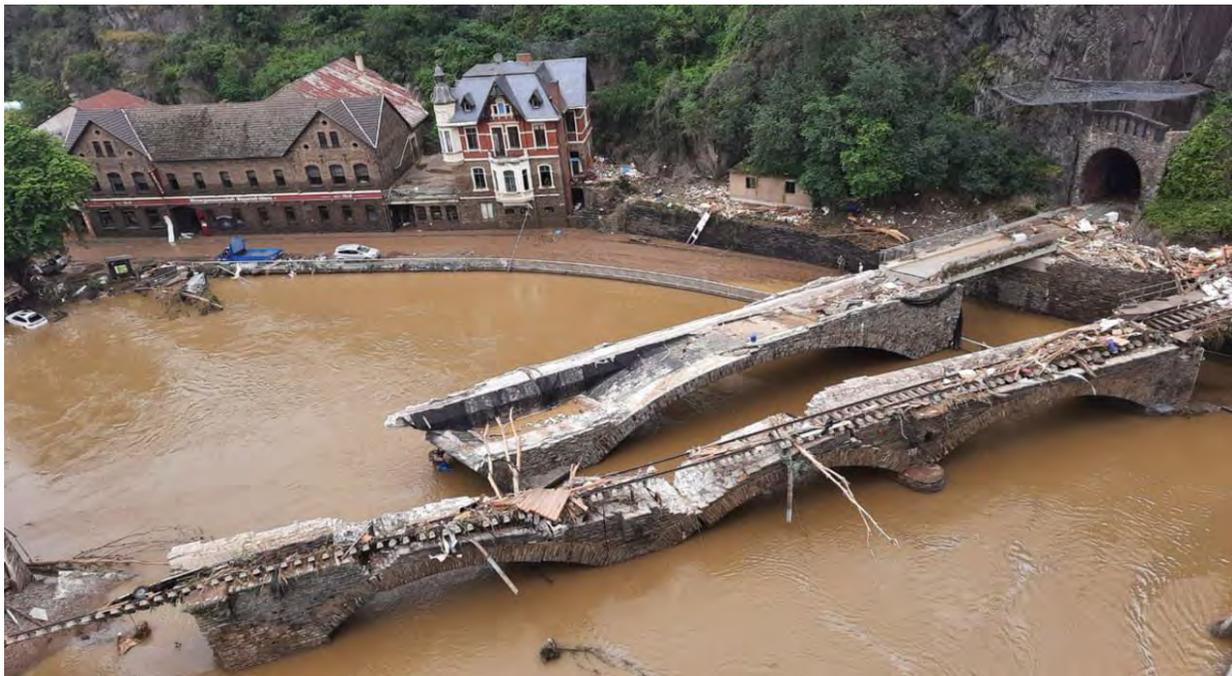
Since the Ahr travels through a narrow bend and extended turn (not visible in the Figure), the water level rise occurs very quickly and pushes water immediately through the tunnel. During the 2021 flood event the tunnel was nearly completely filled, the water level mark is within 1.0 to 1.5ft of the tunnel top (as observed by the team visiting the inside of the tunnel). Figures 3.148 – 3.149 show the tunnel entrance area along with the rail and bicycle/pedestrian bridge shortly after the night of the flood.

Figure 3.148. Aerial view of tunnel entrance in July 2021, shortly after the flood night (photo: Polizei Thüringen, accessed at <https://www.mdr.de/nachrichten/deutschland/panorama/hochwasser-katastrophe-milliarden-schaden-bahn-strasse-100.html>)

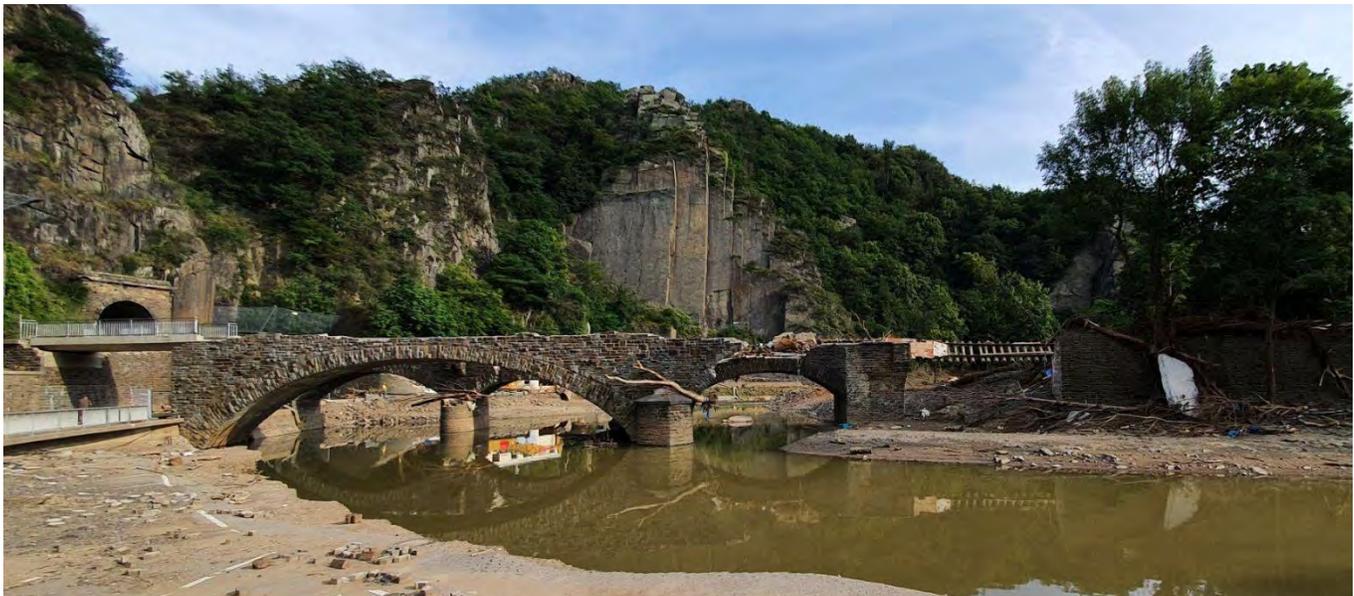
Even though much of the debris, such as cars and large pieces of wood were cleaned up, the area around the tunnel was still declared a high-risk area, with access to the public prohibited. Both bridges (rail and pedestrian) suffered severe and irreparable damage. While the middle piers of both bridges remained standing, the arches were largely destroyed and substantial erosion around the abutment areas left rail tracks tangling in the air (see Figure 3.150 and Figure 3.151).

Figure 3.150. Photograph of remainder of the pedestrian bridge at tunnel entrance (front) and the severely damaged rail bridge in the back (50.5164851, 6.99482486)

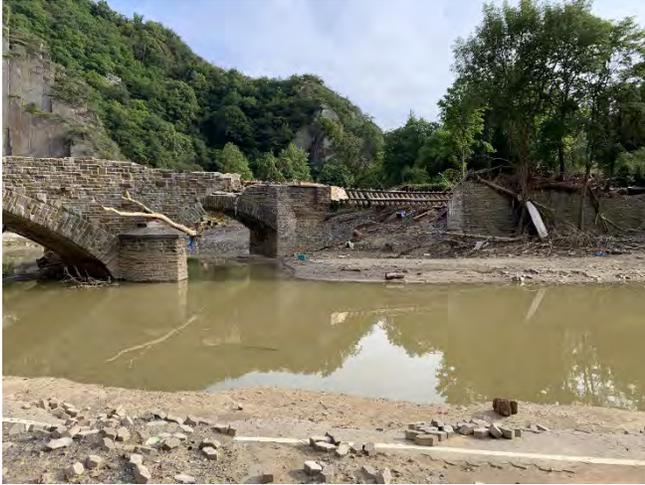
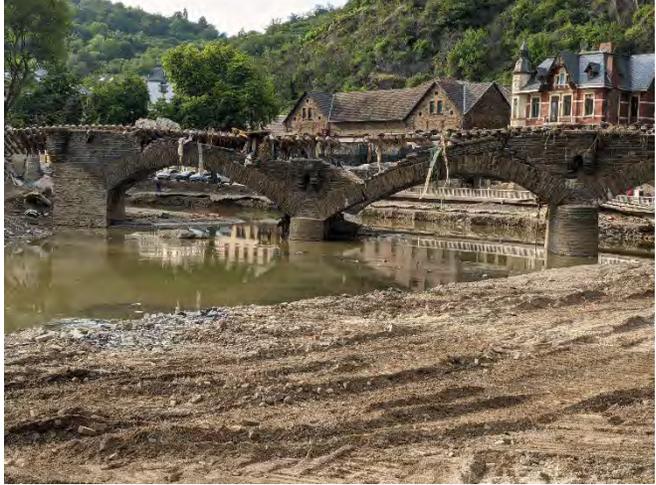
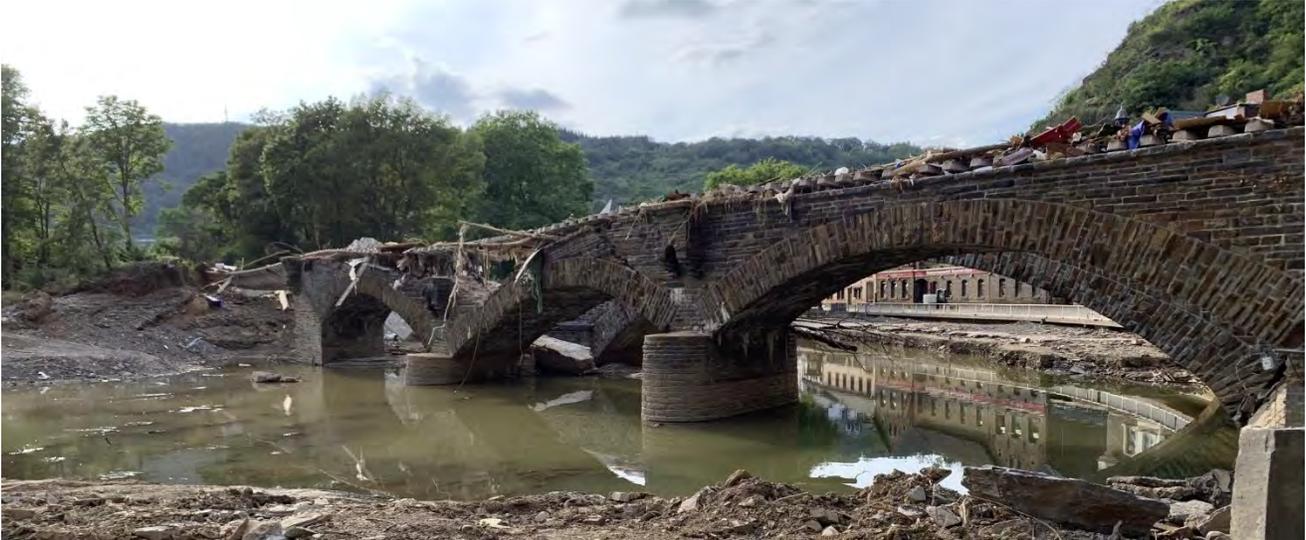
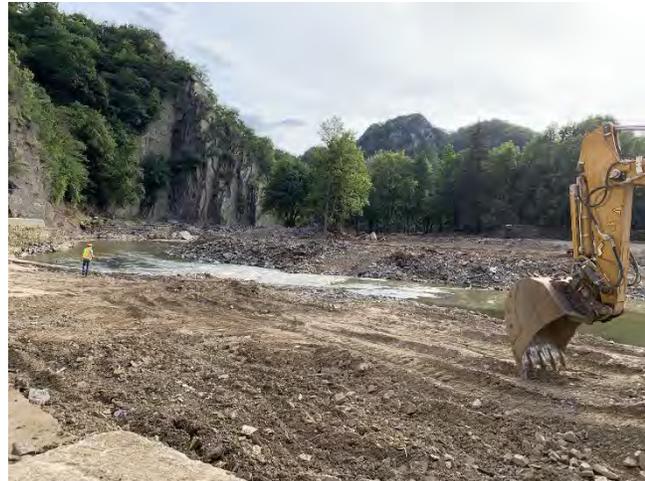
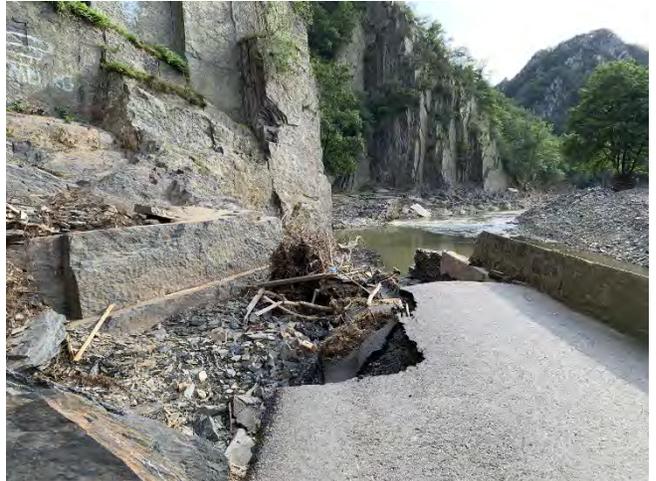
Figure 3.151 shows several additional photographs taken of the double bridge, showing the damage to the bridge deck and the wash out of the abutment area and the infill in the arches (Figure 3.151 center). The photos at the bottom show the damage to the street adjacent to the Ahr past the tunnel entrance.

Figure 3.151. Damage to old rail bridge near tunnel entrance and areas surrounding the bridge damage. Photos by GEER team in August 2021(50.5164851, 6.99482486).

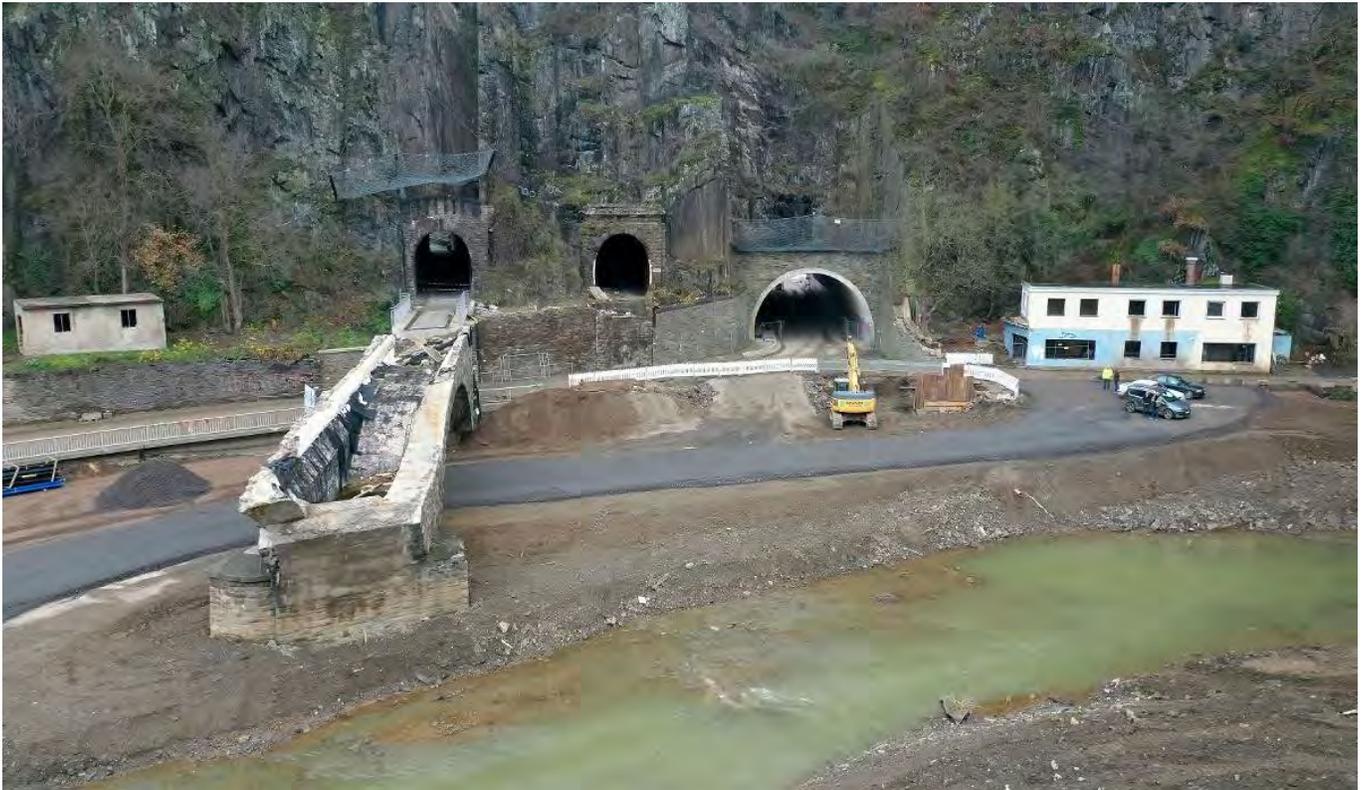
Figure 3.152. Tunnel Entrance, October 2021. Only one bridge arch remains, reconstruction of road access, one bridge was completely demolished. Source: unknown, GPS Coordinates: 50.51637961742962, 6.995167798855734.

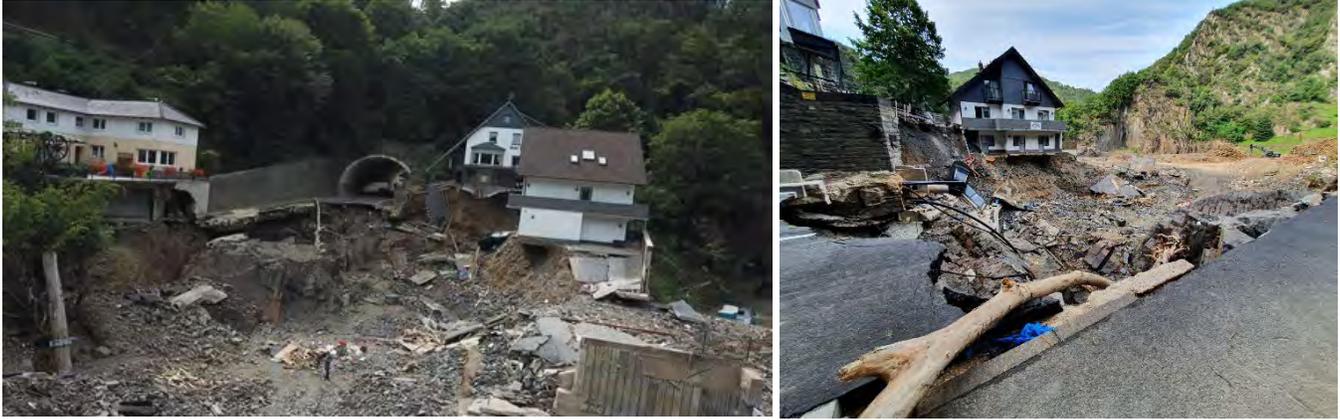
Figure 3.154 shows a Google Earth Image (March 2020) and a Google Street View of the tunnel exit (May 2021), followed by a photograph of the tunnel exit during the 100-year flood in 2016 (Fig. 3.155). Figure 3.156 shows the tunnel exit and surrounding area on August 13, 2021, approximately four weeks after the flood.

Figure 3.156. Destroyed Tunnelstrasse @ the tunnel exit following the 2021 flood (50.51631664, 6.9968335)

The road damage and abrupt cut-off of the pavement is visible from the photographs taken inside the tunnel (Figures 3.156 right, and Figure 3.158 left) and at the tunnel exit edge (Figure 3.157, right). The cut-off was approximately 1-2 meters within the immediate vicinity of the tunnel exit and approximately 3-5 meters at distance (Figure 3.158). Figure 3.158 also shows the aerial extent of the damage surrounding the tunnel exit. It is estimated that the entire area shown in Figures 3.158 and 3.159 was submerged with water. Substantial erosion occurred underneath the street and near the residential housing adjacent to the tunnel. At the time of the teams' visit, the underlying rock appeared eroded and fractured near the surface as result of water pressure and flood forces (Figures 3.158 and 3.159).

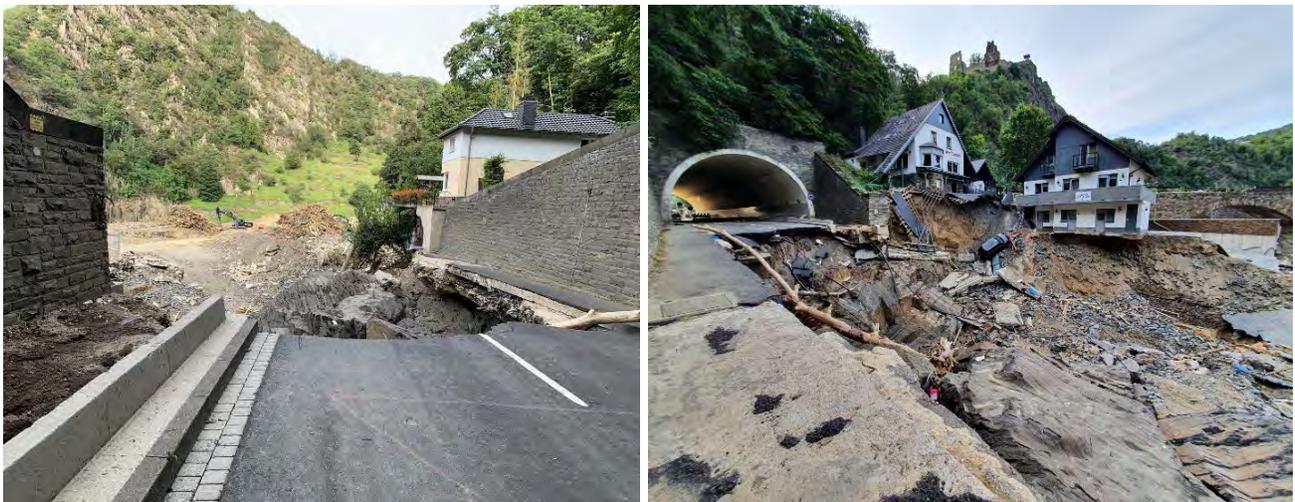
Figure 3.158. Cut-off of Tunnelstrasse at the Altenahr tunnel exit. View from inside the tunnel (left) and immediately outside the tunnel (right), (50.51631664, 6.9968335).

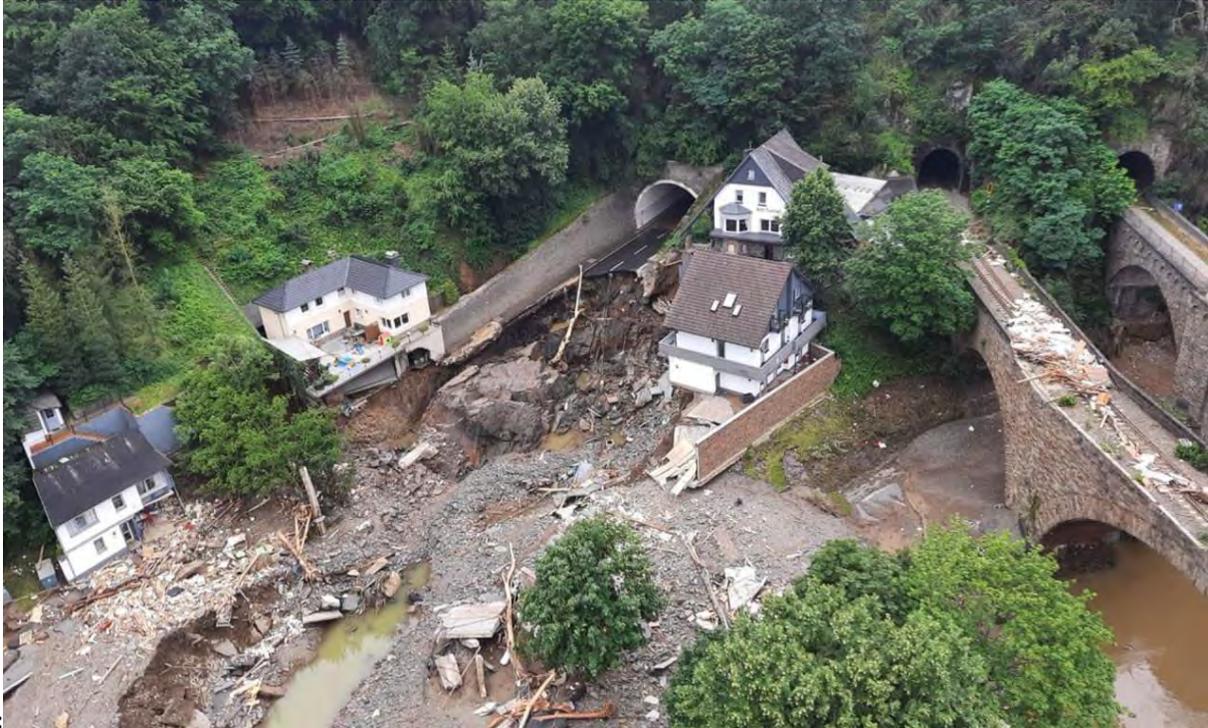
Figure 3.159. Aerial view of tunnel exit one week after flood, source:Skyscrapercity.com (access not available anymore)

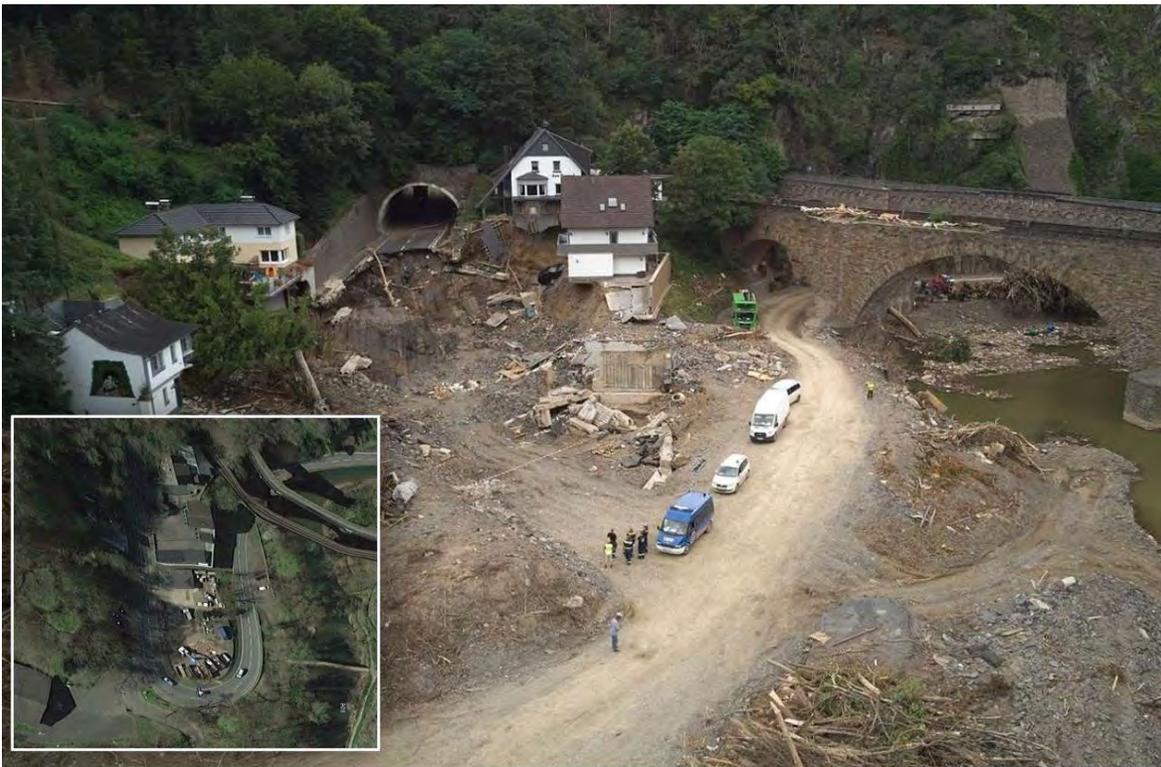
Figure 3.160. Aerial view of tunnel exit, with inlet figure showing pre-flood road alignment, photo: <https://www.stuttgarter-zeitung.de/inhalt.vor-und-nach-der-flut-beeindruckendes-video-zeigt-die-zerstoerung-im-ahrtael.c6922fcb-b67a-41fe-bd62-b3748db25fec.html>

Two of the adjacent residential structures to the right side of the tunnel exit (Figure 3.160) remained standing but were heavily scoured at the foundation level. Both structures were demolished after the flood. Immediately below the right-hand side buildings, another building was destroyed and washed away by the flood (Figure 3.161).

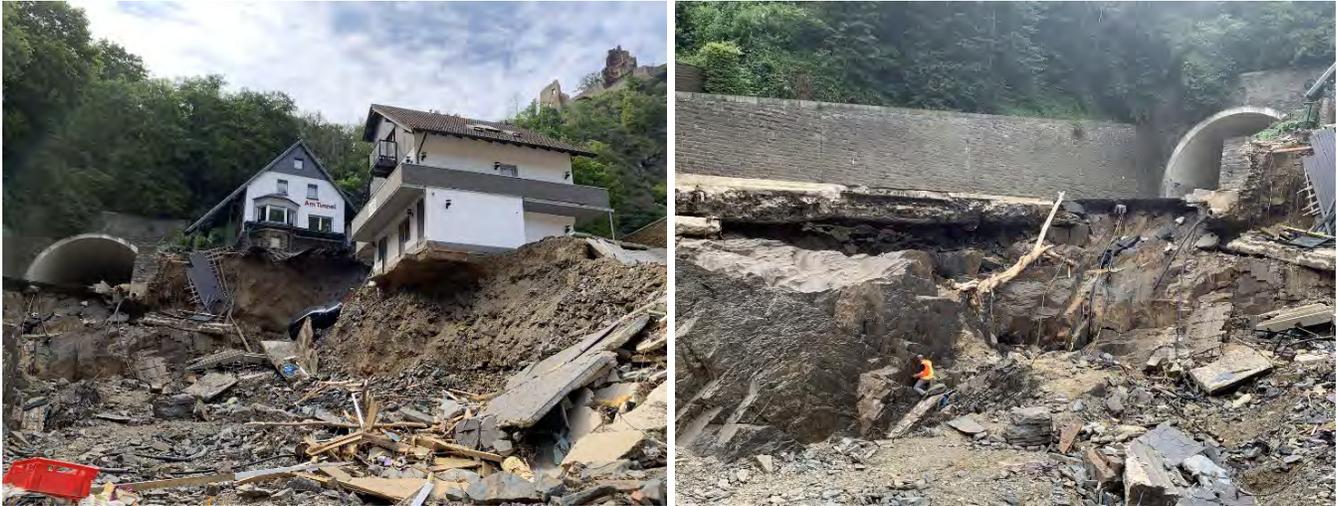
Figure 3.161. Left: extreme scour and erosion of the foundations of the residential buildings adjacent to the tunnel exit; right: washed out soil and rock just below the tunnel exit, causing a deep cut of 3+ meters, (50.5165261, 6.9975355)

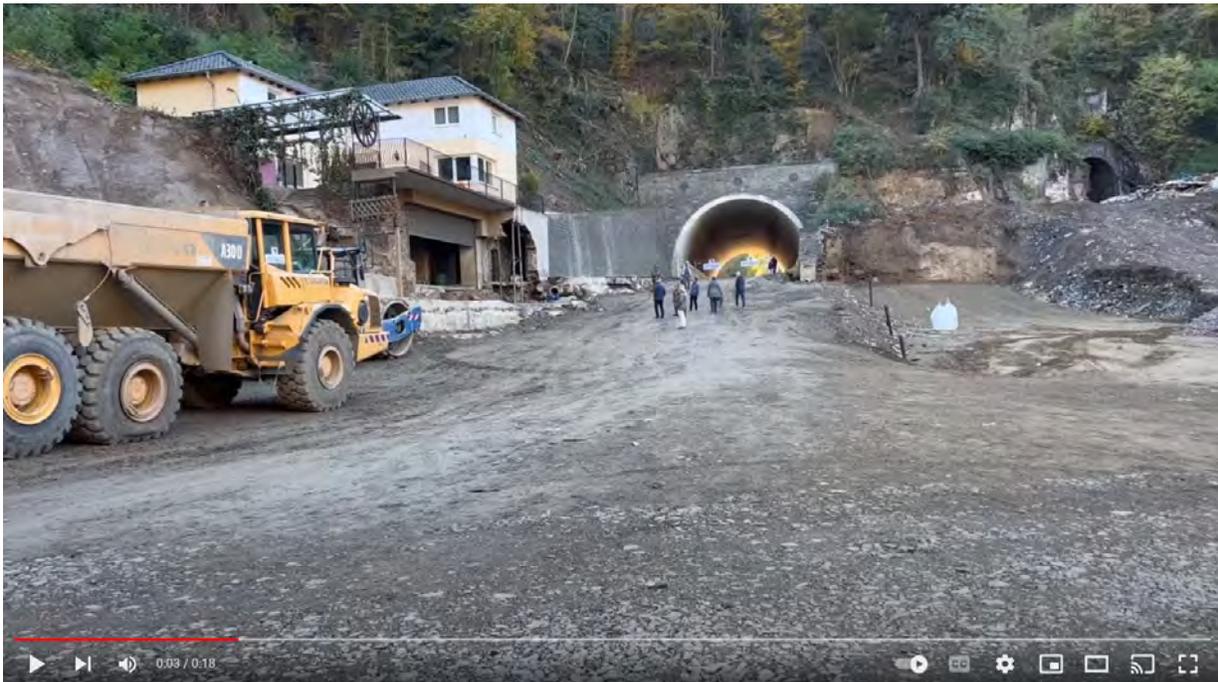
Figure 3.162 shows the tunnel exit in October 2021. The footage was obtained through online video documentation. Except for one building to the left, all residential structures (or their remains) have been removed.

Figure 3.162. Tunnel Exit on October 24th, 2021. Screenshot obtained from https://www.youtube.com/watch?v=ol4SYAb_Olc

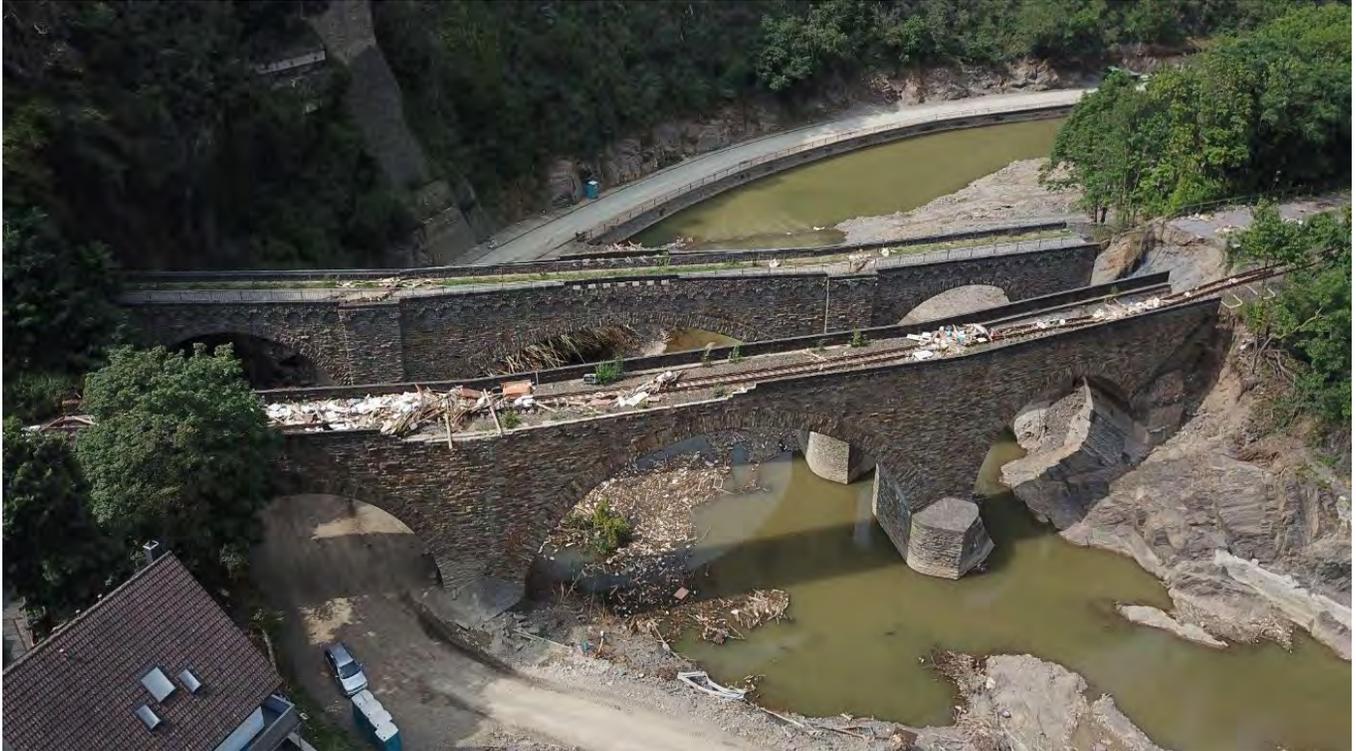
Figure 3.164. Aerial photograph of historic rail and pedestrian bridge at tunnel exit (50.5169260, 6.9970019)
