Geotechnical Reconnaissance of the 2021 Western European Floods

Flood Event: July 14-15, 2021

Flood locations: Germany, Netherlands, Belgium, and Luxembourg

Reconnaissance Visit: August 9-18, 2021

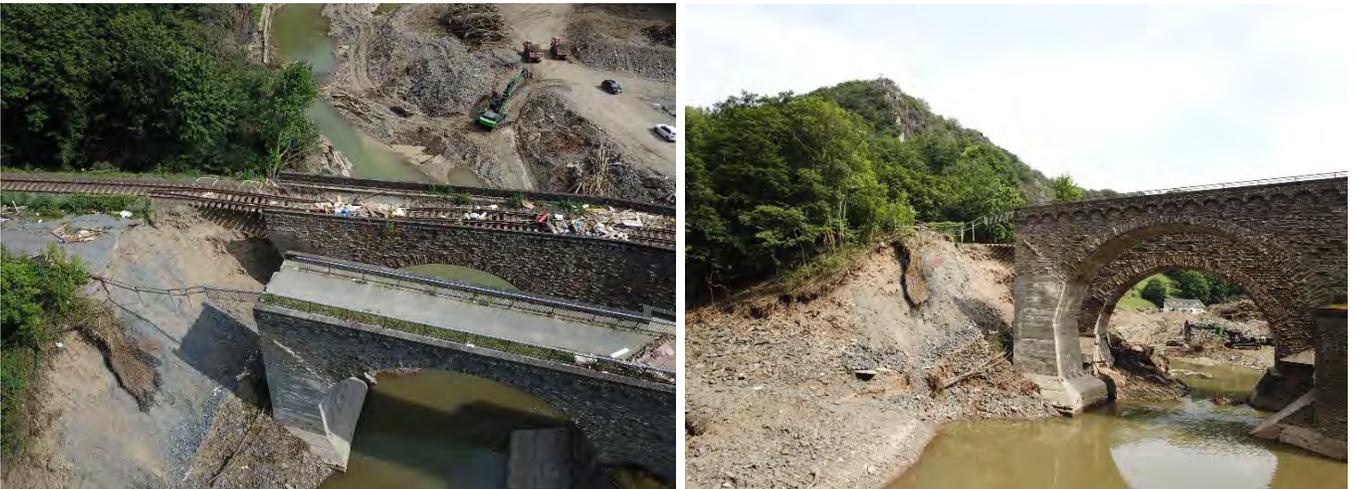
Figure 3.165. Major erosion around bridge abutment areas (50.5169260, 6.9970019).

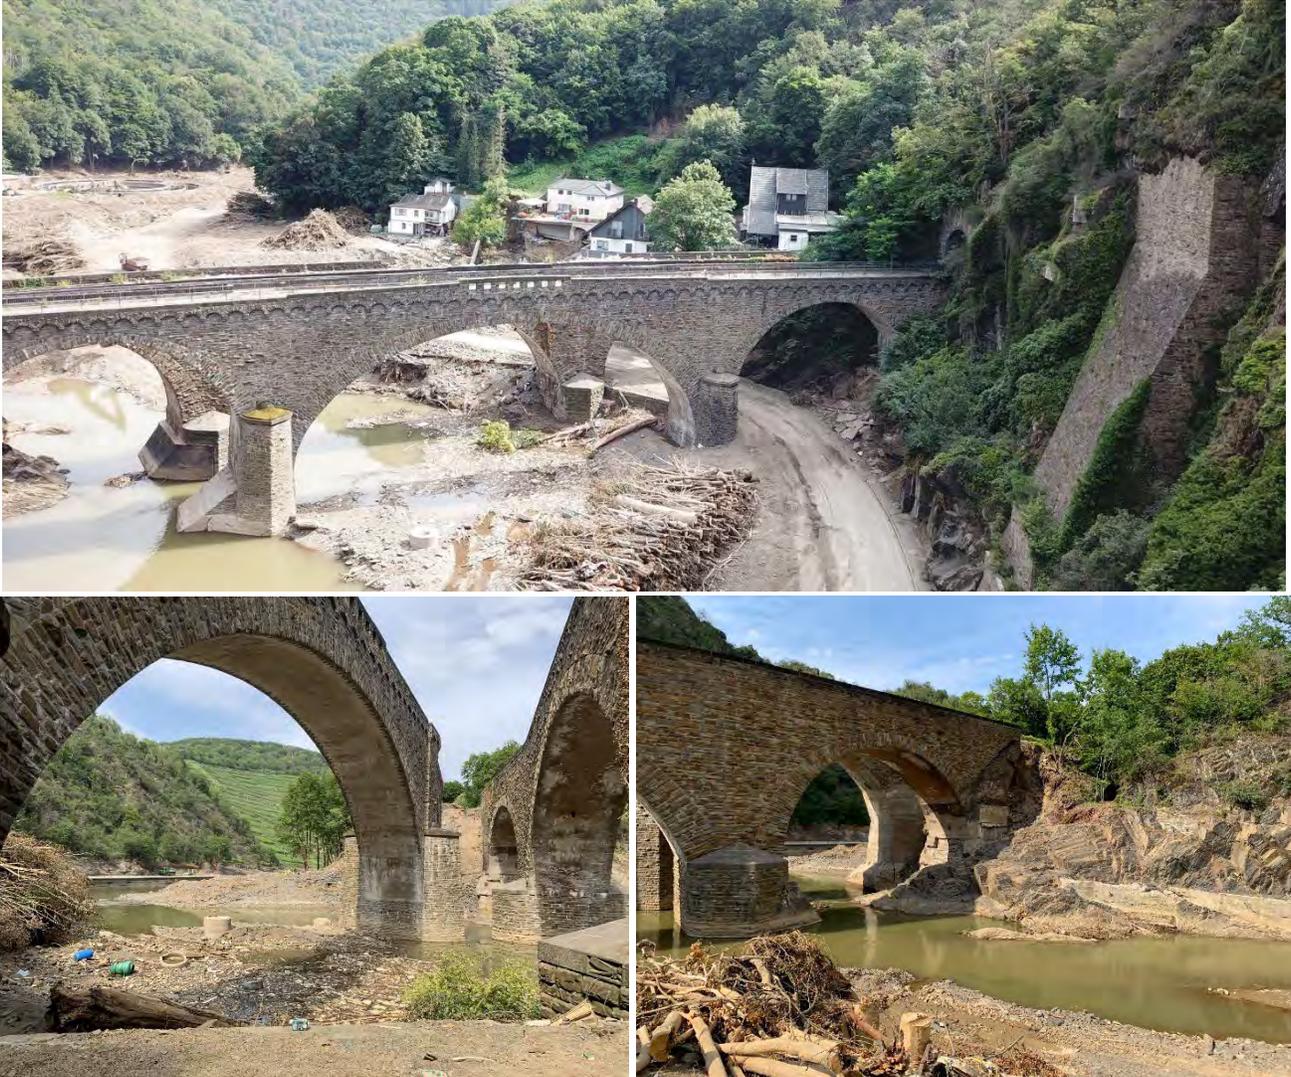
Figure 3.166. Photographs of “double bridge”, showing mud fields and tree clean-up work (top photo) as well as erosion around bridge abutment and along the riverbanks (bottom photos), (50.5169260, 6.9970019).

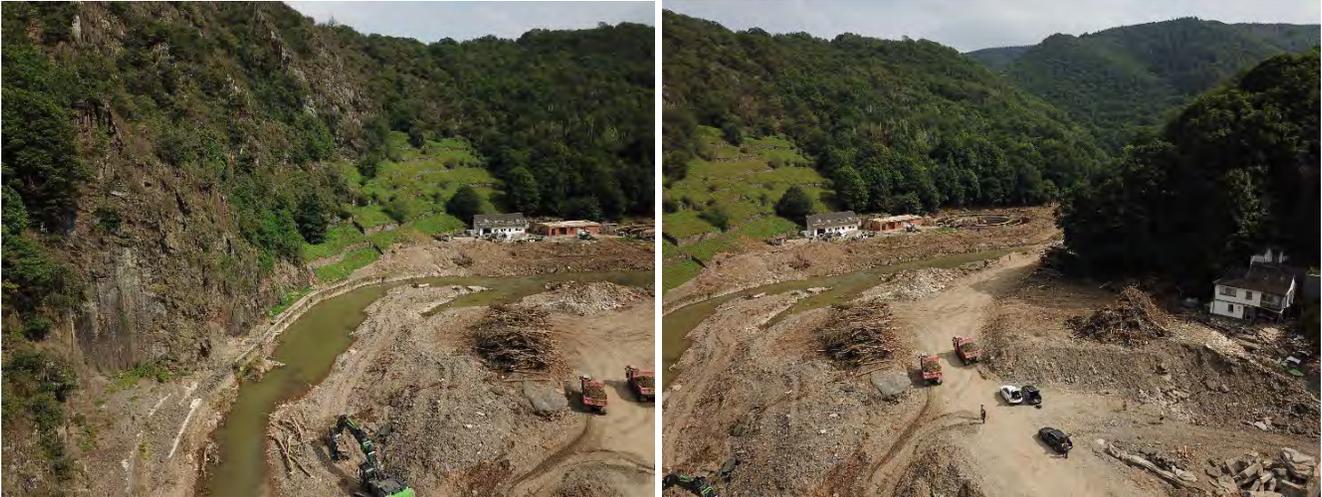
The wastewater plant adjacent to the tunnel exit was also severely damaged and still remains closed six months after the flood. The plant was located where water from the Ahr river (which flooded the narrow Ahr-bend (“Ahrschleife”) and the water flowing through the tunnel intersected. Figure 3.167 shows photos of the area around the treatment plant.

Figure 3.167. Aerial photograph of destroyed river and floodplains, as well as damaged wastewater treatment plant (50.51617525, 6.9989579).

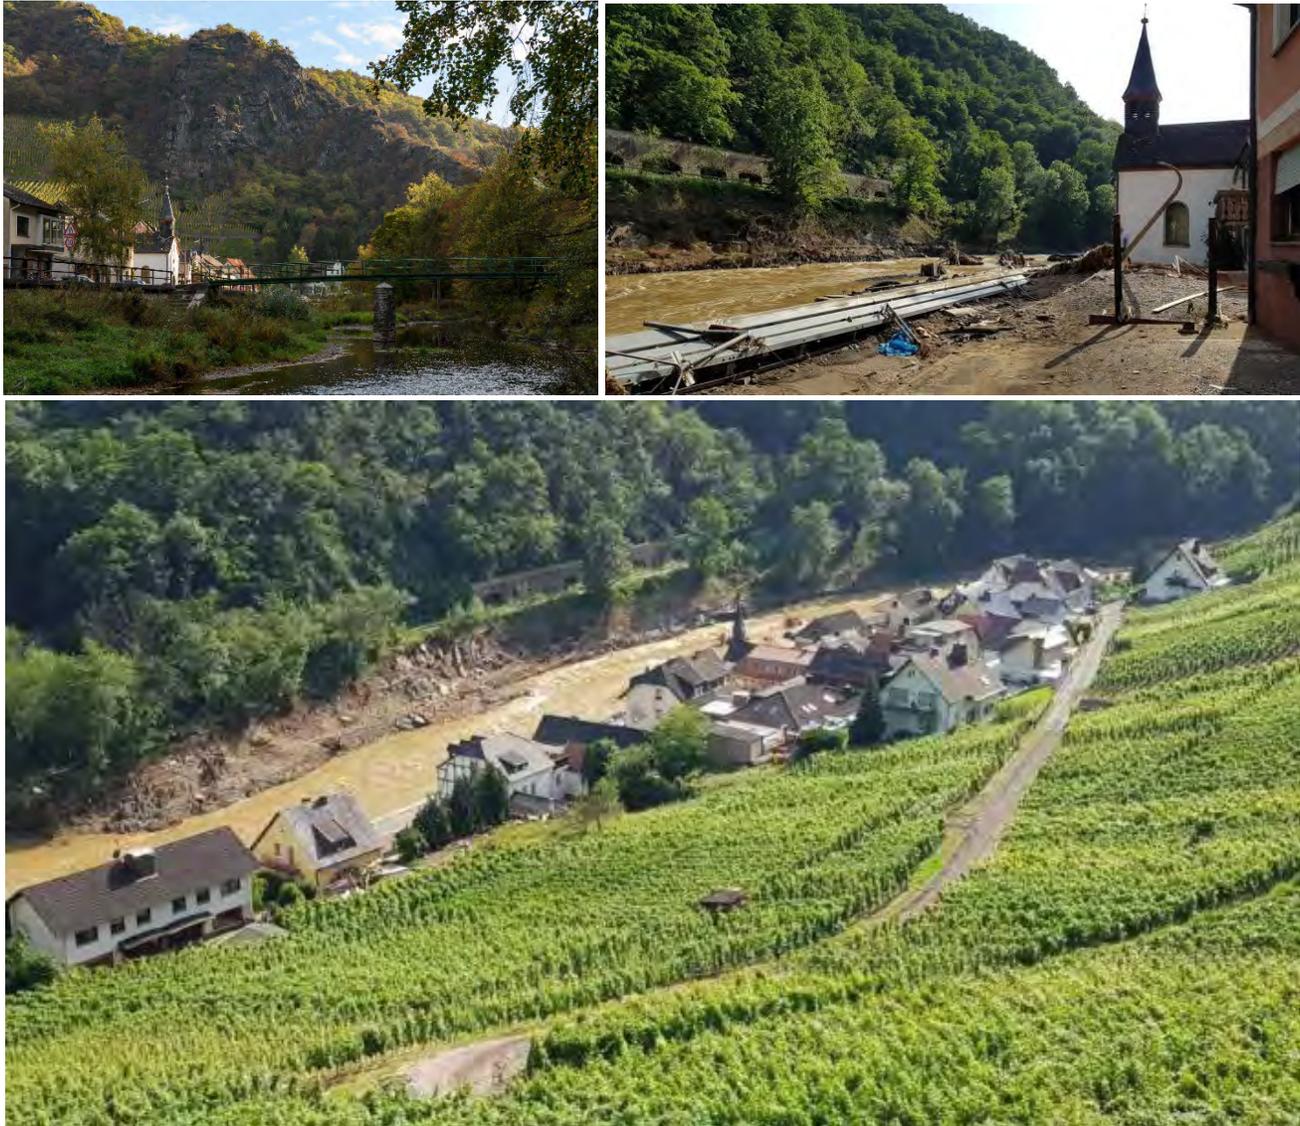
Along the route from the Altenahr Tunnel to Reimerzhoven, massive amounts of debris were deposited along the riverbanks and within the embankment areas. Both bridges in Reimerzhoven were destroyed. The bridge shown in Figure 3.169 (top left) from upstream direction was completely washed away. Figure 3.169 top right shows the location of where the bridge was once standing. Figure 3.169 bottom shows the substantial amount of erosion along the riverbanks.

Figure 3.169. Location of pre-flood pedestrian bridge with aerial view of Reimerzhoven. Top left: bridge before flood (credit: Heinz Grates, Source: https://www.aw-wiki.de/index.php/Ahrbr%C3%BCcken_im_Kreis_Ahrweiler), Top right: flood damage and missing bridge, Bottom: global photo of area. Photo source: <https://www.inforadio.de/dossier/2021/silvester/beitraege/flutkatastrophe-ahr-ahrtal-nordrhein-westfalen-rheinland-pfalz-lonijosten-reimerzhoven.html>

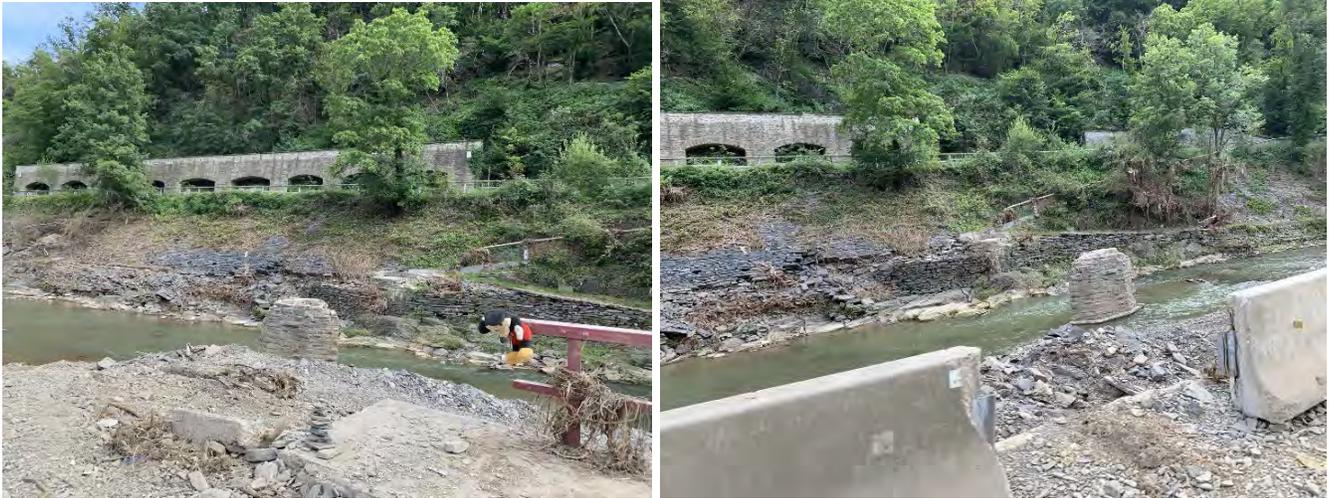
Figure 3.170 shows the remains of the bridge depicted in Figure 3.169. Except for a middle pier and some abutment wall leftovers, little evidence indicates the once existing pedestrian bridge. Figure 3.170 shows debris and destruction around the Ahr river and its limited flood plains between Reimerzhofen and Laach. The Steep terrain on both sides of the Ahr river yielded high water levels as shown in Figures 3.171. Visible dirt lines indicate water elevation to be well in or above the 2nd story of the adjacent residential building. For typical German construction (story heights ~2.30m) this suggests a water elevation in the bottom photograph of Figure 3.172 of nearly 5.0 meters.

Figure 3.170. Remaining middle pier of pedestrian bridge in Reimerzhoven, and soil erosion near embankment (50.5195072, 7.004132)

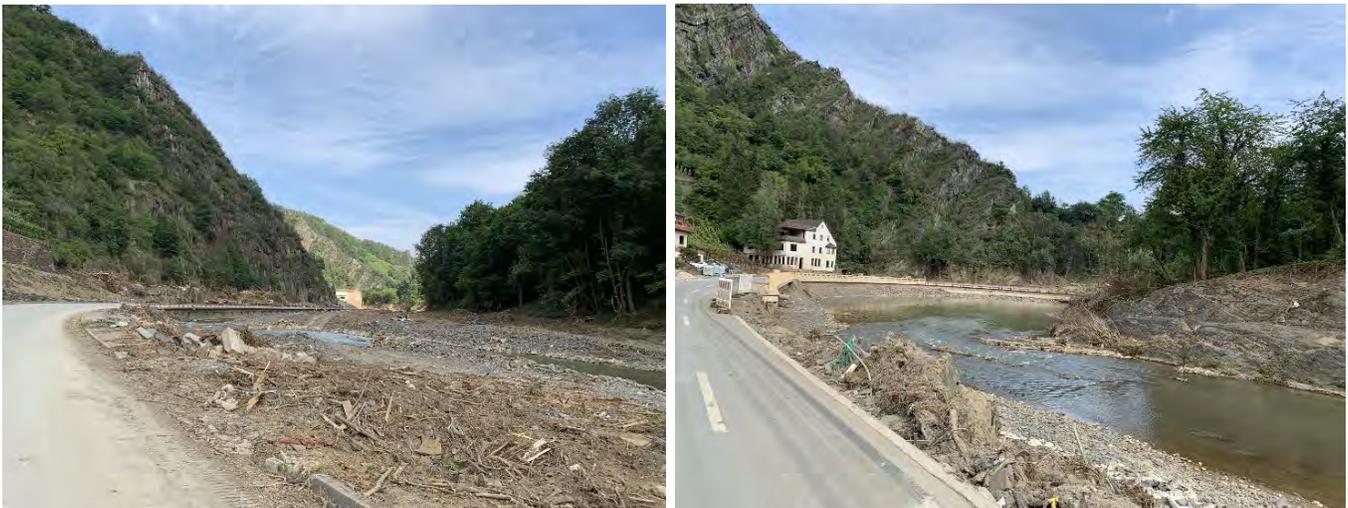
Figure 3.171. Debris and deposits along the river, after the first major clean up. Photos take on the road between Reimerzhoven and Laach (50.5199710, 7.0070852)

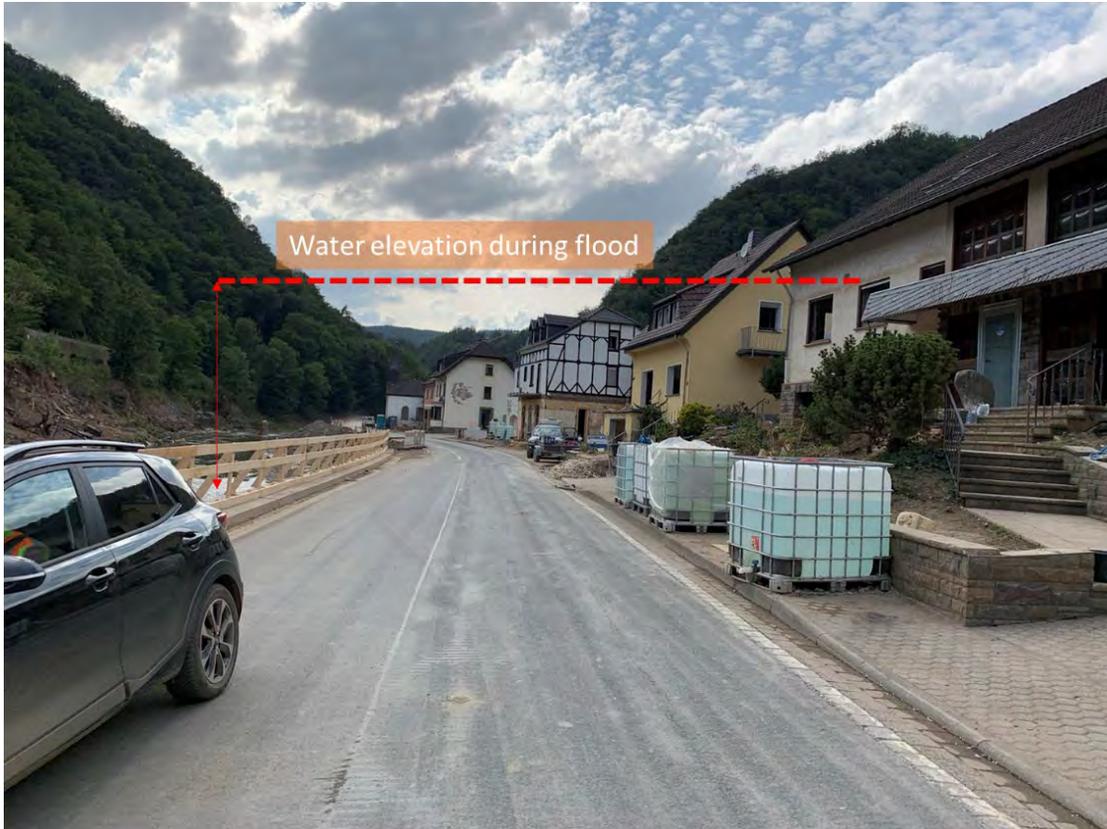
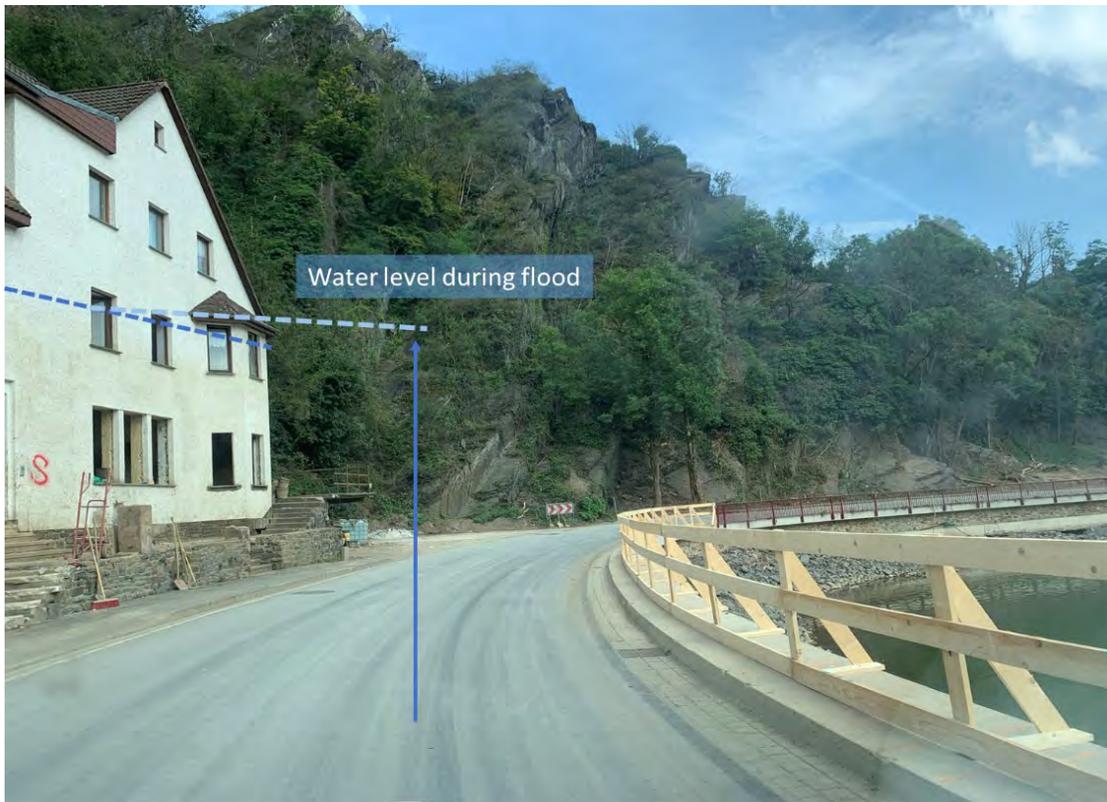
Figure 3.172. Water elevation in Reimerzhoven, based on visible watermarks on buildings (50.5201175, 7.006573)

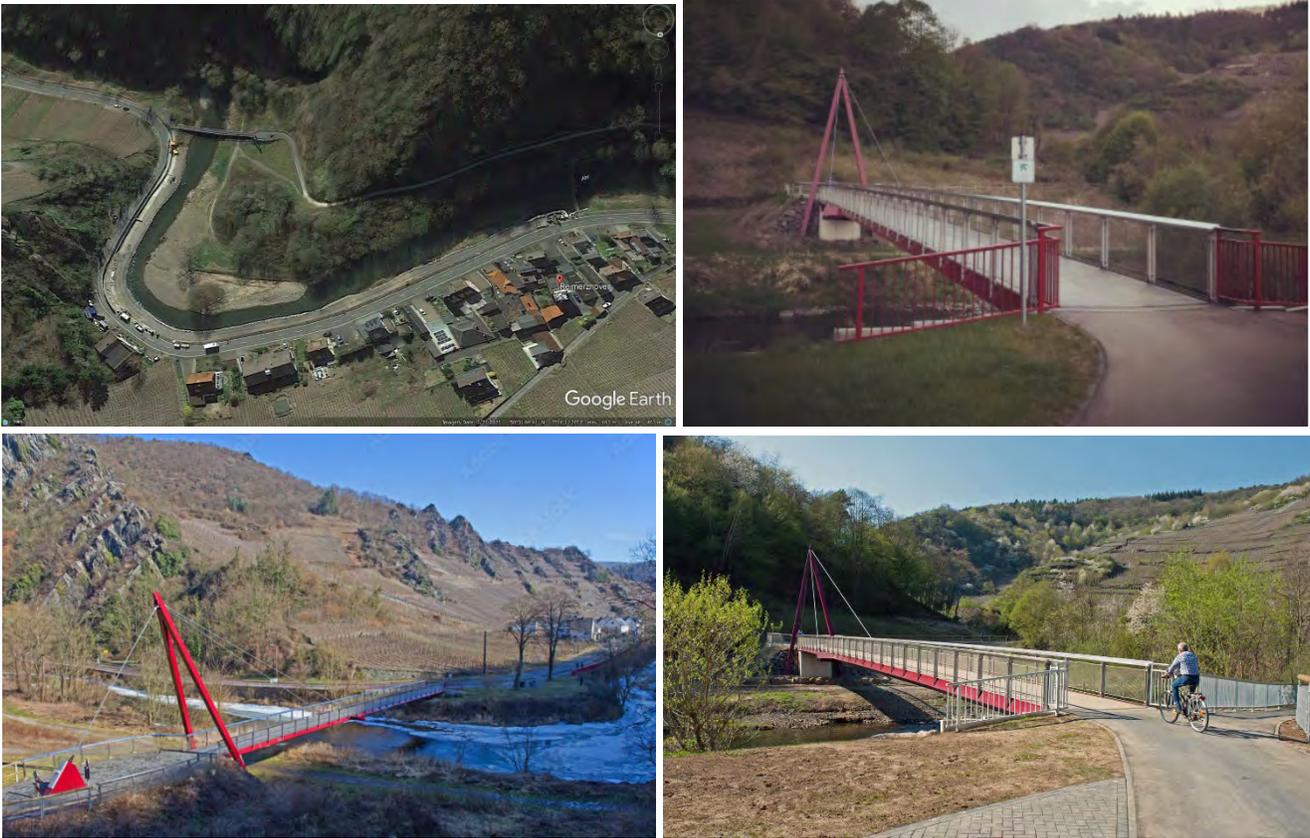
Figure 3.173 shows the second bridge, a bicycle bridge in Reimerzhoven. This bridge is a single span, cable stayed bicycle bridge with steel girders and steel deck. Photos in Figure 3.173 show the location of the bridge (top left), and photographs taken prior to the flood event.

Figure 3.173. Location of damaged bicycle bridge (top left) and pre-flood pictures of bridge, Source:

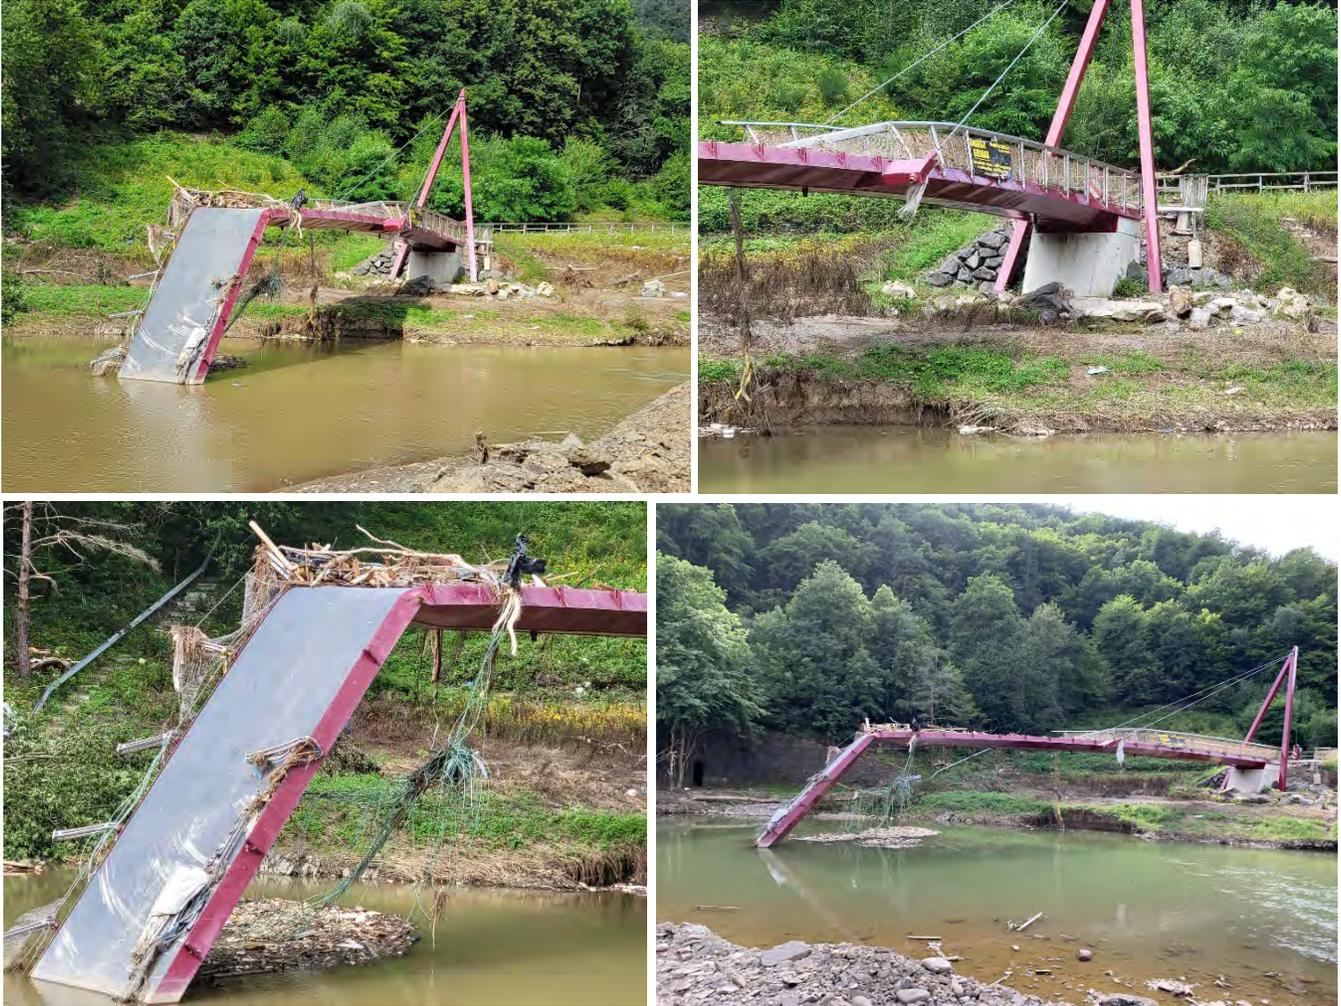
Figure 3.174 shows the bicycle bridge on August 13, 2021. The bridge was clearly damaged, the bridge deck was still connected to its abutment structure (this was a fixed structural connection due to the single, cable span mechanism), but the bridge deck was rotated in downstream direction. The bridge deck was bent down into the river at approximately midspan.

Figure 3.174. Bridge damage of the bicycle bridge in Reimerzhoven documented by the GEER team (50.5188435, 7.00714039)

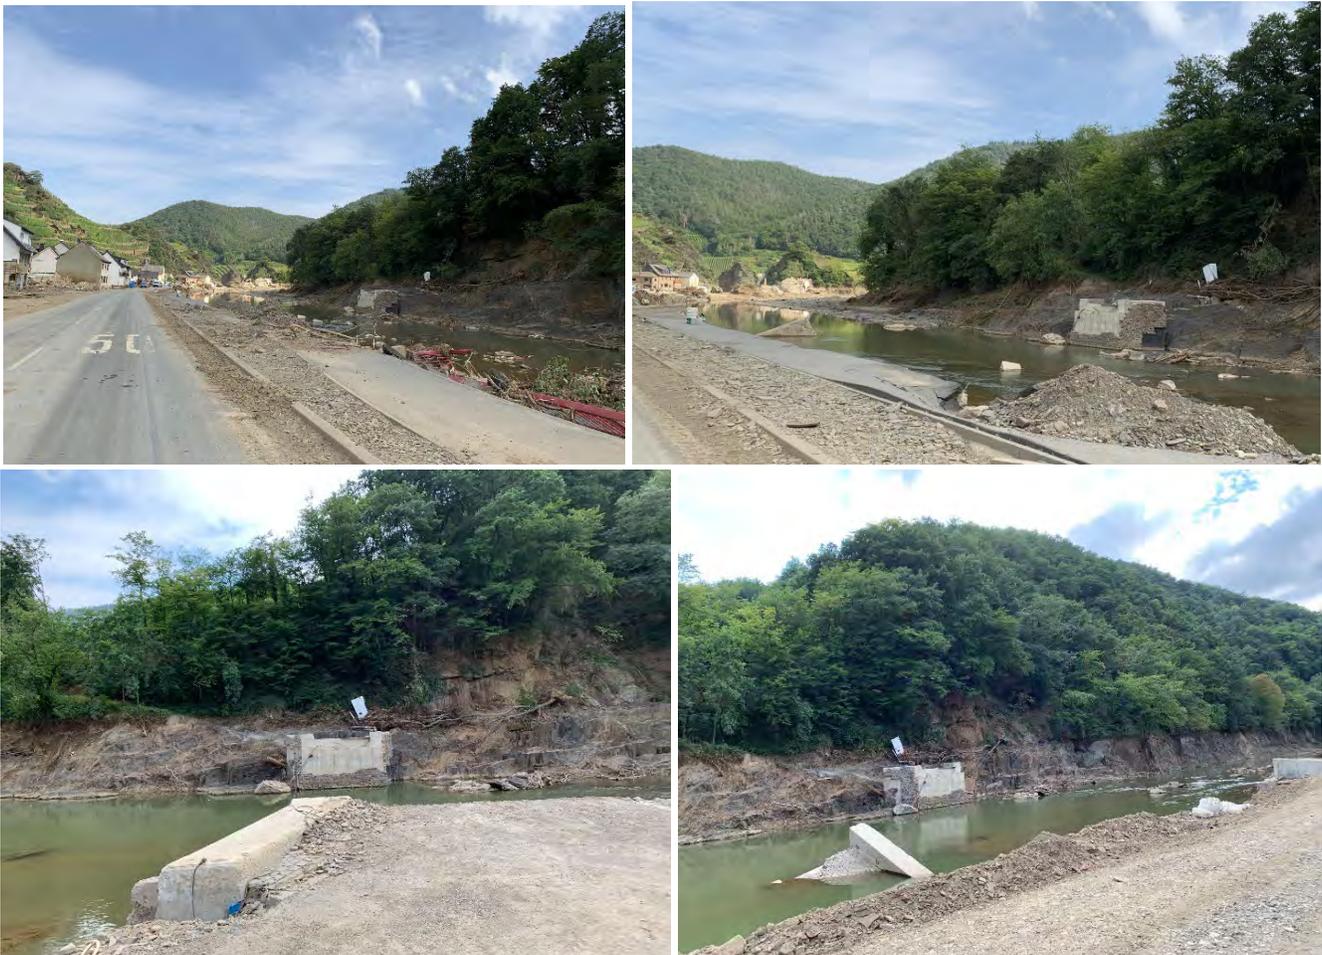
The remaining components of the bridge in Laach are shown in Figure 3.176. Figure 3.176 (bottom right) also shows the cut off and erosion, exposing the steep rock slopes adjacent to the river.

Figure 3.176. Remaining abutment structures of the pedestrian timber bridge Laach at the time of the team's visit (50.517824, 7.00952)

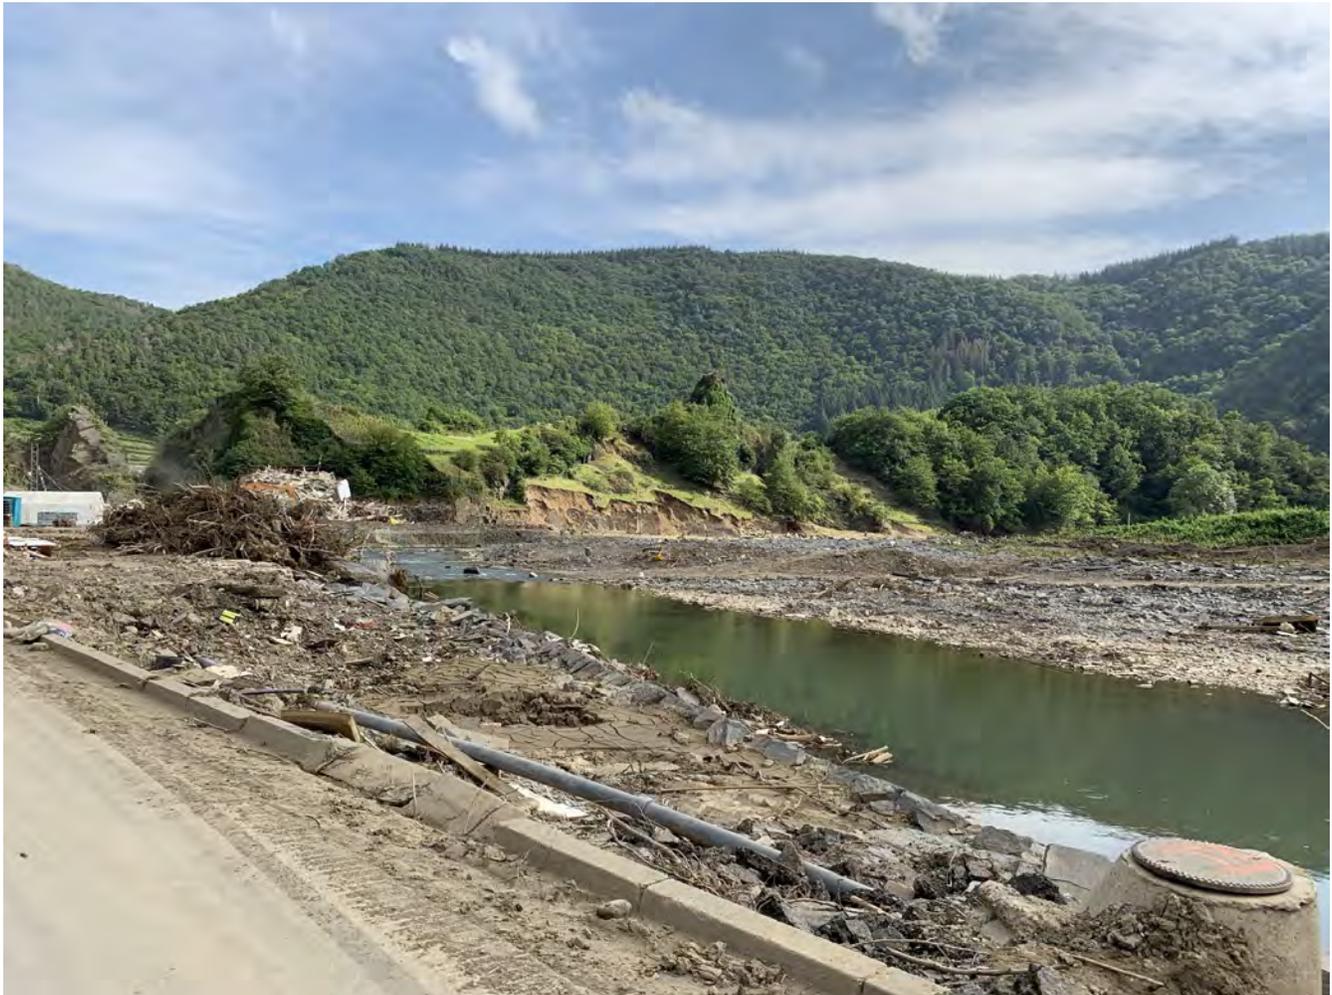
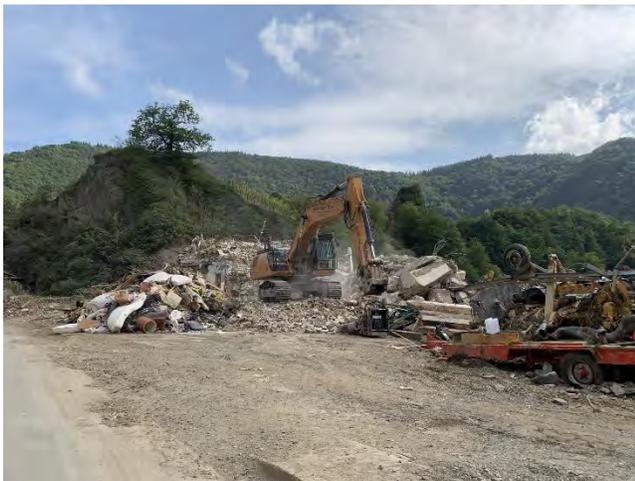
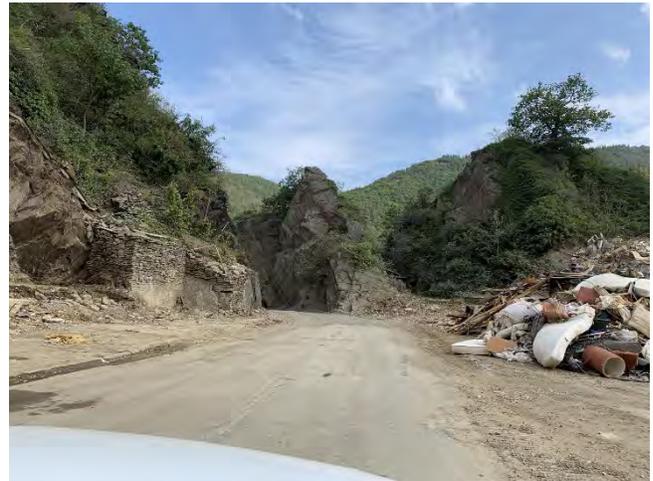
Figure 3.177 shows the devastation around the river between Laach and Mayschoss. Steep cuts are visible along the slopes adjacent to the river.

Figure 3.177. Damage and devastation along the Ahr river between Laach and Mayschoss. Thousands of tons of debris and trash are still to be removed (bottom photo) (50.5165985, 7.01311363)

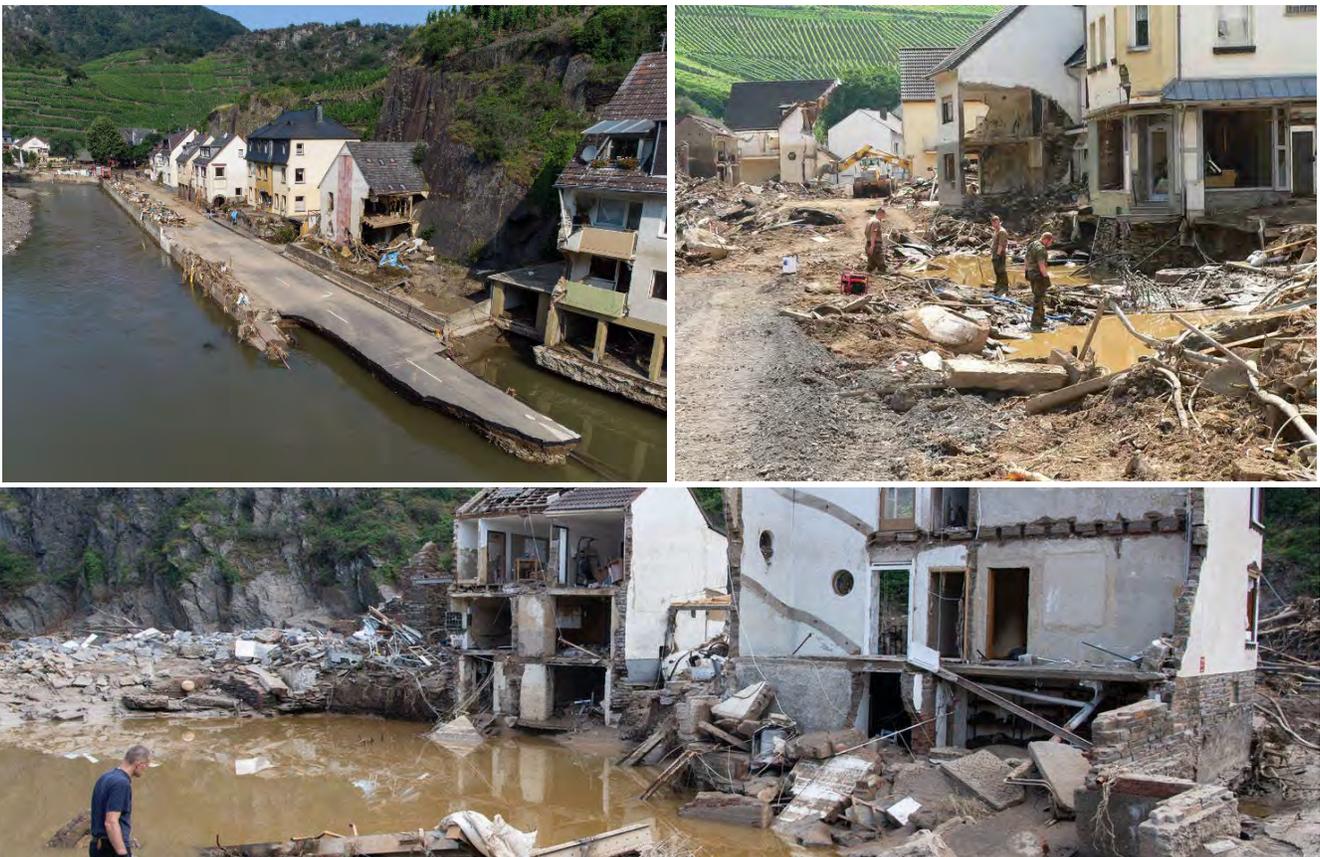
According to the municipality, around 158 of some 351 buildings in Mayschoß and Laach were damaged or completely destroyed. The Mayschoß-Altenahr winegrowers' cooperative, which claims to be the oldest winegrowers' cooperative in the world, was flooded. Almost all bridges were destroyed (SWR.de, 2022). Inhabitants were supported by military, which flew in food, drinking water and other essential supplies for 5 consecutive days. Thereafter an emergency road to and across Mayschoss was constructed and paved. Figure 3.178 (top left) shows the destroyed road in Mayschoss which cut the town's access. Figure 3.178 depicts damage to residential and commercial buildings in Mayschoss. Mayschoss was one of the key wine towns in the Ahr Valley.

Figure 3.178. Damage in Mayschoss and cut-off of main access road. Sources: Top Left: <https://www.augsburger-allgemeine.de/panorama/Katastrophen-Alle-fuer-alle-Wie-sich-ein-Dorf-aus-dem-Schlamm-kaempft-id60205721.html>; https://www.rhein-zeitung.de/region/aus-den-lokalredaktionen/kreis-ahrweiler_artikel,-ueberleben-im-chaos-mayschoss-hat-es-organisiert-_arid,2285542.html; Photo bottom: <https://www.swr.de/swraktuell/rheinland-pfalz/koblenz/mayschoss-nach-dem-hochwasser-100.html>

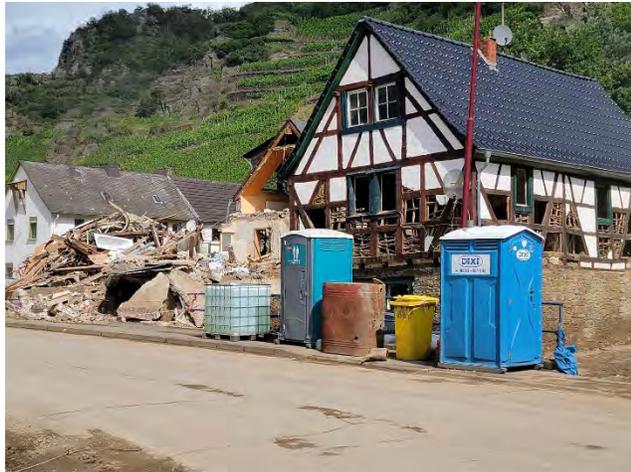
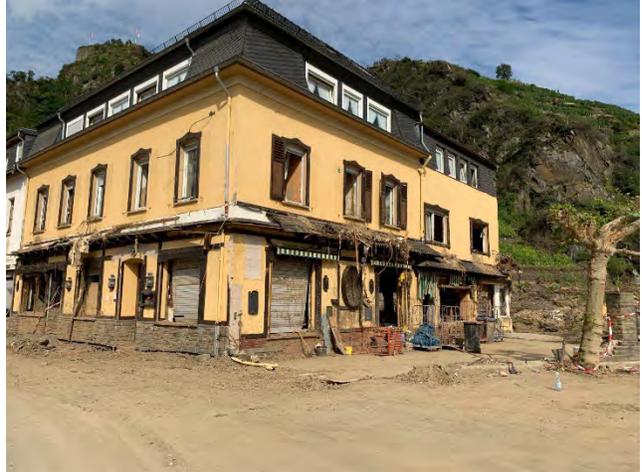
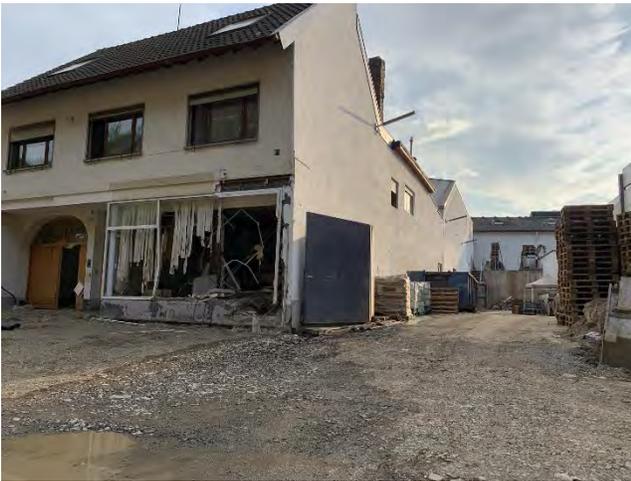
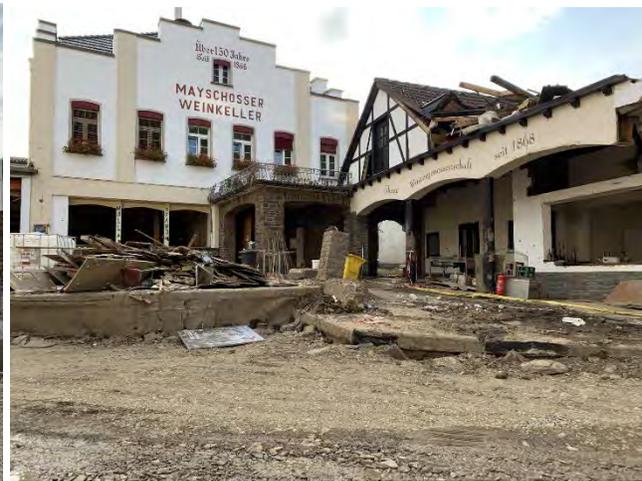
In February 2022, seven months after the flood, the Mayschoss community was reconnected to the electricity and water networks, and public transportation into town was provisionally restored. The municipality has set up 20 Tiny Houses for those affected by the flood. According to the reconstruction staff, a total of 25 buildings in Mayschoß and Laach are affected by the demolition, some may not be rebuilt in the same place. The winegrowers' cooperative also has to demolish buildings (SWR.de, 2022). Figure 3.180 and 3.181 shows damage in Mayschoss recorded by the GEER team in August 2021.

Figure 3.180. Damage to residential and commercial buildings in Mayschoss (50.5184234, 7.0205426)

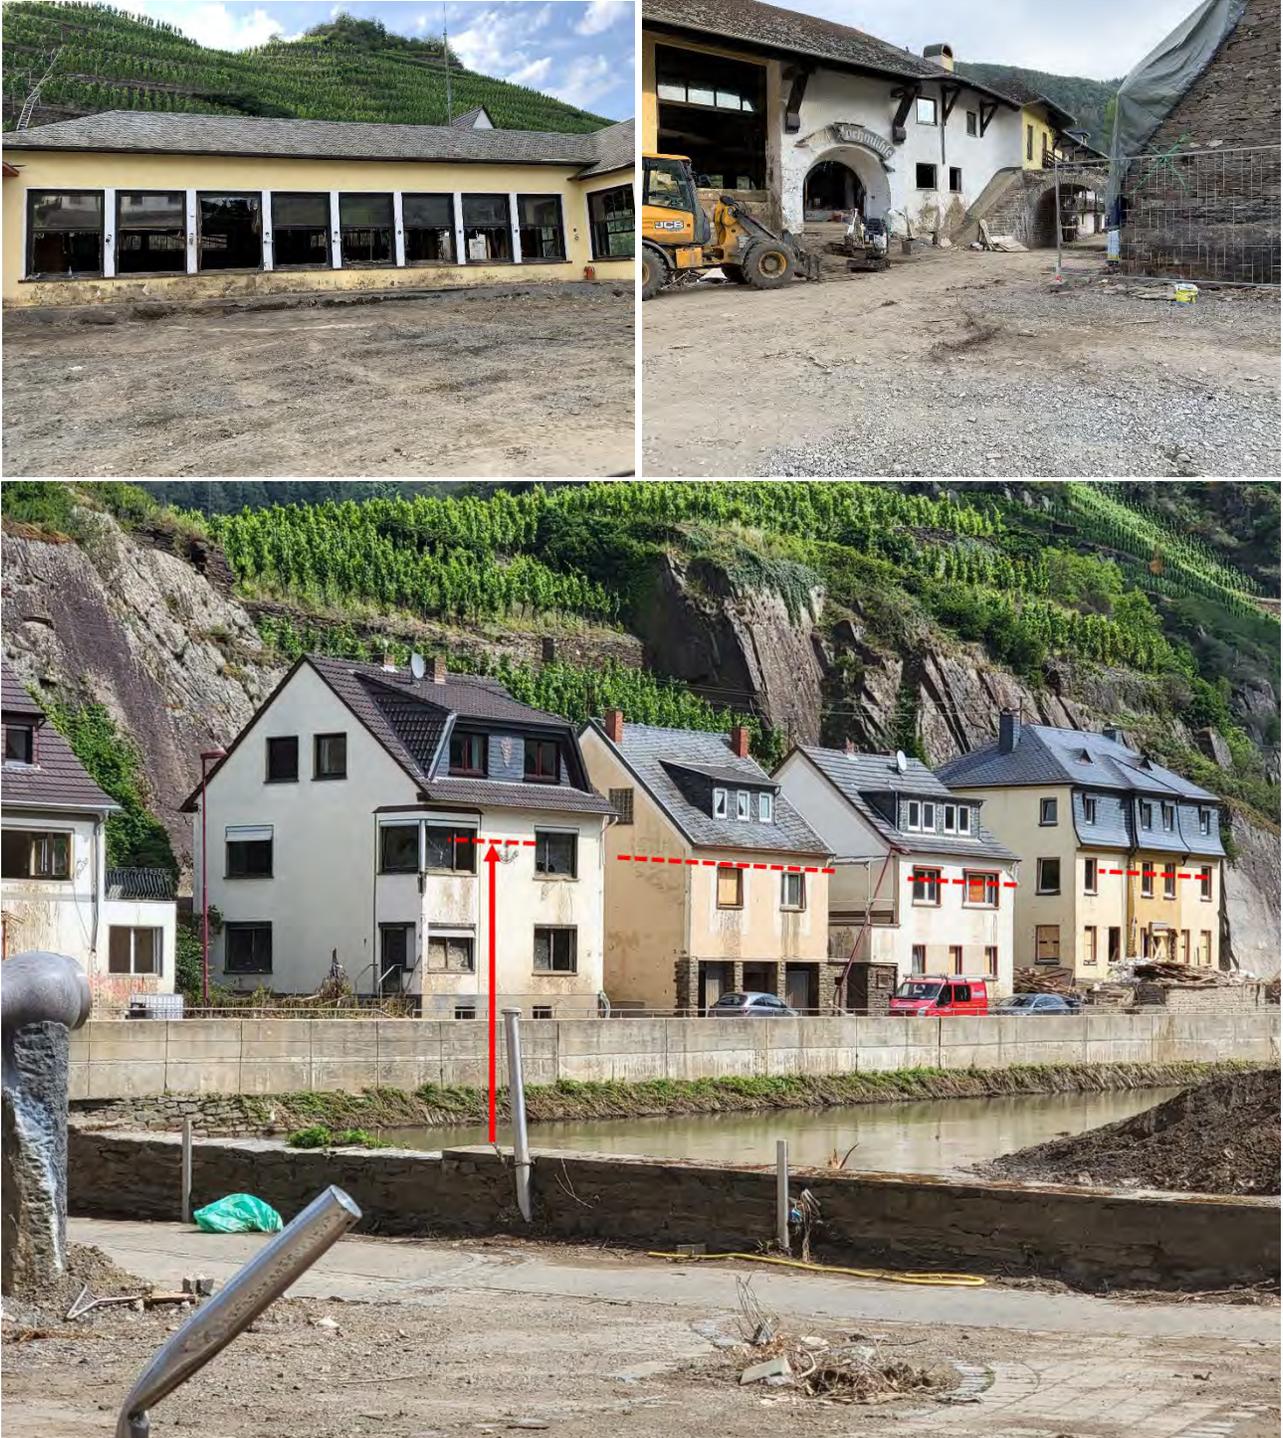
Figure 3.181. Top: Remains of a flooded winery in Mayschoss; Bottom: watermarks at several residential buildings along Bundesstrasse 267 in Mayschoss indicating water level rise during flood (50.52194645, 7.021036269)

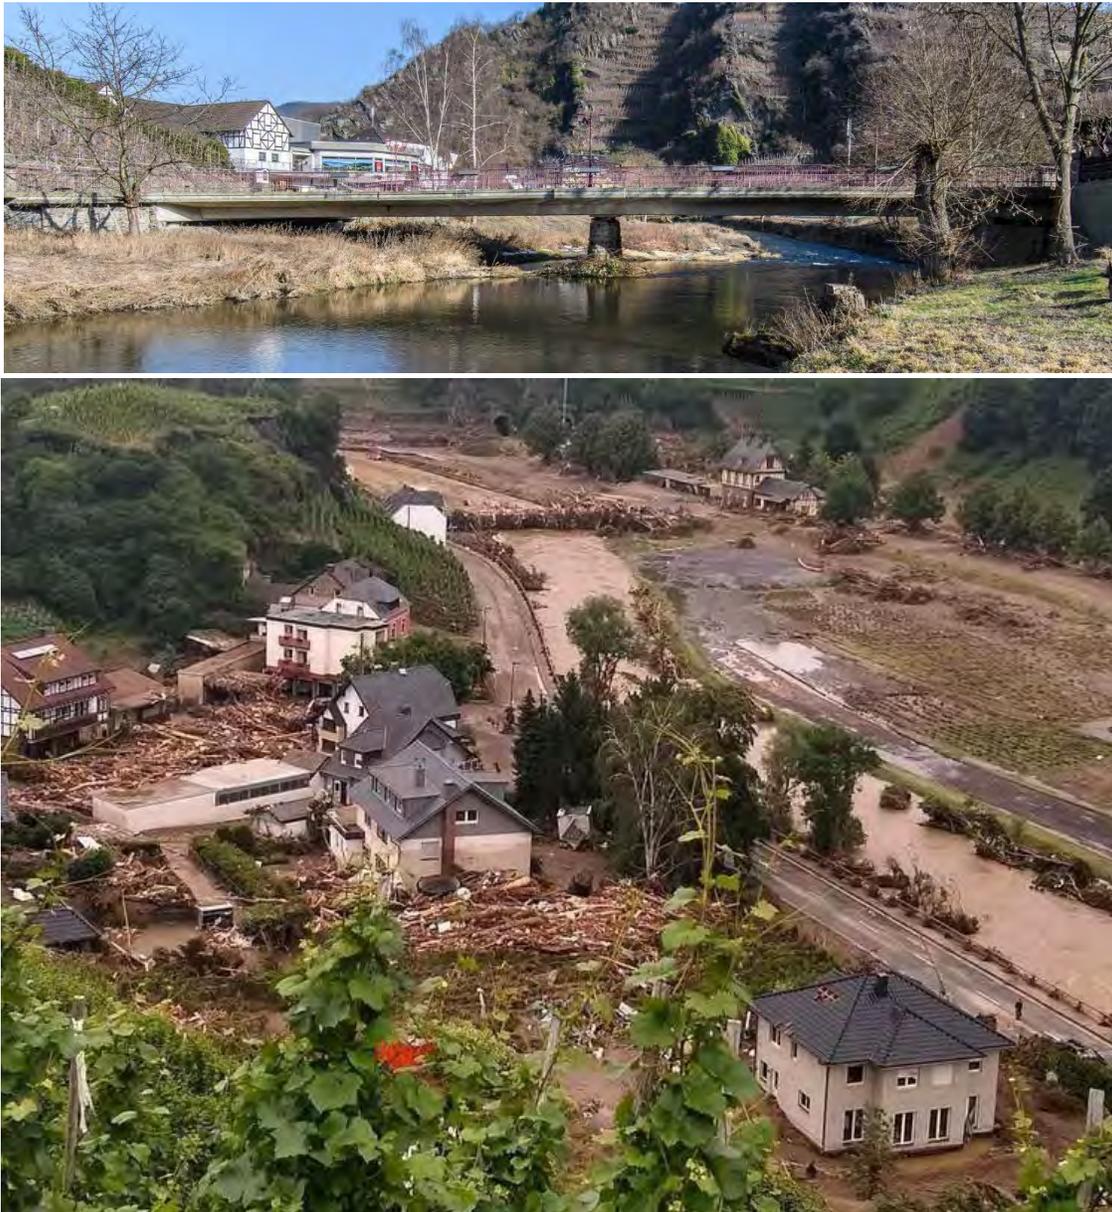
All bridges in Mayschoss were severely damaged. Figure 3.183 shows before/after photos of the road bridge to the train station Mayschoss, which is located across the river, on the right hand side as shown in Fig. 3.183 bottom. The bridge was damaged due to debris deposits, however, remained structurally intact. The bridge deck, as well as the abutment areas appeared stable at the time of the team's visit. A temporary railing was installed, and the bridge was continued to be used (Figure 3.184).

Figure 3.183. Foto of Mayschoss, bridge to train station in background, Top: prior to the 2021 flood, photo by Heinz Grates via https://www.aw-wiki.de/index.php/Ahrbr%C3%BCcken_im_Kreis_Ahrweiler), bottom after the 2021 flood, Source: https://www.rheinpfalz.de/lokal/speyer_artikel,-flutkatastrophe-b%C3%BCrger-sollen-f%C3%BCr-mayscho%C3%9F-spenden-arid,5231261.html

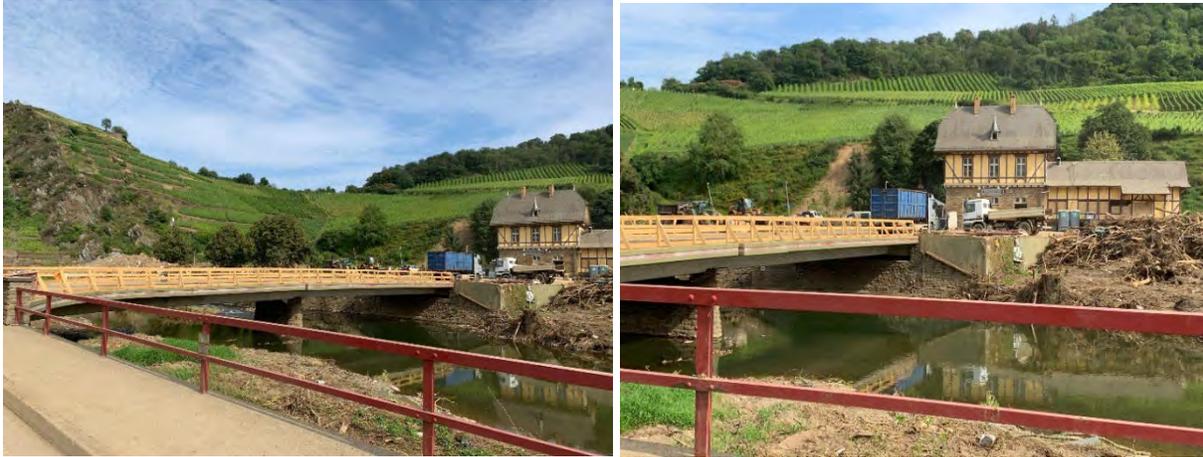
Figure 3.184. Bahnhofsbrücke Mayschoss on August 13, 2021 (50.51784531, 7.02004213)

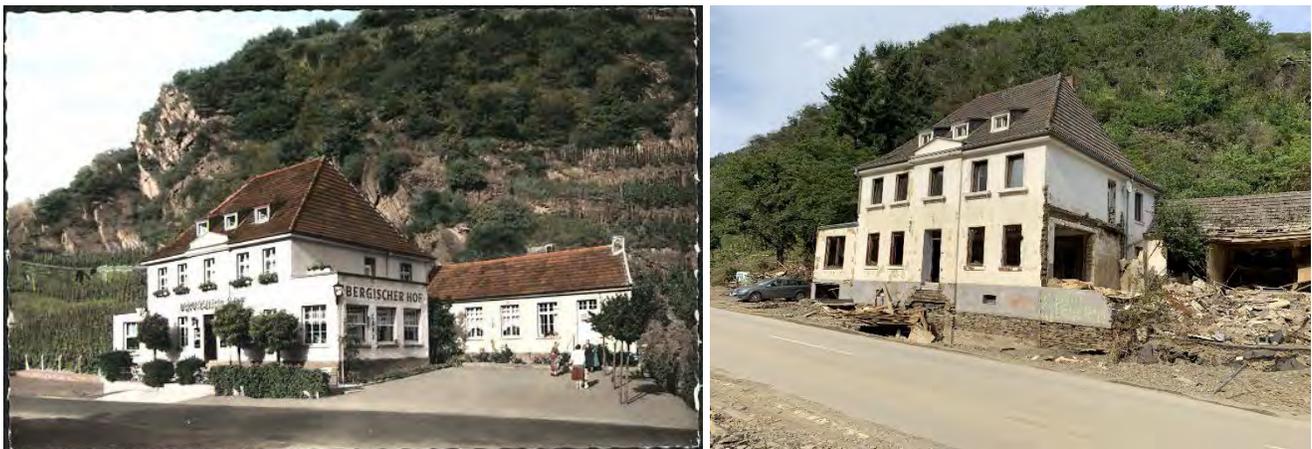
Figure 3.187. Historic Photo of Hotel Bergischer Hof (left, Source: <https://oldthing.de/AK-Mayschoss-Hotel-Restaurant-Bergischer-Hof-Cafe-0042096931>) and post-flood photo of Hotel Building (August 2021, 50.518393429, 7.026975)

The building “Hotel Bergischer Hof”, previously run as a hotel served in recent years as residence to the family who once ran the Hotel business. The house was in the process of remodeling and served as landmark along the Bundesstrasse B267 towards Rech (Figure 3.186). Figure 3.187 shows a photograph of the Hotel prior to the flood, and post 2021 flooding.

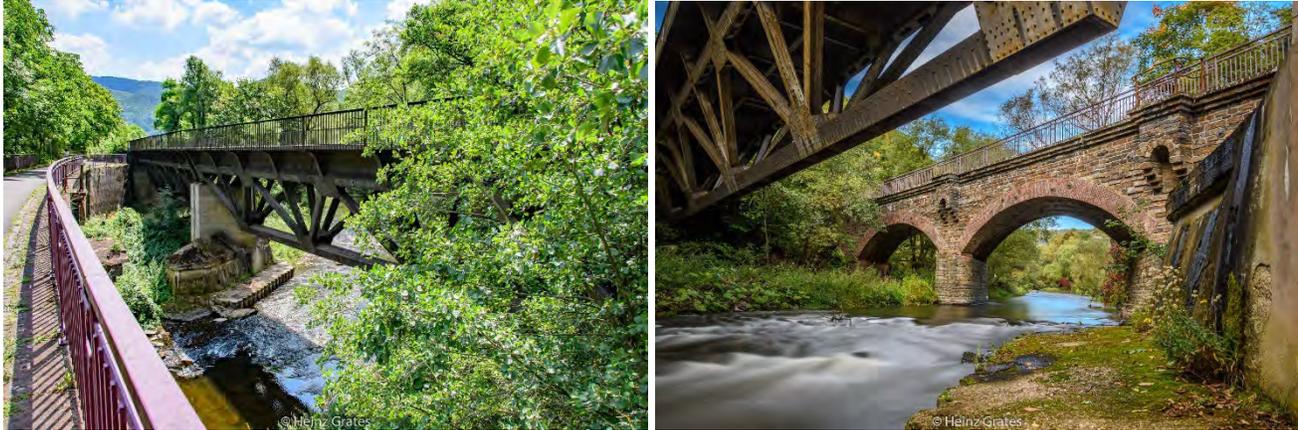
The double bridge next to the “Hotel Bergischer Hof” consisted of the typical duo: a bicycle/pedestrian bridge next to the rail bridge (Figure 3.186). The pedestrian bridge was location upstream of the rail bridge and consisted of a historic brick-arch bridge (Figure 3.188).

Figure 3.188. Rail and bicycle/pedestrian bridge at Hotel Bergischer Hof prior to flood. Photos by Heinz Grates, Source: https://www.aw-wiki.de/index.php/Ahrbr%C3%BCcken_im_Kreis_Ahrweiler#Mayscho.C3.9F
