Geotechnical Reconnaissance of the 2021 Western European Floods

Flood Event: July 14-15, 2021

Flood locations: Germany, Netherlands, Belgium, and Luxembourg

Reconnaissance Visit: August 9-18, 2021

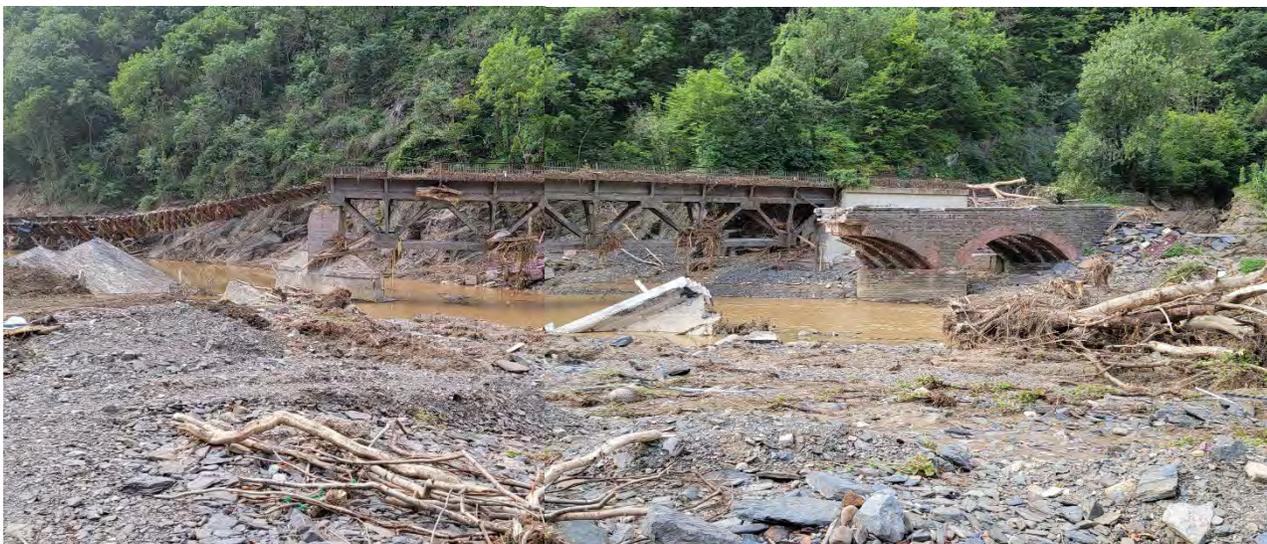
Figures 3.189 – 3.191 document the intense damage to both bridges. As shown in Figure 3.189, the upstream pedestrian bridge was completely destroyed, with only 1.5-arch remaining standing. The rest of the bridge was washed away, a few selected pieces of the bridge foundation remained visible in the riverbed. The rail bridge also suffered irreparable damage. The bridge abutment constructed in the adjacent rock remained intact, along with one intermediate bridge support wall (Figure 3.189 and 3.190). The rest of the bridge supports laid in the river, part of the superstructure truss was washed onto the downstream shore (see Figure 3.191)

Figure 3.189. Destroyed rail and bicycle bridge at “Hotel Bergischer Hof” in Mayschoss. Photo taken by GEER team 2021(50.51818719, 7.02648801)

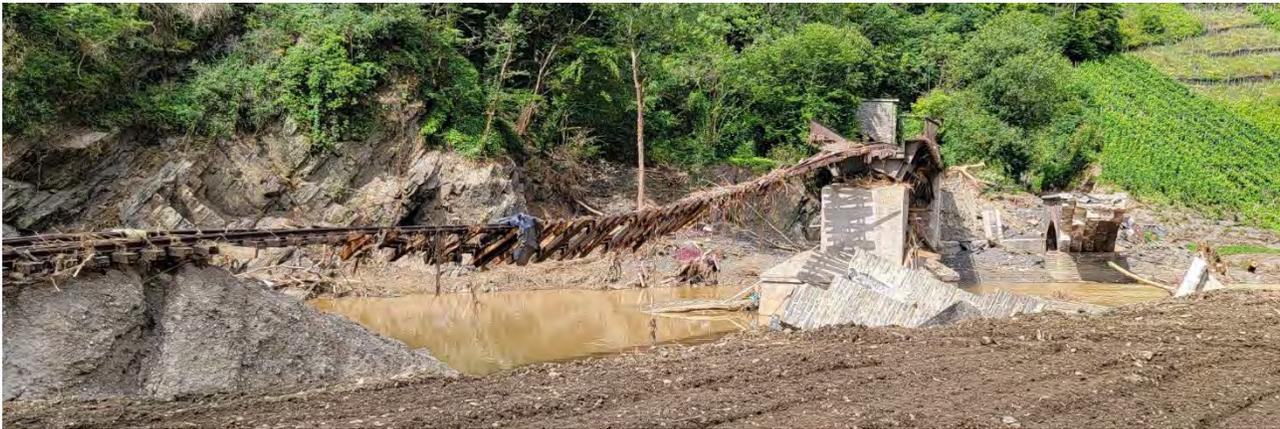
Figure 3.190. Panoramic view of destroyed rail bridge at Hotel Bergischer Hof. Photo Credit: Heinz Grates accessed through: https://www.aw-wiki.de/index.php/Ahrtalbahn-Br%C3%BCcke_Mayscho%C3%9F

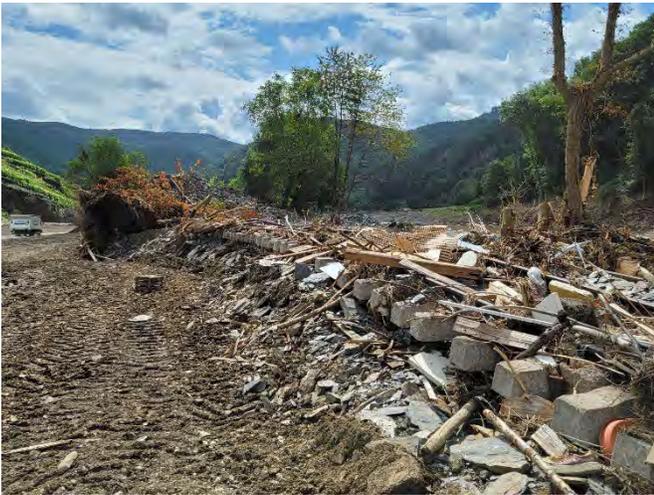
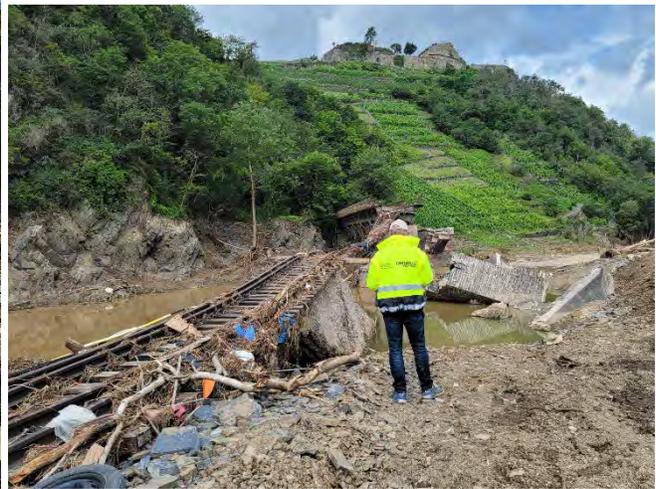
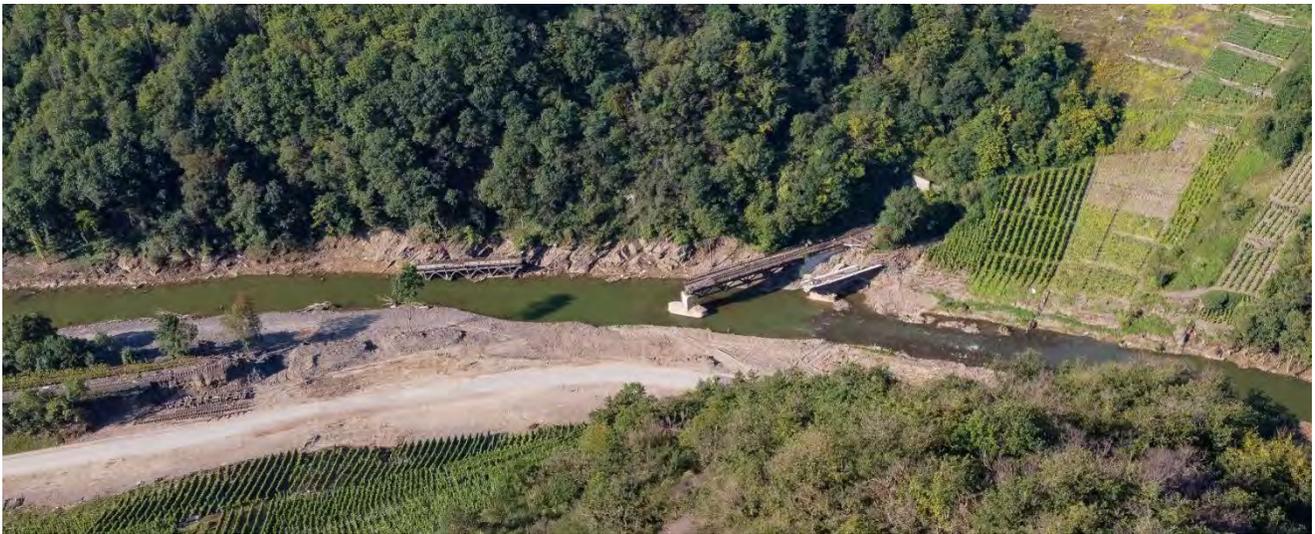
Figure 3.191. Damage around bridge showing destroyed rail tracks (top left, (50.51818719, 7.02648801)), Submerged bridge foundation components (top right), and aerial view taken several months later by Heinz Grates, Source: https://www.aw-wiki.de/w/thumb.php?f=Mayscho%C3%9F_-_Heinz_Grates_%28320%29.jpg&width=1200

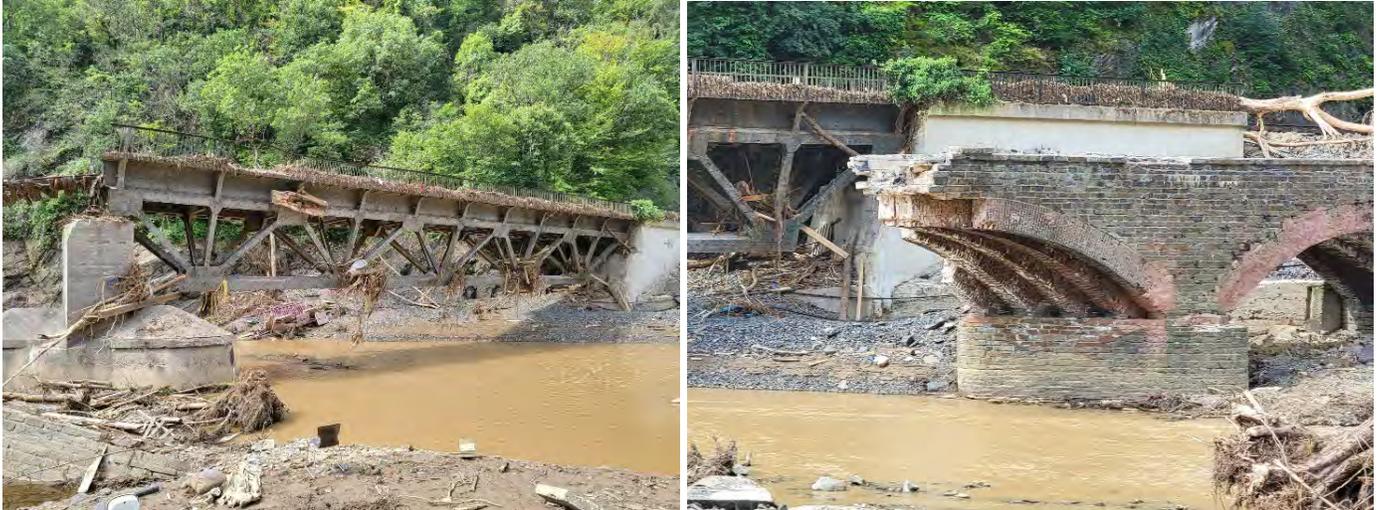
Figure 3.192 shows close-up photographs of both bridge superstructures. Photographs suggest that the superstructure was broken off and washed away due to the impact from debris and objects carried by the flood waters.

Figure 3.192. Remaining sections of the two bridges at Hotel Bergischer Hof, (50.51818719, 7.02648801).

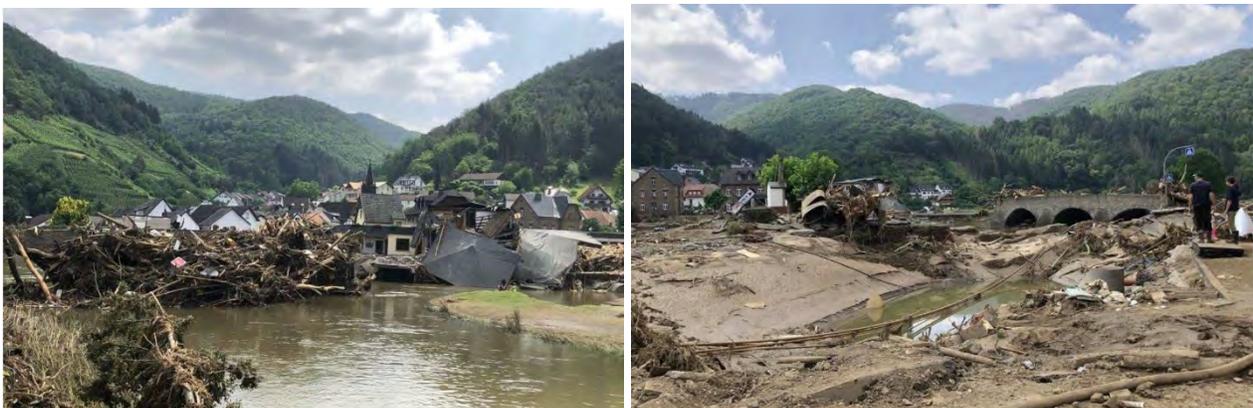
Rech is a small municipality in the district of Ahrweiler with a population of 565 inhabitants. Rech is known for its wineries and its location along the famous “red wine hiking trail” (Rotweinwanderweg), which begins at the foot of the Are castle ruins in Altenahr and leads through the vineyards of Mayschoß, Rech, Dernau via Marienthal, Walporzheim, Ahrweiler, Bad Neuenahr, Heppingen, over the Landskrone to Lohrsdorf and to Bad Bodendorf. The total length is 34 km. The red wine hiking trail is probably one of the most frequented themed hiking trails in Germany. Rech was severely destroyed during the flood events and was closed off to public access for several days. The famous Ahr bridge “Nepomukbrücke”, which connects both parts of Rech, was destroyed. Figure 3.193 shows damage in Rech.

Figure 3.193. Damage in Rech, Source: https://ga.de/fotos/region/flutkatastrophe-im-kreis-ahrweiler-bilder_bid-61312581#28

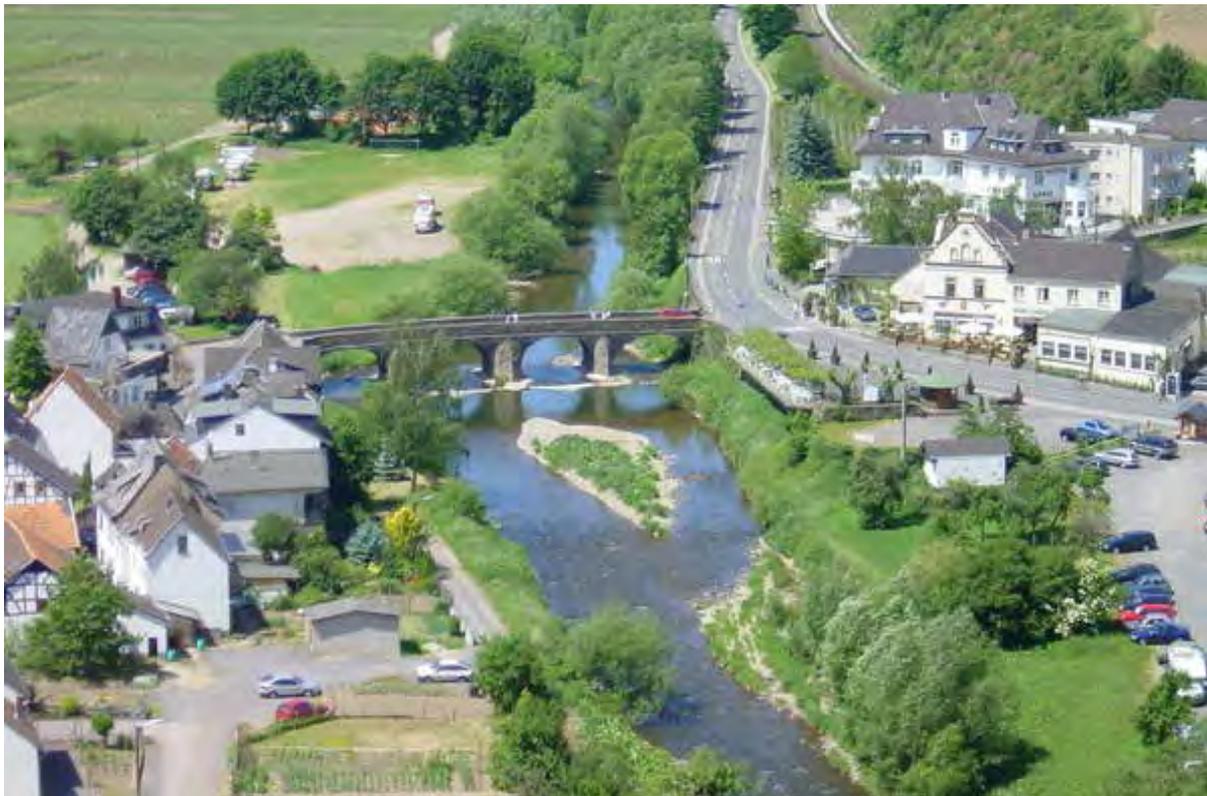
The Ahrbrücke (also called The St. John of Nepomuk Bridge) in Rech, is a stone arch bridge over the Ahr River. The road bridge connects the village center with the federal road B267. The structure has been a protected cultural monument since 1981. ([https://de.wikipedia.org/wiki/Ahrbr%C3%BCcke_\(Rech\)](https://de.wikipedia.org/wiki/Ahrbr%C3%BCcke_(Rech))). From 1723 to 1724, the municipality of Rech built two stone piers in the Ahr River, on which a three-span wooden beam bridge was placed. In 1759, the bridge structure was replaced by two arches made of quarry stones. After a flood in 1804, the addition of two arches followed. The flood of the Ahr on June 13, 1910 destroyed all smaller and eight large Ahr bridges. Only the bridges near Dernau and Rech were preserved. Extensive bridge renovation work was carried out in 2008. The construction costs amounted to 934,000 euros. The bridge, which is about 43 meters long and up to five meters high, is made of graywacke masonry and has four flat, 4.94-meter-wide basket arches. The two inner arches have a clear width of 8.40 meters each, the outer ones of 9.45 meters and 9.12 meters respectively. The pier widths vary between 1.85 meters and 2.92 meters. A 47-centimeter-thick, 76-centimeter-high brick parapet delimits the 4.0-meter-wide roadway. The bridge was severely damaged during the flood of the Ahr River on July 14-15, 2021. The fourth arch of the bridge was swept away along with a large part of the southern, right bank. Traffic crossing the Ahr was provisionally handled first by shuttle boats, then by an armored fast bridge until August 25, 2021. By January 2022, the town of Rech has determined that the Nepomuk Bridge will not be rebuilt. In addition, 13 plots of land may no longer be built on. Replacement sites are being sought for the owners. The traffic routing in the village is also being planned anew (SWR.de, 2022). Figures 3.194 and 3.195 show the bridge before and after the flood event.

Figure 3.194. Aerial view of Nepomuk Brücke in Rech prior to the 2021 flood, obtained through: <https://www.bundeswehr.de/de/organisation/personal/fluthilfe-im-ahr-tal-nachbar-helfer-soldat--5207408>

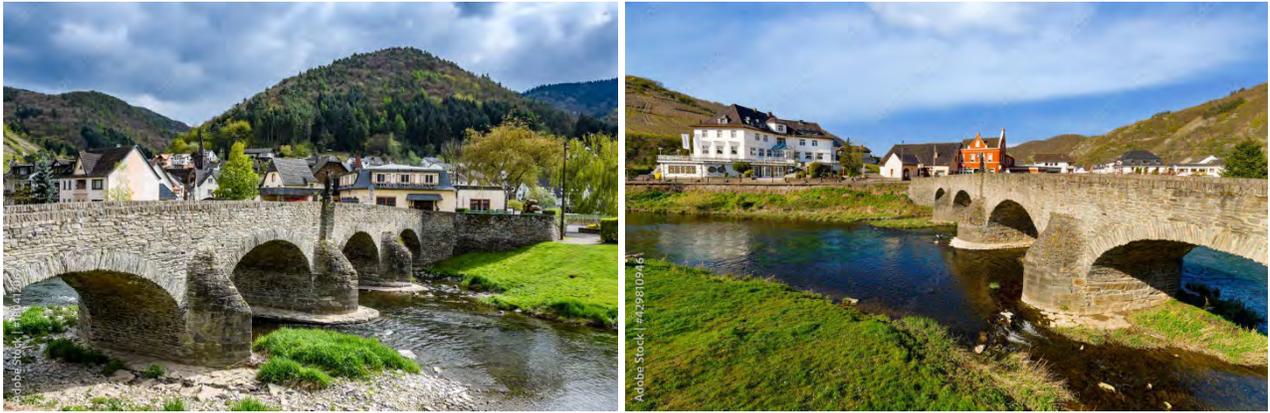
Figure 3.195. Before photos of the Nepomuk bridge in Rech, Source: Adobe photostock, standard license (free)

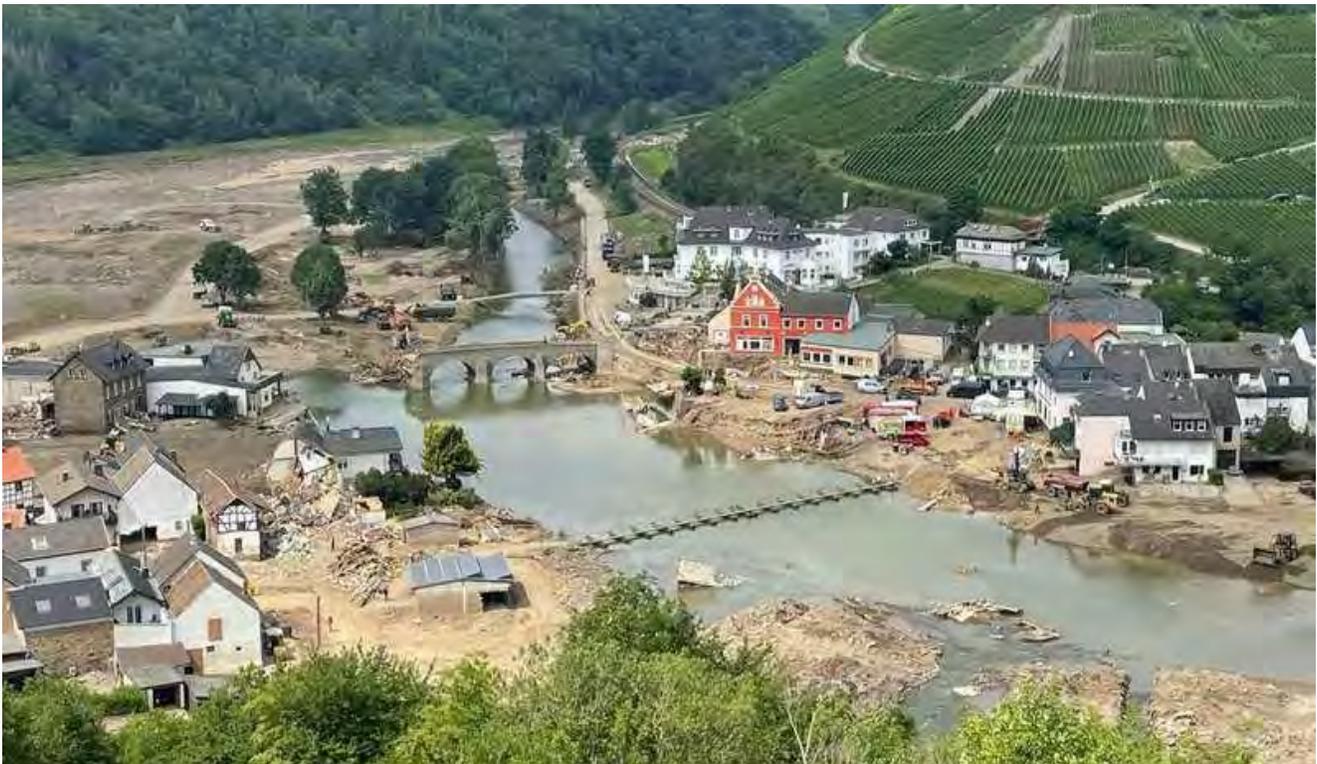
Figure 3.196 – 3.198 show post-flood images depicting the destroyed Nepomuk bridge as well as two of the three emergency bridges erected in Rech. The part of town shown on the left-hand side in Figure 3.196 was cut-off by the flood and only accessed with helicopters during the first days of emergency response. A total of three emergency bridges were constructed in Rech by the German military as shown in Figure 3.198. Figure 3.199 (top and 2nd row) shows a temporary floating pedestrian bridge which was erected on July 23rd, within 6 days of the flood. This bridge enabled pedestrian access to the “cut-off” part of Rech. Later, two road bridges were constructed (shown in the back of Figure 3.198 and in Figure 3.199).

Figure 3.196. Post-flood aerial image of Rech and its Nepomuk bridge, Source: Deutsche Bundeswehr, <https://www.bundeswehr.de/de/organisation/personal/fluthilfe-im-ahrtal-nachbar-helfer-soldat--5207408>

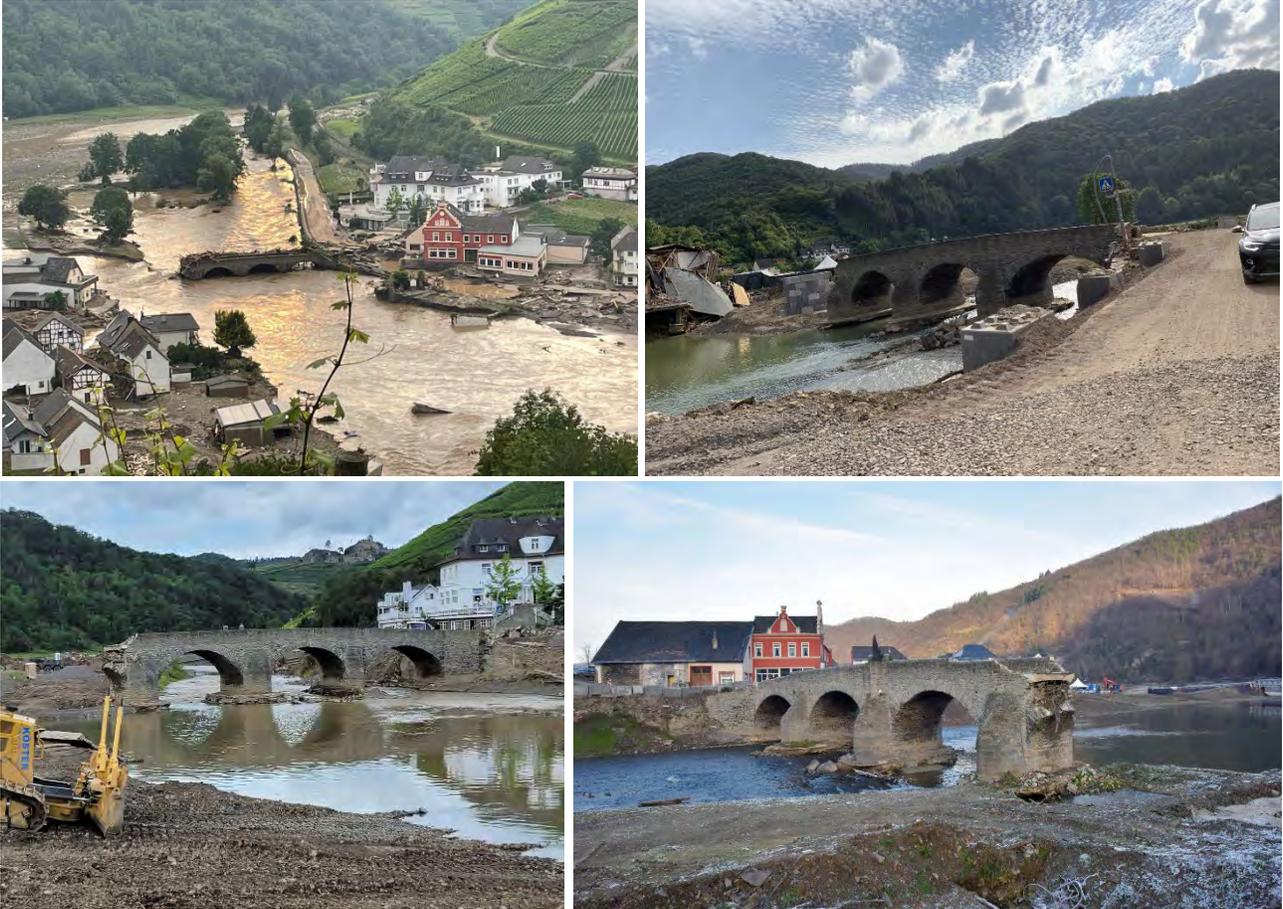
Figure 3.197. After flood photos of the Nepomuk bridge in Rech, showing missing bridge arch and abutment structure (50.5141233, 7.03625453)

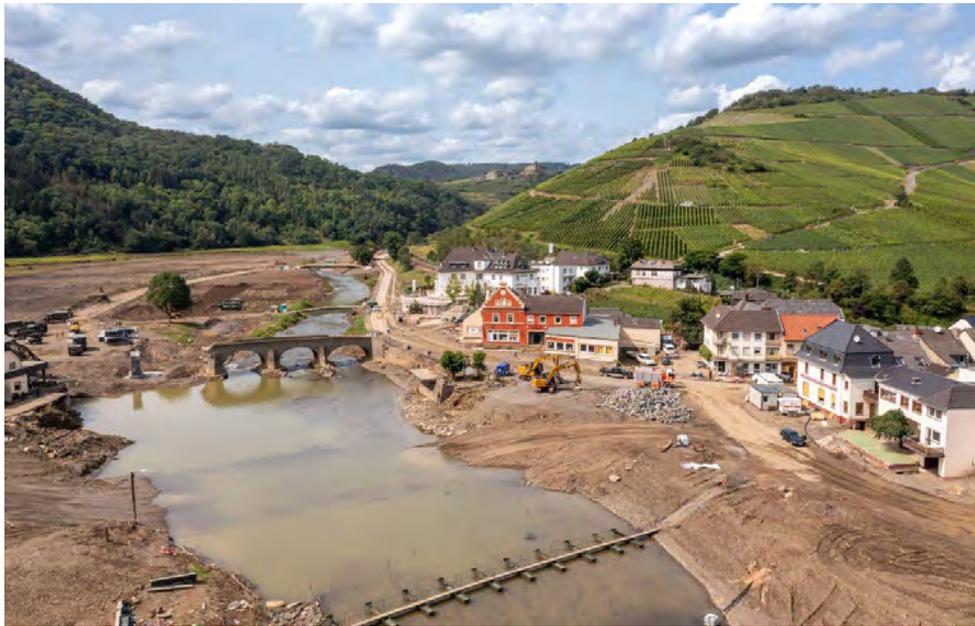
Figure 3.198. Rech and the destroyed Nepomuk bridge (middle) with a pedestrian emergency bridge (front) and two road bridges (background)

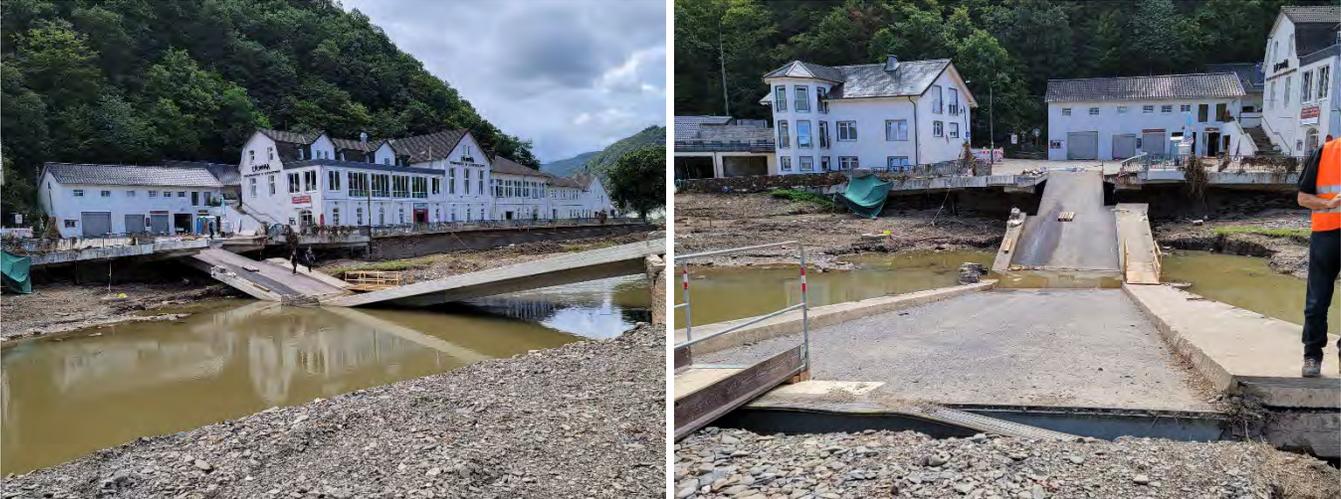
Figure 3.201. Damaged Ahr bridge in Dernau on August 10th, 2021, documented by the GEER team (50.533719356, 7.0453862)

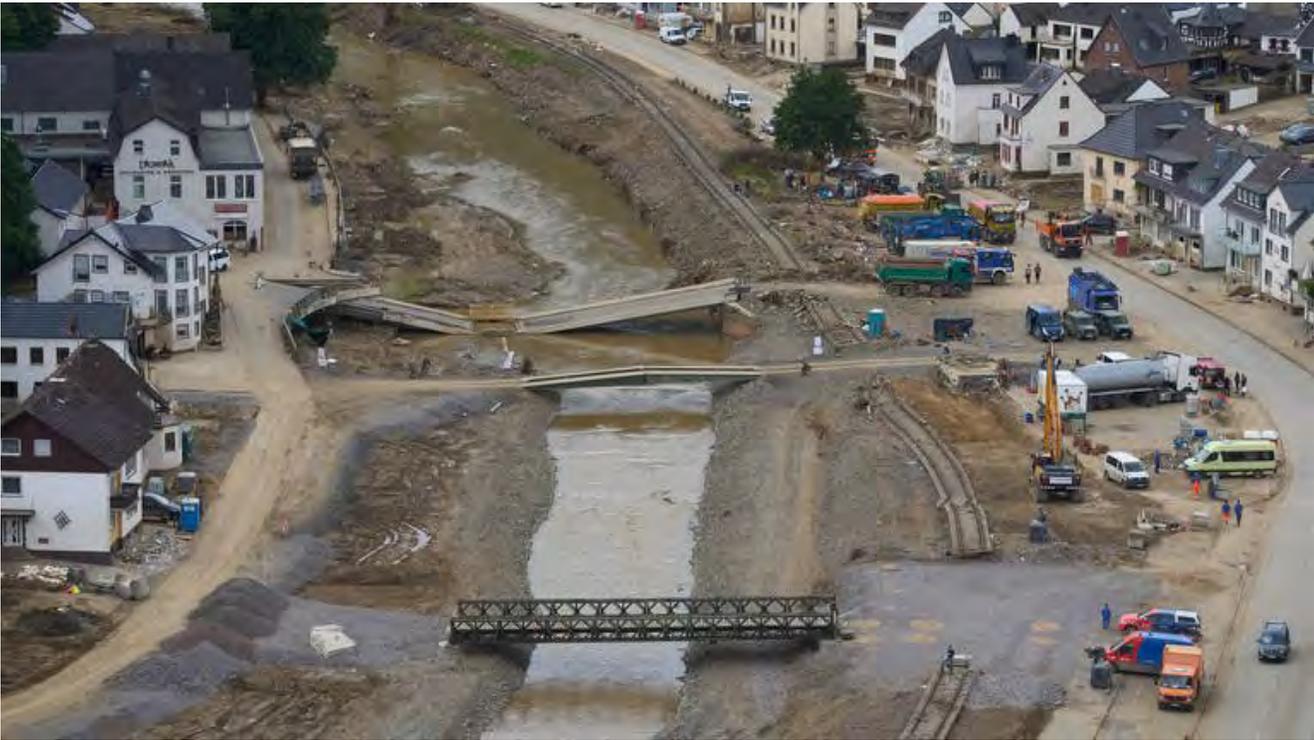
Figure 3.202. Damaged bridge with 2 emergency bridges (Jan 2022), Source: SWR.de, accessed through: <https://www.swr.de/swraktuell/rheinland-pfalz/koblenz/dernau-nach-dem-hochwasser-100.html>

The village of Dernau which is centrally located in the Ahr valley, within a short drive from Bad Neuenahr Ahrweiler, and famous for its wines. The town has a population of 1700 inhabitants (<https://en.wikipedia.org/wiki/Dernau>). Dernau is famous for its red wine production. Besides agriculture, tourism is a strong economic factor. According to the tourism association, around 90 percent of the citizens of Dernau were affected by the damage caused by the flood (SWR.de, Jan 2022). In addition, there was massive damage to the infrastructure. For example, the bridge over the Ahr was destroyed. Six months after the flood, 400 houses are still not habitable. 30 buildings have been demolished, with another 20 to follow, according to the municipality. The calculated damage amounts to 87.95 million euros, according to the municipality. In December, a container village for senior citizens was built, and since January there have also been 15 mobile homes and 13 Tiny Houses for residents who lost their homes in the flood (SWR.de, 2022). Figure 3.200 shows a photograph of the Ahr bridge in Dernau immediately after the flood. Figure 3.200 shows a photo taken by the GEER team in August 2021. Figure 3.202 shows a photograph of Dernau with two emergency bridges in place.

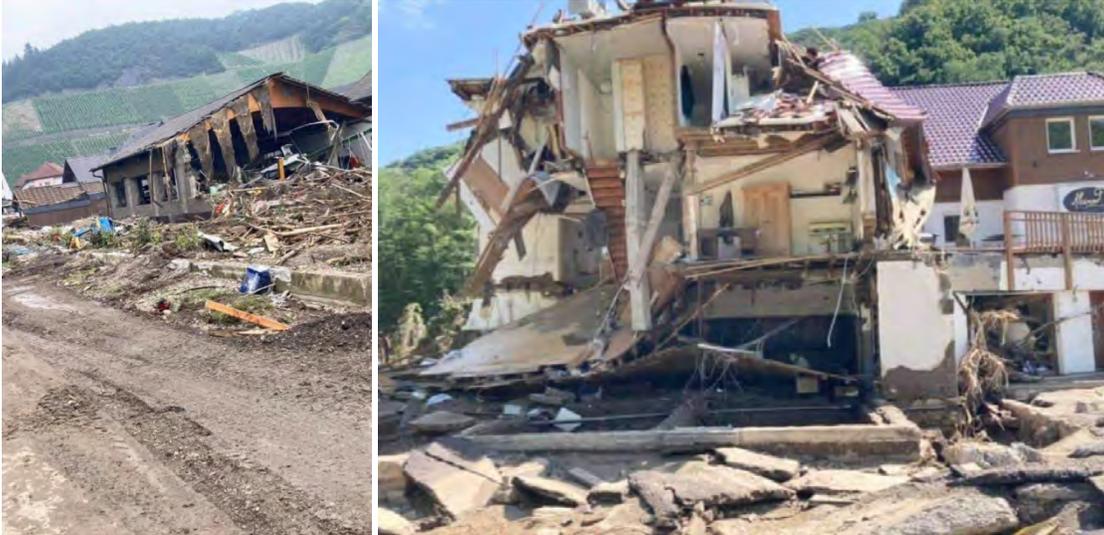
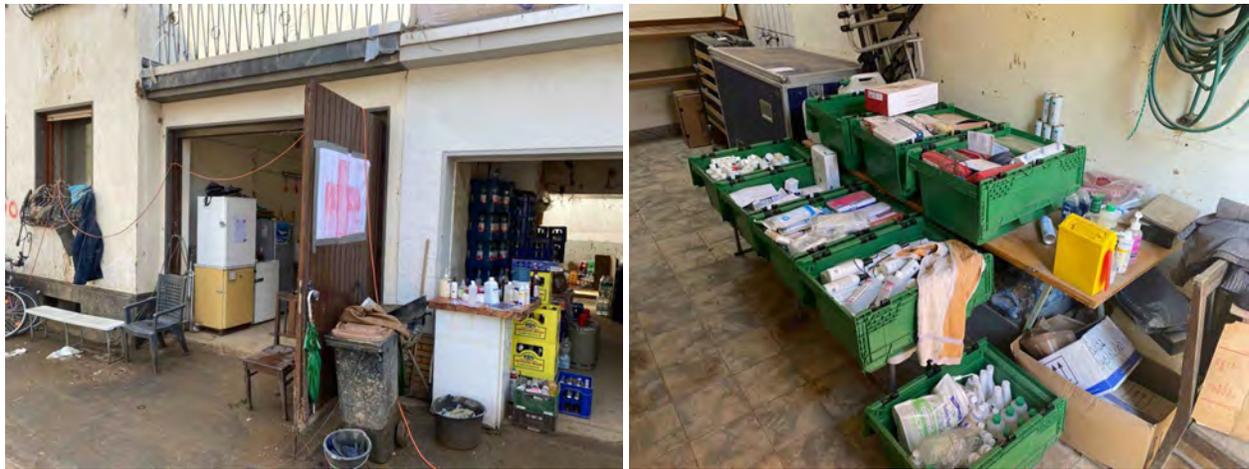
Figure 3. 204. Destroyed houses (top) and post-flood doctors office (bottom) in Marienthal (Source: <https://www.hochwasserhilfe-marienthal.de/bildergalerie/>)

Marienthal is located in the middle of the Ahr valley to the left of the river between Walporzheim and Dernau, surrounded by steep vineyards and forest. Marienthal is a small community with three wineries and just around 100 inhabitants, at an elevation of 120m above sea level. Two wineries have been destroyed and are closed. While vineyards are intact, both winemakers lost all equipment and business infrastructure to keep operations running. Figure 3.203 shows a google satellite image showing the towns of Marienthal and Walporzheim. Five bridges cross the Ahr river within the short distance (2.1km) between Marienthal and Walporzheim are damaged or destroyed. Marienthal itself has been heavily destroyed as shown in Figure 3.204. Marienthal had 105 inhabitants and recorded three fatalities due to the flood (<https://www.hochwasserhilfe-marienthal.de/ein-erster-post-5/>). 90% of all houses were flooded, at least to, and including the first story. Figure 3.204 shows severe damage to two buildings in Marienthal as well as the town's emergency medical office (bottom photos).

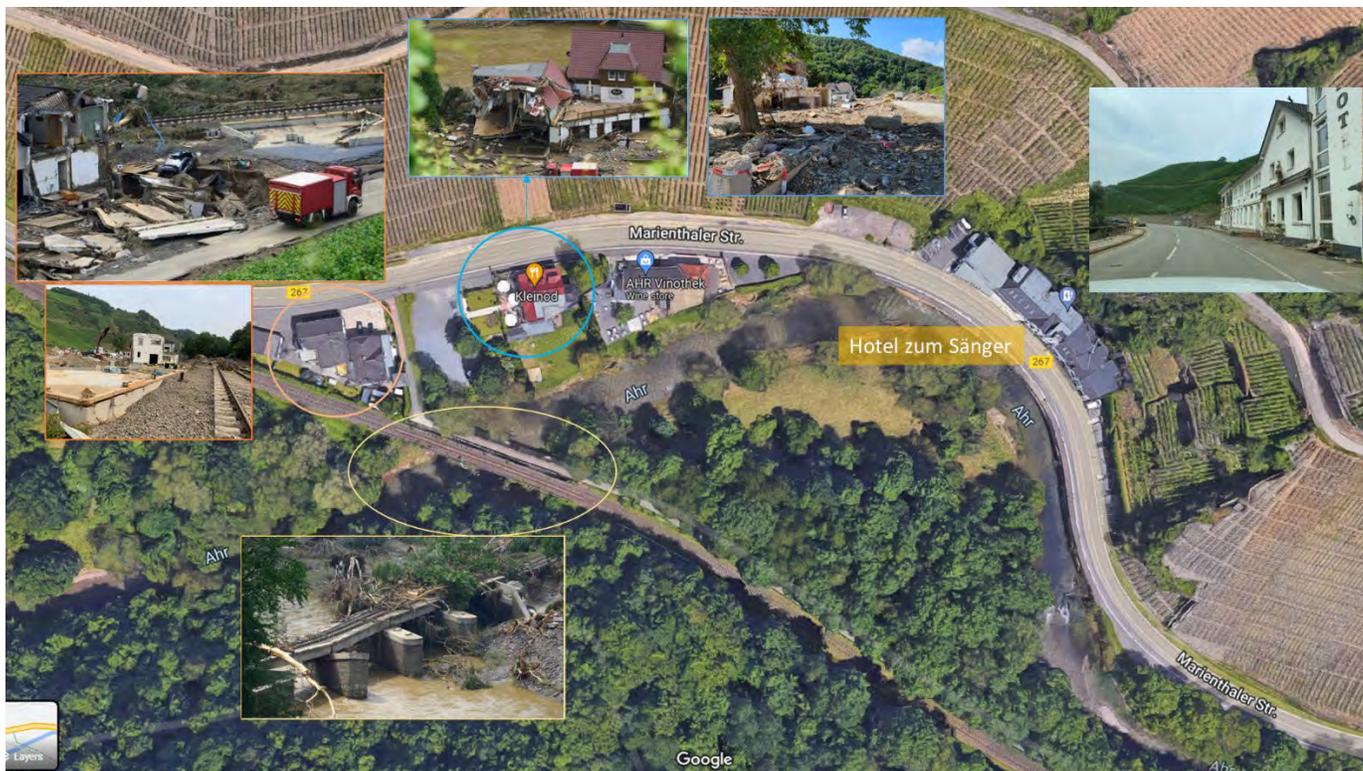
Figure 3.205. Damaged bridges and buildings near the "Hotel zum Sänger" between Marienthal and Walporzheim, Source: google maps overlain with photos by Geer team and Generalanzeiger Online

The team inspected the rail bridge at various locations. Near the “Hotel zum Sänger”, the team documented the bridge damage of two close-by bridges. The Hotel zum Sänger (white building shown in Figures 3.205 and 3.206) was evacuated. Residents reported water levels to be above the 2nd story. This suggested an estimated water level rise of up to (or more than) 7.0 meters. Emergency evacuation was performed by the fire department and Hotel staff using the latter shown in Figure 3.206, which was placed between the roof of the house and the adjacent slope of the vineyard. Eyewitnesses described seeing the hotel guests climbing out of the windows and crossing the floods on the latter, with water elevations being just 30cm below the latter. Figure 3.205 shows all buildings along the landmark and their location.

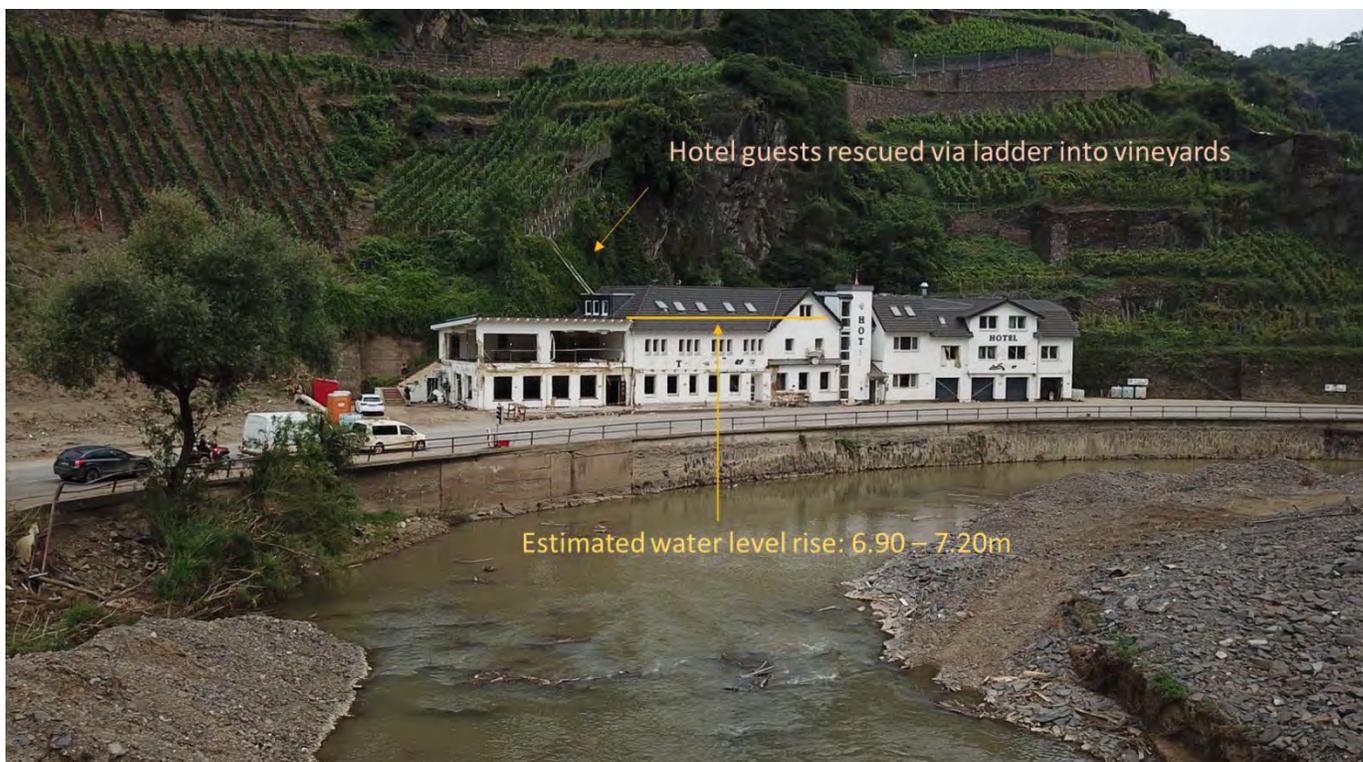
Figure 3.206. Water levels at the Hotel zum Sänger, Marienthal/Walporzheim

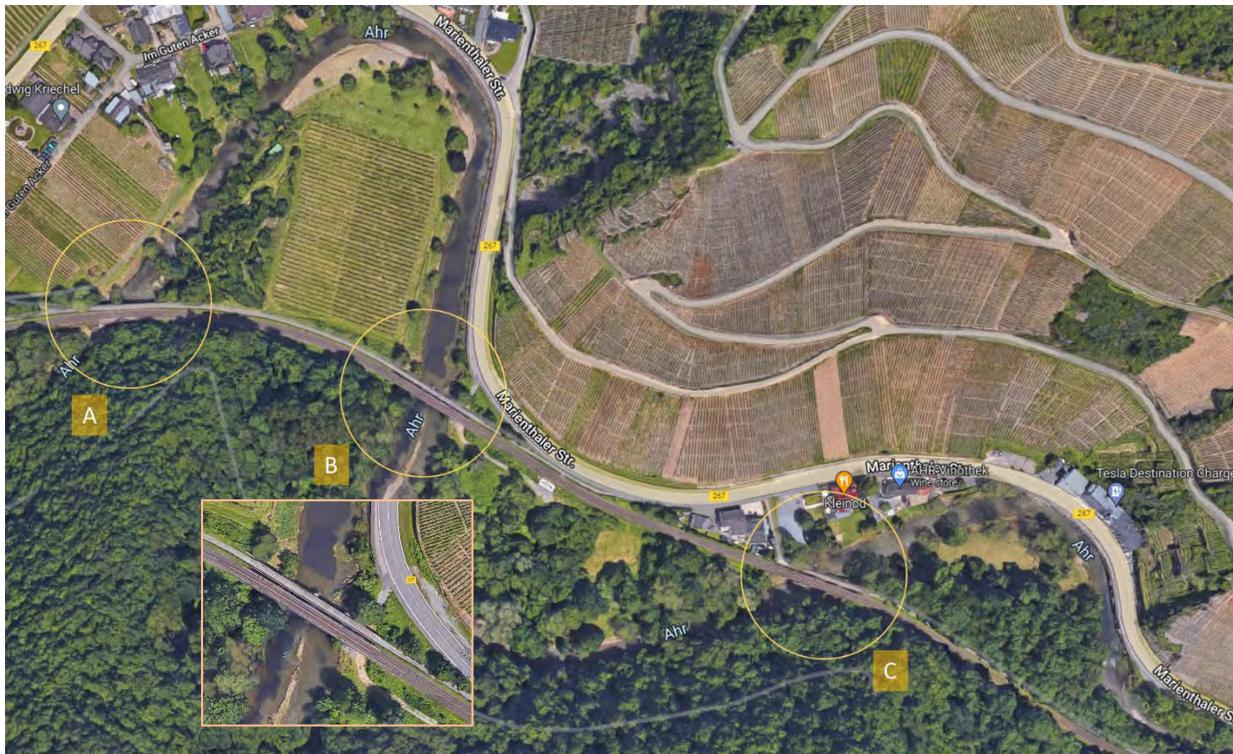
Figure 3.207. Location of rail and bicycle bridges near Hotel zum Sanger

Three rail bridges within the short Ahr bend in Marienthal were inspected by the GEER team. Figure 3.207 show the locations of the bridges. “Bridge A” did experience some damage, but largely withstood the impact of the flood. Bridges B and C experienced irreparable damage and were later removed. Figure 3.208 shows the erosion along the Marienthaler Strasse, the main road shown in Figure 3.207. Figure 3.209 and 3.210 show damage to Bridge B, which consisted of displaced and tilted bridge pier walls, a washed-out left abutment, and displaced rail tracks. Three of the bridge supports appeared to be structurally stable. The pedestrian/bicycle deck was lifted and washed away.

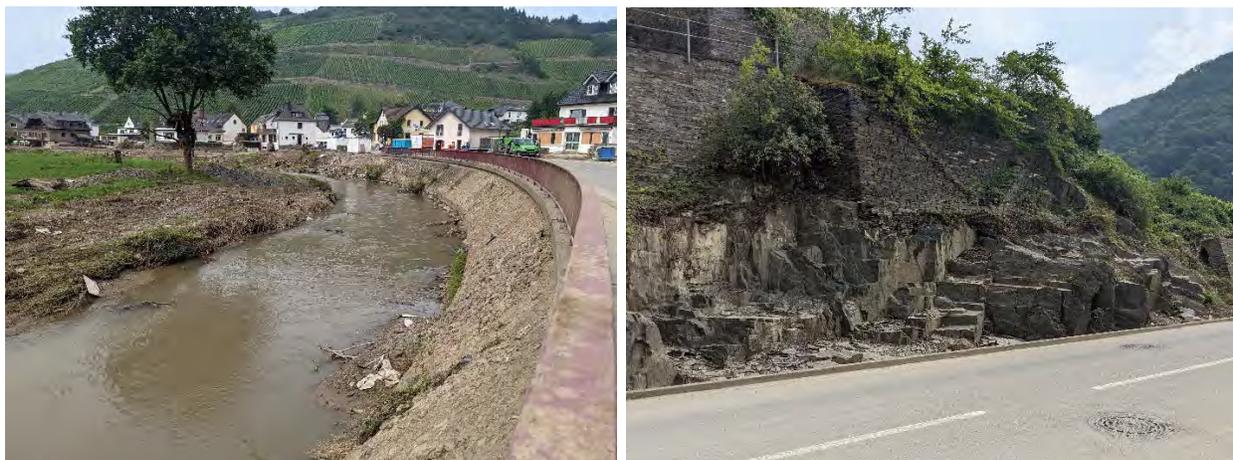
Figure 3. 208. Erosion along the Ahr and adjacent slopes between Marienthal and Walporzheim (50.5343798, 7.05975402)

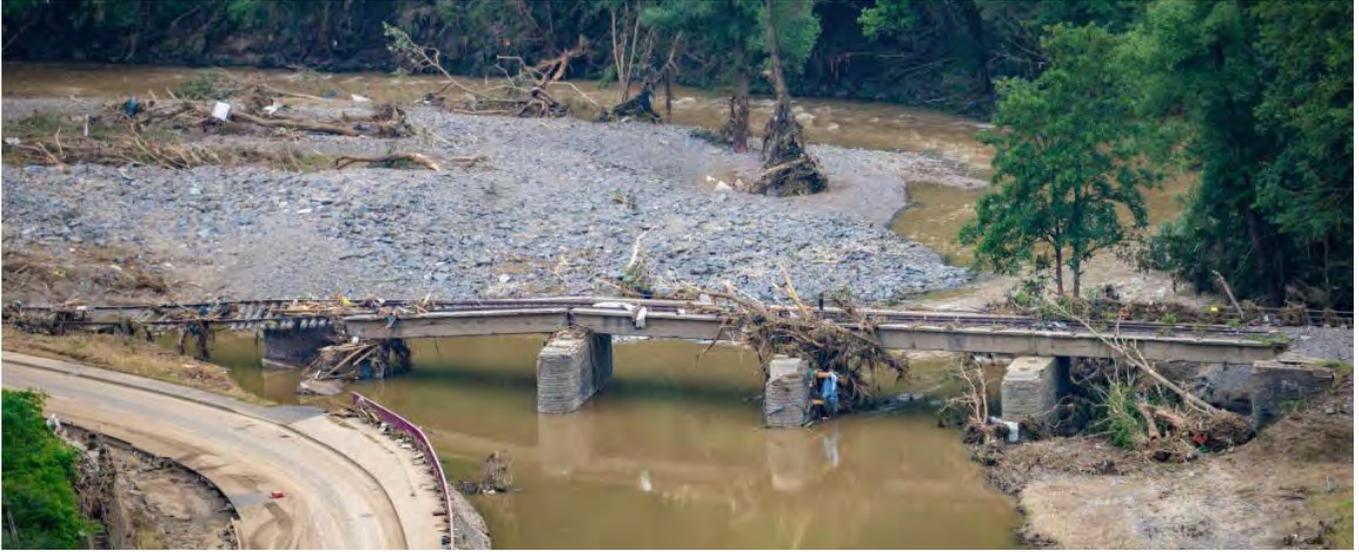
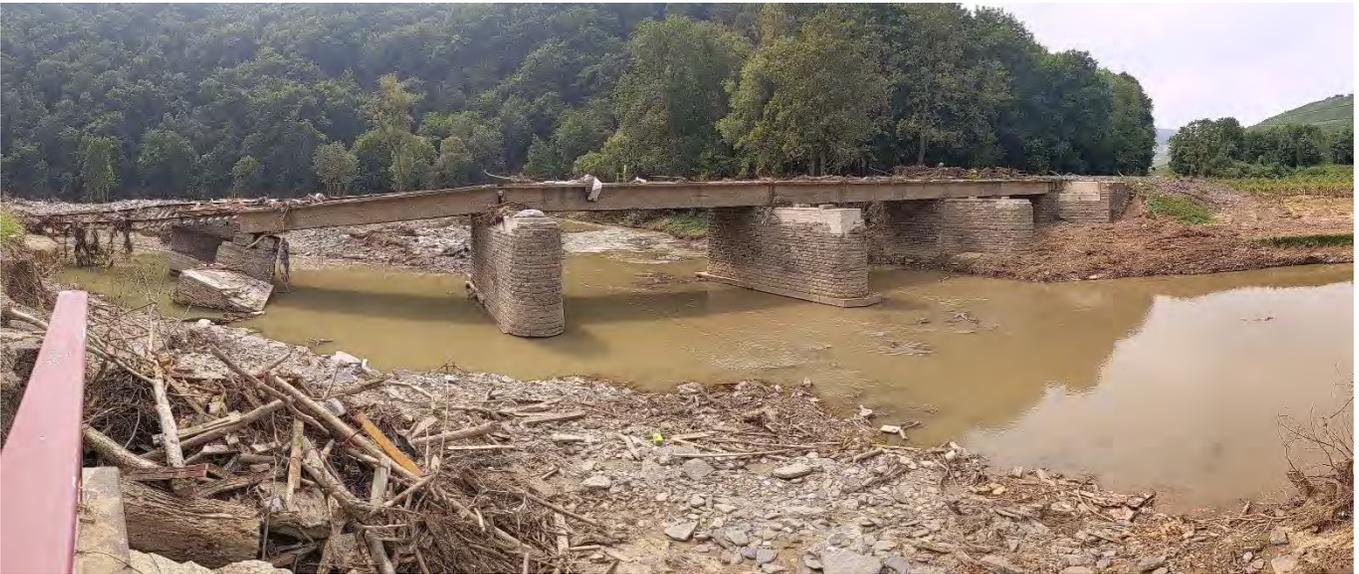
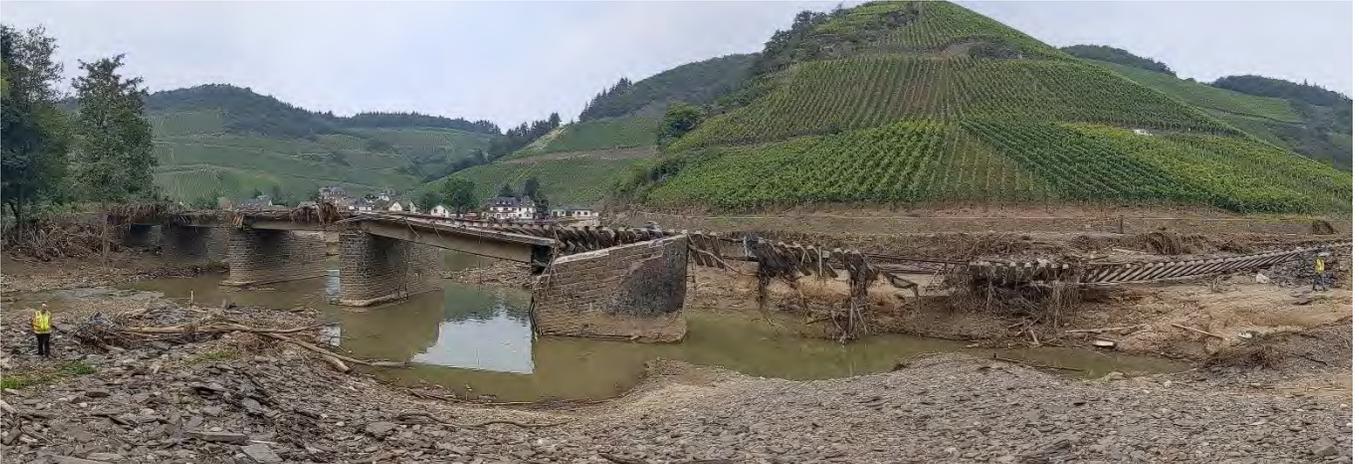
Figure 3.209. Panoramic photographs of Bridge B (rail bridge) from upstream direction (top and center) and downstream (bottom) direction (50.5331621, 7.0592238).

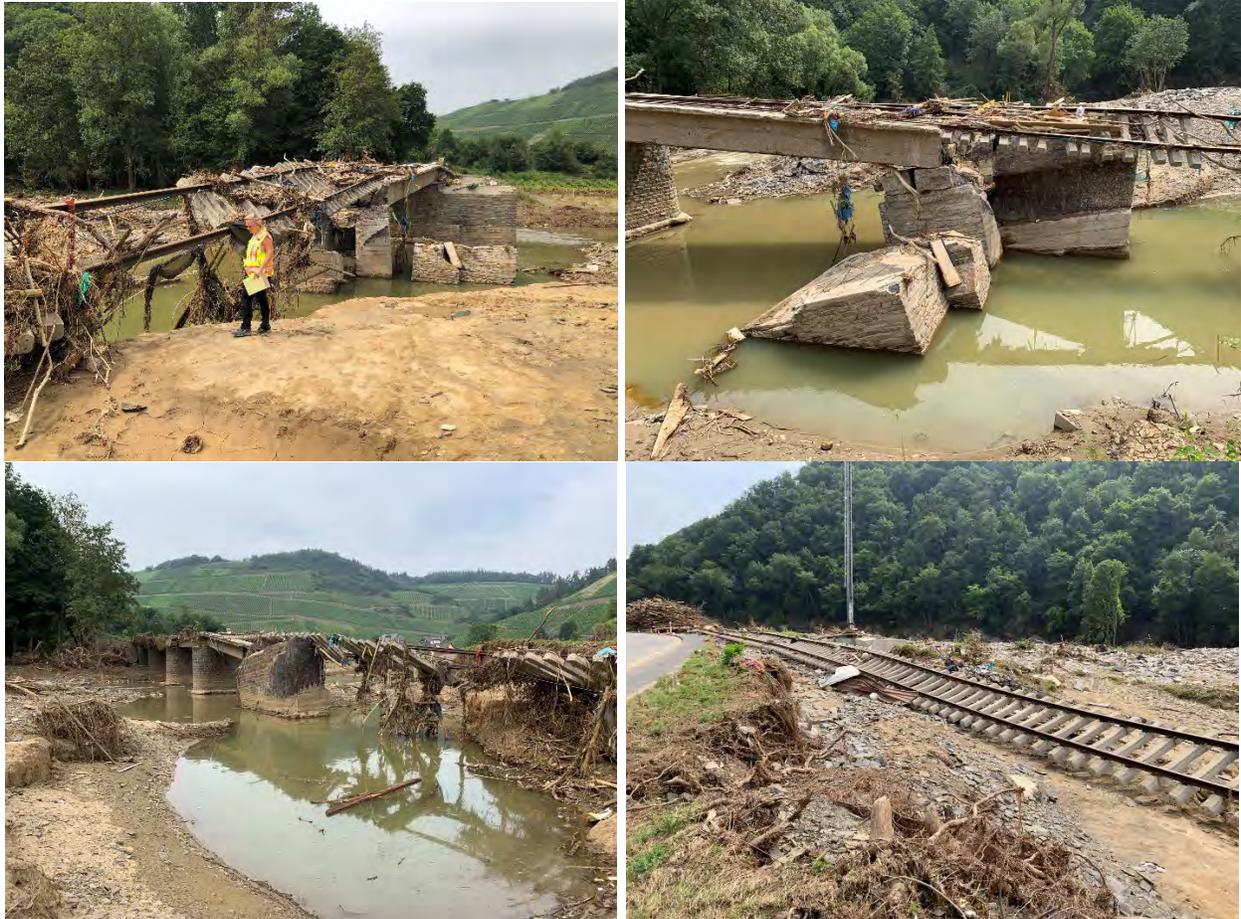
Figure 3.210. Documentation of damage to rail bridge "B" in Marienthal/Walporzheim, (50.5331621, 7.0592238).

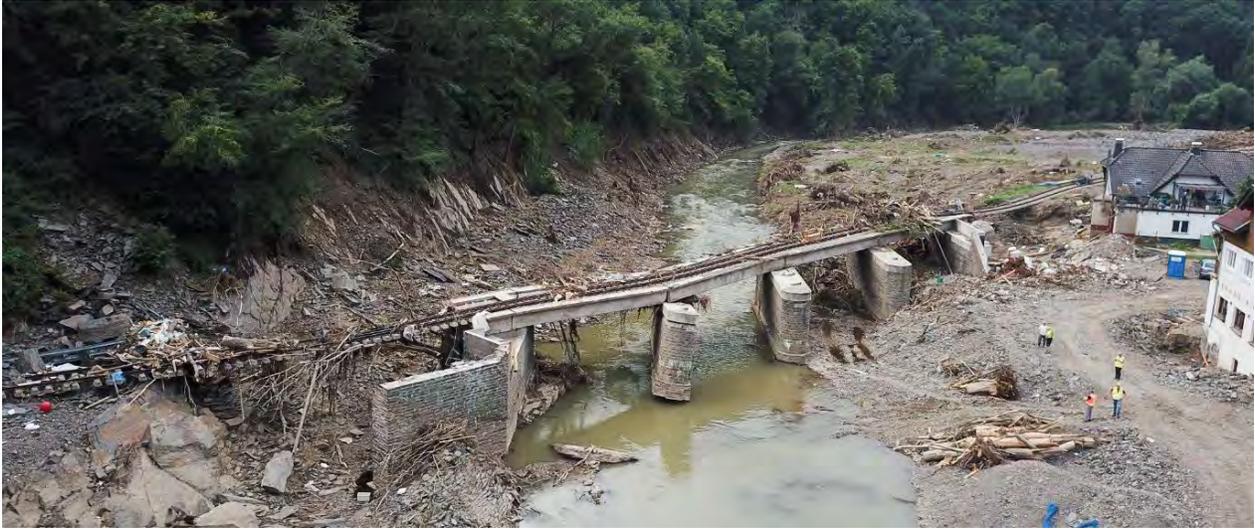
Figure 3.212. Drone image of rail bridge at Hotel zum Sanger (50.532217, 7.0624500)

Figure 3.211 and 3.212 show the bridge close by the Hotel zum Sanger as well as the residential and business buildings (Vinothek "Ahr") shown as "Bridge C" in Figure 3.207. This bridge, similarly to bridge "B" consisted of a rail deck and a pedestrian deck, resting next to each other on several brick support walls. Figure 3.211 shows photographs of the bridge prior to the flood obtained from online sources. A drone photo (Figure 3.212) of bridge C presents the extent of damage, which included completed erosion of the abutment areas, and heavy damage to the abutment structure in downstream direction left (shown on the right hand side in Figure 3.212). Several of the intermediate support walls tilted, rotated, and settled in the riverbed. The photograph also shows the massive erosion along the river to bedrock (see washed-out slopes on the left of Figure 3.212). Figure 3.213 depicts the damaged rail line approaching bridge "C" and the damage to the adjacent residential buildings.
