Geotechnical Reconnaissance of the 2021 Western European Floods

Flood Event: July 14-15, 2021

Flood locations: Germany, Netherlands, Belgium, and Luxembourg

Reconnaissance Visit: August 9-18, 2021

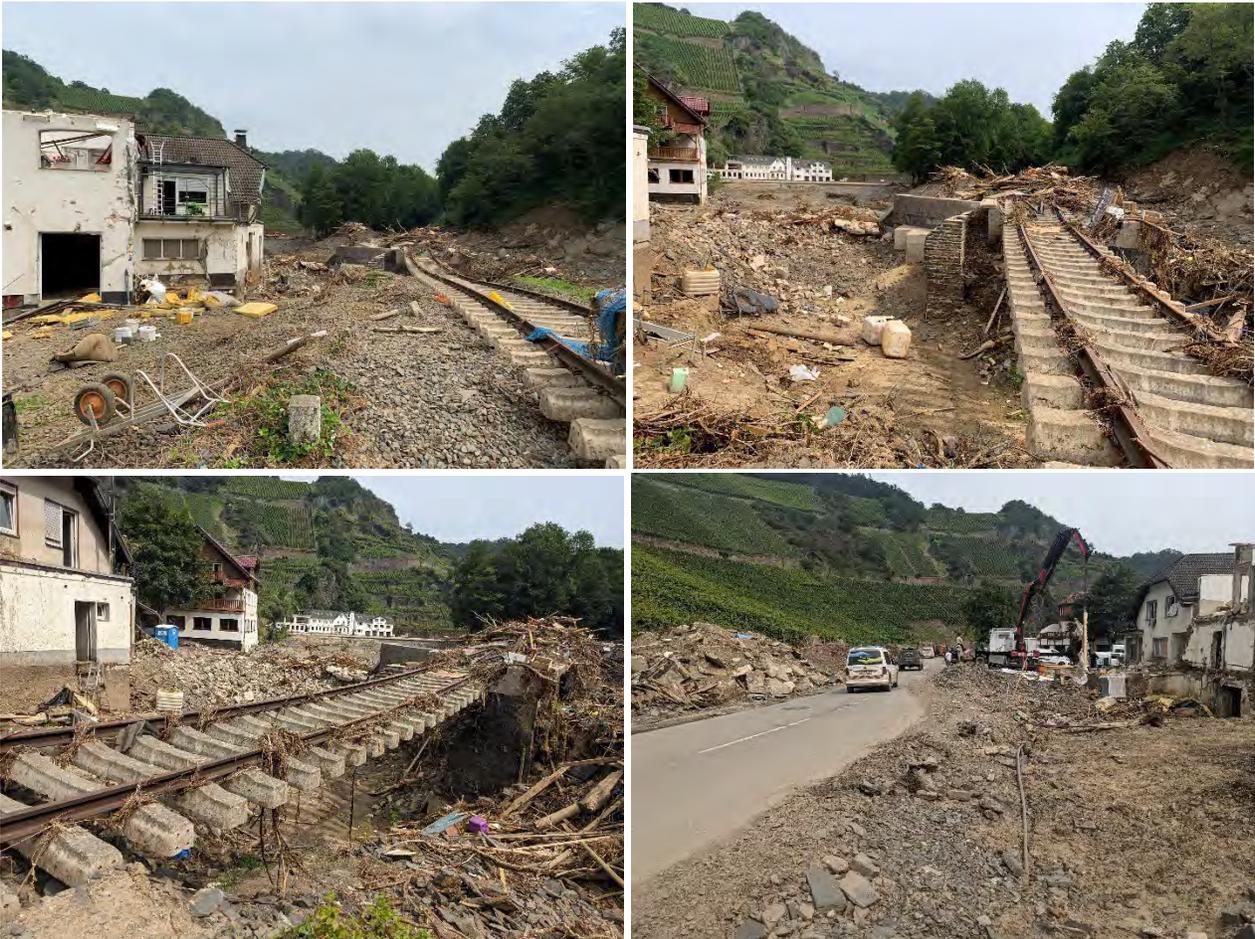
Figure 3.213. Damage documented around the rail bridge and adjacent residential building (50.532217, 7.0624500)

Figure 3.211 and 3.212 show the bridge close by the Hotel zum Sanger as well as the residential and business buildings (Vinothek "Ahr") shown as "Bridge C" in Figure 3.207. This bridge, similarly to bridge "B" consisted of a rail deck and a pedestrian deck, resting next to each other on several brick support walls. Figure 3.211 shows photographs of the bridge prior to the flood obtained from online sources. A drone photo (Figure 3.212) of bridge C presents the extent of damage, which included completed erosion of the abutment areas, and heavy damage to the abutment structure in downstream direction left (shown on the right hand side in Figure 3.212). Several of the intermediate support walls tilted, rotated, and settled in the riverbed. The photograph also shows the massive erosion along the river to bedrock (see washed-out slopes on the left of Figure 3.212). Figure 3.213 depicts the damaged rail line approaching bridge "C" and the damage to the adjacent residential buildings.

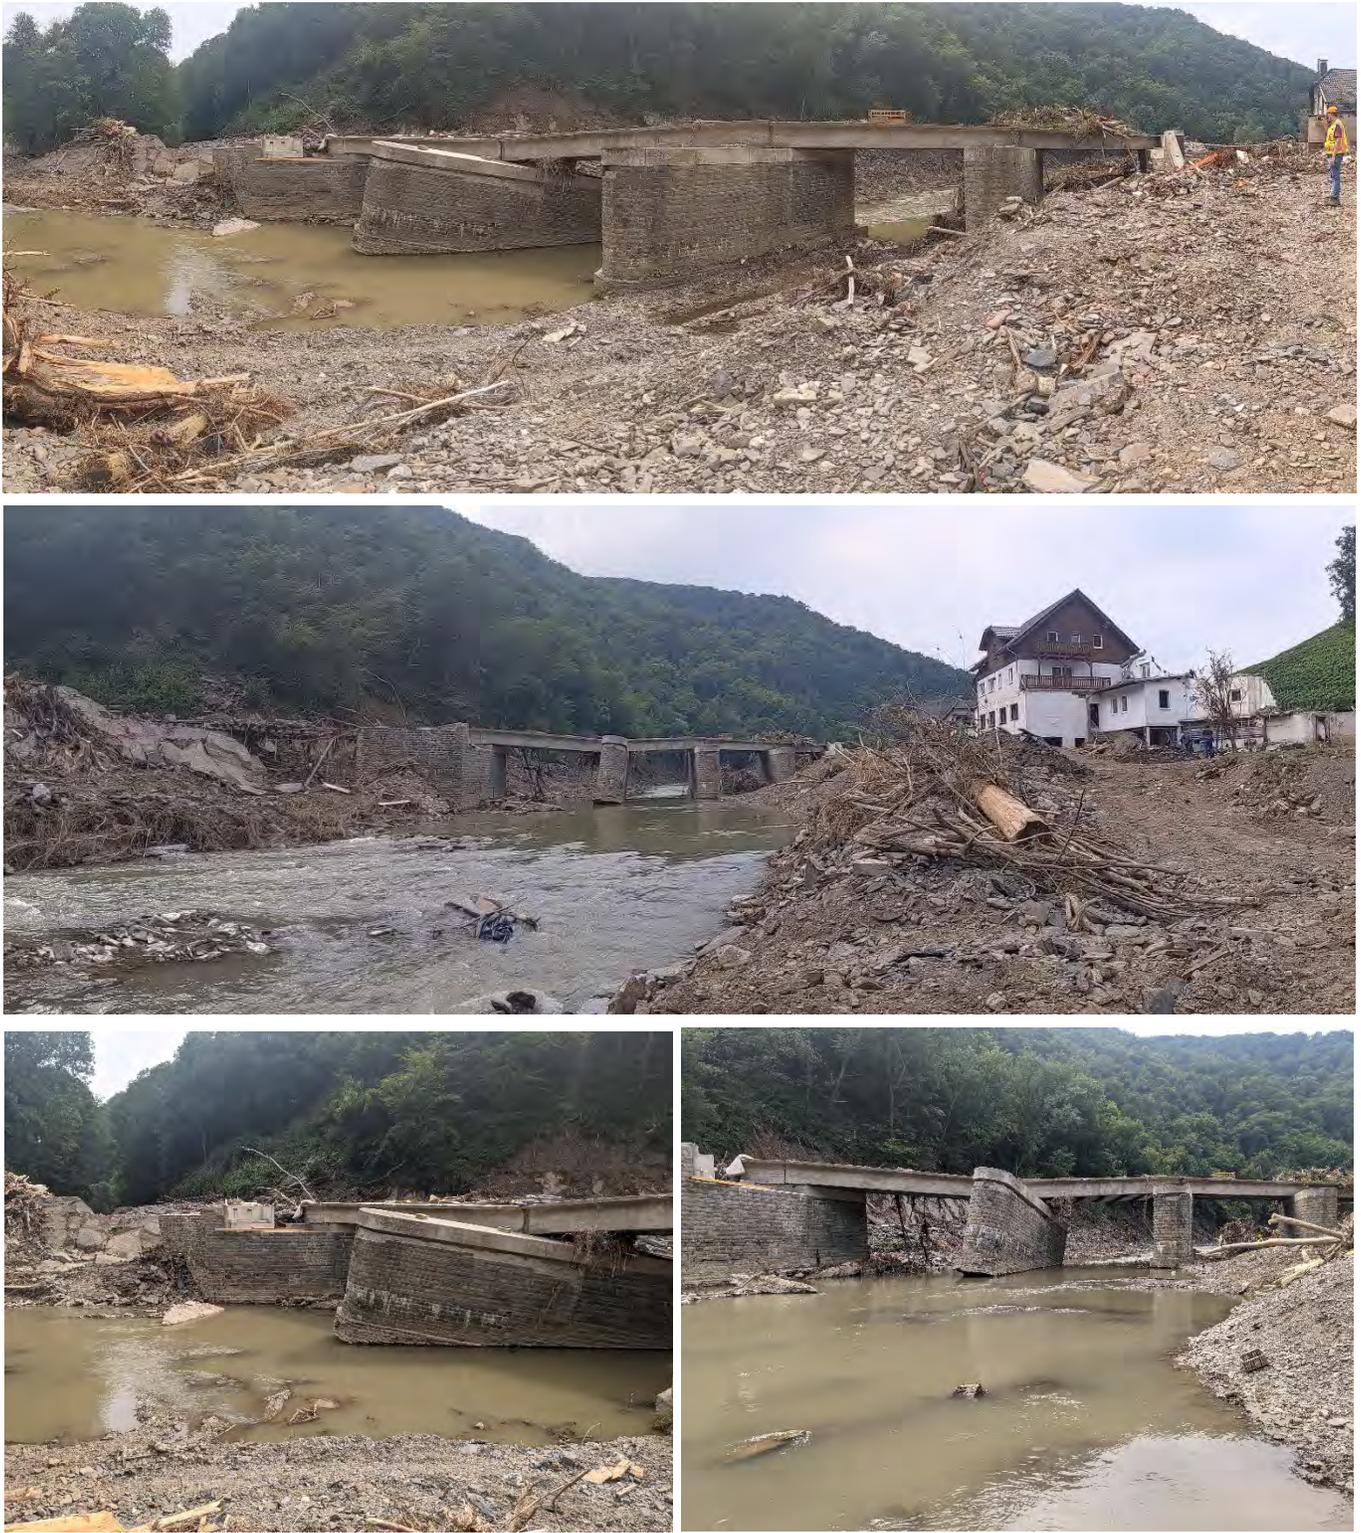
Figure 3.214 shows more photos of “bridge C” near the Hotel zum Sanger and depicts the severe tilt of the middle foundation support.

Substantial difference in elevation is visible around the deck and the water level, indicating rotation accompanied by settlement and soil erosion around the foundation element.

Figure 3.214. Rail bridge damage near Hotel zum Sanger, Marienthal/Walporzheim, (50.532217, 7.0624500).

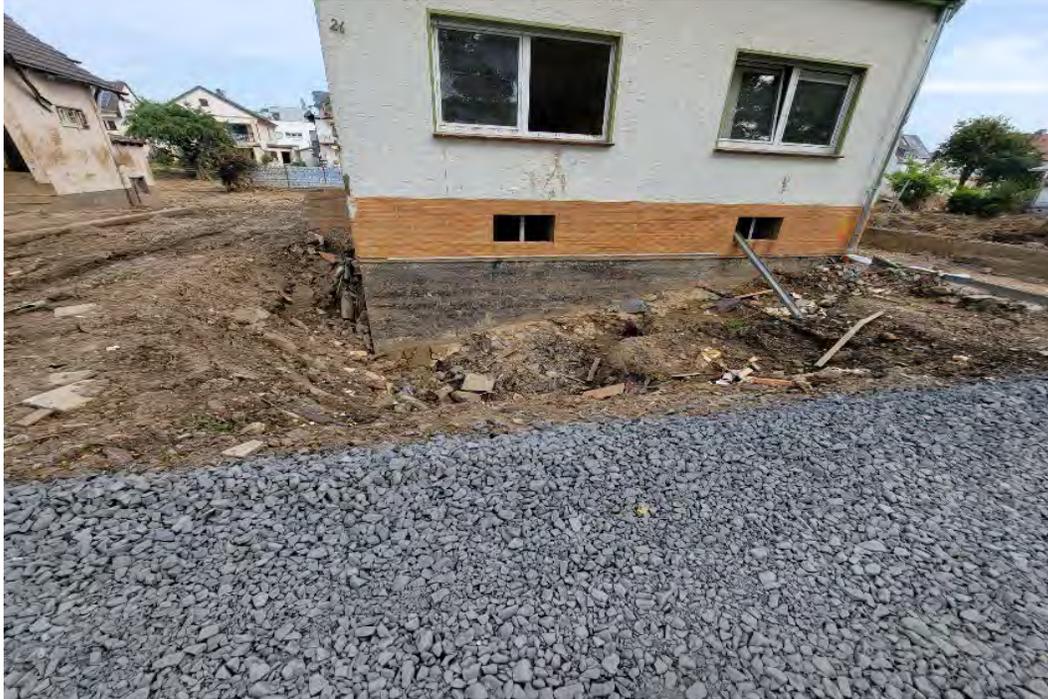
Figure 3.216. Residential building in Bad Neuenahr-Ahrweiler about 100 m from the Ahr river showing scour at corner of the building, destruction of yards and roads, and the original road just being temporarily replaced by a gravel road.

In Bad Neuenahr-Ahrweiler, the damage along the Ahrallee was investigated between the Bachemer bridge and the Amseltal bridge. Since most of the buildings here are located at a considerable distance to the river, the damage to buildings appeared less severe than in narrower locations of the Ahr valley. Nevertheless, damage to buildings, especially undercutting of foundations, was considerable in this area as well. The GEER team observed traces or scour around buildings reaching down to basement and foundation levels, destroyed yards, and roads (Fig. 3.216). Substantial high-watermarks in excess of 2 meters were visible in the same area. (Fig. 3.217).

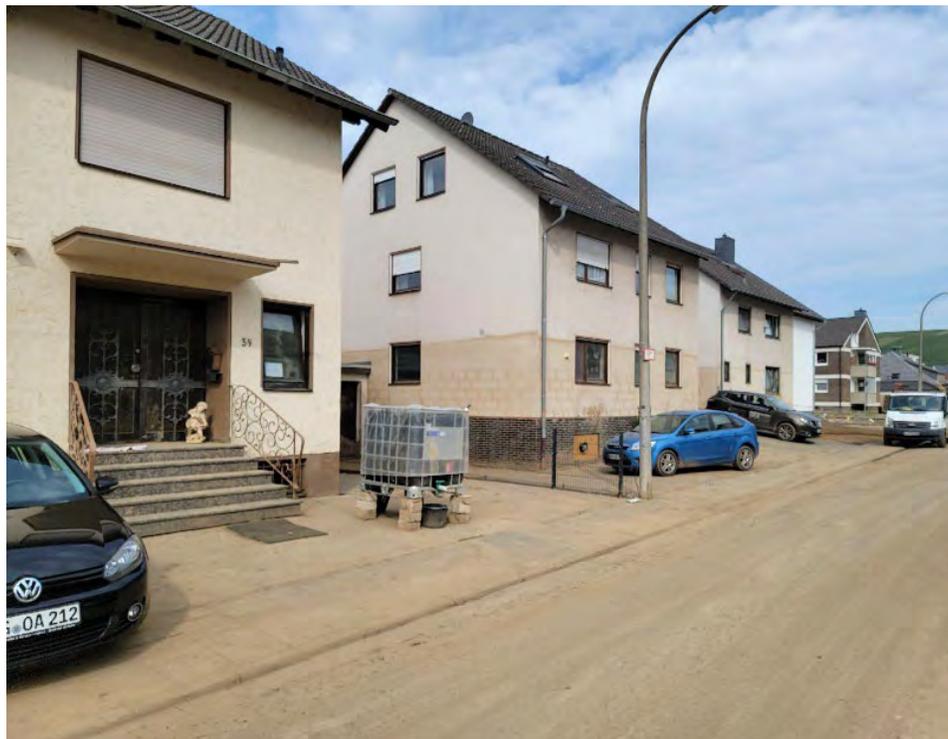
Figure 3.217. Residential area near the Ahr river, in Bad Neuenahr-Ahrweiler showing destruction of the road and high water marks on residential buildings in excess of 2 m. (50.5411069, 7.108835)

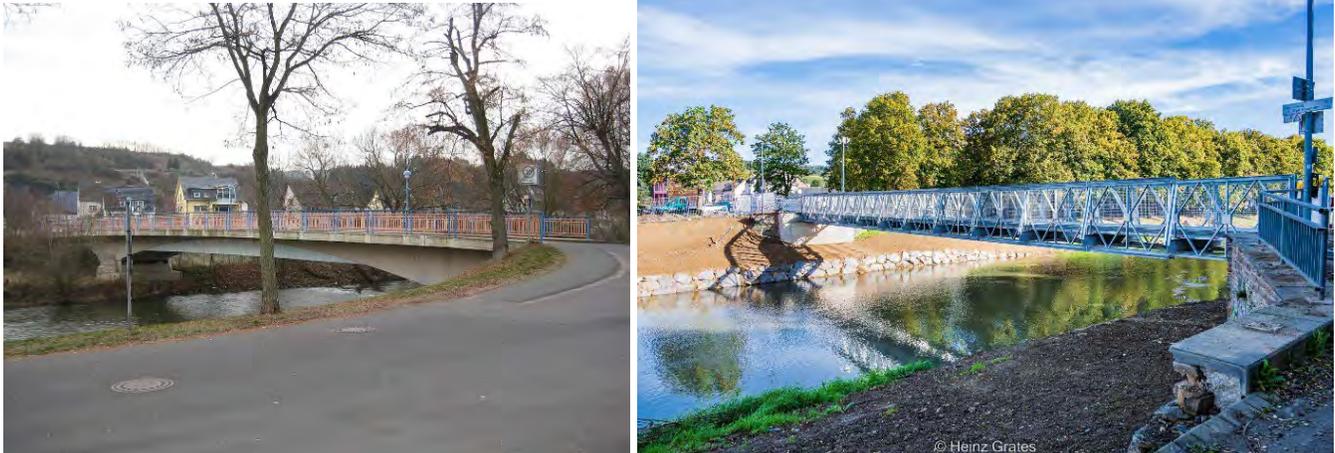
Figure 3.218. Left: Bachemer bridge before the flood event (source: https://www.aw-wiki.de/index.php/Ahrbr%C3%BCcken_im_Kreis_Ahrweiler); right: replacement bridge for the destroyed Bachemer bridge.

Of the four bridges in this section, the Bachemer Bridge and the Amseltal Bridge were completely destroyed by the flood (Figs. 3.218 and 3.219, respectively).

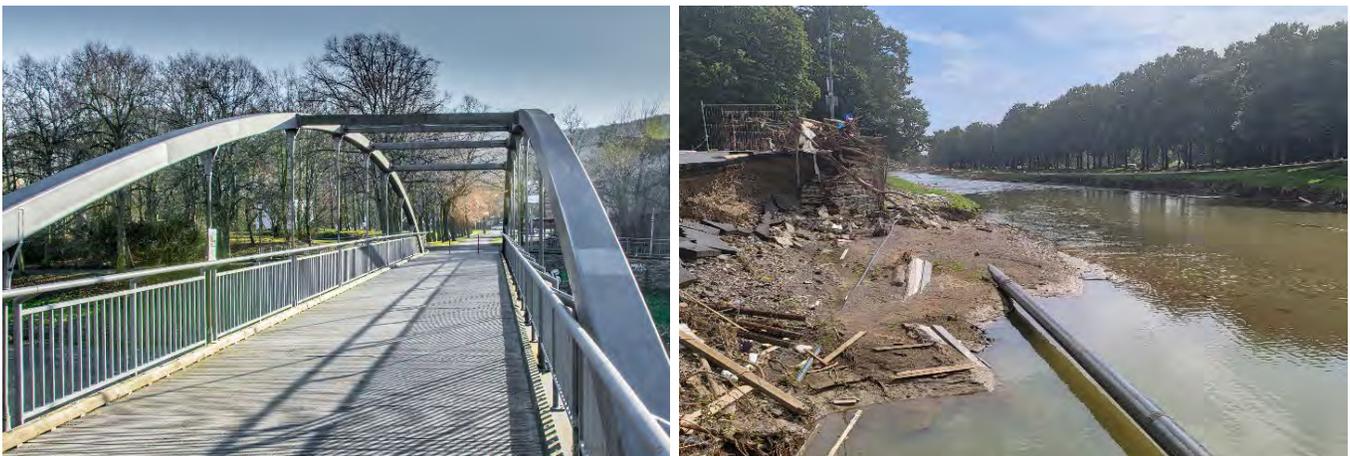
Figure 3.219. Left: Amseltal bridge before the flood event (source: https://www.aw-wiki.de/index.php/Ahrbr%C3%BCcken_im_Kreis_Ahrweiler); right: Destroyed Amseltal bridge at the time of the GEER visit (50.542624927, 7.124041563).

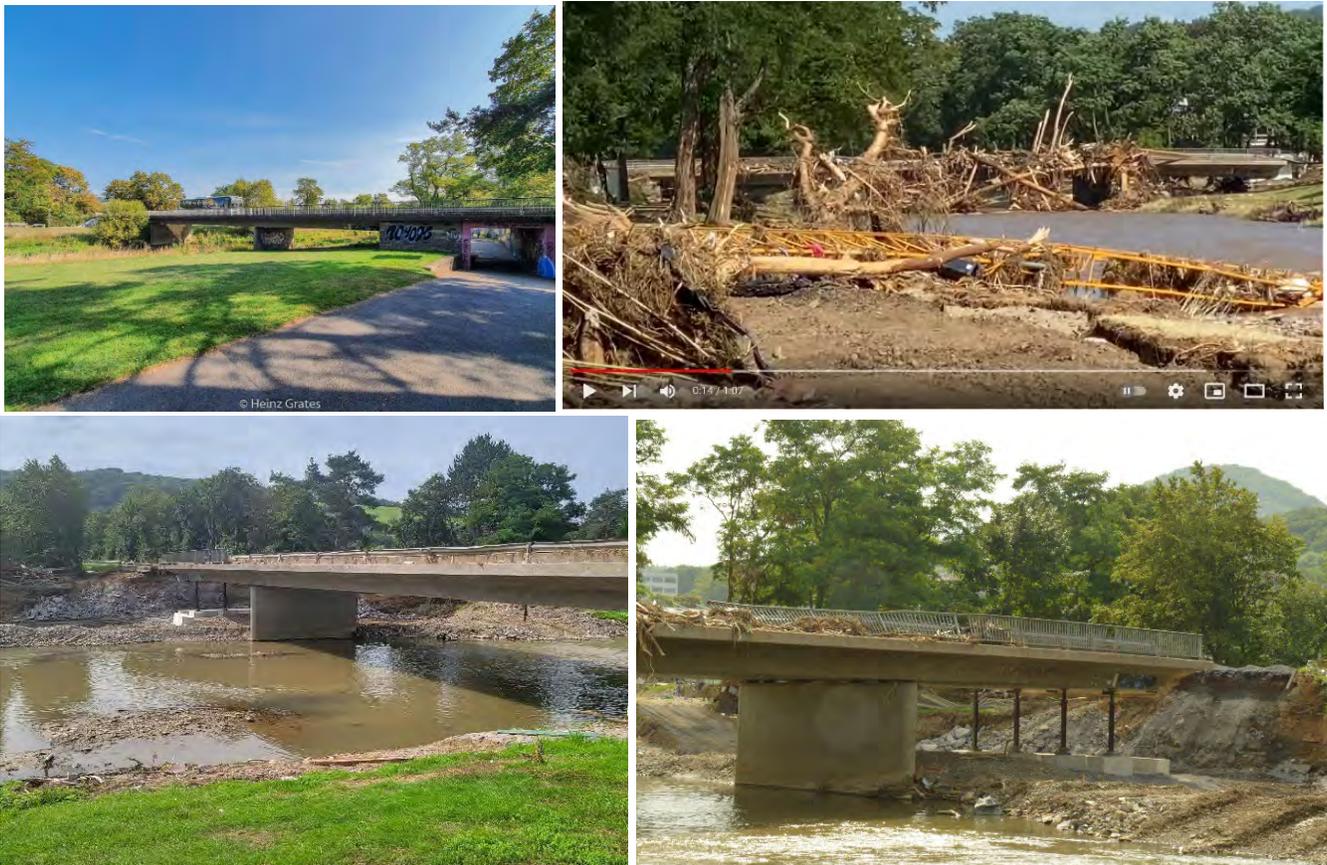
The bridge across the Bundesstrasse L83 was severely damaged. The accumulation of significant amounts of flotsam debris was documented shortly after the flood event. Riverbanks showed significant erosion around the bridge, and the underpass for pedestrians and cyclists was destroyed, requiring immediate stabilization of the bridge deck (Fig. 3.220). Figure 3.220 shows the bridge before the flood, immediately after the flood and at the time of the teams visit with damage to the bridge railing, significant sediment relocations at the riverbanks and within the riverbed, and the destruction and temporary stabilization of the pedestrian underpass part of the bridge.

Figure 3.220. L83 bridge Bad Neuenahr-Ahrweiler. Top left: prior to the flood event (source: https://www.aw-wiki.de/index.php/Ahrbr%C3%BCcken_im_Kreis_Ahrweiler); top right: significant deposition and accumulation of debris against and around the bridge during and shortly after the flood; bottom): the bridge at the time of the GEER team visit (50.542527; 7.121371)

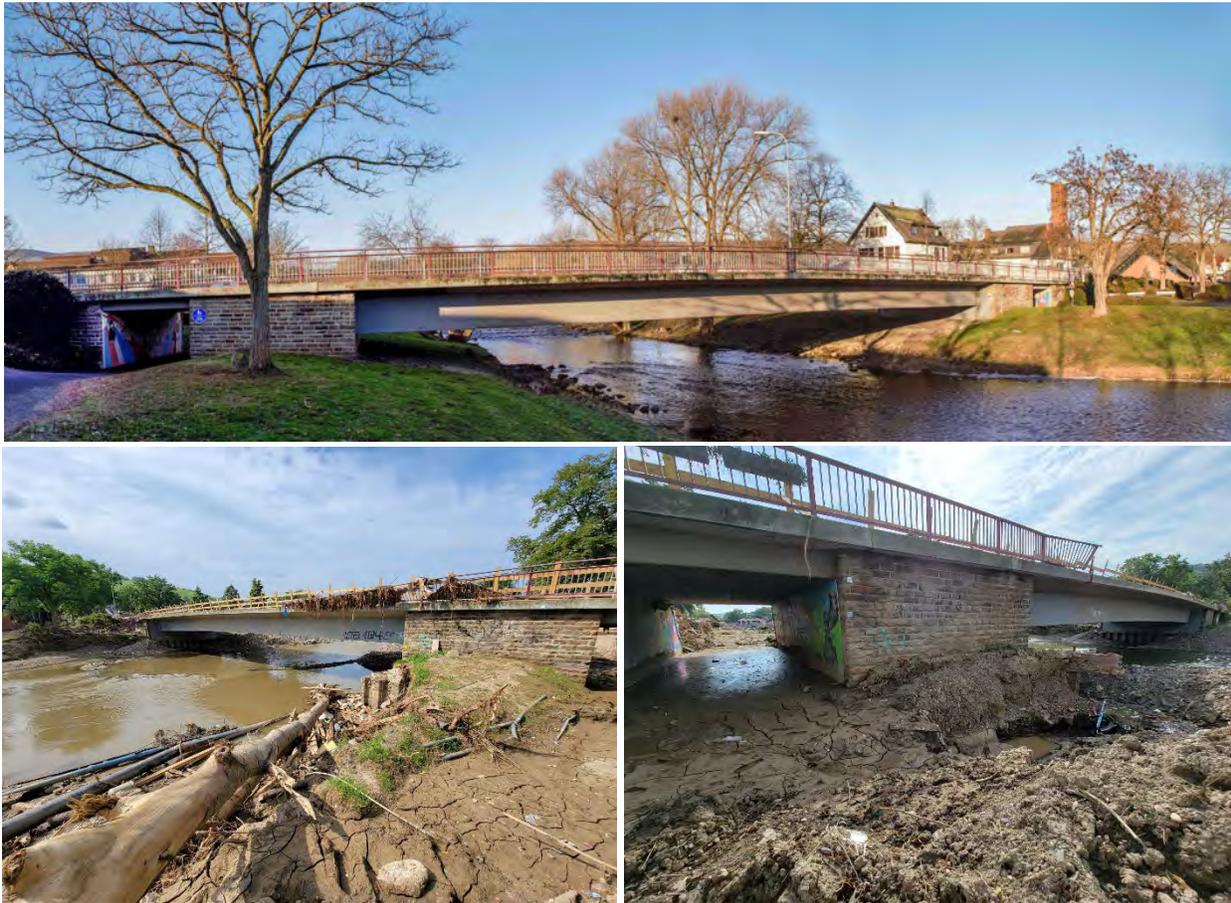
Figure 3.221. St.-Pius bridge Bad Neuenahr-Ahrweiler. Top) Bridge before flood; bottom) observations by the GEER team on August 12, 2021 (50.542423, 7.115540328).

At the St. Pius Bridge (Figure 3.221), scour was observed by the GEER team at the bridge pier that separates the pedestrian underpass from the river span. Despite the scour and damage to the bridge rails, this bridge was less severely damaged and was open to traffic at the time of the GEER team visit. Fig. 3.222 offers a close up at the scour. Responsible maybe a combination of efflux coming from a pipe that was exposed (Fig. 3.222) and shows a significant pool that appears likely associated to flow efflux, and of flow- bridge pier inter action creating scour particularly at the upstream river-side corner of the pier. Together, both processes may have formed the significant scour hole that is wrapping around the upstream side of the pier

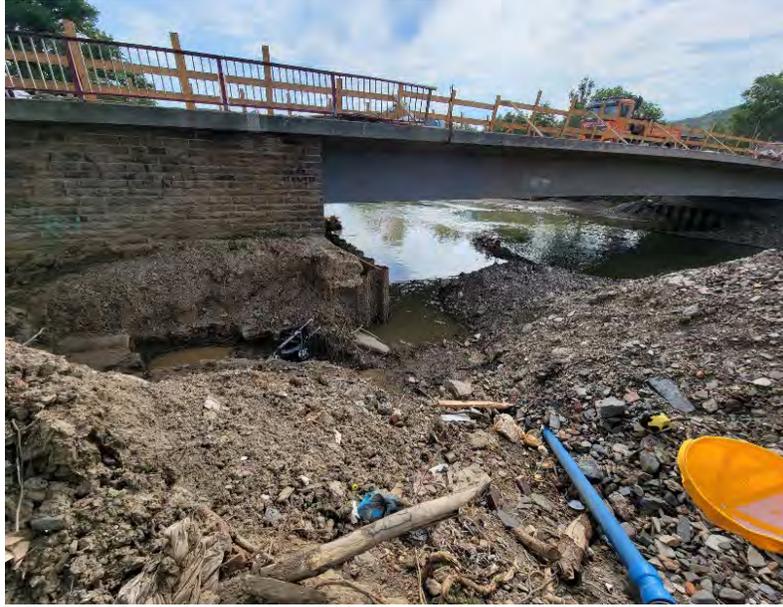
exposing gravelly substrata supporting the pier as well as a sheetpile construction towards the river side. It appears that the sheet pile wall succeeded to mitigate scour to undermine the pier.

Figure 3.222. Close up of the St. Pius Bridge pier in Bad Neuenahr-Ahrweiler separating the pedestrian underpass part of the bridge from the river crossing span. Significant scour is observed wrapping around the upstream part of the pier (50.542423, 7.115540328).

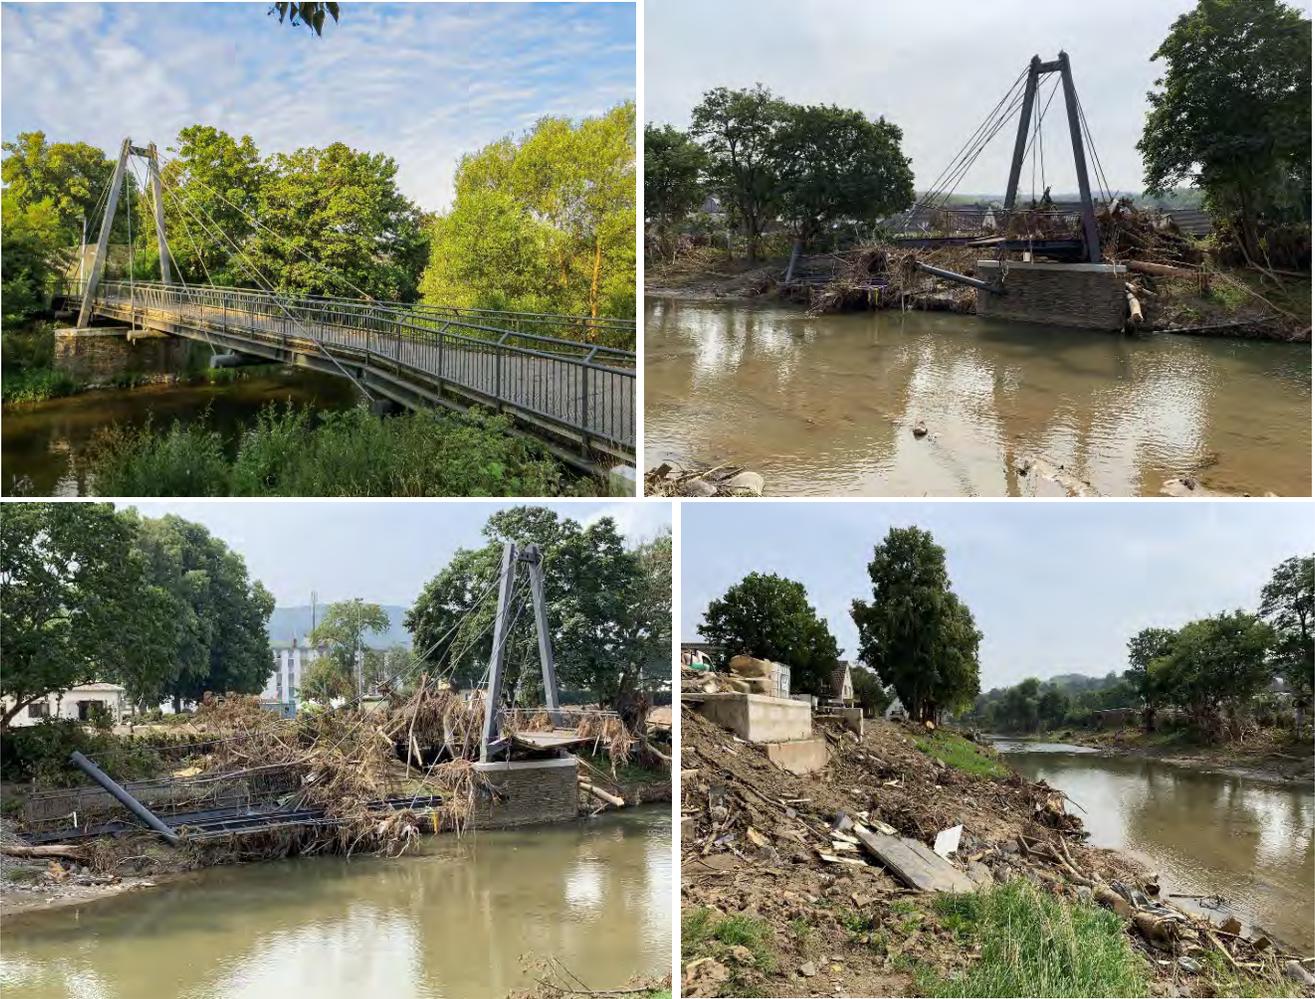
Figure 3.223. Otterbrücke, Bad Neuenahr Ahrweiler. top left) before the flood event top right & bottom left) destroyed bridge deck, rotated counterclockwise in downstream direction on August 12, 2021; bottom right) bridge abutment (downstream left), structurally intact at the time of the team's visit (50.53874, 7.1013125)

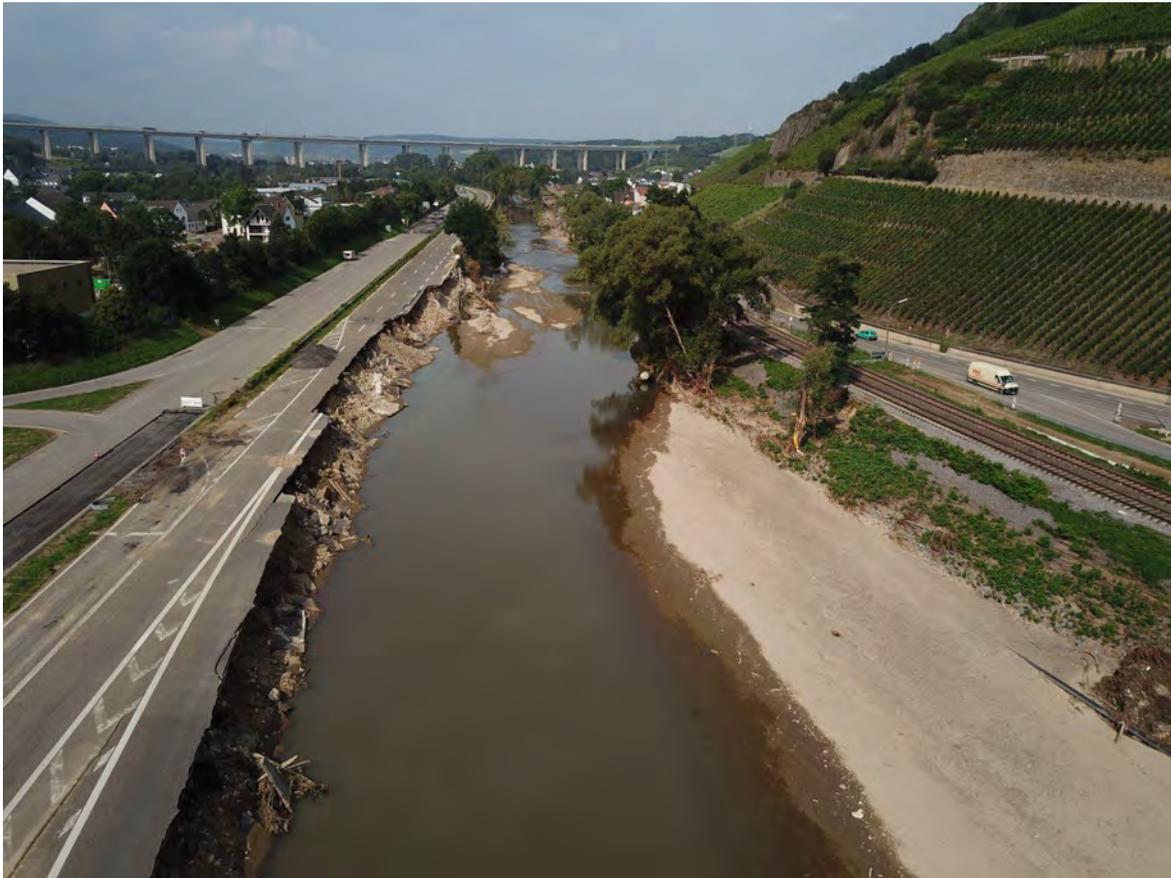
Figure 3.224. Overview image showing the Ahr river, undermining of B266 (left) and the railway tracks on August 12, 2021, after the flood (50.5468469, 7.1817397).

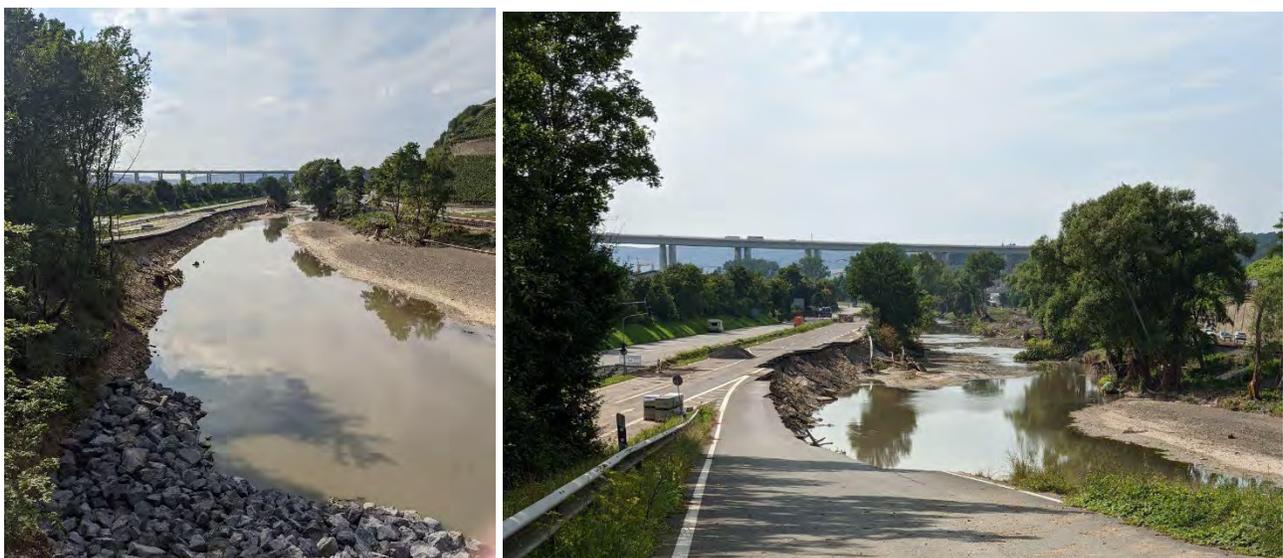
Figure 3.225. Shift of the Ahr river to adjacent to the B266 and associated road damage (50.5465709, 7.1828458).

In the town of Green, the Ahr river is fringed by railway tracks and the Landskroner Strasse to the North and by the federal highway 266 (B266) to the North with sometimes less than 20 m between the river and the railway tracks and as little as 10 m between the river and the highway. During the flood event, the riverbanks eroded so severely that erosion led to road damage to B266 and the riverbanks reached the railway tracks (Fig. 3.224). Overall, the river appears to be relocated in terms of a shift to the South approaching B266, while sediment deposits seem to have accumulated on the northern side (Figs. 3.225 and 3.226). Resulting road damage was significant (Fig. 3.224), particularly to a small asphalt road paralleling B266 between the highway and the river in some sections. However, railway track damage was also observed along short sections (Fig. 3.226). Local authorities recognized the risk to bridges and applied gravel and riprap scour protection and abutment stabilization (Fig. 3.226). It is unknown to the GEER team

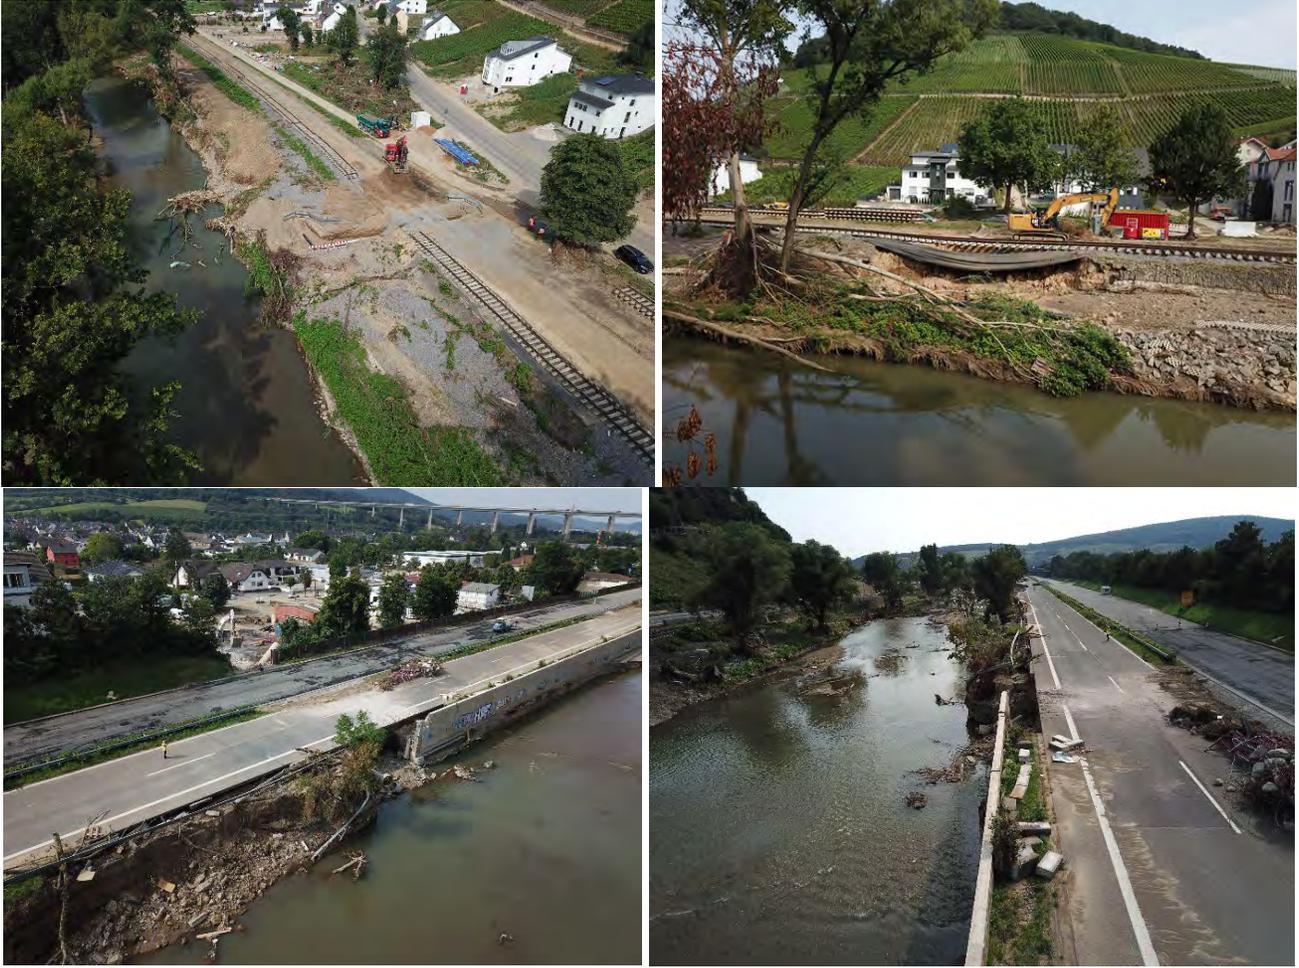
Figure 3.226. Rail damage (top) and embankment wall damage (bottom) along both sides of the Ahr river (50.547131515, 7.176075868).

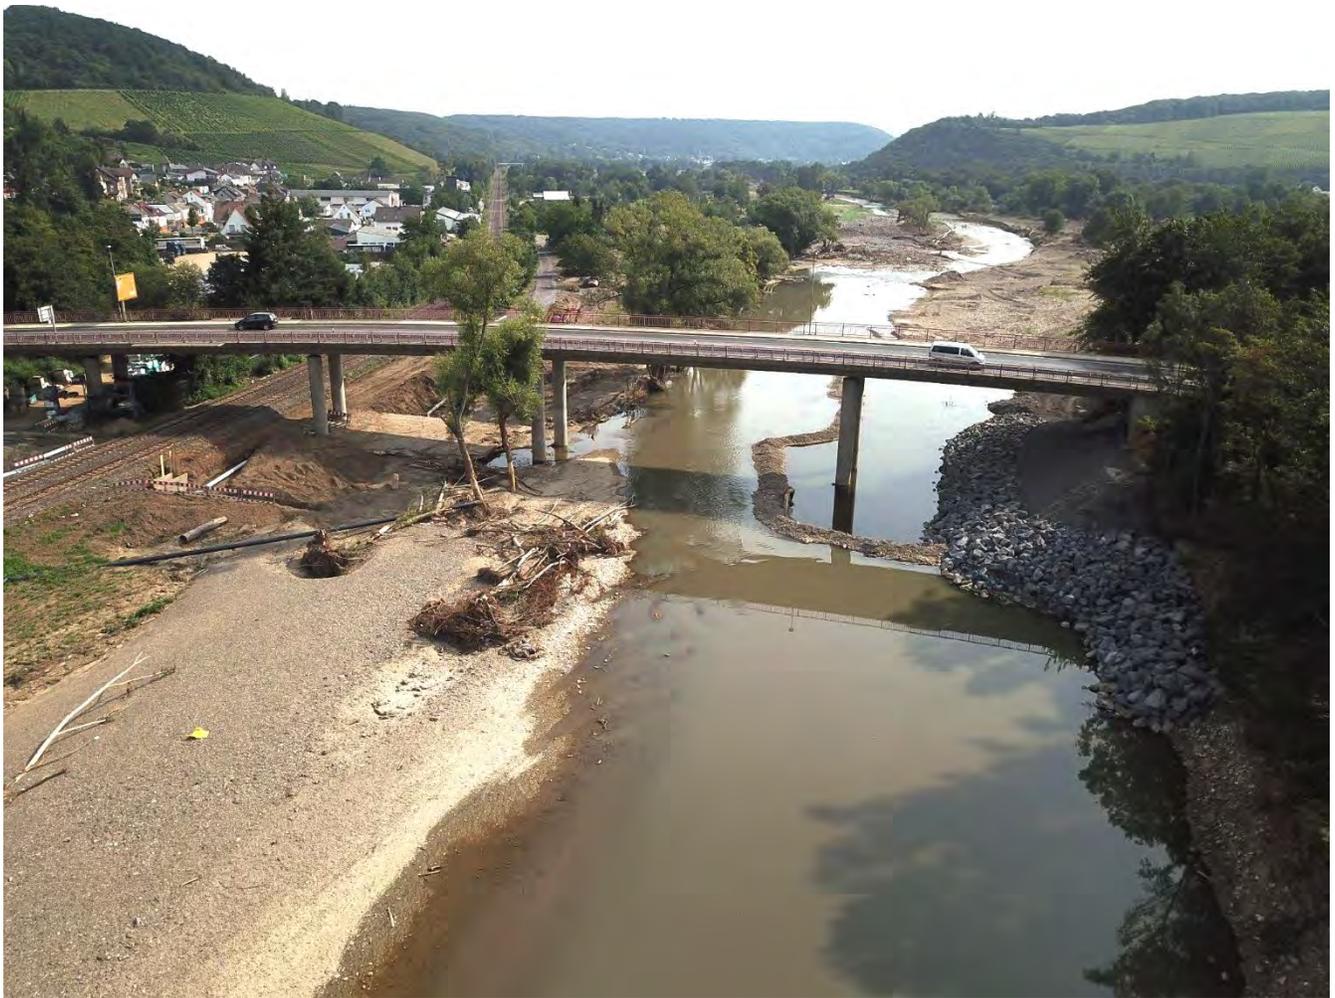
Figure 3.227. Recent gravel and riprap deposits supporting the bridge abutments in Green (50.5470057, 7.18318548).

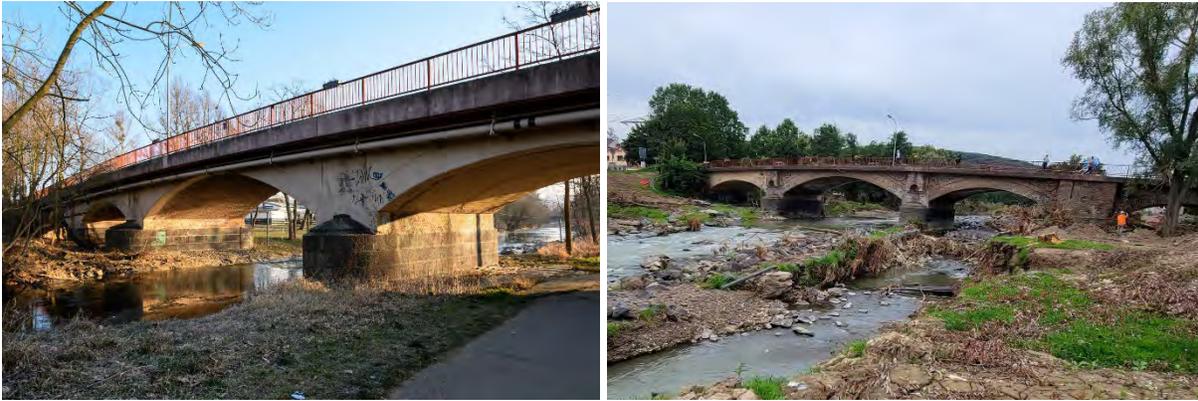
Figure 3.228. Koelner Strasse bridge crossing the Ahr in Sinzig (left, source: https://www.aw-wiki.de/index.php/Ahrbr%C3%BCcken_im_Kreis_Ahrweiler) before the flood event and (right) at the time of the GEER-visit (August 12).

The section between the Kölner Straße bridge (Fig. 3.228) and the B9 bridge, both crossing the Ahr, was investigated in Sinzig by the GEER team. Only minor damage was caused to Koelner Strasse bridge as a result of the flood event. However, significant scour was documented under the northern arch spanning from the abutment to the first bridge pier over the river bank and around the northern bridge pier. A scour depth of consistently ~ 60 cm was reported (lpm.rlp.de). Riprap was filled into the scour hole and into an erosion channel that suggests severe flow from the upstream northern riverbank through the northernmost arch of the bridge, likely serving the load-bearing capacity of the pier (Fig. 3.229). It appears that reinforced soil around the abutment of the bridge mitigated scour at the abutment. The bridge was reopened to traffic on August 12, the same day as the investigation by the GEER team (lpm.rlp.de).

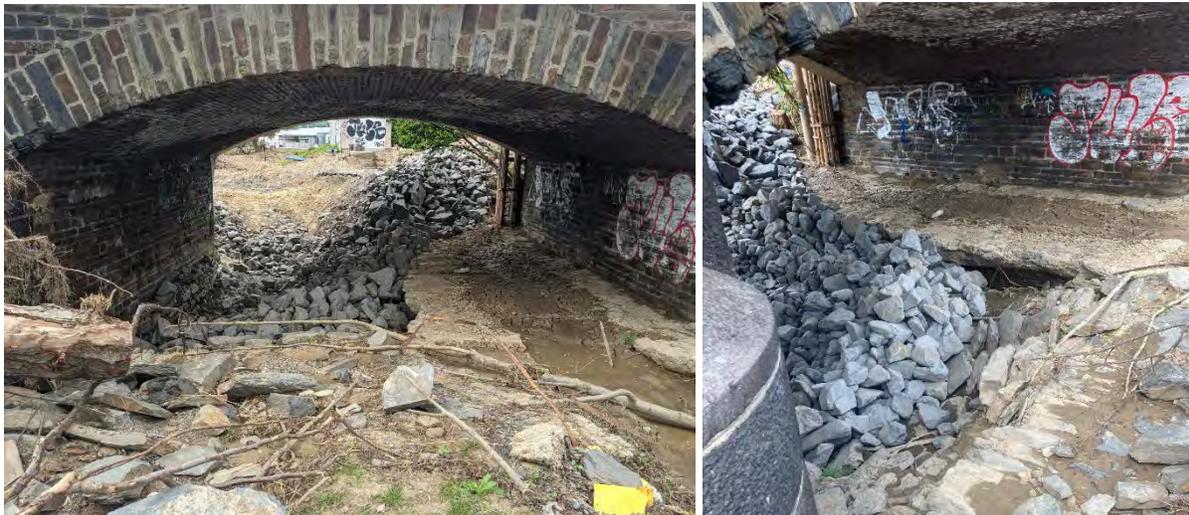
Figure 3.229. Infill of the scour hole and of an erosion channel suggesting flow from the top of the upstream northern riverbank down through the northernmost bridge arch (50.549856, 7.244673).

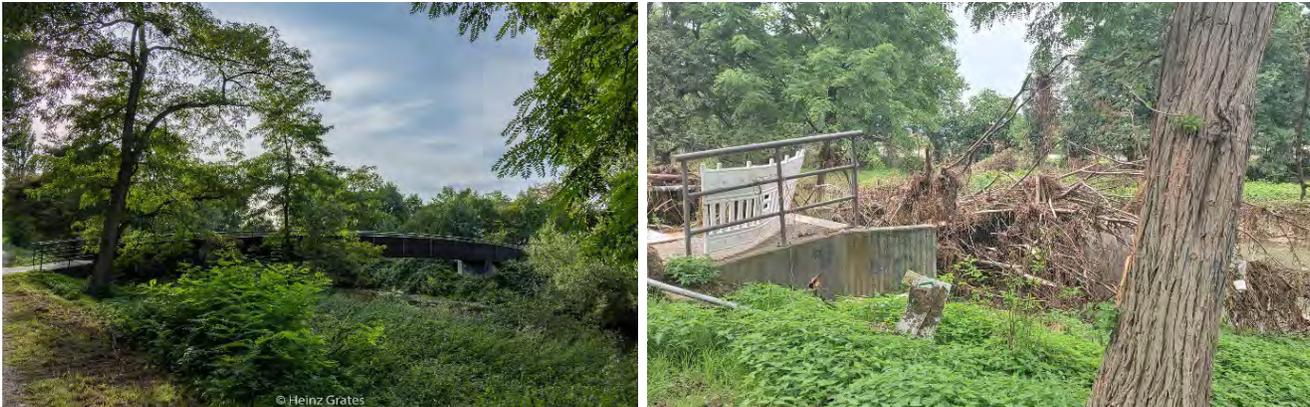
A pedestrian bridge between Koelner Strasse and B9 was completely destroyed by the flood (Figure 3.230). Significant debris, mostly trees and vegetation were deposited in the original location of the bridge (Fig. 3.230).

Figure 3.230. Pedestrian bridge Sinzig before the flood (left, photo by Heinz Grate @ https://www.aw-wiki.de/index.php/Ahrbr%C3%BCcken_im_Kreis_Ahrweiler) and on August 12, 2021 (50.551174; 7.249713).

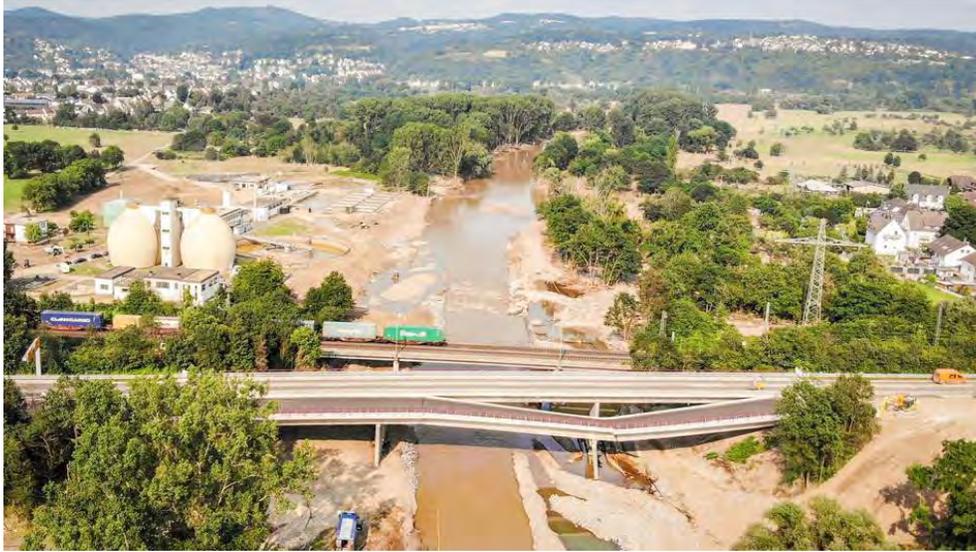
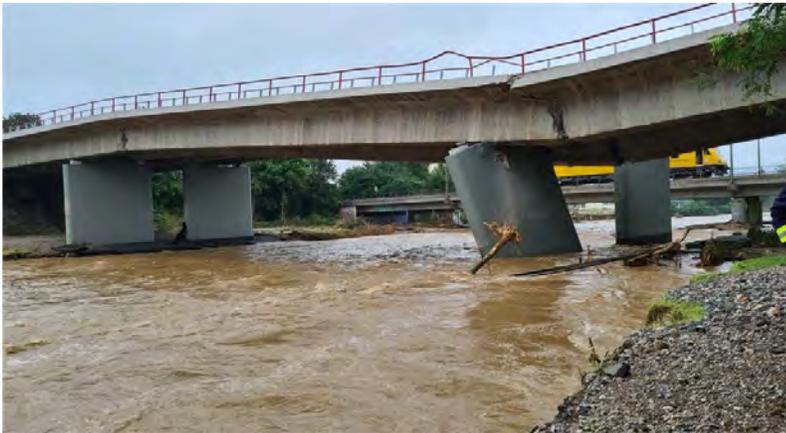
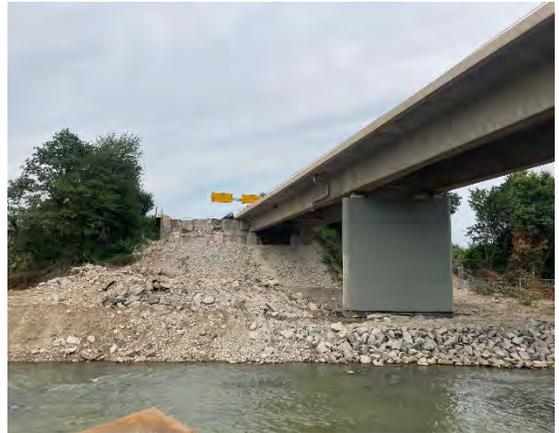
Figure 3.231. B9 bridge in Sinzig (left) shortly after the flood event, Source: blick-aktuell.de;

The federal highway 9 (B9) bridge in Sinzig experienced significant damage during the flood event (Fig. 3.231). The bridge piers of this bridge are typically located on the riverbanks and not exposed to flow. However, soil deposits suggest the significant expansion of the Ahr width during the flood event reaching a water treatment facility just downstream of the bridge (Fig. 3.231). Soil deposits may also suggest that significant flow, possibly enhanced by the presence of asphalt-bicycle ways leading from higher grounds to the river plain may have contributed to the more focused damage at the southern bridge pier. A significant scour hole formed, and the southern bridge tilted, leading to sagging and breaking of the bridge deck (Figs. 3.231 and 3.232). The railway bridge downstream of the B9 bridge seemed less impacted with traffic ongoing.

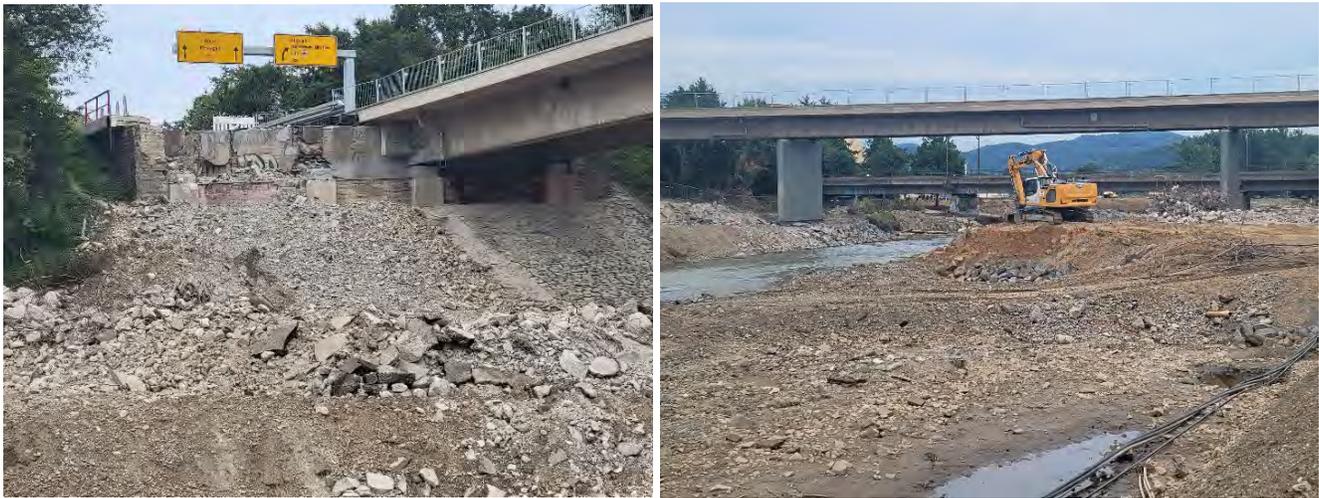
Figure 3.232. Left: Removed damaged bridge deck of the B9 in Sinzig on August 12, 2021, northern riverbank. Right: Active soil preparation and infill ongoing on the southern riverbank side (50.55218, 7.253561)

At the time of the GEER team visit on August 12, 2021, the failed upstream bridge deck was removed and soil preparation and stabilization for reconstruction was ongoing (Fig. 3.232).

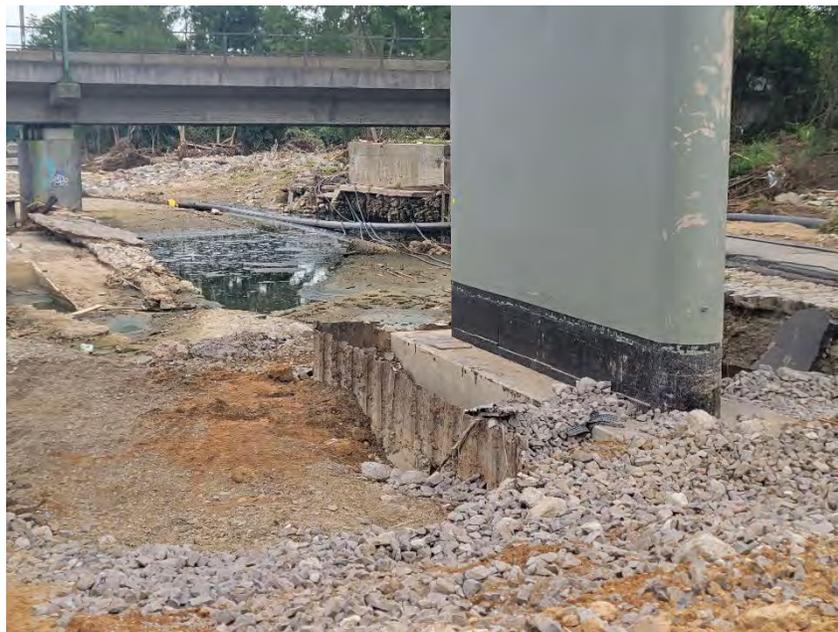
The GEER team also inspected the downstream southern riverbank bridge pier. Erosion exposed sheetpile wall reinforcement around the foundation caps to a soil depth of about one meter around the entire pile (Fig. 3.233). Asphalt and cobble-concrete reinforcement along a pedestrian path was damaged, but also in some instances still in place. Erosion is also clearly visible towards the railway bridge piles; however, erosion seems to not have reached to critical levels here.

Figure 3.233. Sinzig B9 bridge downstream southern bridge pier at the time of the team visit (August 12) with the railway bridge in the background (50.55218, 7.253561).

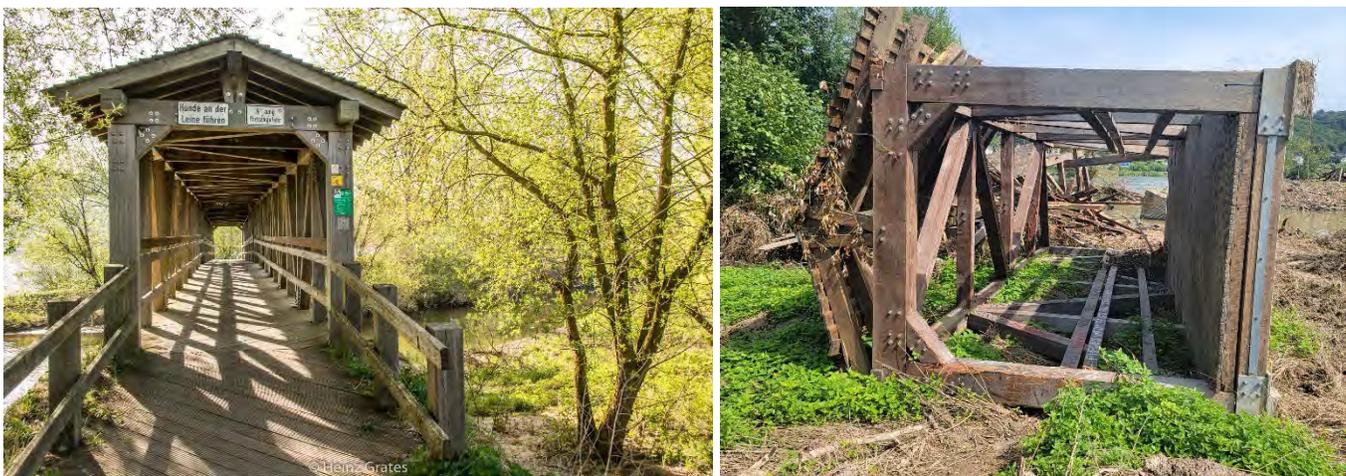
Figure 3.235. Bicycle path bridge across the Ahr before the flood (left, source: https://www.aw-wiki.de/index.php/Ahrbr%C3%BCcken_im_Kreis_Ahrweiler) and on August 12, 2021 (right), (50.558957; 7.276552).

The confluence of the Ahr river to the river Rhine in Kripp-Remagen was investigated on August 12. At that time it appeared like business as usual in Kripp including active ferry and other river traffic on the Rhine. The confluence area Ahr-Rhine classifies as a nature reserve (nature reserve “Mündungsgebiet der Ahr”) with development limited to recreational bicycle paths. A small wooden bridge connected the bicycle path across the Ahr and parallel to the Rhine (Fig. 3.234). This bridge was completely destroyed by the flood (Fig. 3.235). Large amounts of debris were deposited around this location. The bridge abutments seemed still in place and stable; however, the bridge pier was clearly tilted forward. This may suggest to be a result of severe scour that eroded the soil directly adjacent upstream of the pier, possibly undermining the pier if on shallow foundations so that the pier was able to slip and tilt into its own scour hole (Fig. 3.236).
