Geotechnical Reconnaissance of the 2021 Western European Floods

Flood Event: July 14-15, 2021

Flood locations: Germany, Netherlands, Belgium, and Luxembourg

Reconnaissance Visit: August 9-18, 2021

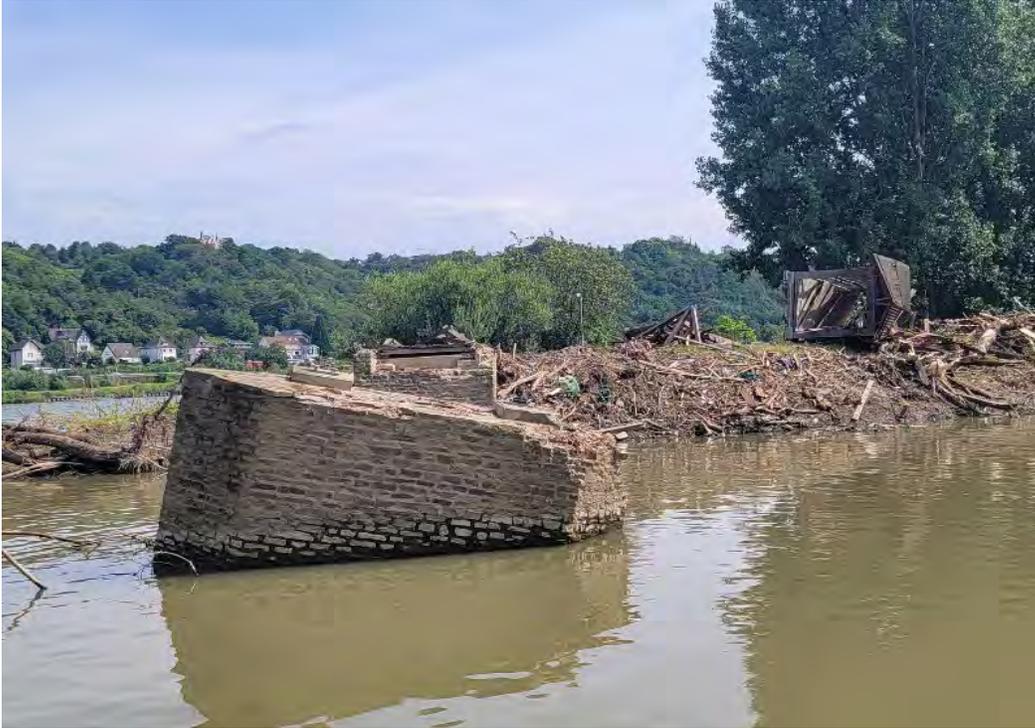
Figure 3.236. Tilted bridge pier of Ahr-Rhine confluence bicycle bridge (50.558957; 7.276552).

The confluence of the Ahr river to the river Rhine in Kripp-Remagen was investigated on August 12. At that time it appeared like business as usual in Kripp including active ferry and other river traffic on the Rhine. The confluence area Ahr-Rhine classifies as a nature reserve (nature reserve “Mündungsgebiet der Ahr”) with development limited to recreational bicycle paths. A small wooden bridge connected the bicycle path across the Ahr and parallel to the Rhine (Fig. 3.234). This bridge was completely destroyed by the flood (Fig. 3.235). Large amounts of debris were deposited around this location. The bridge abutments seemed still in place and stable; however, the bridge pier was clearly tilted forward. This may suggest to be a result of severe scour that eroded the soil directly adjacent upstream of the pier, possibly undermining the pier if on shallow foundations so that the pier was able to slip and tilt into its own scour hole (Fig. 3.236).

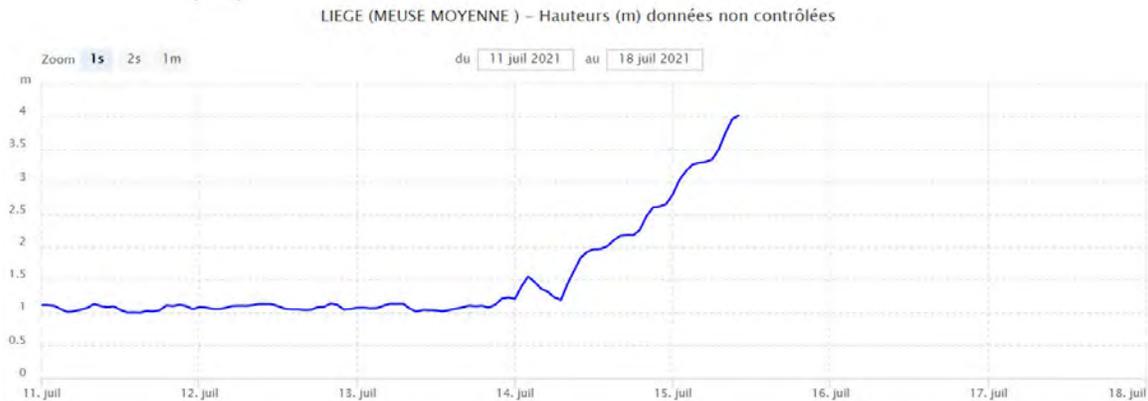
Figure 3.238. Meuse river water level. River flood alerts in Belgium as of 16 July 2021. Image: Voies Hydrauliques Wallonie. Source: <https://floodlist.com/europe/floods-belgium-july-2021> <https://www.reuters.com/business/environment/belgium-warns-against-travel-flood-death-toll-hits-14-2021-07-16/>

The water level of the Meuse river elevated in the city of Liege from 1.2m (July 14) to 4.01m (July 15) (Figure 3.238). The Meuse is a major European river flowing through France, Belgium and the Netherlands over a total length of 925 kilometers before draining in the North Sea. In Belgium, approximately 1,000 residents close to the riverbanks were asked to evacuate the area. The districts of Chênée and Angleur in the south of Liege, close to where the Ourthe river (a right tributary to the river Meuse) flows into the mainstem, were heavily affected.

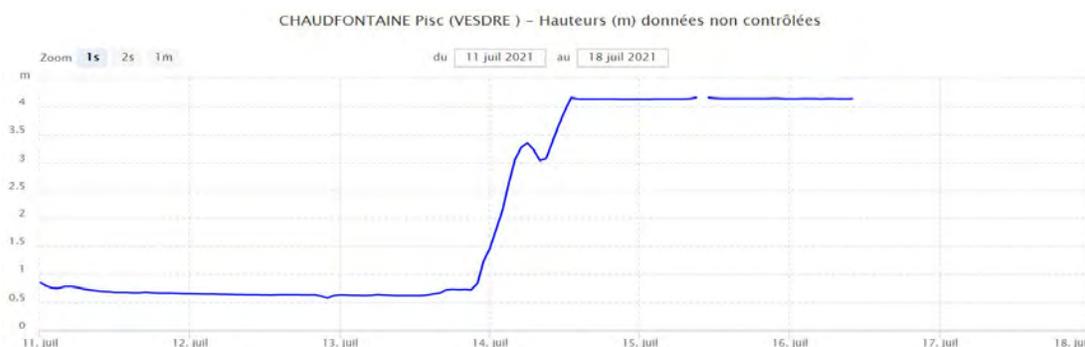
Figure 3.239. Vesdre river water level at Chaudfontaine. River flood alerts in Belgium as of 16 July 2021. Image: Voies Hydrauliques Wallonie. <https://floodlist.com/europe/floods-belgium-july-2021>
<https://www.reuters.com/business/environment/belgium-warns-against-travel-flood-death-toll-hits-14-2021-07-16/>

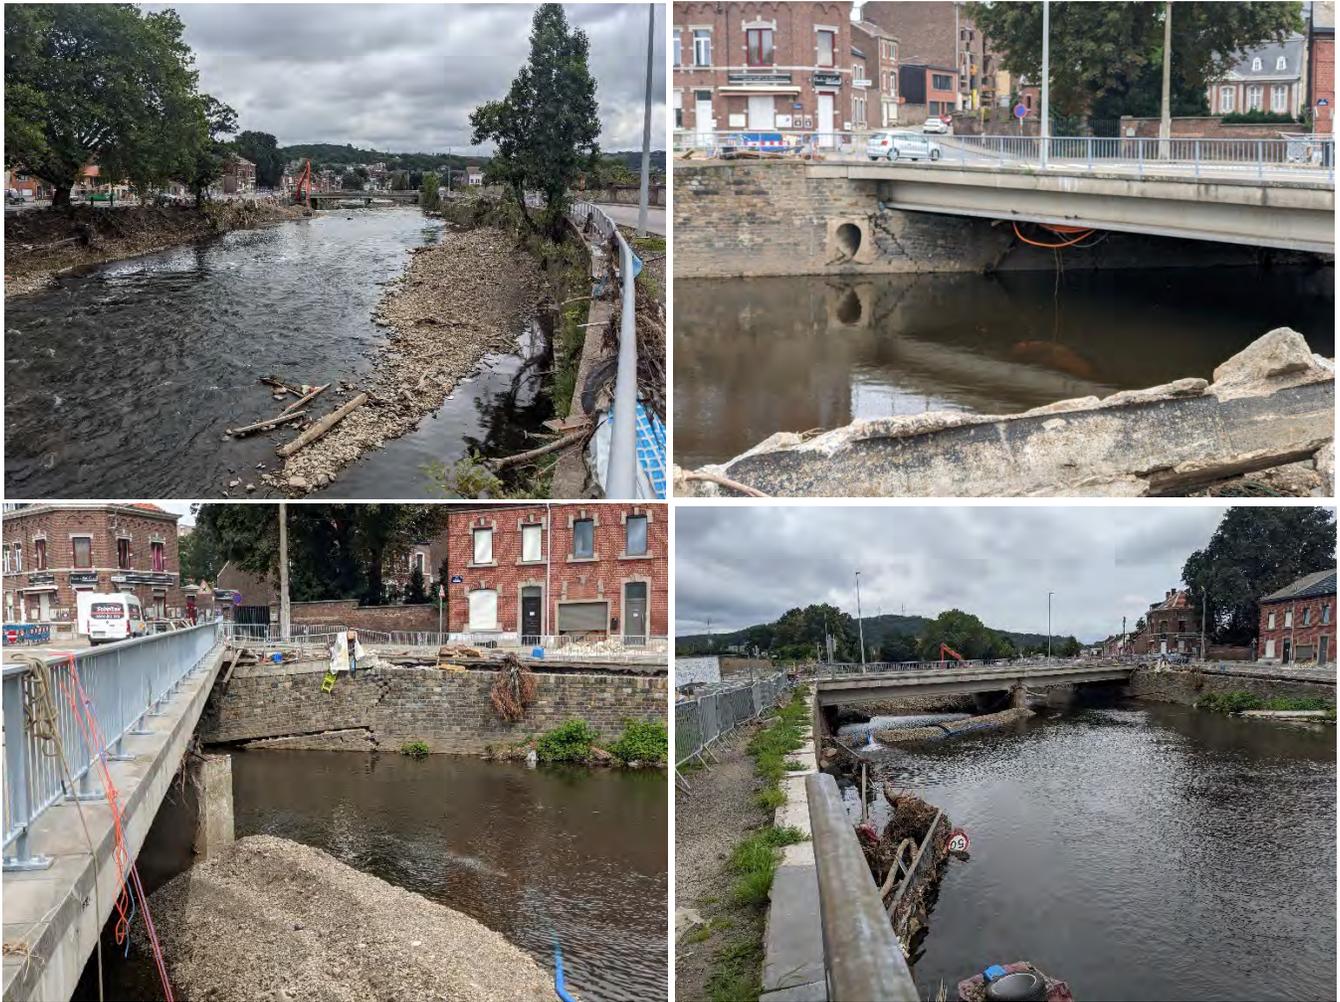
Figure 3.243. Bridge "Pont du L'honneux" in Liege (50.609966, 5.6194468).

Substantial damage around the bridge Pont du L’honneux (50.609965, 5.619422) was observed along the pedestrian walkway, the bridge support walls, and the surrounding embankment walls (Figure 3.243). Even though substantial cracking was visible in one of the support walls, (see Figure 3.243 bottom), the bridge remained in use. The bridge support walls consisted of masonry walls, an outlet for wastewater is visible in Figure 3.243 top right.

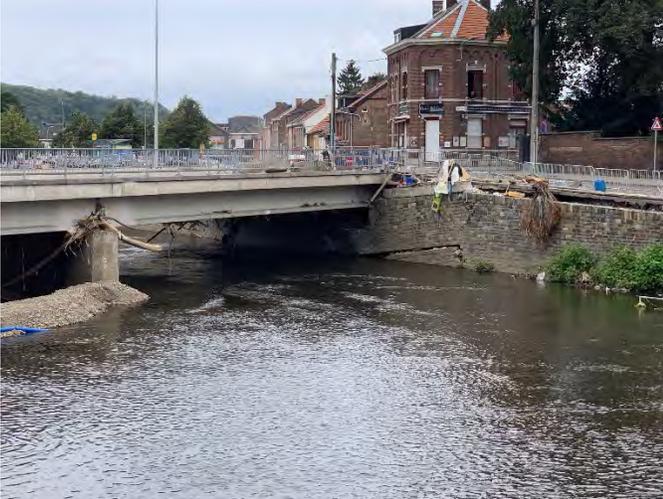
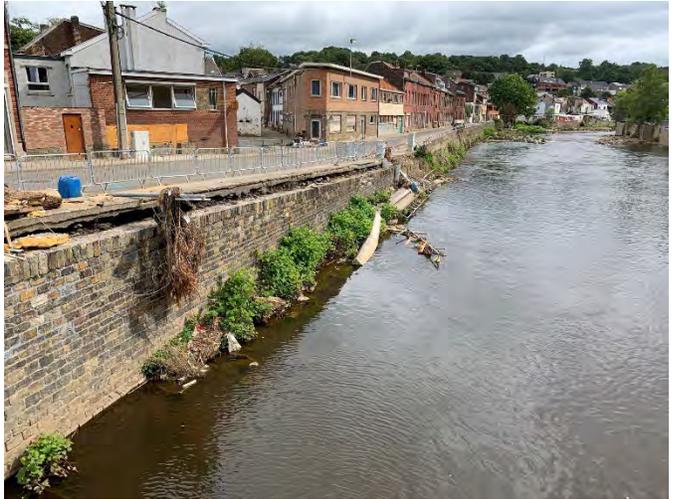
Figure 3.244. Pont du L'honneux damage: left embankment wall in upstream direction(50.609966, 5.6194468).

Damage along the embankment wall is shown in more detail in Figure 3.244. The pedestrian walkway was eroded, the deck and fill material missing. Figure 3.244 shows the exposed utility lines near the bridge, along with debris washed into the gap.

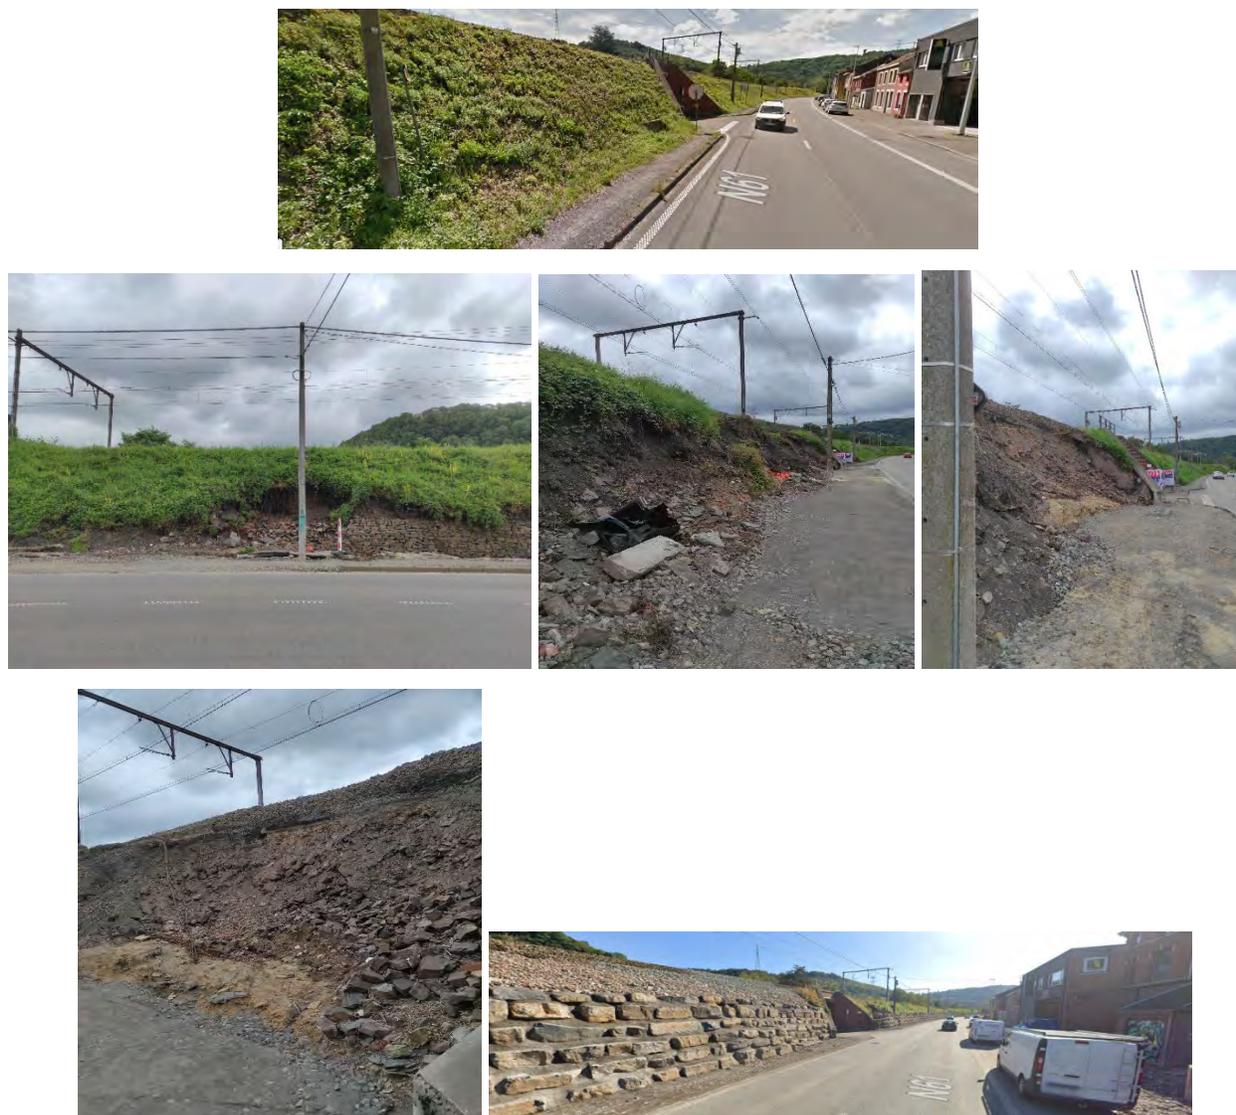
Figure 3.246. Embankment failure along railway 37 near Chaudfontaine (50° 35' 51.58" N, 5° 37' 53.38" E); top: before the flooding (June 2019, Source Google street view), Center and Bottom left: Failure documented by the GEER team, Bottom right: after repair works (October 2021, source google street view)

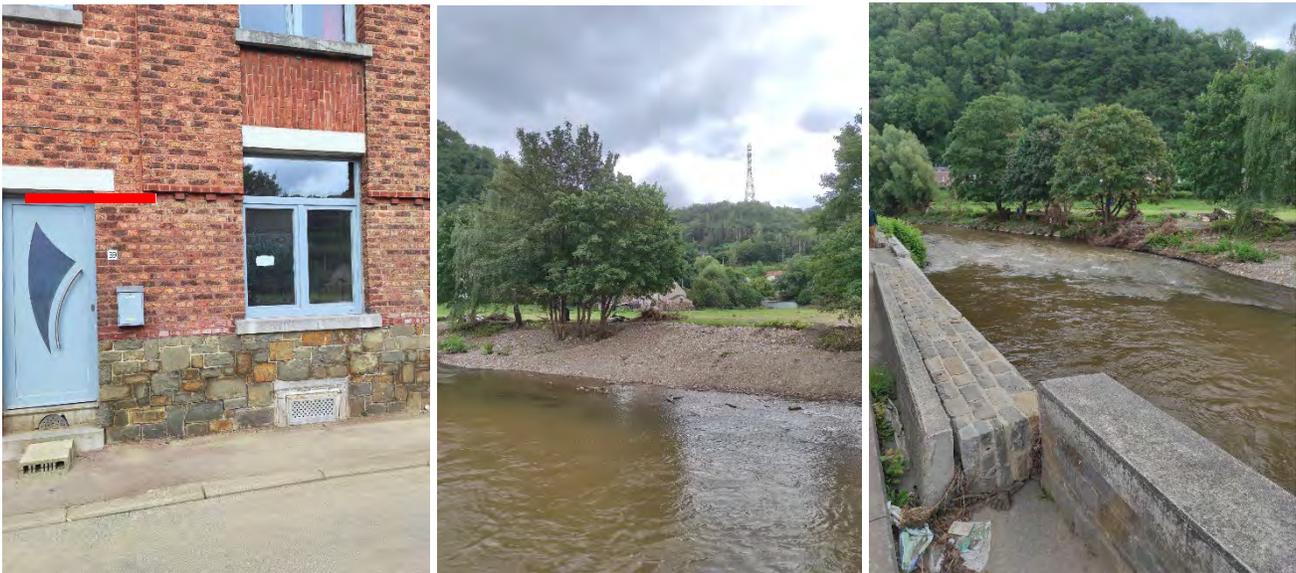
Figure 3.247. Vesdre riverbank (Rue de la Vesdre, Chaudfontaine, 50° 35' 47.65" N, 5° 38' 0.01" E)

The GEER reconnaissance team visited the banks of the Vesdre river, near Rue de La Vesdre Chaudfontaine (Figure 3.247). While there was no structural damage to the houses that may provide direct risk to their stability, the water level had reached about 2 m high on the facade. Along the riverbanks, the GEER team observed failure of the retaining walls, calving of the river banks, and fresh sediment deposits on shore, as depicted in Figure 3.247. It was unclear what caused the retaining wall to fall: this could possibly have been caused by a water level difference between the river and the street, causing excessive moments in the unreinforced natural stone masonry wall. The failure mode of the wall does not suggest that the foundation of the wall has been eroded, since the wall tilted towards the riverbank.

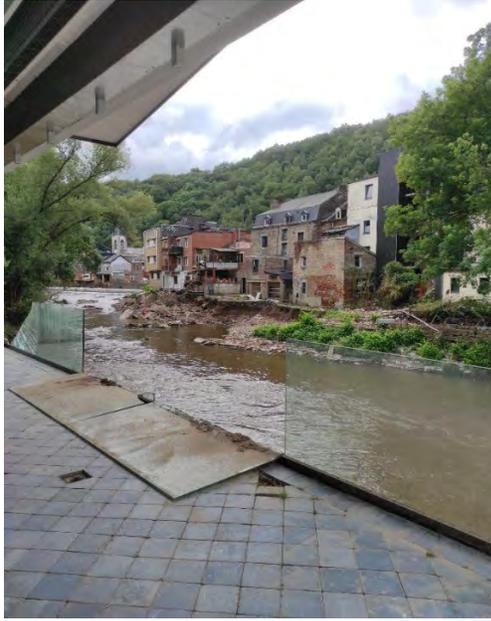
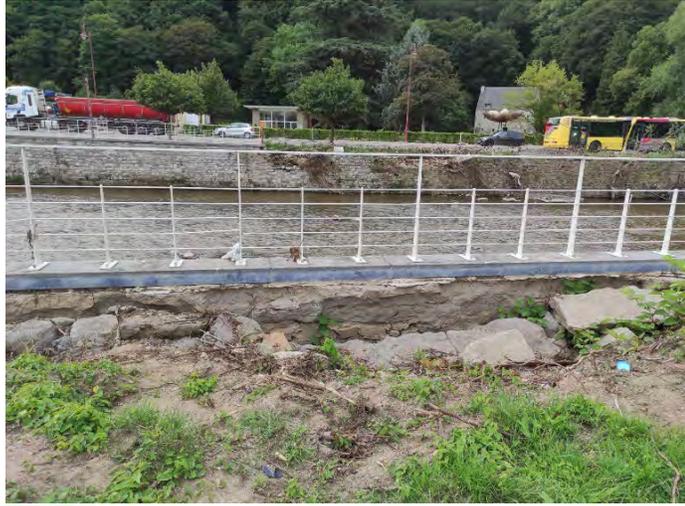
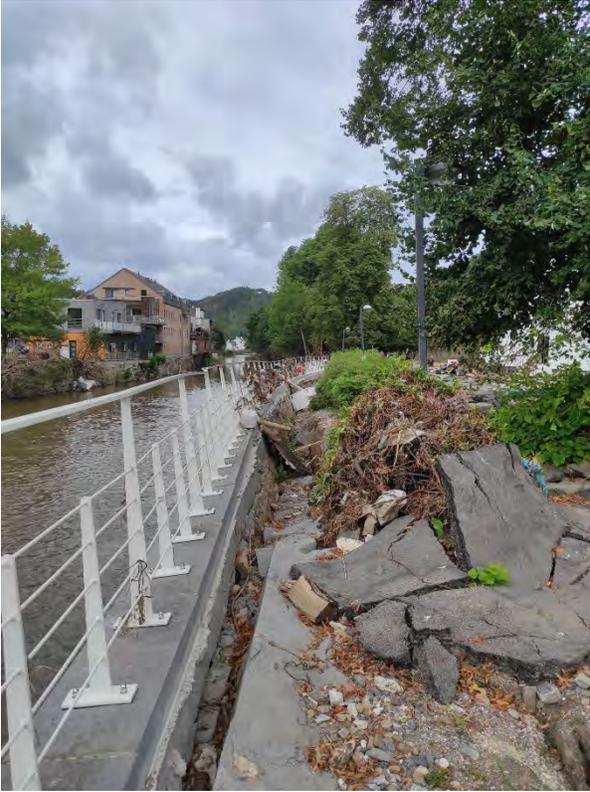
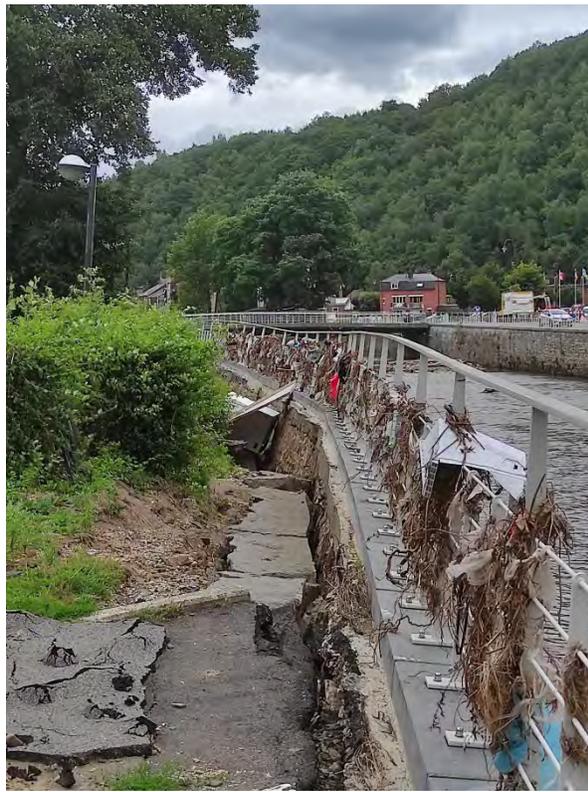
Figure 3.248. Embankment damage along the river near Chaudfontaine center (50° 35' 10.71" N, 5° 38' 34.46" E)

More apparent damage was observed in the vicinity of Chaudfontaine Railway station (Esplanade, Chaudfontaine). Figure 3.248 shows damaged glass balustrade of the “Rive Droite” Restaurant and damaged houses on the left bank of the Vesdre river (50°35'08.2"N 5°38'42.5"E). Furthermore, there are pronounced failures of the retaining walls near the banks (in particular in front of the Grand Casino Chaudfontaine-Liège, closed down), with a tilting of the wall combined with erosion and deposition of debris along the banks.

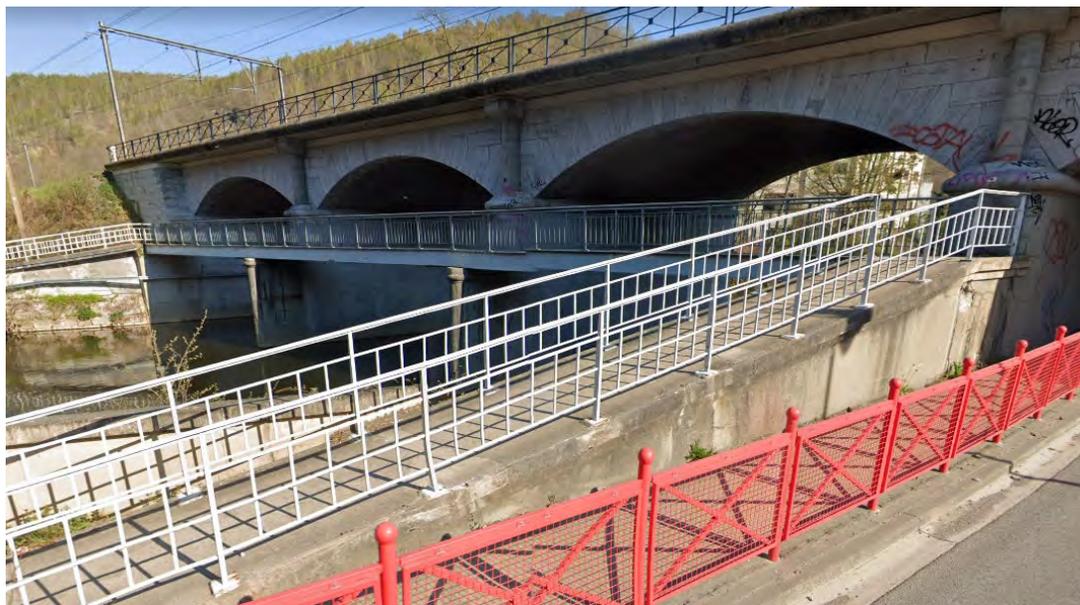
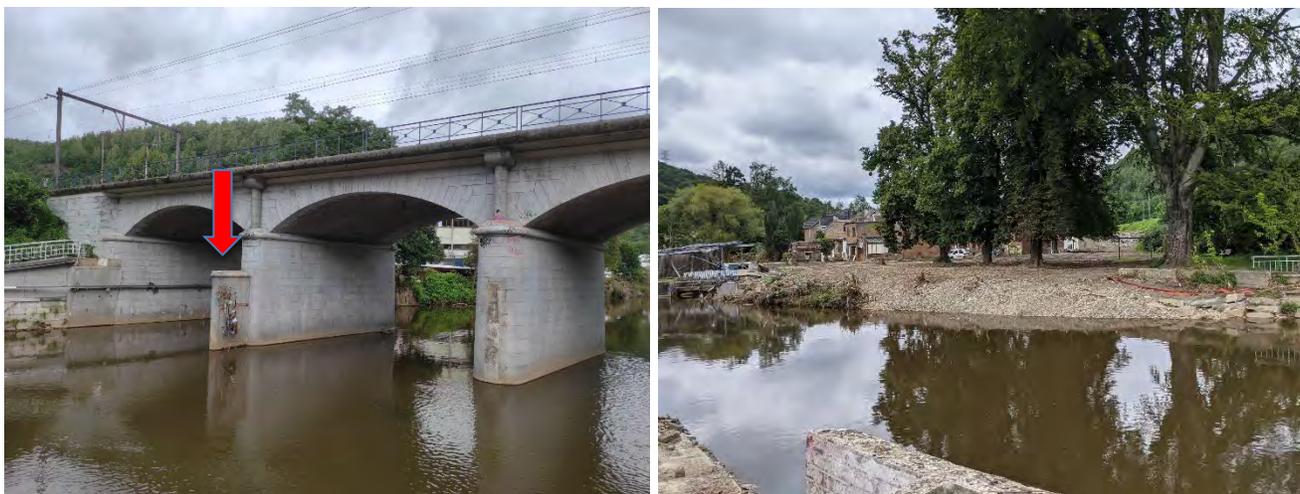
Figure 3.250. Bridge at Avenue des Thermes, from Chaudfontaine to Liège, Wallonia (exact location 50° 35' 9.44" N, 5° 38' 56.41" E). Top: Bridge before damage from April 2021, bottom: at the time of the GEER visit

Figure 3.250 shows the damage to the railway bridge at Avenue des Thermes, from Chaudfontaine to Liège. The railway bridge also included a small pedestrian bridge that was washed away. The red arrow in the upper photo shows the location of the pedestrian bridge. This pedestrian crossing was a later addition to the historic masonry bridge, at a lower level. There was no visual damage to the old masonry bridge, while the bridge abutments have been reinforced after the events by Infrabel.

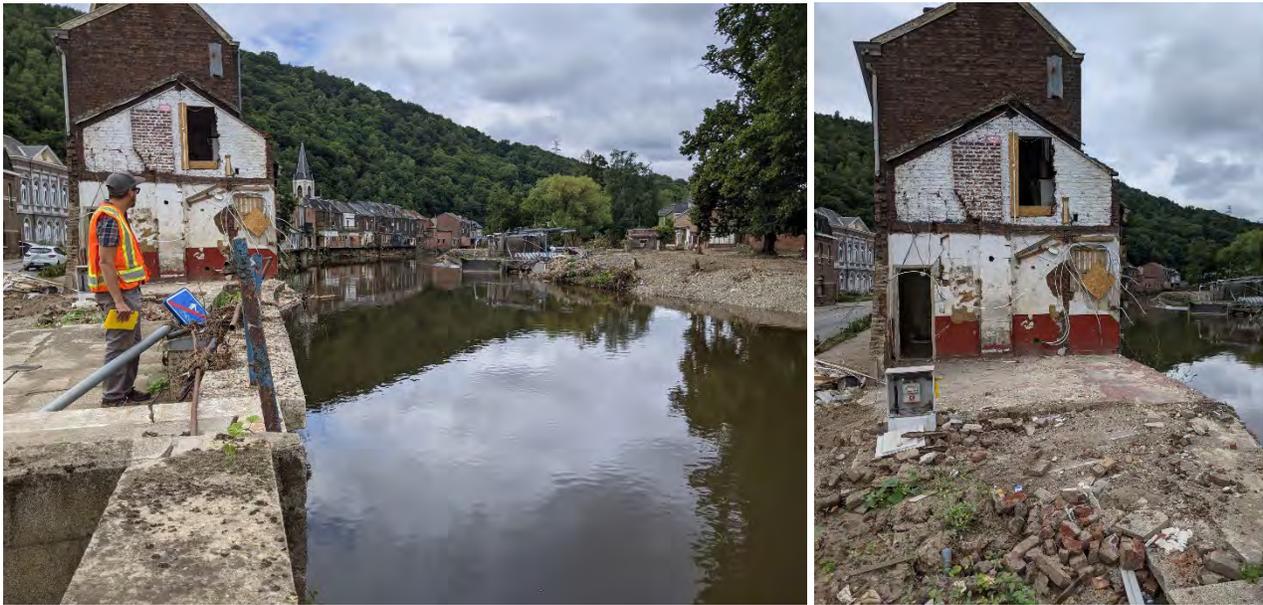
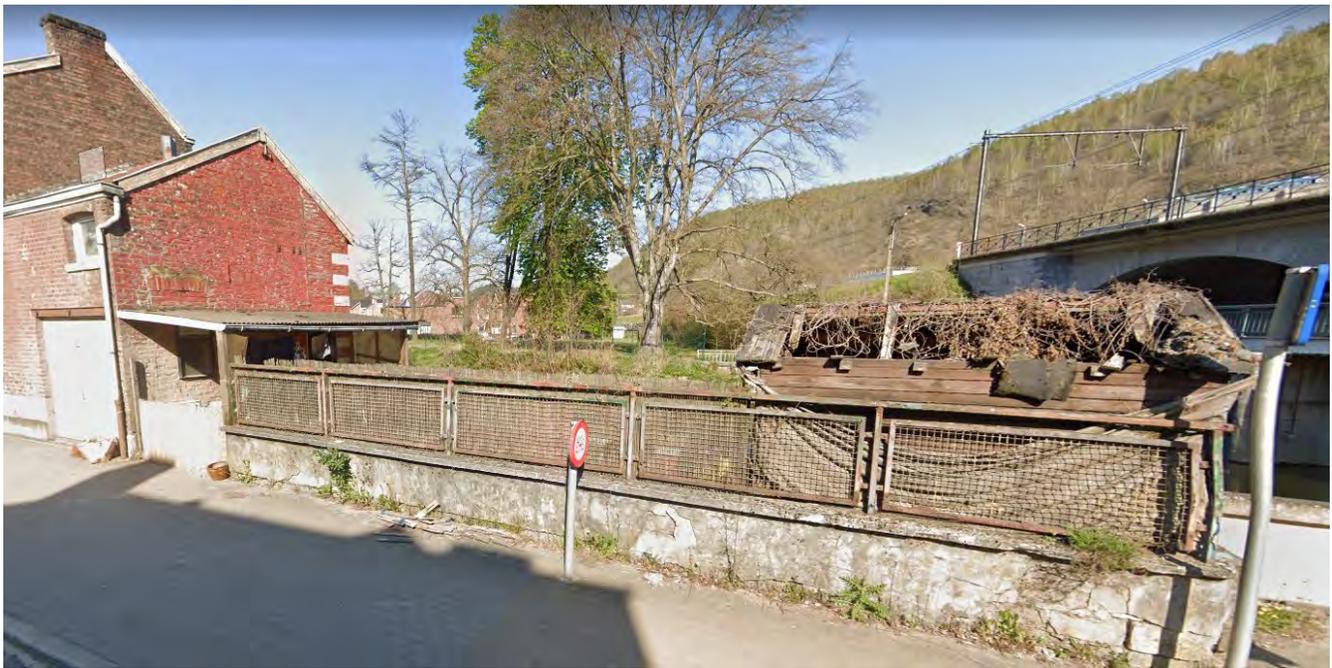
Figure 3.251. Building and fence on 124 Av. des Thermes (from Chaudfontaine to Liège, Wallonia: exact location $50^{\circ} 35' 9.44''$ N, $5^{\circ} 38' 56.41''$ E)

Figure 3.251 shows heavily damaged houses between the railway station and the railway bridge Chaudfontaine.

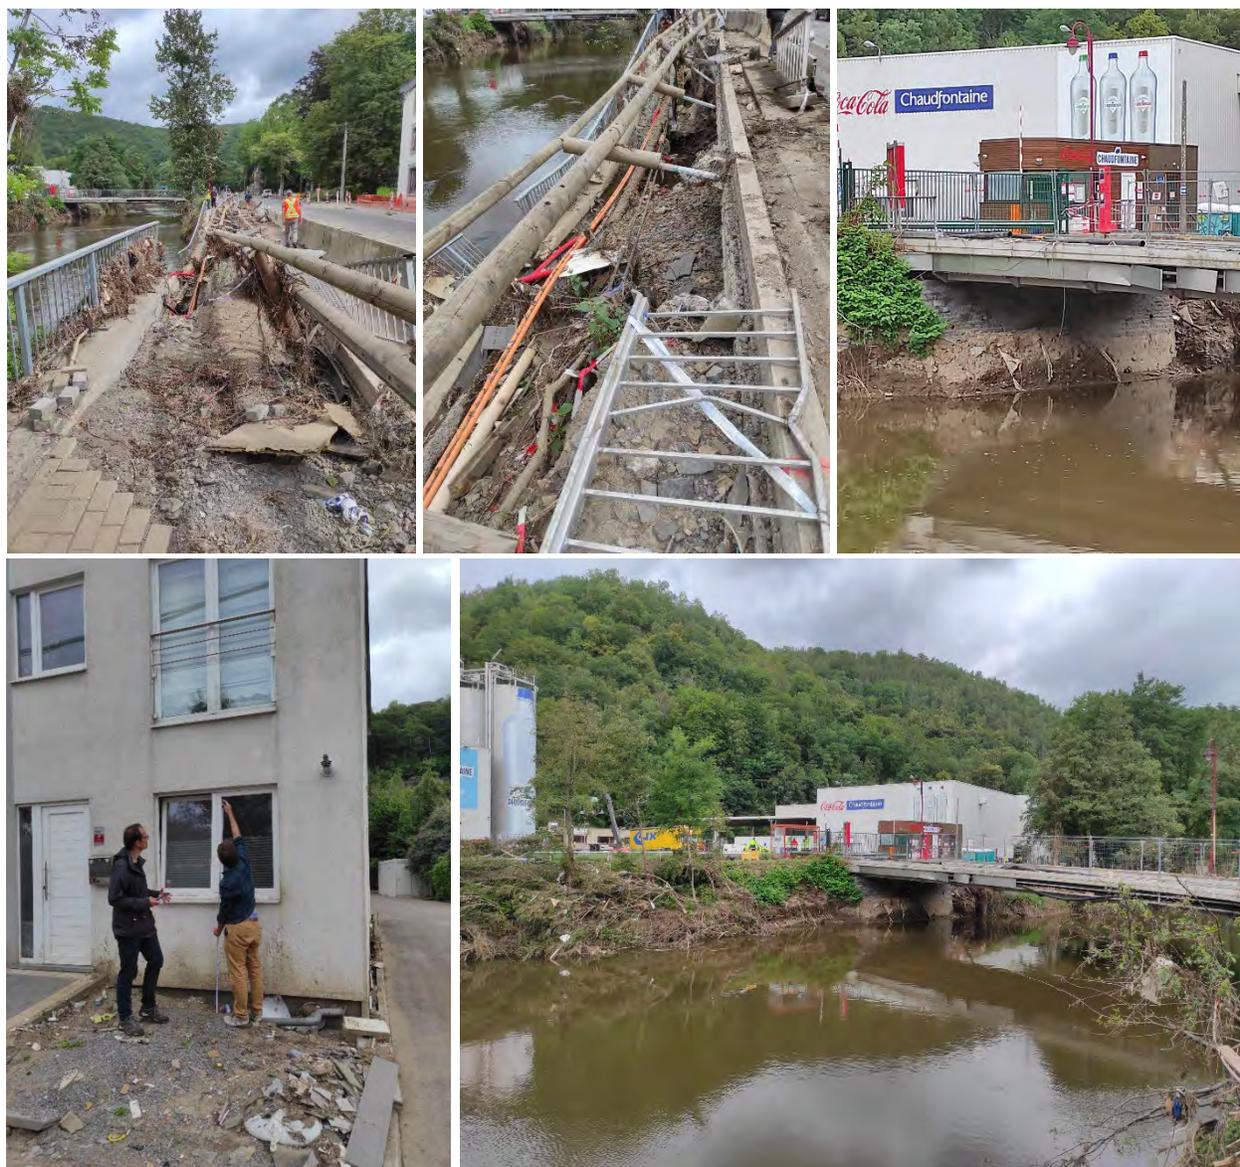
Figure 3.252. Damage and water level in the area in front of the Coca-Cola Enterprises site in Chaudfontaine (50.58746206, 5.6503174)

Figure 3.252 shows heavy damage to the retaining wall of the Vesdre river bank that caused tilting of the wall. Clear signs of erosion of the backfill layer can be observed, which also triggered the guard rails and parapets to fail. There is also visible damage to the access bridge to the Chaudfontaine water bottling plant, part of the Coca-Cola company. The factory itself was not visited during the GEER mission, since it had just restarted operation after being forced to stop the activities in the wake of the events. The ground floor of the plant was heavily affected, with water levels raising over a height of 2 m (confirmed by the GEER team, Figure 3.252 bottom). The wells and the boreholes used to bring the water to the plant site, are located on the first floor (where bottling takes place) and were not affected by the flood. (<https://www.retaildetail.eu/en/news/food/chaudfontaine-expects-stock-shortages-after-floods>)

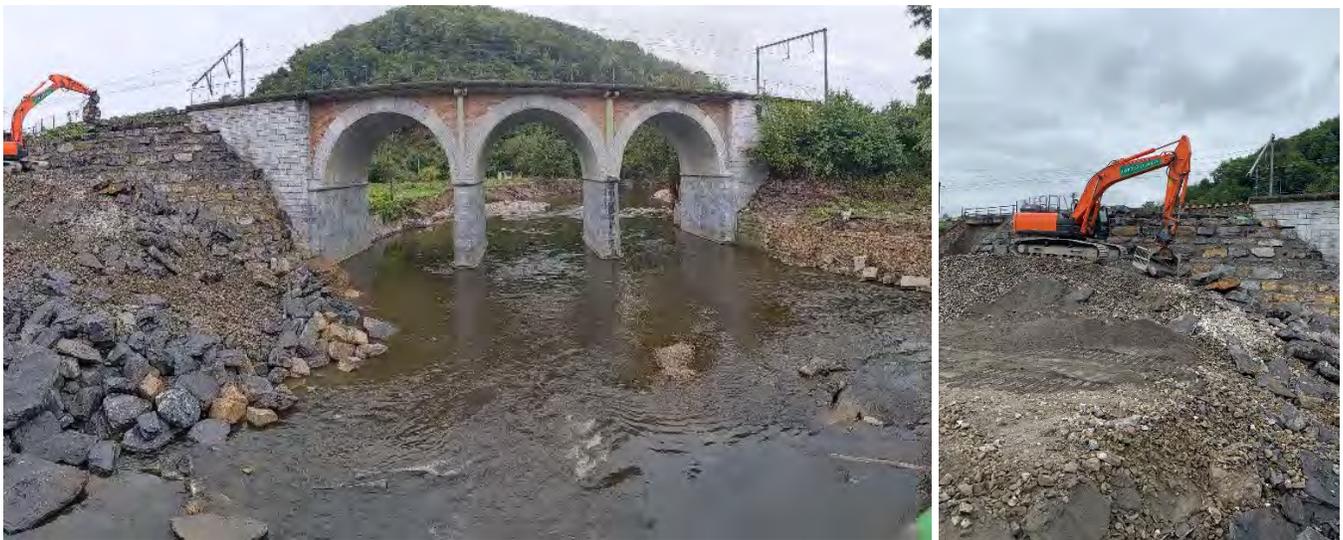
Figure 3.253. Bridge abutment failure. (50° 34' 12.34" N, 5° 44' 13.68" E)

Figure 3.253 shows the damage to the abutments and ongoing repair works to the railway bridge over the Vesdre river in Trooz (50°34'12.3"N, 5°44'13.7"E), which is also a historic masonry arch bridge composed of natural stone and brickwork. Similar to the railway bridge in Chaudfontaine, there was no visible damage to the railway bridge, but the flooding caused the embankment near the abutment to erode, leaving the abutments exposed so that railway traffic could not pass without causing further damage to the bridge and embankments. These crucial repair works were implemented with high priority, as a part of the entire retrofitting and renovation of railway line 37, as discussed above.

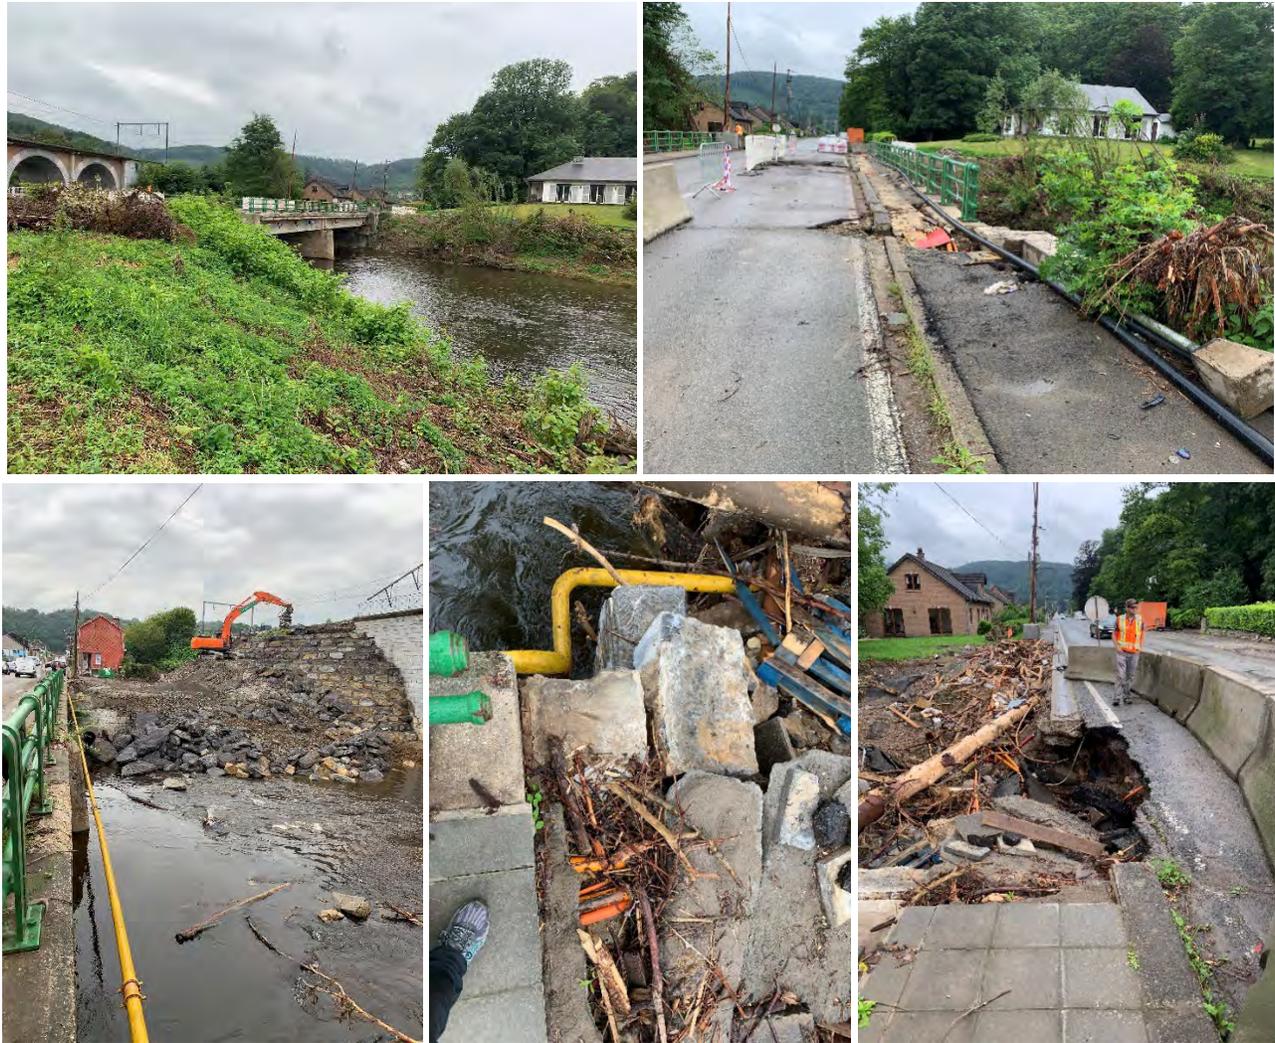
Figure 3.254. Damage of the road bridge along Rue Franklin Roosevelt (50°34'12.3"N, 5°44'13.7"E)

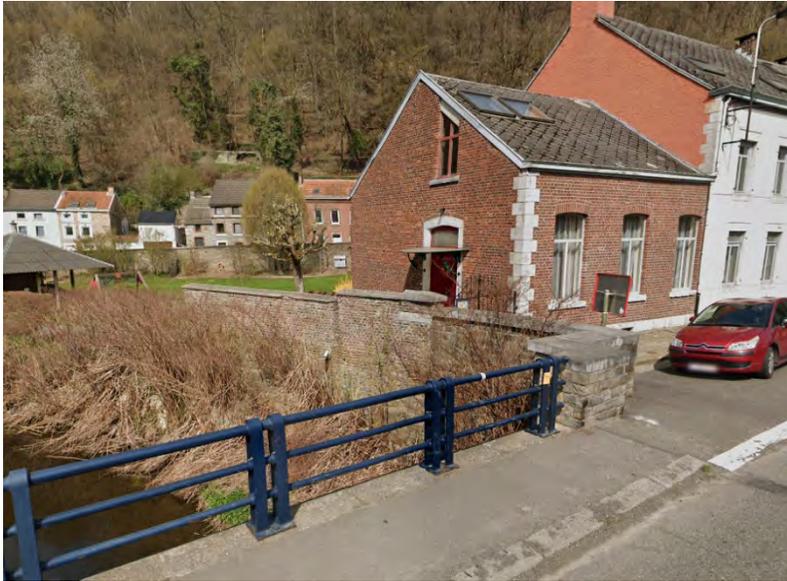
Figure 3.255. Photographs before (left - google maps) and after (right) damages in the Centre Protestant de Nessonvaux near a Vesdre river bridge abutment in Nessonvaux (50.574176, 5.742544)

The collapse of part of the *Centre Protestant de Nessonvaux* located at the banks of the Vesdre river was observed during the GEER mission in the town of Nessonvaux (Figures 3.255 – 3.257, exact location 50° 34' 26.88" N, 5° 44' 32.23" E). The flooded river washed out the soil underneath the abutment, which subsequently caused the collapse of the entire abutment wingwall (Figures 3.256 and 3.257). Evidence of water rise during the event is illustrated in Figure B18. The abutment backfill is then exposed and is consequently washed out. At the same time the erosion of the foundation soil allows the building's foundation to be washed out. This in its turn, causes the building's facade and its side along the riverbank to collapse. The damage included part of the road, uncovering utility lines (gas, electricity lines). During the GEER mission, the road was (partially) closed due to the damage involved at this particular location.

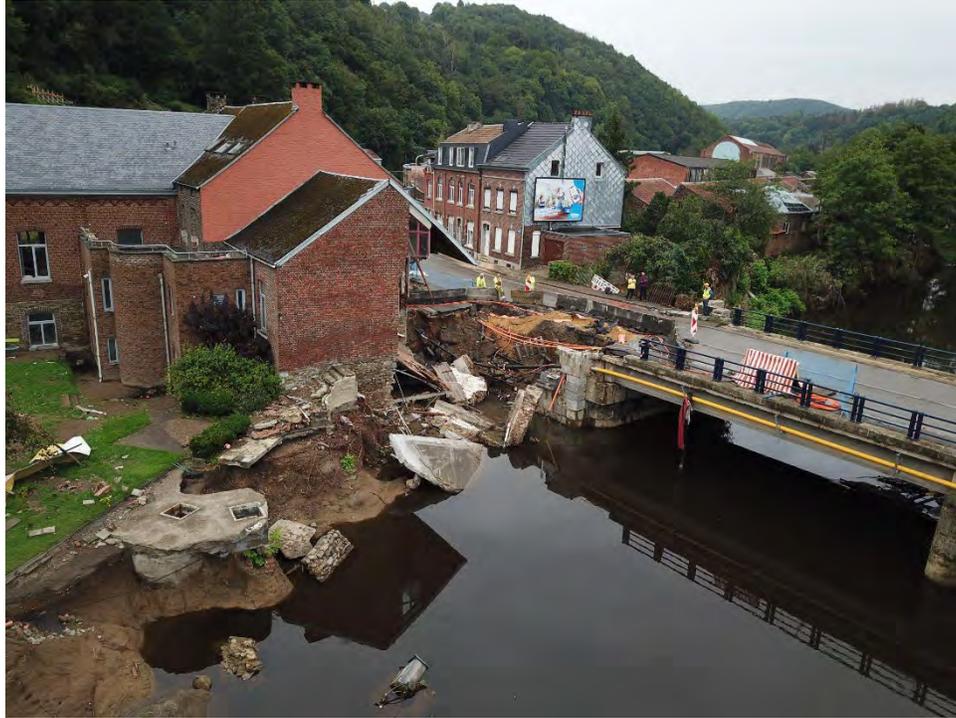
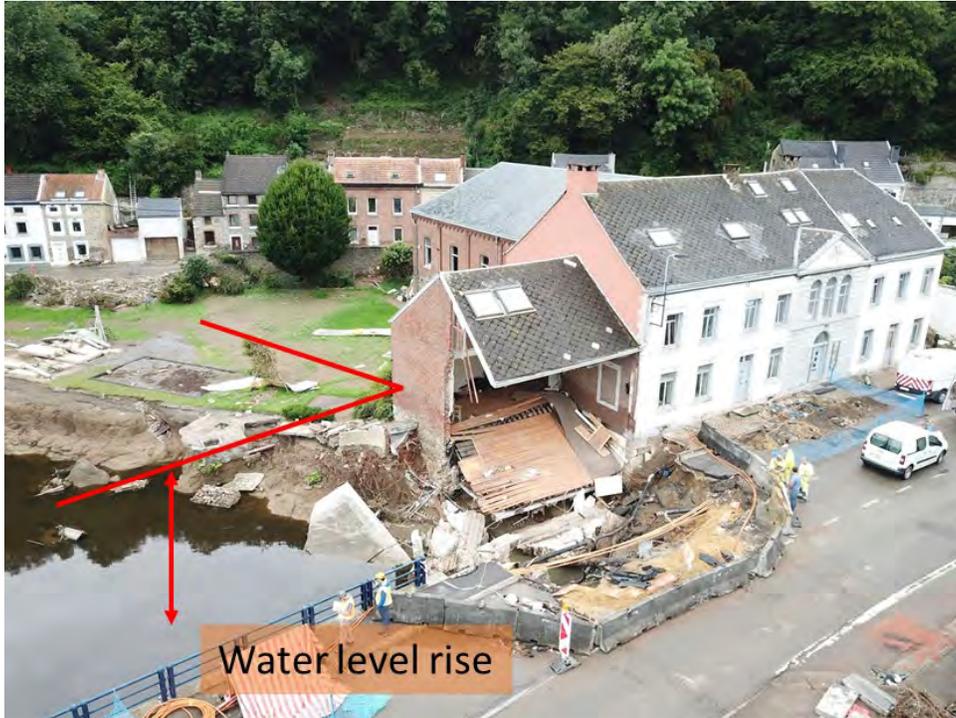
Figure 3.257. Aerial view of Centre Protestant de Nessonvaux and bridge abutment damage. Wingwall structural damage and soil erosion (top). Evidence of high-water level during the event (bottom), (50.574176, 5.742544).

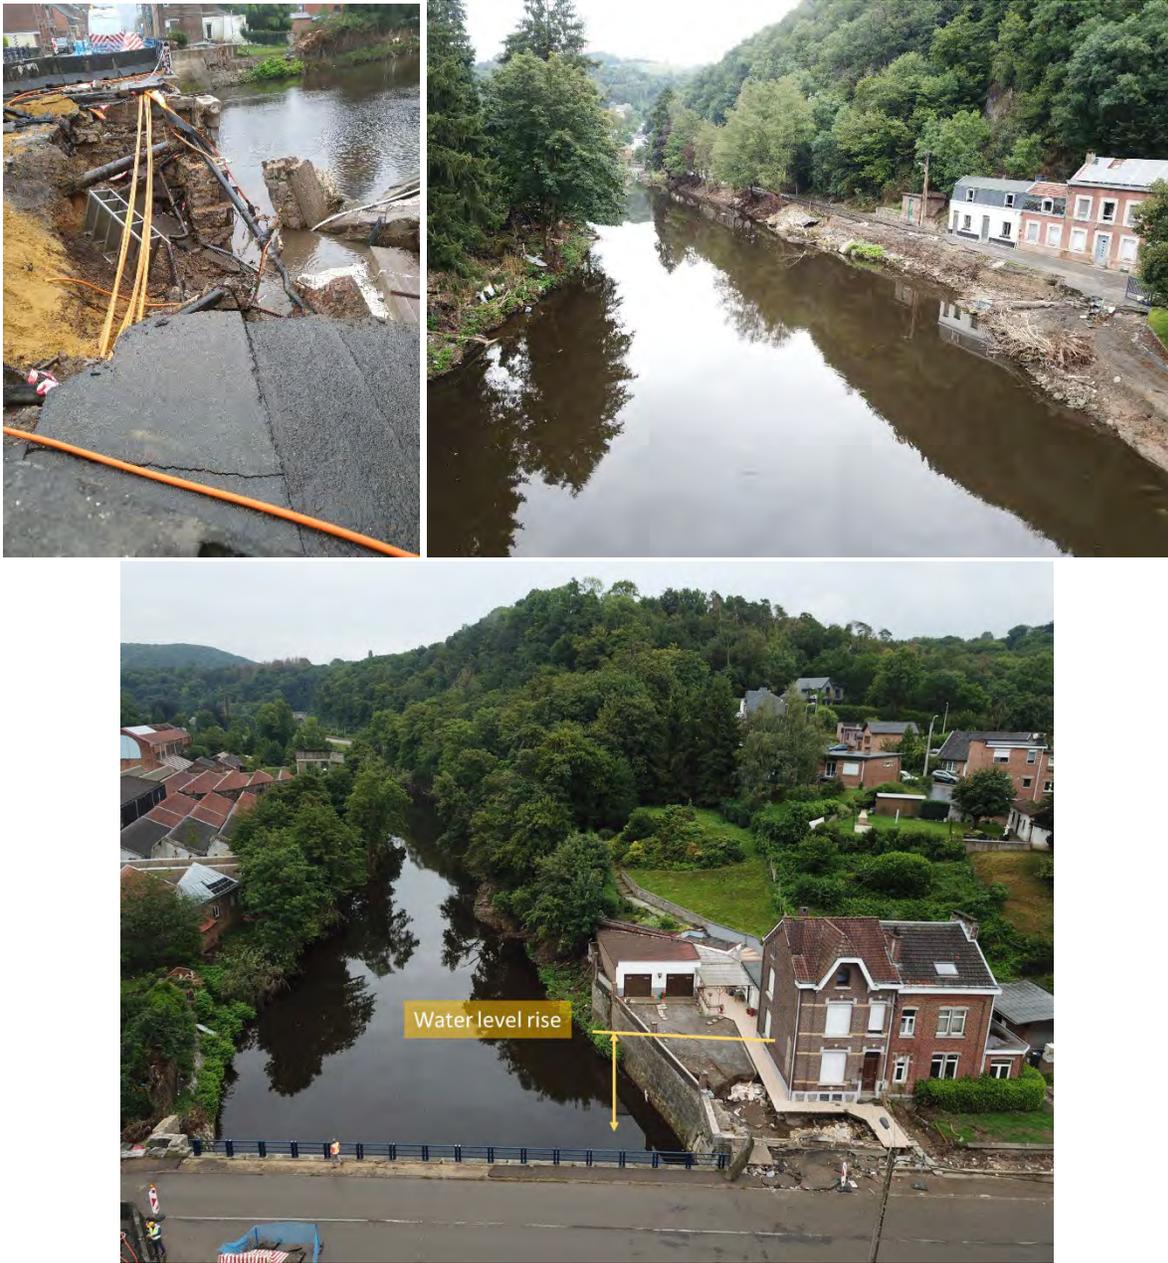
Figure 3.258. Damage of abutment and wingwall area on the other side of the road bridge, (50.574176, 5.742544).

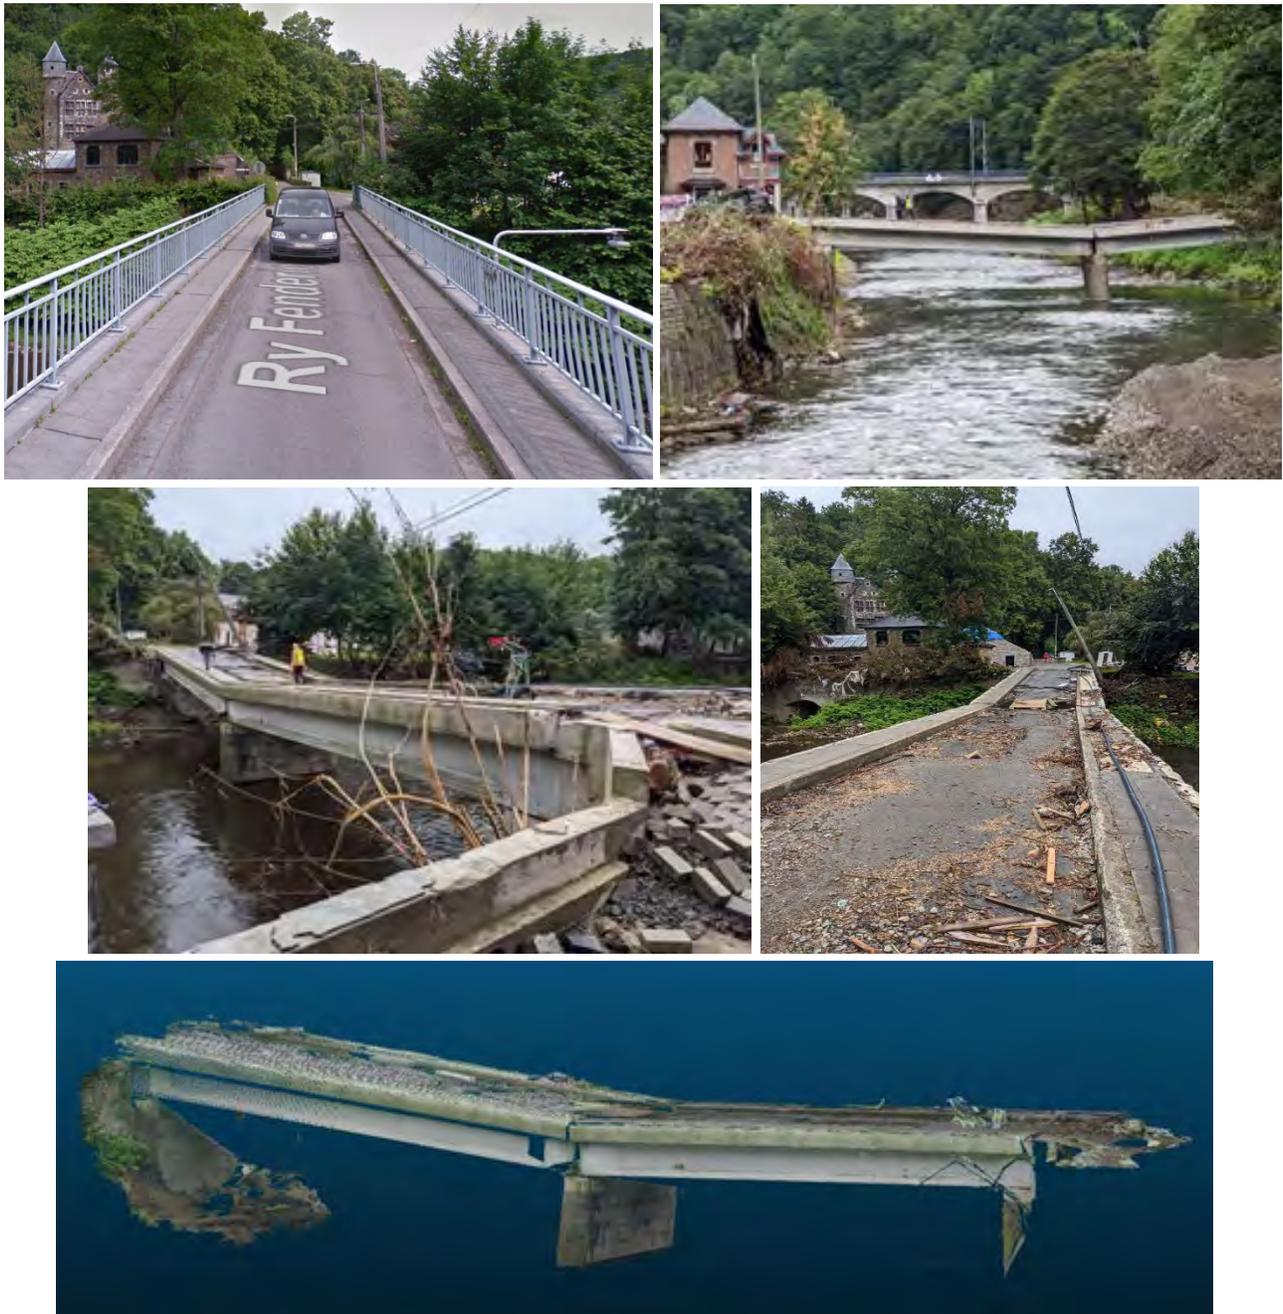
Figure 3.259. Photographs and point cloud model (13.5 million points) obtained from LiDAR scanning (Location: Trooz, Belgium 50.571160, 5.689884, Rue de Verviers 6, 4870 Trooz & Ry Fenderie)

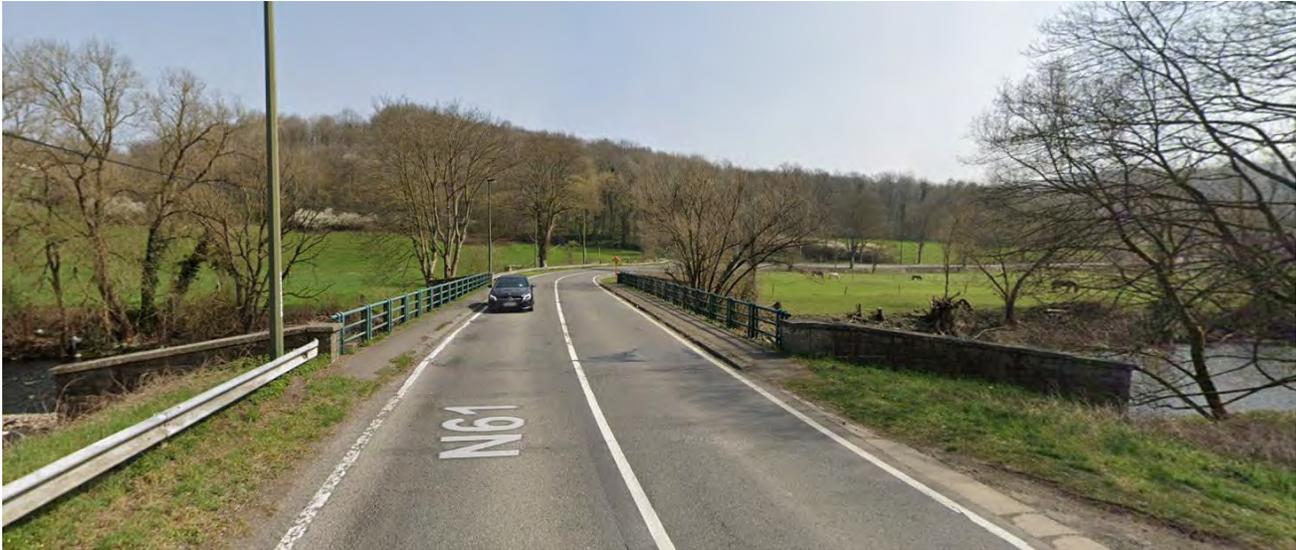
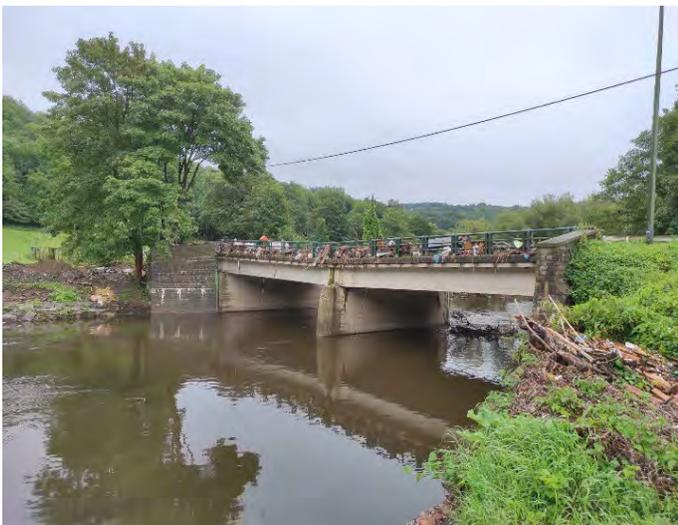
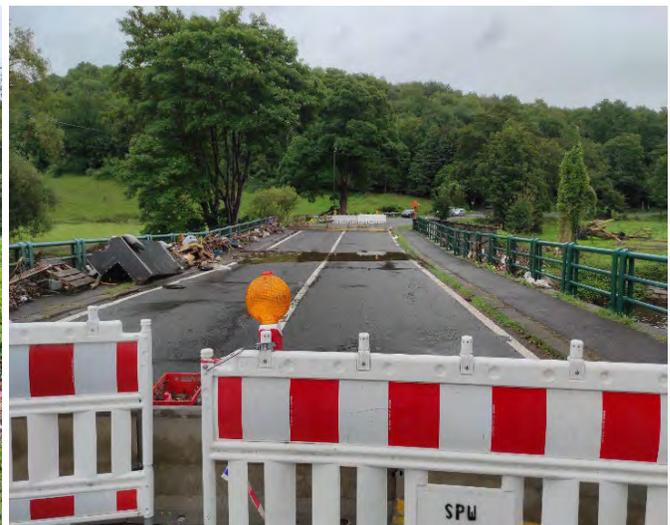
Figure 3.260 shows the damaged Louheau bridge which links Trooz to Pepinster via Nessonvaux on the road N61. The central bridge pier experienced evident settlements, likely caused by the scouring of its foundation. The bridge was closed during the GEER mission. A photo from google streets dated in April 2021 is also included to provide an image of the bridge prior to experiencing the heavy floods. The top photograph shows the google street view prior to the flood, pictures at the bottom document the damage observed by the GEER team.

Figure 3.260. Damage to Louheau bridge which links Pepinster to Trooz via Nessonvaux on the N61 in Wallonia, Belgium. Excessive settlement of the middle pier foundation (top). Before flooding (source: google street, April 2021). Exact location 50°34'1.32"N, 5°46'56.
