Geotechnical Reconnaissance of the 2021 Western European Floods

Flood Event: July 14-15, 2021

Flood locations: Germany, Netherlands, Belgium, and Luxembourg

Reconnaissance Visit: August 9-18, 2021

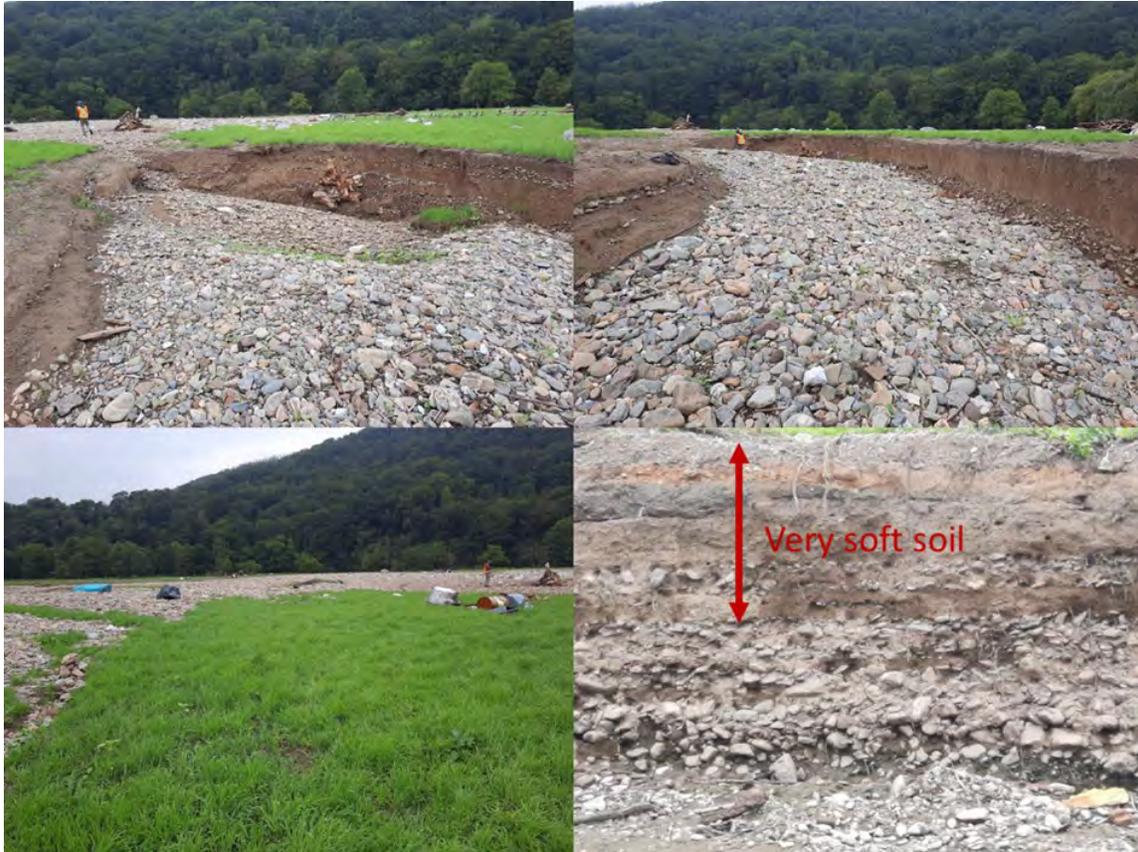
Figure 3.262. Depositional material near Louheau bridge (N61 linking Pepinster to Trooz via Nessonvaux). Exact location 50°34'1.32"N, 5°46'56.72"E

are visible in Figure 3.261 (bottom), suggesting that the depositional debris cut through the top soil layers and spread across a larger area in the field. As shown in more detail in Figure 3.262, the flood debris consisted of primarily natural materials (large gravels, including small rocks).

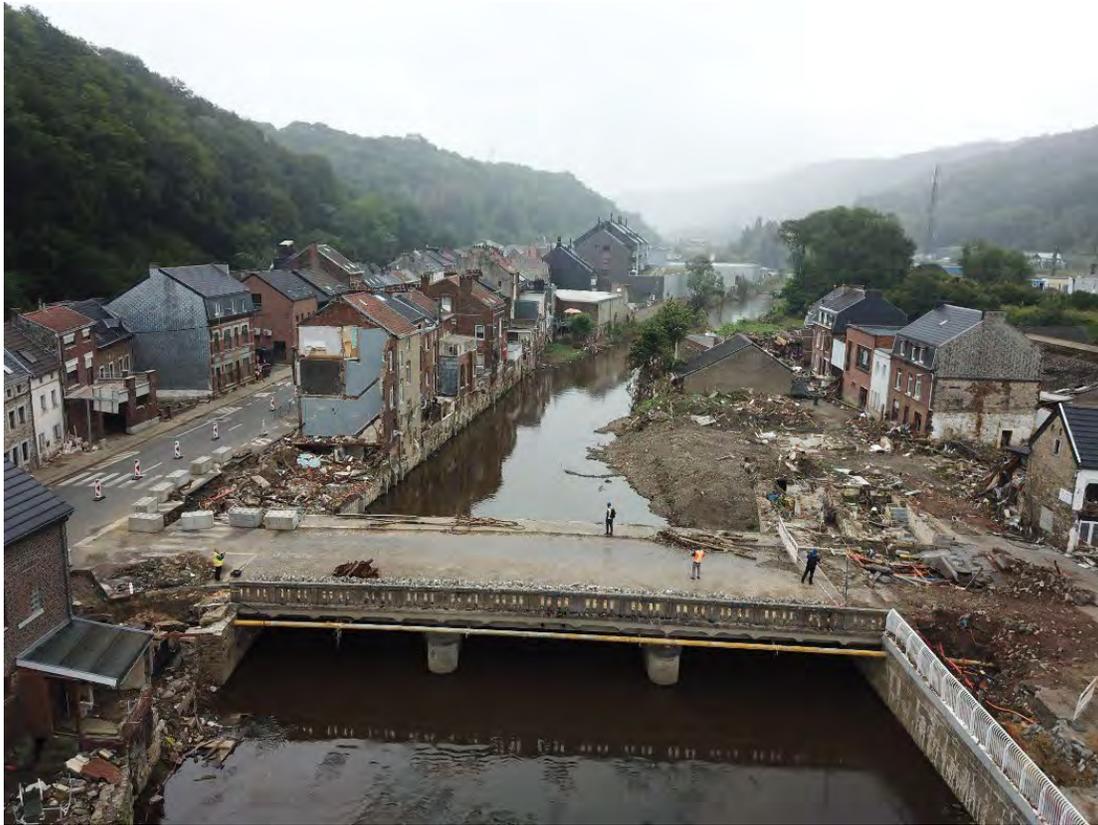
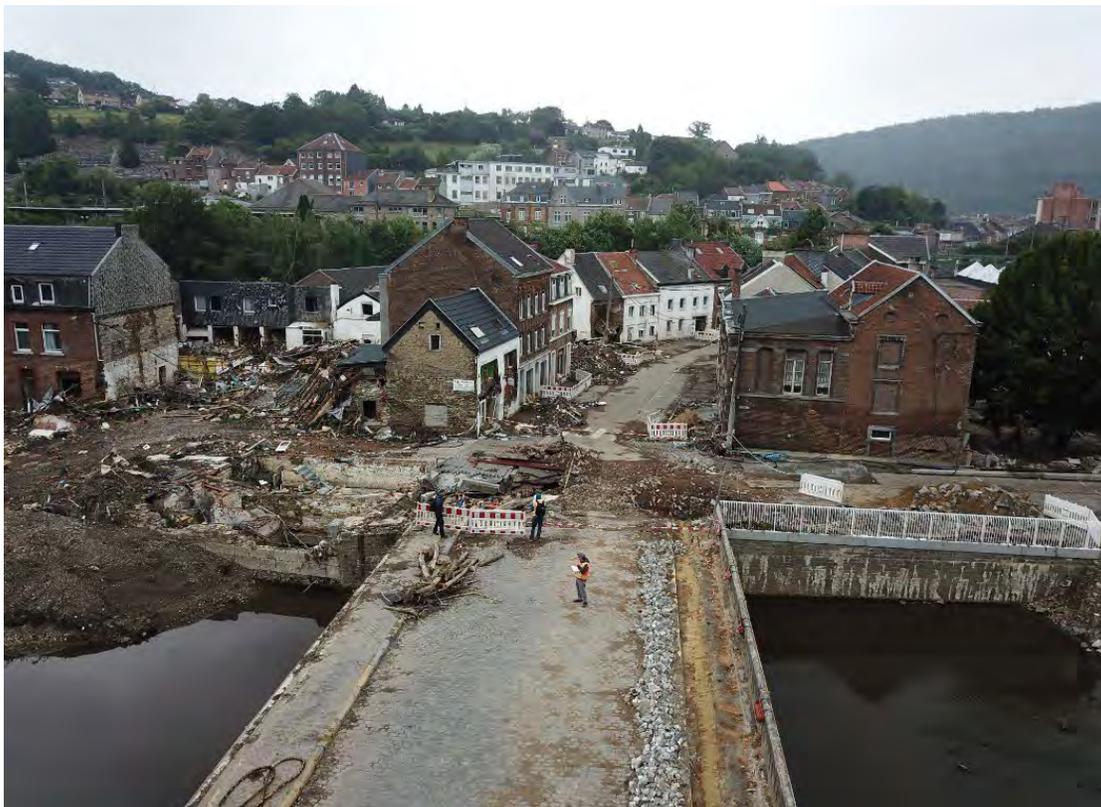
Figure 3.265. Aerial photos of damage in Pepinster, at Rue "Pont Walrand", (50.569710, 5.804977).

Houses in the Rue Hubert Halet street along the Vesdre river are scheduled for demolition. On the other hand, houses at 41, 43 and 45 Rue Hubert Halet have collapsed totally. The Hoegne and Vesdre rivers burst their banks and lead to severe damages in the city center. Aerial photos best illustrate the level and extent of damage (Figures 3.265, 3.266).

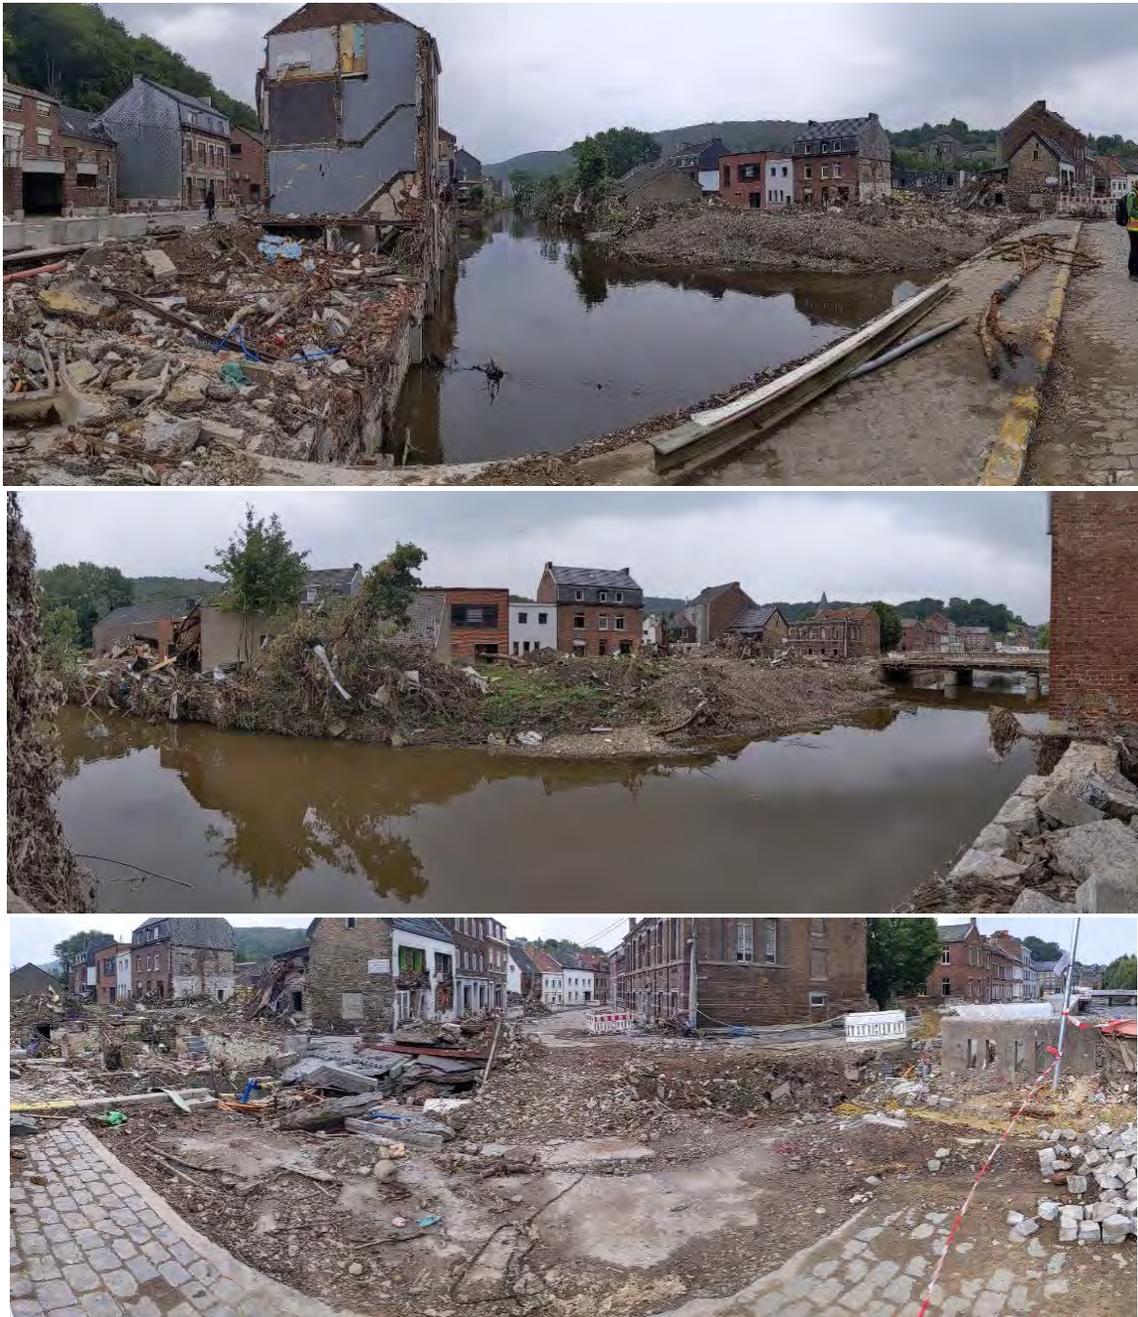
Figure 3.267. Photographs of flood damage in Pepinster (top: residential destruction, middle: embankment failure, bottom: road and foundation failures), (50.569710, 5.804977).

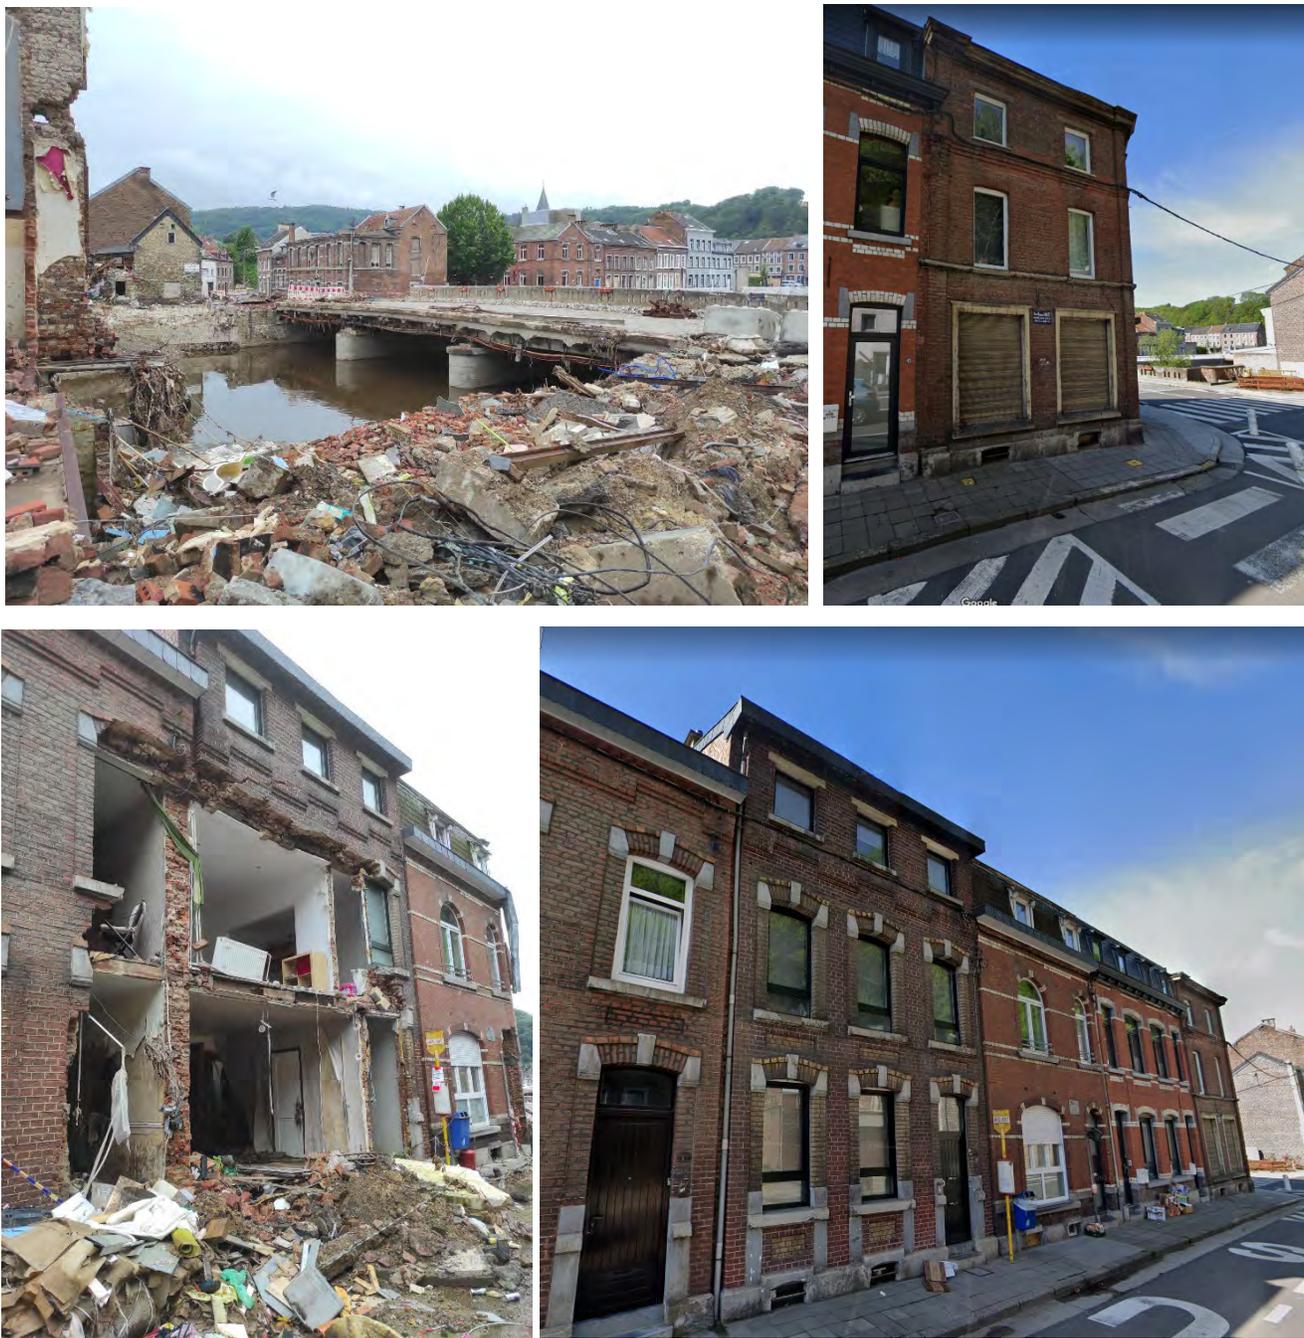
Figure 3.268. Post- (left) and pre- (right) flood damages to buildings and infrastructure along Rue Hubert Halet in Pepinster, Belgium (top 50° 34' 11.14" N, 5° 48' 19.42" E and bottom 50° 34' 11.43" N, 5° 48' 20.25" E)

A comparative photo, which further illustrates the level of damage is shown in Figure 3.268. The buildings in the right photos have vanished (top) or have experienced severe damages (bottom) during the flood events.

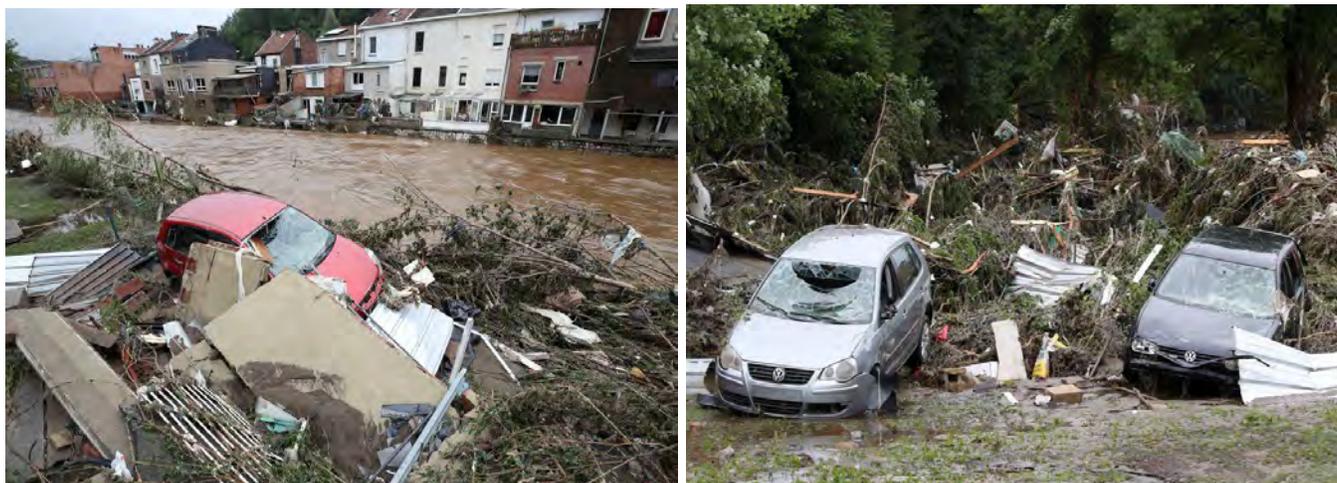
High water levels reached in the city center have been measured according to evidence, as shown in Figure 3.269. Additional footage of the flood damage and debris deposition in Pepinster is gathered from the news. Figure 3.270 shows soon after the floods cars washed out.

Figure 3.270. Top: a damaged vehicle is seen next to the river, following heavy rainfalls, in Pepinster, Belgium, July 16, 2021. Bottom: Vehicles damaged by heavy rainfalls are pictured in Pepinster, Belgium, July 16, 2021; Source: REUTERS/Yves Herman <https://www.reuters.com/business/environment/belgium-warns-against-travel-flood-death-toll-hits-14-2021-07-16/>

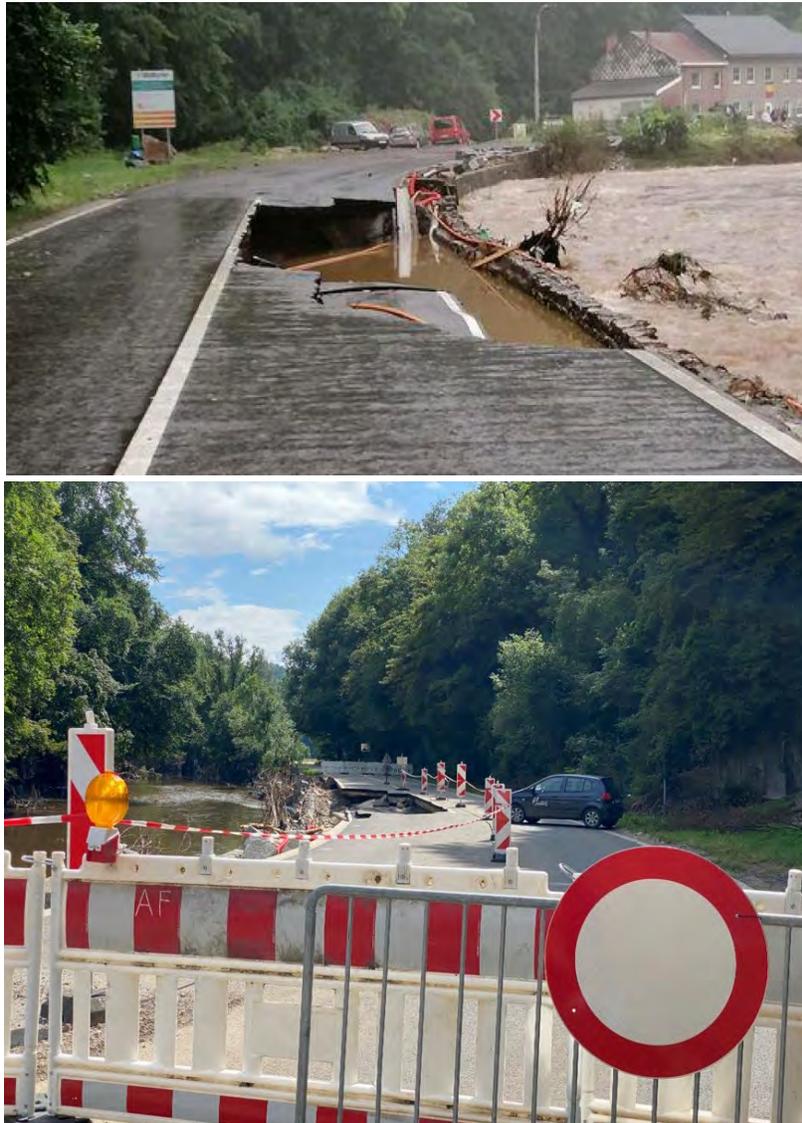
The N61 urban motorway between Dolhain and Verviers was closed for several weeks following the floods. The reason is the road collapse next to the river Vesdre as shown in Figure 3.271 (location: 50.616650, 5.927750). Most likely, the foundation soil under the wall retaining the road embankment eroded, the wall collapsed, and the embankment backfill was washed out, resulting in the collapse of the road deck as shown in the photographs. Soon after the damage, the City of Limbourg decided to ban traffic in both directions.

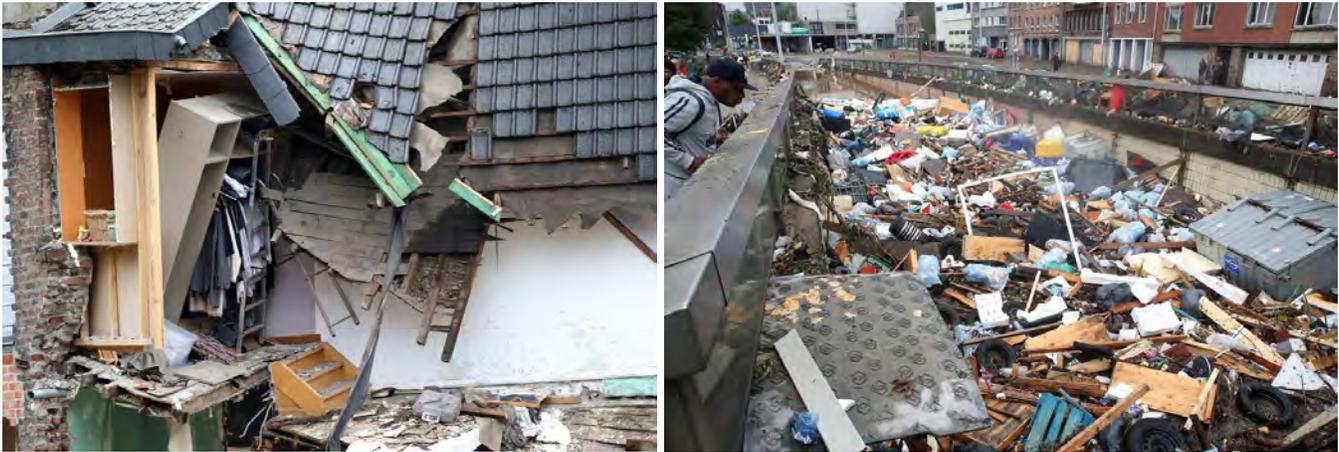
Figure 3.272. Top left: A partially destroyed house following heavy rainfalls, in Ensival, Verviers, Belgium, July 16th, Top right: Wreckage lies on the river, following heavy rainfalls in Verviers, Source: <https://www.reuters.com/business/environment/belgium-warns-against-travel-flood-death-toll-hits-14-2021-07-16/>

Damage to residential housing in Verviers is reported in Figures 3.272 and was collected from media sources shortly after the flood.

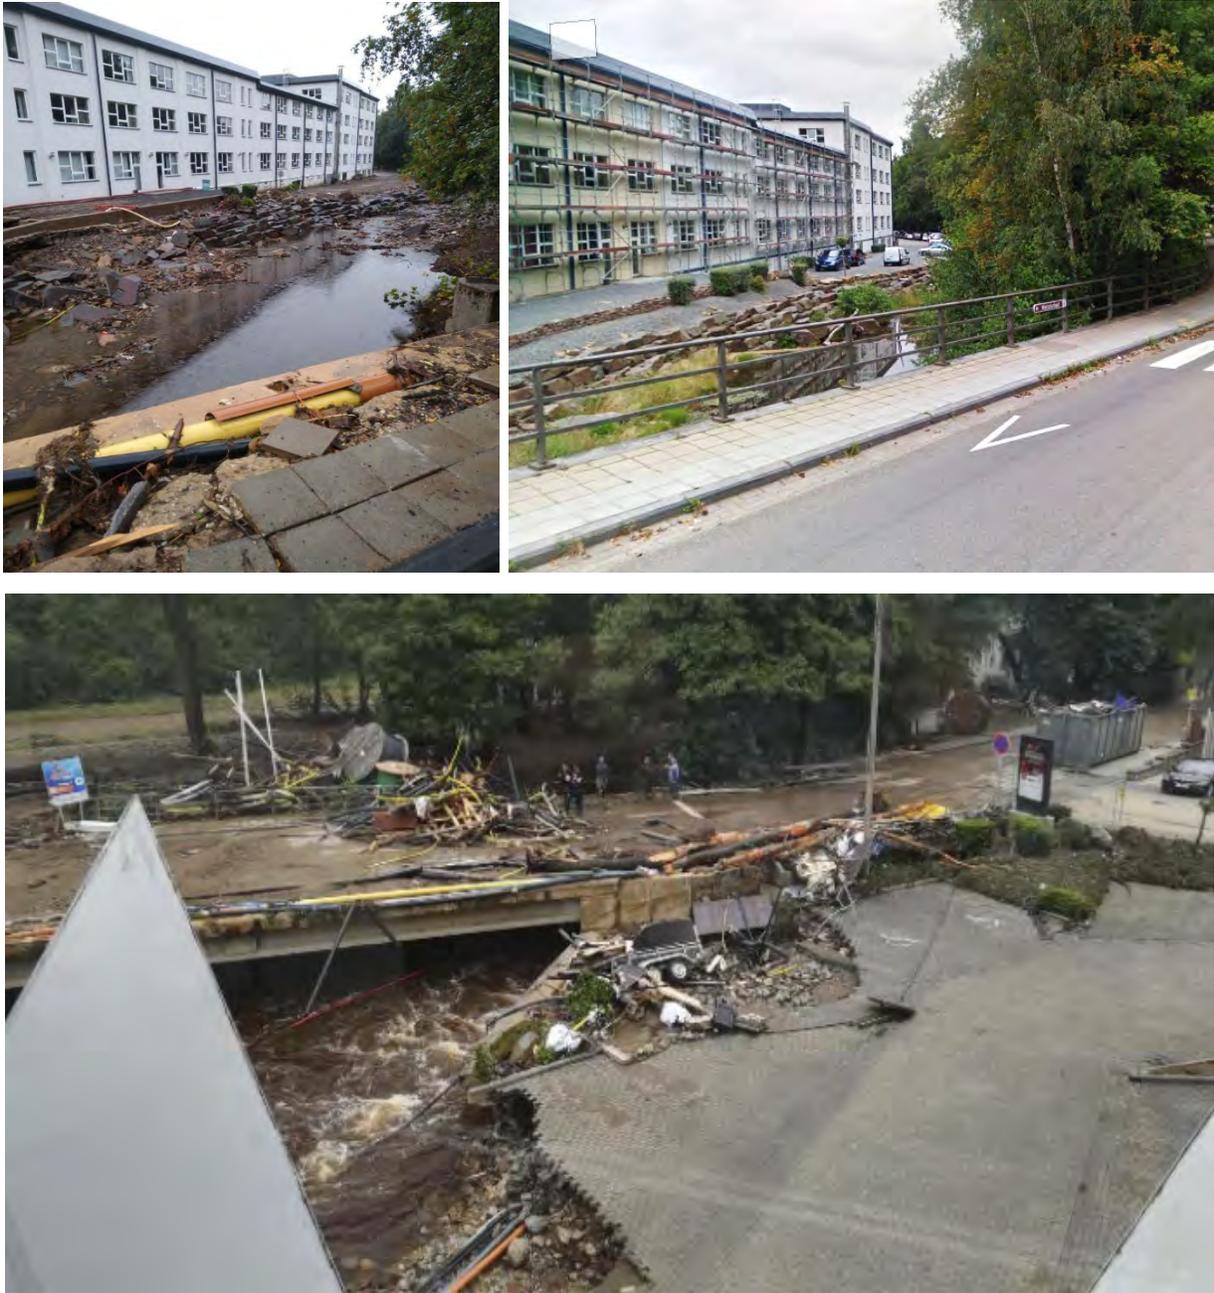
Figure 3.273 (left) shows a gravity wall failure along the Hill river/stream in the suburbs of Eupen, at Hutte. The Hill rises near the highest point in Belgium, the Signal de Botrange and empties into the Vesdre (Weser) at Eupen, 25 km further north. It is evident that there is no access to the parking lot at the back of the *Arbeitsamt der Deutschsprachigen Gemeinschaft Belgiens* building (right photo). Additional damage is shown in Figure 3.273 bottom. Part of the parking lot in front of the building has vanished due to the foundation soil being washed out. Utility lines have been uncovered and the traffic has been blocked due to debris blocking the bridge deck.

Figure 3.273. Top: Gravity wall failure in Eupen (exact location: 50.614888, 6.045164), Bottom: Parking lot collapse due to river bank being washed out and traffic interrupted. Main entrance of the Arbeitsamt der Deutschsprachigen Gemeinschaft Belgiens, Eupen in Belgium. Source: <https://www.grenzecho.net/59306/artikel/2021-07-21/arbeitsamt-der-dg-zieht-vorubergehend-die-oberstadt>

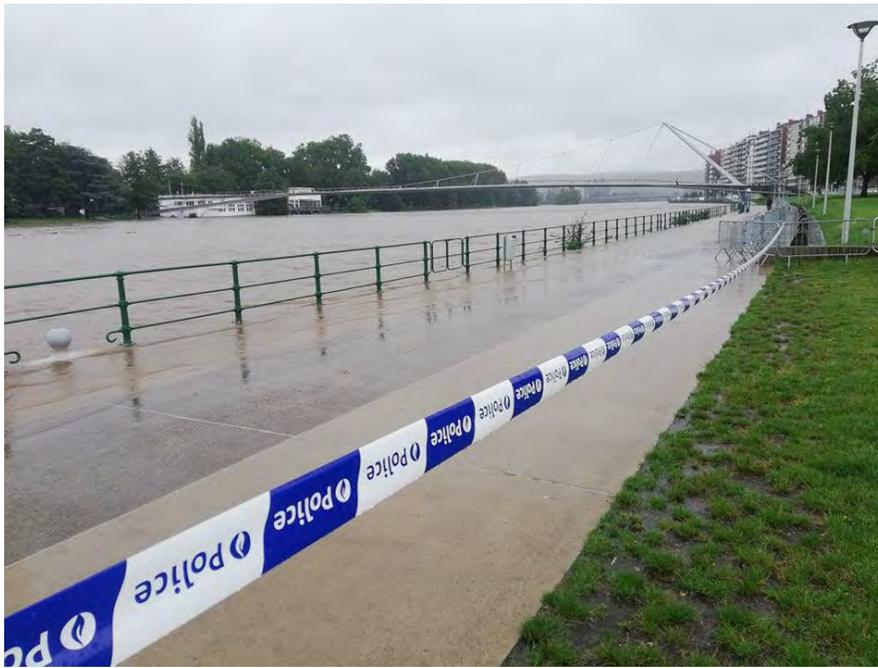
Figure 3.274. Flooding along the banks of the Meuse River in Liege, Belgium. Photo: Ville de Liege
<https://floodlist.com/europe/floods-belgium-july-2021>

The water level of Meuse river in Liege, Belgium rose 2.81 meters from July 14 to July 15, which resulted in an evacuation of over 1000 people in residential areas near the river. The Monsin Dam is located only 5 km upstream of Liege's city center and at one point had only two out of six sluice gates operational. Due to the fear of a potential failure of the Monsin dam the entire city of Liege was encouraged to evacuate on July 15th, but not required. The majority of infrastructure damage along the Meuse river was located in Dutch regions of the river and is addressed more comprehensively in the following section. Figure 3.274 show the flooding along the riverbanks of the Meuse river in Liege.

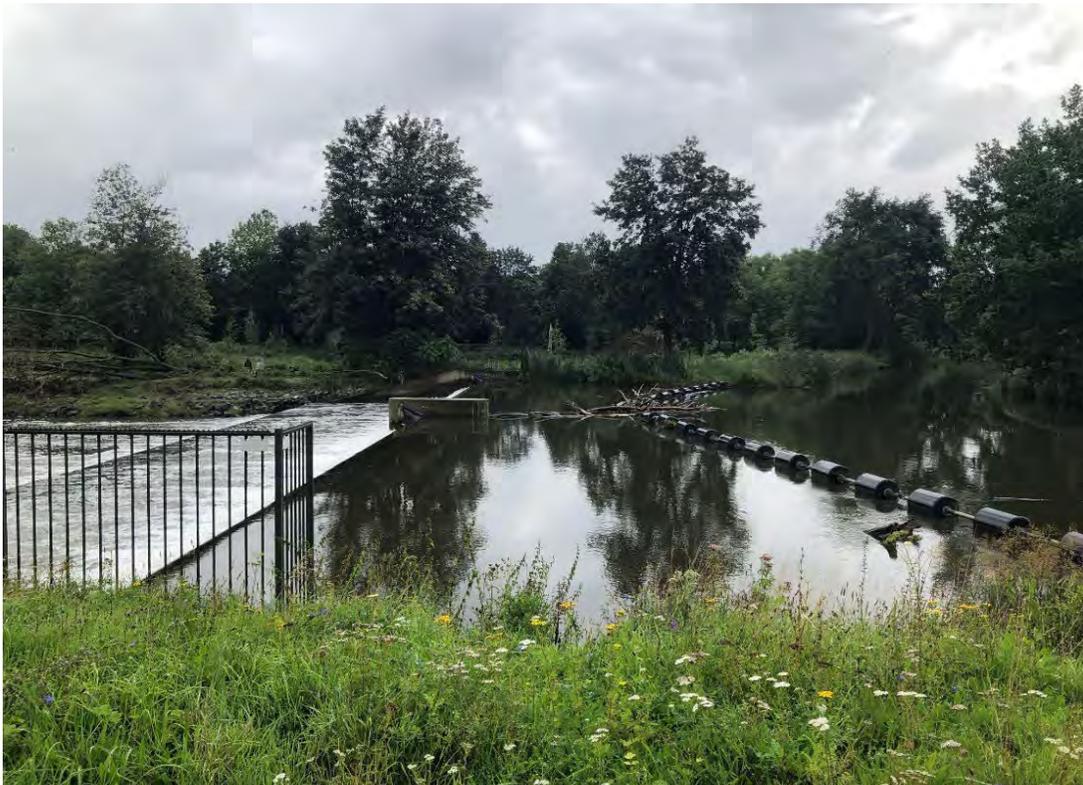
Figure 3.276. Intersection of the Roer and Hambeek rivers in Roermond, Netherlands. Water rose to the banks of the river but did not reach the roads or the power station nearby. (51°11'06.4"N 5°59'19.2"E)

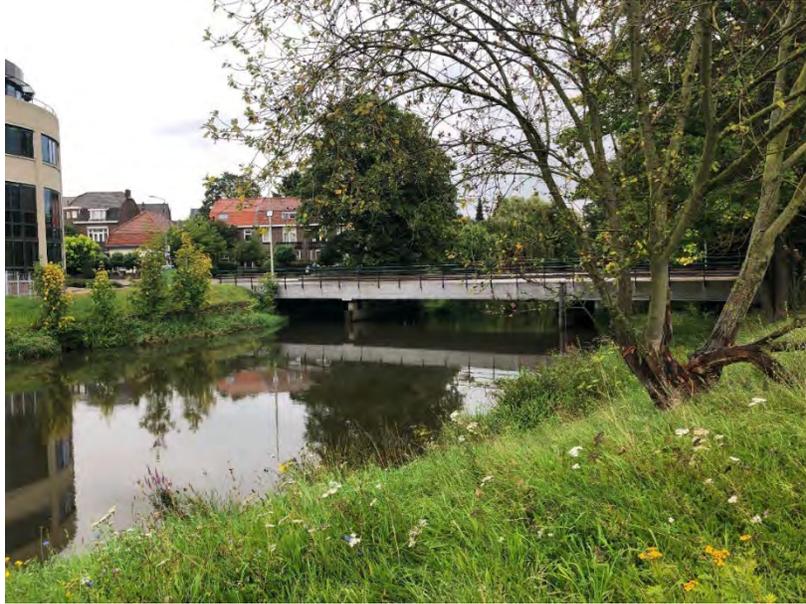
Figure 3.277. Approx. 50 meters from the intersection of the Roer and Hambeek rivers, a road bridge shows no signs of scour along the piers or embankment. Water levels did not breach the deck. (51°11'06.6"N 5°59'19.4"E)

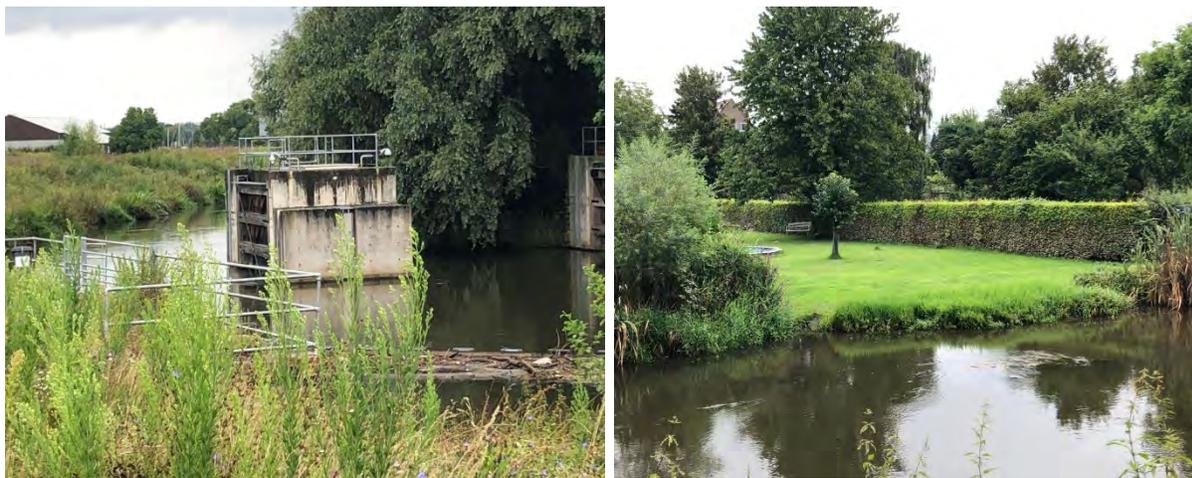
Figure 3.278 (left) shows the Roer river lock system, which is 1 km away from the intersection of the Roer and Meuse rivers. The lock system was closed at the onset of the flooding to protect the city of Roermond from flooding. Water levels reached the top of the concrete portion of the structure on July 17th, which resulted in a piping failure behind the right door and leaking through the center doors. Due to the closing of the lock doors, discharge from the Roer was therefore redirected towards the western Hambeek river. In the 1990's, an additional spillway called the Green River was built to accommodate future flood waters, however the Green River was not utilized in this scenario due to instability. A concrete top would have needed to be excavated first to activate it, which there was no time for. Figure 3.278 (right) shows the high-water mark along a row of bushes.

Figure 3.278. Left: Open river lock system on the Roer river (51°11'13.1"N 5°58'51.3"E); Right: High water marks shown on bushes in a residential yard near a 2-m dyke failure along the Roer river, which was repaired by the time of visit (51°11'08.3"N 5°59'04.0"E).

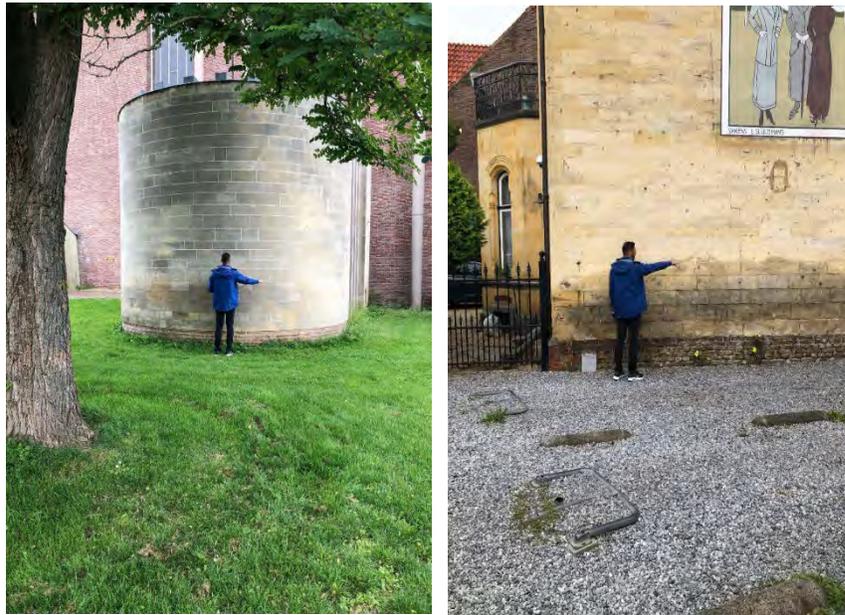
This section documents damage due to the flooding of the Geul river in the city of Valkenburg. Figure 3.279 shows high water marks visible on various structures, the GEER team member used for reference is 1.88m tall. Figure 3.280 shows damage to a masonry retaining wall structure. The retaining wall was structurally still intact, outside façade bricks seem to have detached and fell into the riverbed.

Figure 3.279. Left: High water mark on a building in the city center of Valkenburg ($50^{\circ}51'50.2''N$ $5^{\circ}50'03.3''E$), Right: High water mark along a residential building along the Geul river, Location $50^{\circ}51'53.0''N$ $5^{\circ}49'48.4''E$

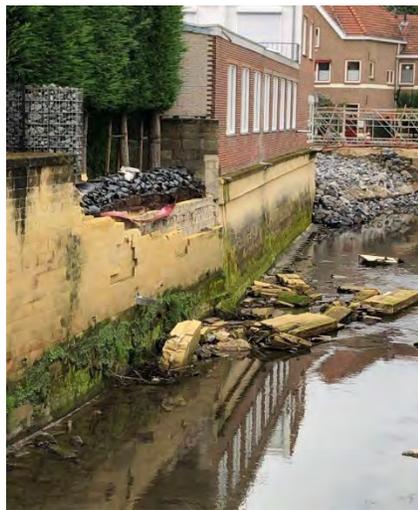
Figure 3.280. Retaining wall failure along the Geul river in Valkenburg ($50^{\circ}51'54.3''N$ $5^{\circ}49'49.8''E$)
