# Anterior uterine wall: normal and abnormal CT and MRI findings after cesarean section

## ABSTRACT

Cesarean section is the most commonly performed surgical procedure in women. The surgical incision line in the uterus is generally located in the lower segment of the anterior uterine wall. Acquaintance with the normal and abnormal findings of the anterior uterine wall is of critical importance for imagers in this era of ever increasing cesarean sections performed worldwide.

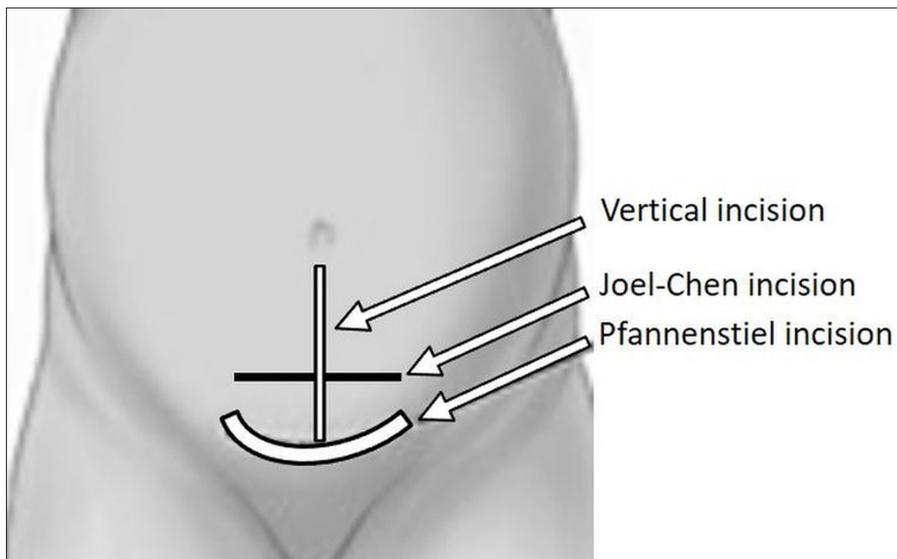
**Figure 1.** A diagram showing the Joel-Cohen, Pfannenstiel, and vertical incisions. The main difference between these techniques is the location of the skin incision.

Pfannenstiel transverse skin incision, which has been in use since the early 1900s, is a commonly utilized surgical approach made popular when first described by Monro Kerr in 1926 (3). Joel-Chen incision is a different surgical technique that was reported to cause less morbidity compared with Pfannenstiel approach (3). The main difference between these two techniques is the location of the skin incision (Fig. 1). The usual incision site in Pfannenstiel incision is 2 fingerbreadths above the pubic symphysis, while it is 3 cm below the line between the anterior-superior iliac spines in Joel-Cohen incision (3). After the skin incision, the underlying fascia is sharply opened and the rectus muscle is dissected and separated. After the peritoneum is reached the operator should be extremely meticulous while entering the peritoneum, in order not to damage any adjacent anatomic structures like urinary bladder and adjacent bowel segments. After this step, the uterus is well-exposed to the surgeon and an incision in the lower segment of the anterior uterine wall is created (this step is also called “hysterotomy”) (3). A transverse incision is preferred over a vertical incision as there is lower risk of uterine rupture in subsequent pregnancies, less blood loss, and a lower risk of bladder rupture. After this step the baby is delivered by applying pressure on the fundal segment of the uterus, which is followed by the delivery of the placenta (3). The uterine incision is then sealed with double-layer closure approach over single layer closure as the risk of uterine rupture is lower with the former (5). The surgery is finalized after closing the peritoneum, fascia, and the skin.

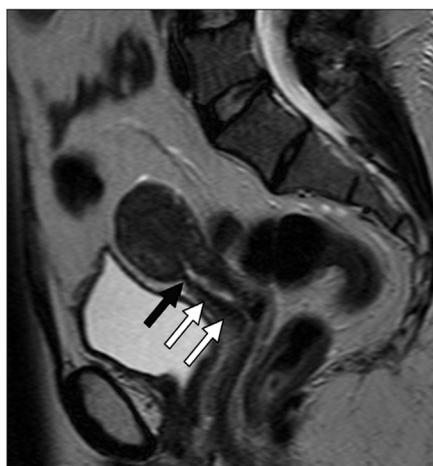
**Figure 2.** A 32-year-old woman with CS. Normal post-CS anterior uterine wall demonstrating long segment muscular loss and thinning (arrows) in the lower segment of the anterior uterine wall on T2-weighted sagittal image.

A variety of imaging modalities can be used in the evaluation of normal and abnormal post-CS findings (4). Ultrasonography (US) is the most preferred first-line imaging method (4). US may be useful in showing pelvic effusion and hematoma, but may be inadequate to assess the extent of abnormalities. The most preferred imaging method to show the abnormal post-CS findings is computed tomography (CT) (6, 7). The most important advantage of CT is that it allows for rapid evaluation of the entire pelvic region. CT can also be used to rule out vascular abnormalities such as active arterial bleeding and thrombosis. Intravenous contrast material should be administered to distinguish normal and abnormal findings on CT images. Recently, MRI has increasingly been used to show post-cesarean complications (4, 8). The most important advantage of MRI is that it shows the localization and extent of abnormal postpartum abnormalities better than CT because of high tissue contrast (4). In the early phase after CS, the incision site of the hysterotomy may appear as an oval area extending from the uterine cavity to the outer edge of the anterior uterine wall. This incision site appears hypoechoic relative to the myometrium on US, shows as an oval hypodense area on CT, and has higher signal intensity relative to muscles in the myometrium of the anterior lower uterine segment on T1- and T2-weighted images (4, 8). Low signal intensity at the incision site on T2-weighted images, probably secondary to subacute hematoma, should not be confused with dehiscence. The low transverse incision site is best visualized in the sagittal plane reformat on CT or MRI and the vertical incision site is best visualized on axial CT or MRI (Figs. 2 and 3). Also, a small hematoma which appears hyperechoic on US and a high-attenuation collection on CT

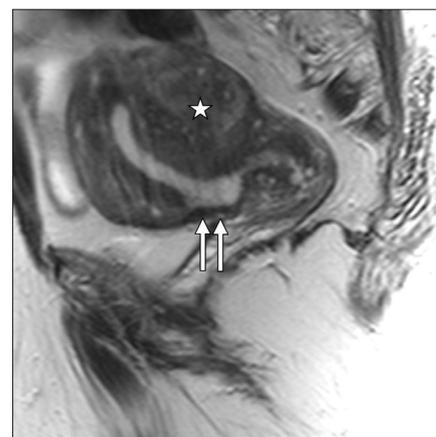
**Figure 3.** A 28-year-old woman with CS. Normal post-CS anterior uterine wall demonstrating shorter segment muscular loss and thinning (arrows) in the lower segment of the anterior uterine wall on T2-weighted sagittal image. Also, note the presence of adenomyosis in the myometrium (asterisk).

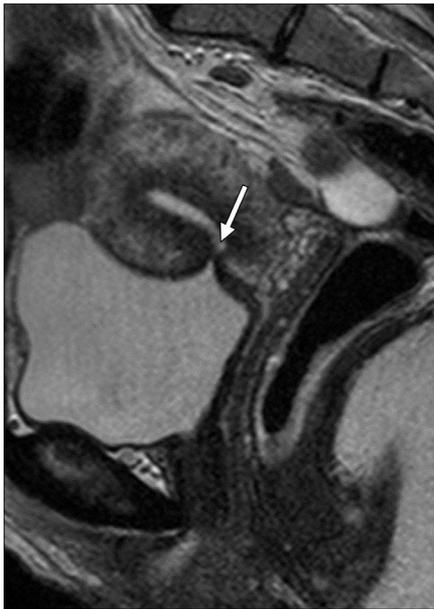
**Figure 4.** A 34-year-old woman complaining of urine draining from the vagina which started immediately after CS. Sagittal T2-weighted image of the uterus shows direct communication (*arrow*) between the lower segment of the anterior uterine wall and the bladder.

to surgical injuries (9). Intermittent hematuria, urine leakage, and incontinence are the most commonly reported clinical complaints. These fistulas are located at the level of isthmus or cervix, and the tract is lined by granulation tissue, inflammatory cells, and fibrous tissue (9). Vesicouterine fistulas may heal spontaneously, albeit, this is a rare occurrence. Surgical treatment is generally indicated. Cystoscopy, hysterosalpingography, and cystography are common conventional diagnostic modalities with imaging playing an ever-increasing role in the diagnosis. Transvaginal US may directly detect the fistula in some cases (10). CT may also be helpful to outline the abnormal tract. MRI, with its excellent soft tissue resolution, is very helpful for the diagnosis, making it the imaging modality of choice. T2-weighted images are the most commonly utilized sequences and may allow direct visualization of the abnormal communication (11) (Fig. 4).

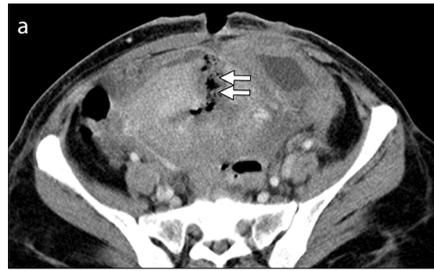
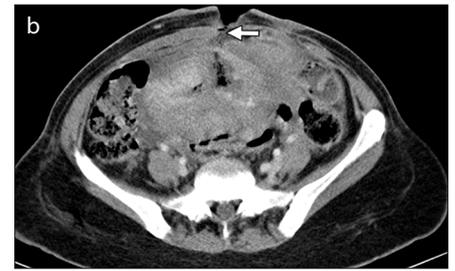
**Figure 5. a, b.** A 29-year-old woman with purulent drainage through the CS scar starting 3 days after the surgery. Axial contrast-enhanced CT image (a) shows the fistulous tract extending from the endometrial cavity to the skin (*arrows*). CT image from a lower level (b) shows the opening of the fistula to the skin (*arrow*).

conventional diagnostic methods, with the advent of cross-sectional imaging modalities the diagnosis can also be safely made with CT or MRI (Fig. 5).

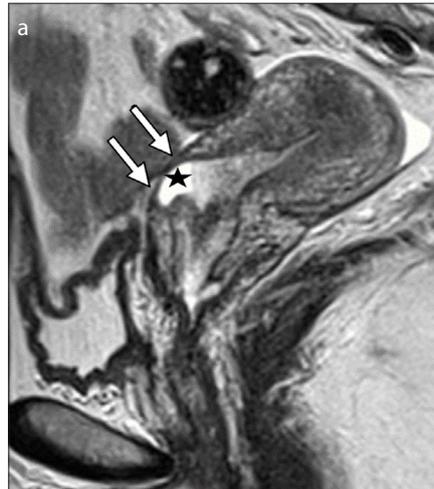
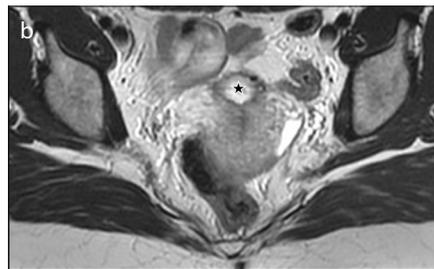
**Figure 6. a, b.** A 34-year-old woman with continuous abnormal uterine bleeding and pelvic pain 3 months after CS. Axial plane T2-weighted image (a) shows herniating endometrial content (*asterisk*) through the anterior uterine wall defect. Sagittal plane T2-weighted image (b) of the same patient better outlines the anterior uterine wall defect (*arrows*) and the externally herniated endometrium (*asterisk*).

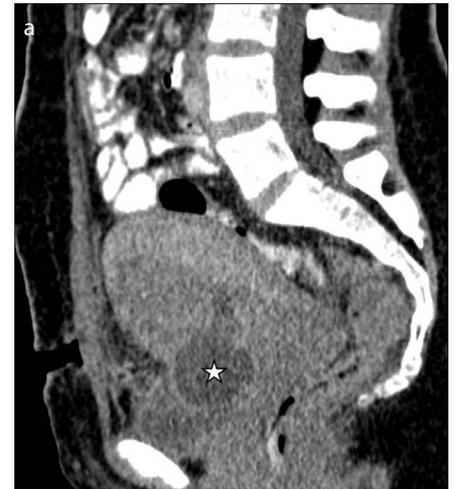
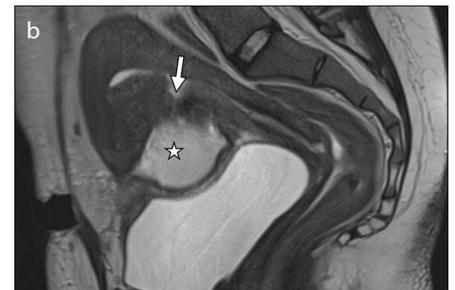
**Figure 7. a, b.** A 28-year-old woman with severe pelvic pain and copious bleeding per vagina 2 days after the cesarean section. Sagittal reconstructed contrast-enhanced CT image (a) shows an abnormal cystic structure (*asterisk*) anterior to the uterus. Sagittal T2-weighted image (b) of the same patient shows that the cystic structure depicted in the CT image represents a large isthmocele (*asterisk*).

relative paucity of scientific data regarding the diagnosis and treatment of CSD. Repeat CS, uterine position, labor before CS, and surgical technique have all been mentioned as risk factors for CSD occurrence. Uterine morphology has also been implicated as a risk factor, with retroverted uterus reported to be more prone to CSD occurrence (13, 15) (Fig. 6). The most commonly associated symptoms with CSD are abnormal uterine bleeding, secondary infertility, ectopic scar pregnancy, and pain (13). Early detection and treatment is of critical importance to prevent these potential complications. Transvaginal US is generally the first imaging modality to be used; however, MRI may better evaluate the complete extent of this clinical problem. T2-weighted sequences are the most commonly utilized images as internal genitalia can be evaluated in detail (Fig. 7). Detection of an anterior myometrial wall defect and continuation of the endometrial contents into the isthmocele pouch are the most helpful imaging clues.
