Pathological Manifestation and Restoration Procedures Analysis of the Historic Building, located in Belém-PA

Catarina de Nazaré Pereira Pinheiro, Adriene Rodrigues Barbosa.

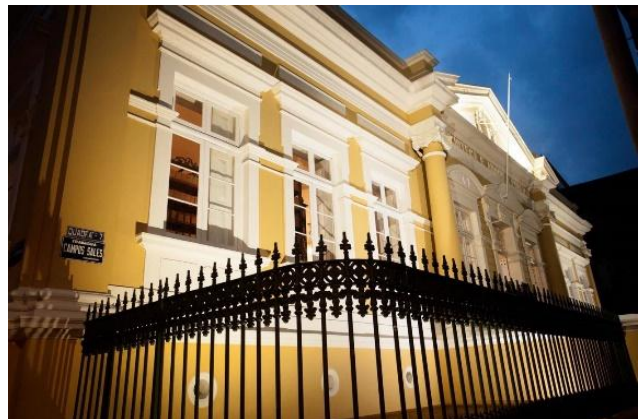
After the construction work ended, it was performed and released to the public a photographic record of the reform and restoration attained results (Fig. 31 and 32). The building was reopened to the public in October of 2017 and operates regularly nowadays.

Fig. 35: Library Arquivo Público (Source: Press Release 2017)

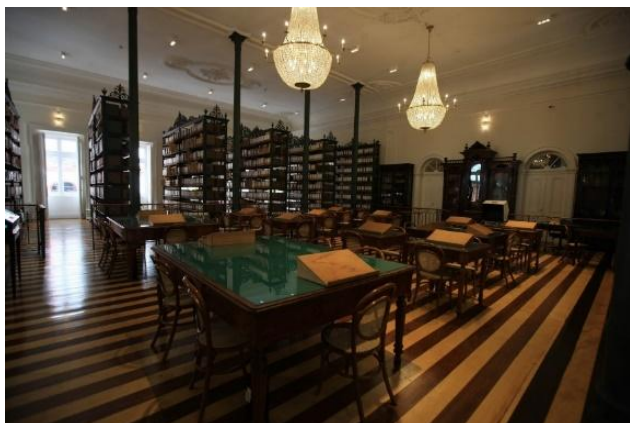
Fig. 32: Restoration of ground floor (Source: Press Release 2017)
