BUILDING PERFORMANCE EVALUATION OF THE EMERGENCY ANTARCTIC MODULES OF BRAZIL BASED ON THE SATISFACTION OF ITS USERS

Cristina Engel de Alvarez* & Wagner Gomes Martins

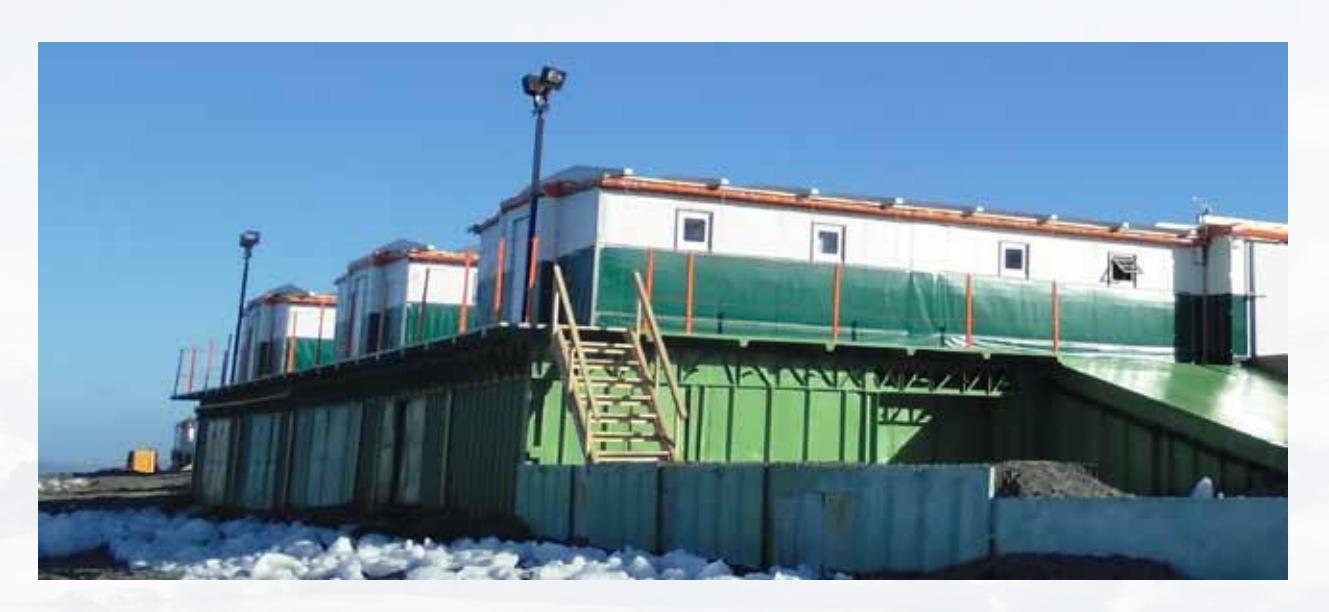
The Emergency Antarctic Modules (MAE, Figure 1) were installed in the area of the Comandante Ferraz Antarctic Station (EACF) in early 2013 to support the removal of the debris from the fire in 2012 and for the continuation of scientific activities undertaken at the site. The MAE has been in use since February 2013 and has a minimum service life of 5 (five) years with the possibility of dismantling and relocation (Marinha do Brasil, 2012).

Figure 1. Exterior view of the MAE. Source: Laboratório de Planejamento e Projetos - LPP/UFES - Photographs Collection.
